IFFCO
KALOL UNIT

P & S SECTION
MAINTENANCE DEPTT.
REPORT NO. 7/1984

ANNUAL TURNAROUND 1984

1.1.1984 - 25.1.1984

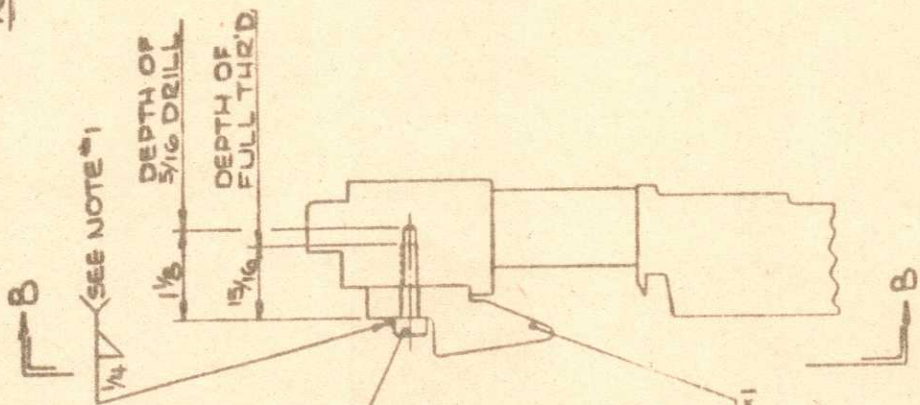
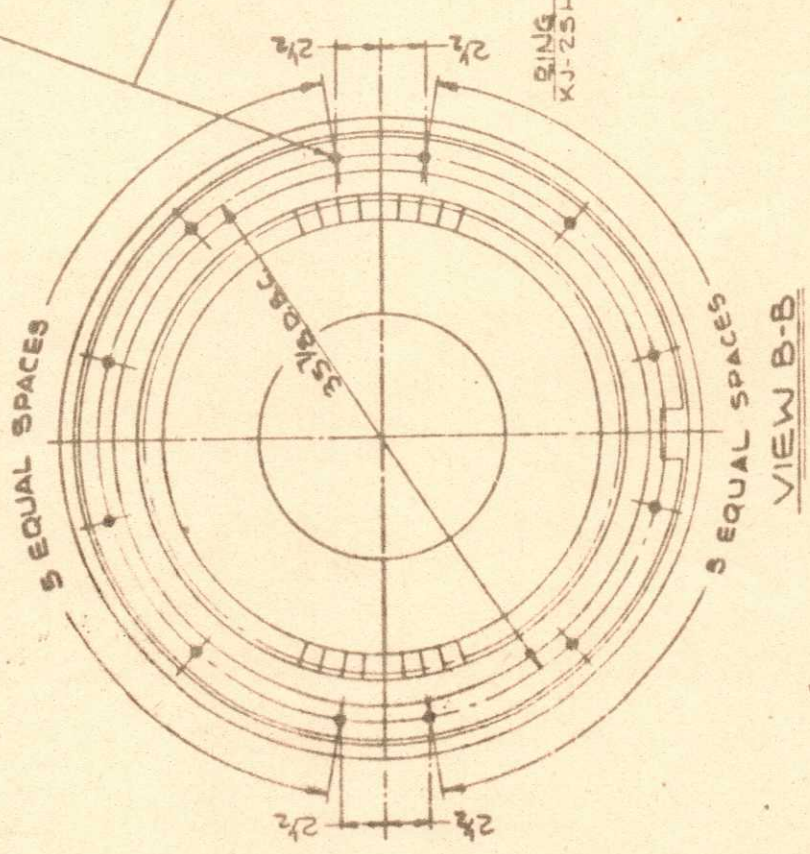
Normally moisture rings are plug welded with the diaphragms ; On long run plug welds get deteriorated in several instances, and thereby permitting the moisture rings to loosen. In case the moisture rings come out completely from the diaphragms, severe damage can occur to the rotor. To prevent this, extra fastening of the moisture rings was suggested by M/s. De Laval. We have carried out the extra fastening of the moisture rings to the diaphragms (5th, 6th & 7th) as per the procedure given by the representative of M/s. De Laval. (Refer Drawing attached herewith)

In our turbine, the plug welds of diaphragms were found in good condition, but to have extra precaution, the above modification was done.

DRILLING & TAPPING NOTE IS WITH MOISTURE RING IN PLACE ON DIAPHRAGM.
 5/16 DRILL TO DEPTH SHOWN, 1 1/2" C BORE
 1 7/32 DEEP, 3/8-16 TAP TO DEPTH SHOWN.
 6 HOLES IN EACH HALF SPACED AS SHOWN ON 35 7/8 O.B.C. TOTAL 12 HOLES.
 12 CAPSCREWS 3/8-16 x 7/8 LG. MATL. ASTM A5-4 (DELAVAL HARDWARE #003030, MATL. 0404)

- TACK WELD EACH CAPSCREW IN PLACE, USE 3/32 DIA. ROD. INCO WELD A.

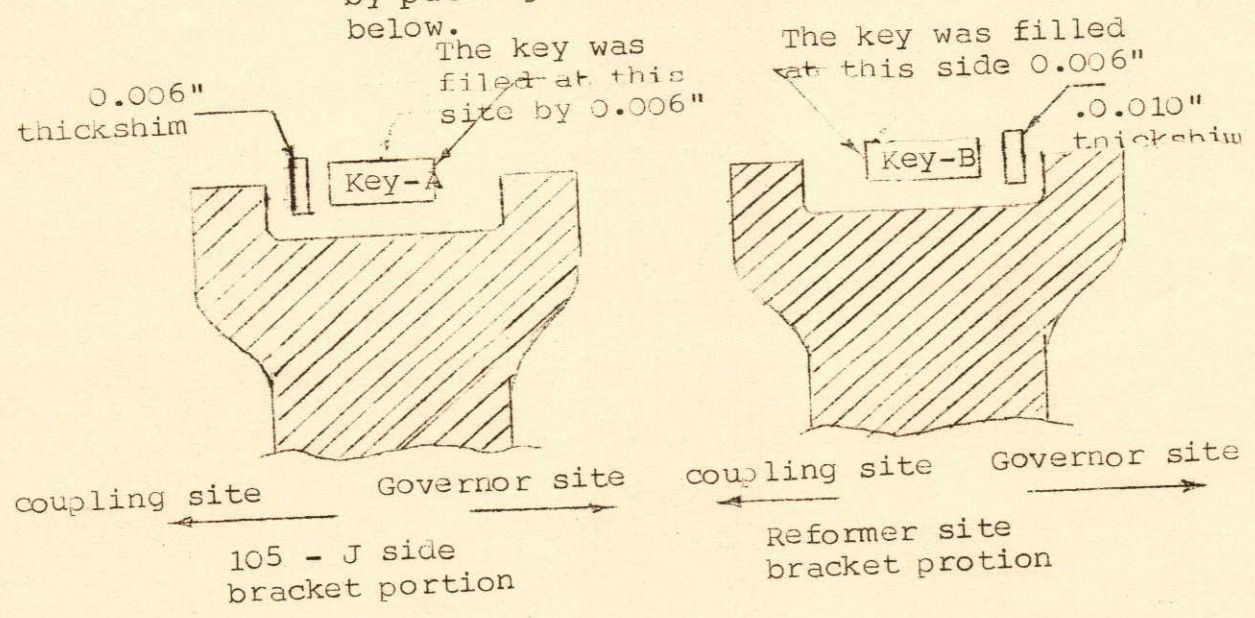
The crack at key portion of bearing pedestal was repaired by metal locking as per following procedure.

- a) Welding was removed by grinding
- b) The cracked piece was knocked off
- c) Faces of cracked portions were ground and thoroughly matched by blue impressions.
- d) Cracked portions were properly clamped with bearing block
- e) Metal locking was then carried out
- f) Also the welding was carried out on the left over portion of metal locking for extra strengthening. The welding was carried out with 680 welding electrodes.

The repaired bearing pedestal was then brought to site and put in position and properly aligned by putting necessary shims as per sketch shown below.

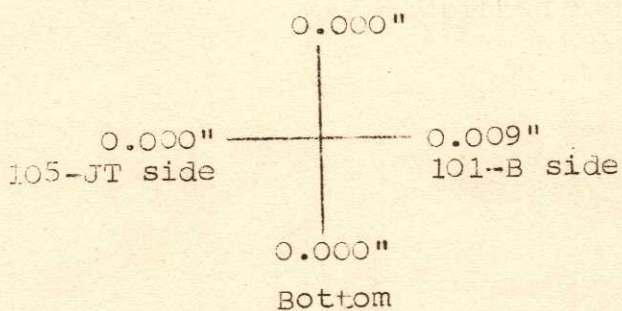
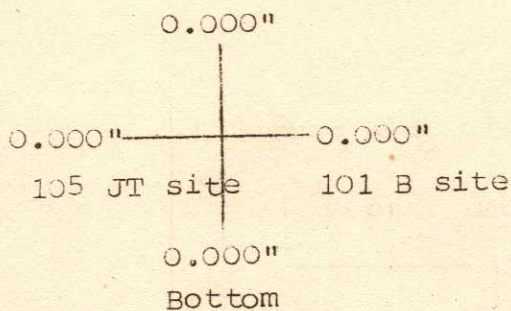
Finally alignment readings were taken which are mentioned below.

Before alignment

After alignment
