IFFCO
Kalol Unit

P & S Section
Maintenance Deptt.
Report No.9/1987

ANNUAL TURNAROUND - 1987
(12th April 1987 - 3rd May 1987)

INDIAN FARMERS FERTILISER CO-OPERATIVE LIMITED

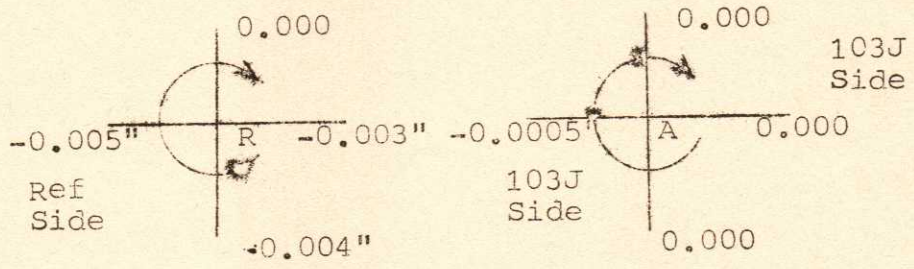
Checked the alignment between the turbine and LP Case before and after installation of exhaust line, found not much difference given below the alignment reading after installing the exhaust line.

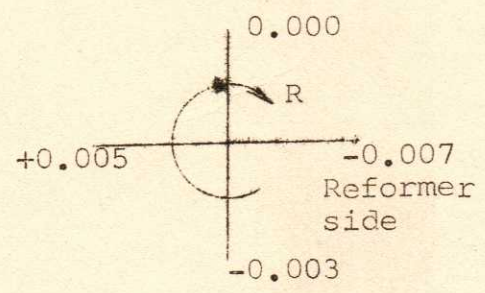
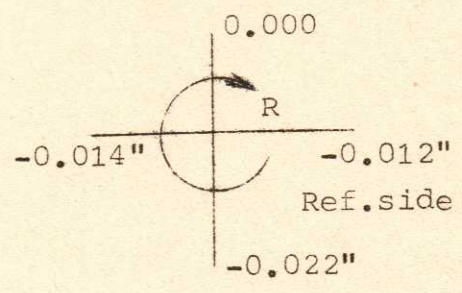
Also checked the alignment between Turbine to G.B. & G.B. to I.D. Fan. Readings are given below:-

Turbine to G.B. <u>Dial on Turbine shaft</u>	G.B. to I.D. Fan <u>Dial on Fan Shaft</u>
---	--
