I F F C O
KALOL - UNIT

P & S Section
Maintenance Deptt.
Report No. 12/1990

PLANT TURNOVER - 1990

(Ammonia Plant 5/02/90 TO 05/03/90)
(Urea Plant 31/01/90 TO 07/03/90)

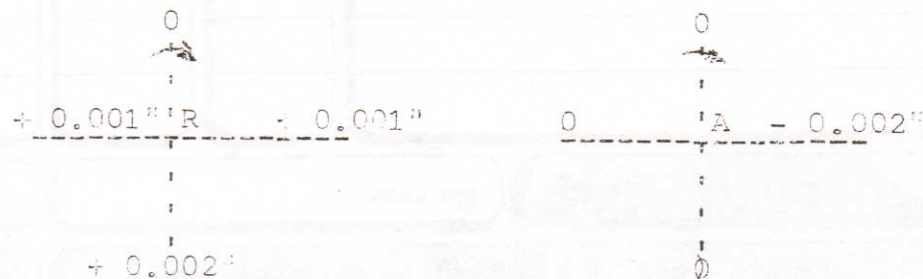
DIAL POINT ON PUMP

The alignment readings are of under.

As a preventive maintenance check up, we have taken out the complete pump (Screw pump) and installed the spare new pump assembly after doing proper alignment between turbine & pump.

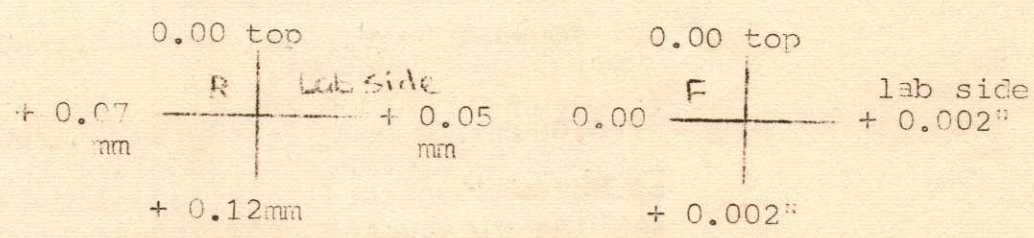
Alignment Reading - Dial on Pump

Code No	Description
3 02 03 & 04	COOLING WATER PUMP P-4402, P-4403 :
	01 Decoupled the pump and Removed casing.
	02 Inspected Rotor condition, casings, and neck rings found Ok.
	03 Cleaned Casings, Gasket area and Rotor manually.
	04 New Gasket of 1mm thickness Champion 20 provided and Boxed up casing.
	05 New Gland packing provided (1" thickness)
	06 Also checked Bearing clearance which is 0.003" on Both side for P-4403.
∠ white	07 Also In-board bearing of P-4402, top Half/metal worn out badly, so replaced, Bearing and clearance maintained as In board bearing - 0.25mm Out board bearing - 0.21mm
	08 Flush gland cooling line and valve changed.
	09 Checked alignment with prime mover Pump (P-4402) found 0.030" down. Realigned pump & motor and coupled it with fresh grease.
	10 Alignment readings maintained are as under (P-4402)

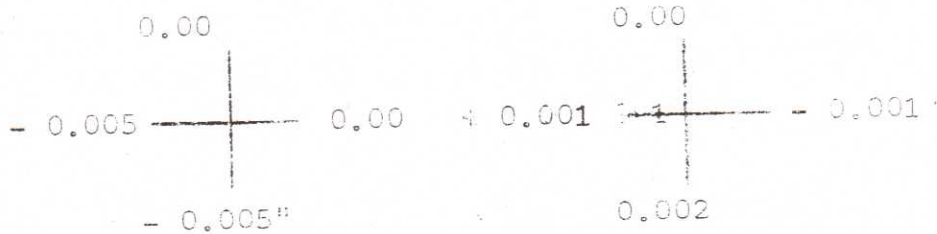
01 Raw water pump P-4101/B Base plate changed, alignment done. Alignment of Raw water pump.
