I F F C O
K A L O L - U N I T

Planning Section
Maintenance Deptt.
Report No.12/1991

R E P O R T
O N
P L A N T T U R N A R O U N D - 1991
(AMMONIA PLANT 24-02-91 TO 13-03-1991)
(UREA PLANT 23-02-91 TO 14-03-1991)

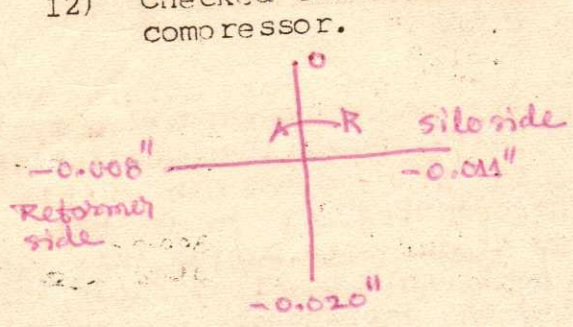
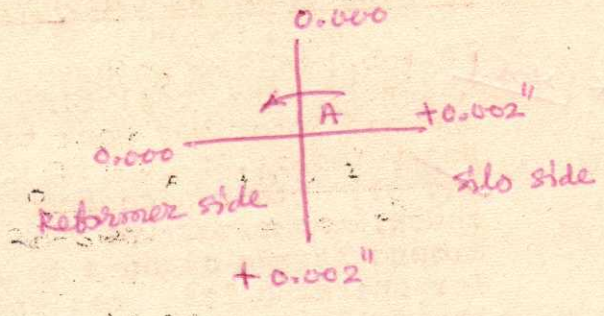
1 01 03 12) Checked the cold alignment between turbine to LP case compressor.

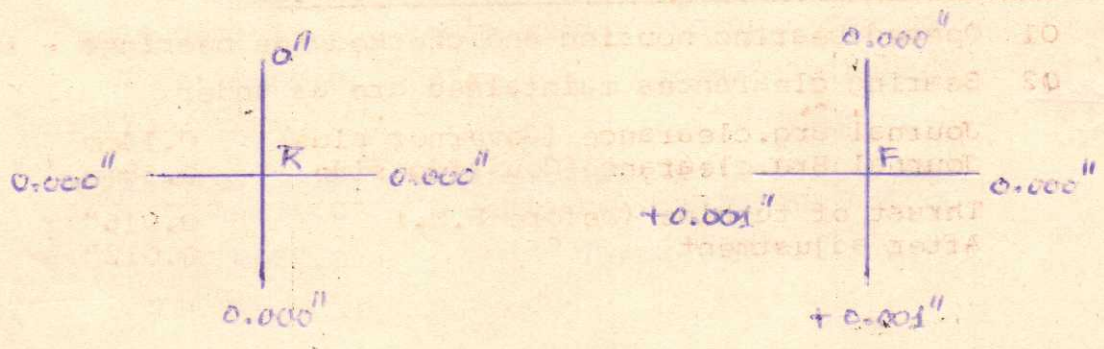
- 01 Decoupled the pump and removed casing
 - 02 Inspected rotor condition, casing and neck rings. Both the shaft sleeves are worn out badly. It was decided to replace the rotor with new one.
 - 03 New neck rings made rotor jam, so replaced with old neck rings.
 - 04 Changed the journal bearings as the white metal portion was damaged at one place.
 - 05 New Gasket of 1.2mm thickness, champion style-20 provided and boxed up the casing.
 - 06 New gland packing (25mm Sq.) Provided.
 - 07 Flush gland cooling lines.
 - 08 Checked alignment with motor. Realigned pump and motor and coupled it with fresh grease.
- Alignment readings maintained are as under.

Also replaced the journal bearing

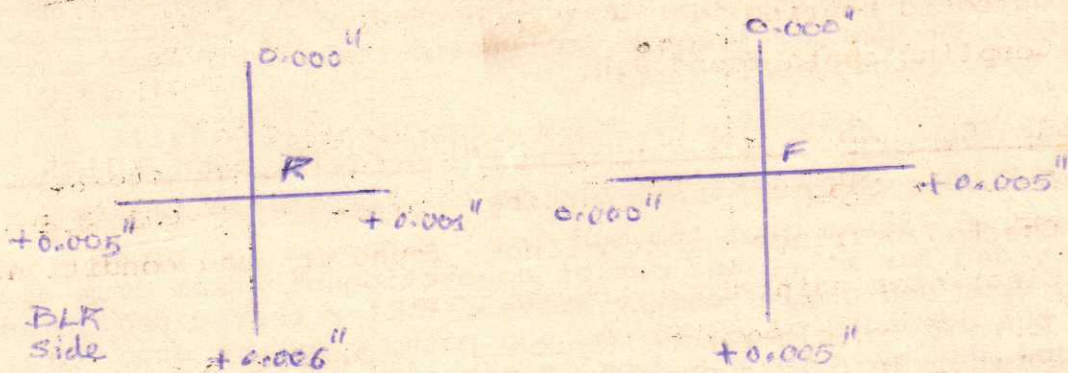
3 03 01 02 Checked alignment (Needle on fan shaft)
