PLANNING SECTION

MAINTENANCE DEPTT.

REPORT NO. 21 / 2001

REPORTONPLANT TURNAROUND( MARCH - APRIL - 2001 )INDIAN FARMERS FERTILISER CO - OPERATIVE LIMITED

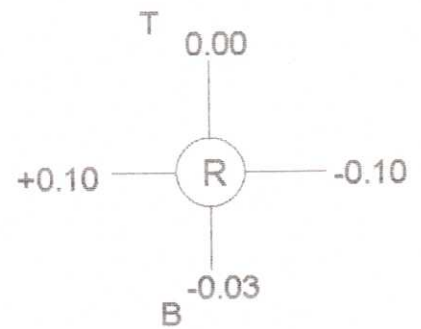
Before Correction (Looking from Turbine End)

- 1) Both the journal bearings as well as thrust bearings were inspected and their clearances were found to be within the acceptable limits.
- 2) The HP case inter stage suction piping from 131-JC was loosened and it was observed that pipe got shifted by about 1.5" towards Northeast. In order to avoid the strain on the pipe line.Piping, was dismantled and was refabricated with tacking in position. After final welding the pipeline was reinstalled into the position and was found to have no strain .The machine was aligned and the readings are as shown below.
- 4) All the four expansion joints were also set to their correct cold settings.
- 5) During startup, south side (inboard) bearing started showing high vibrations from minimum governor speed (1.7 Mils in H direction) and the same reached at App. 3.7 mils at about 6000 RPM .

- 1) Doubting the vibrations beyond a particular RPM due to newly installed FR-4 orifice, the orifice was removed and machine was restarted. However there was no improvement in vibration levels.
- 2) Hence the machine was decoupled and the alignment was checked which was found to be slightly misaligned in horizontal direction with HP case moving towards siloside.
- 3) Both bearings which were found to have their clearances on higher side within the acceptable range (0.17mm) were replaced with new pads. The new clearances were 0.13 mm for both bearings.
- 4) Again all the flanges connected to compressor casing were checked for strain and no strain was found in them.
- 5) The orifice was reinstalled as no improvement was found by removing the same.

The machine was rolled again. However no improvement was found in the vibration levels. The readings taken during the overhaul of all the machines in the train are recorded as under.

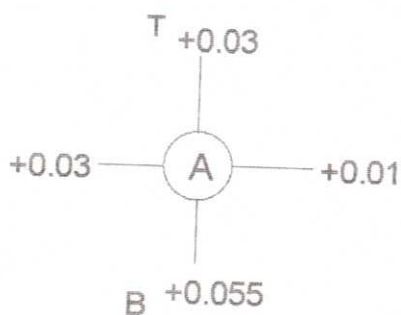
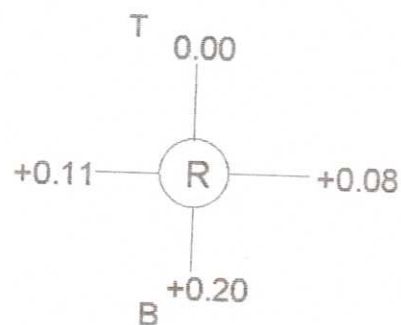
N.G. COMPRESSOR TRAIN ALIGNMENT READINGS - 102

( TURBINE- COMPRESSOR )

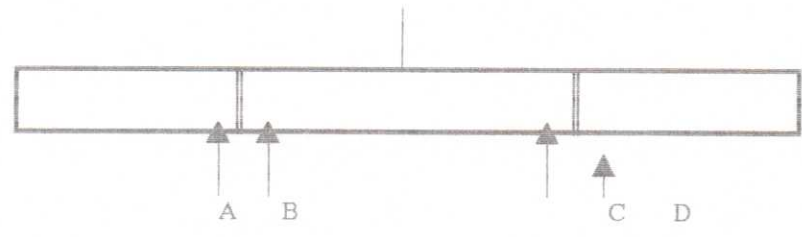
NOTE : (1) ALL DIMENSIONS ARE IN INCH.  
 (2) MAXIMUM DIAMETER OF 5.62512" WAS OBSERVED WHICH CORRESPONDS TO 1.12% CREEP.

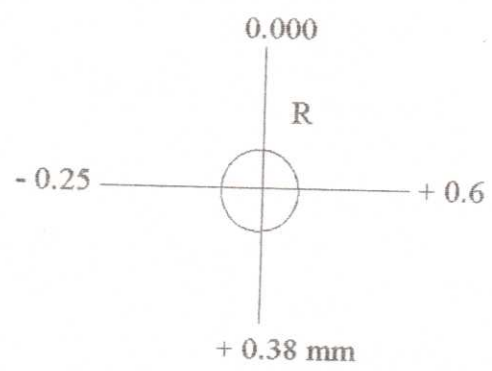
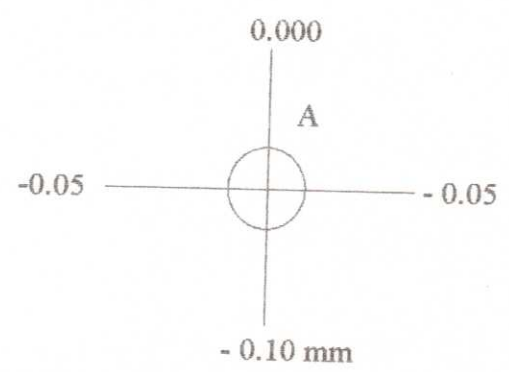
- (a) Both the journal Bearings were checked and found okay.
- (b) The clearances were checked & following are the readings:  
Free end side : 0.008"  
Coupling side : 0.007"
- (c) Pump with gear box of Elliot Turbine alignment was checked  
Following are the readings:  
Dial indicator fixed on gear box (Dial indicator on Pump Shaft)

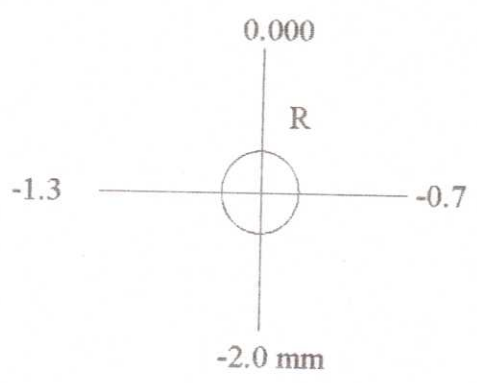
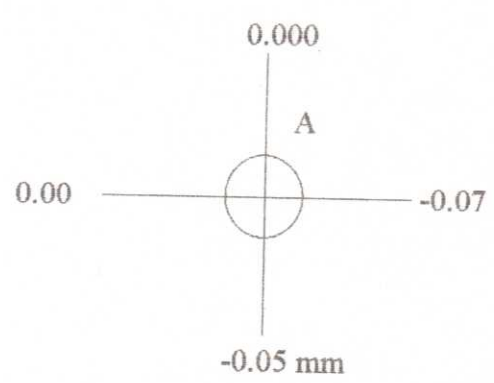
Dial indicator fixed on gear box (Dial indicator on Pump Shaft)

(h) Pump & Turbine alignment was checked.  
Following are the readings.

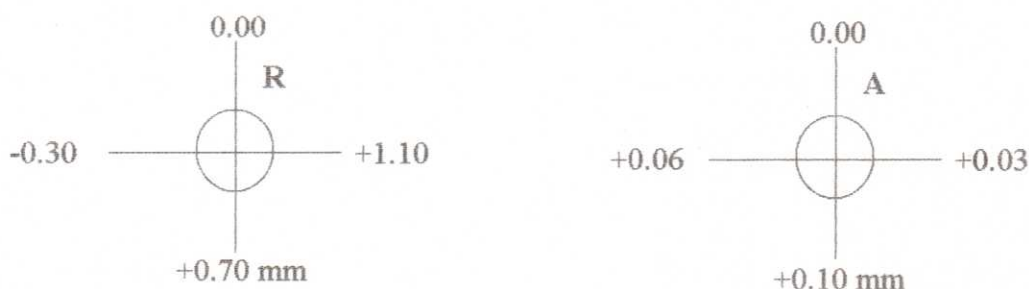
Dial indicator fixed on motor (Dial indicator on Pump Shaft)

- (b) New repaired bearing installed issued from store against store code no. 333200024.
- (c) Two drills of 10 mm dia. and 10 mm deep were made on journal Bearing bottom half to facilitate the easy removal of the bearing.
- (d) The damaged journal Bearing bottom half white metal lining repaired by applying Eutectic -157P paste & deposit white metal filler wire Eutectic-157
- (e) The clearances were checked & following are the readings.  
Free end side : 0.17 mm                      Coupling side : 0.22 mm
- (f) Both the bearing housing were flushed with oil & fresh oil servo prime 68 charged in the both bearing housing.
- (g) Decoupled the pump coupling , cleaned & greasing done.
- (h) Alignment was checked & followings are the readings.
