**IFFCO**  
**KALOL UNIT**

PLANNING SECTION  
MAINTENANCE DEPTT.  
REPORT NO. 22 / 2002

**REPORT**  
**ON**  
**PLANT TURNAROUND**  
**( MARCH - APRIL - 2002 )**

**INDIAN FARMERS FERTILISER CO - OPERATIVE LIMITED**

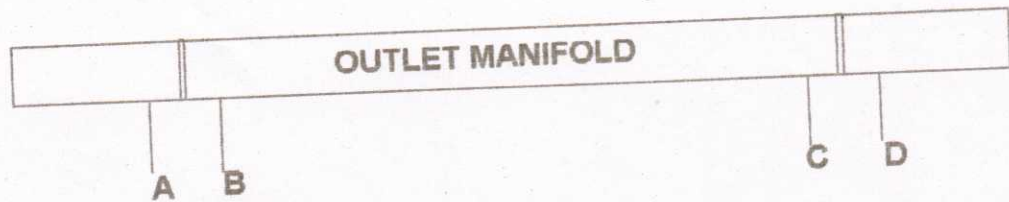
(2) Maximum diameter of 5.6244" was observed which corresponds to 0.5 % Creep.

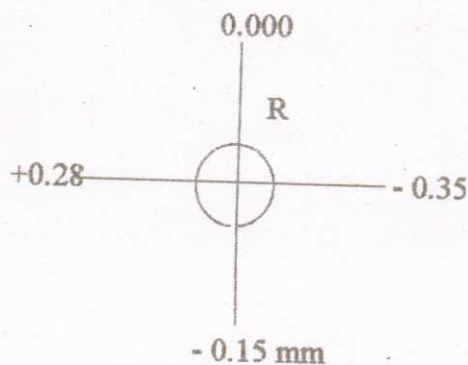
Dial on gear box Coupling

- (e) Pump with gear box of Elliot Turbine alignment was checked  
Followings are the readings:

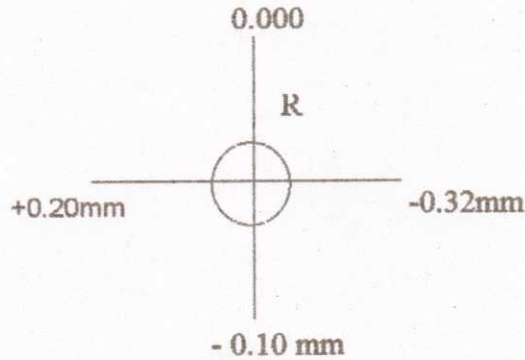
Dial on gear box coupling

Alignment was corrected, Followings are the readings:

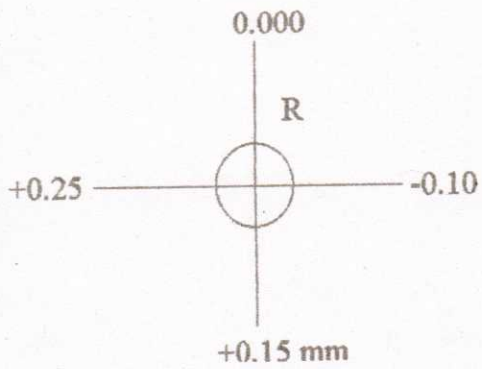
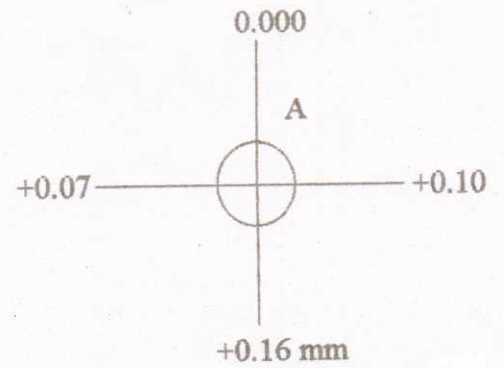
(g) Gear Box to Turbine alignment was checked

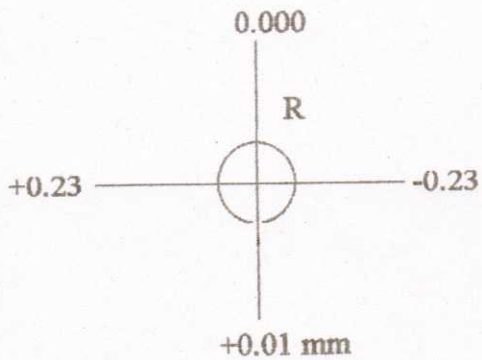
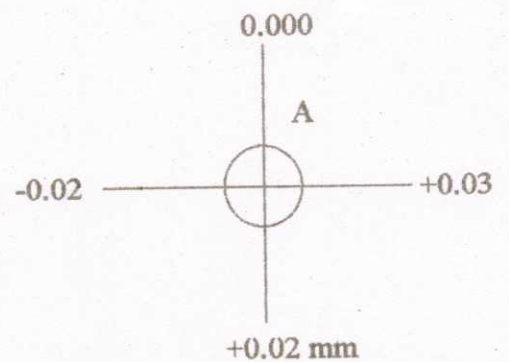
Alignment was corrected, Following are the readings:
