INDEX

2005-1

Plant Turnaround for the year 2005 was carried out from 22-05-2005 to 29-06-2005 for preventive maintenance of the plant equipment / miscellaneous jobs pending for the plant shutdown, including installation & commissioning of various equipments and vessels for the ambitious energy saving schemes of the Ammonia plant.

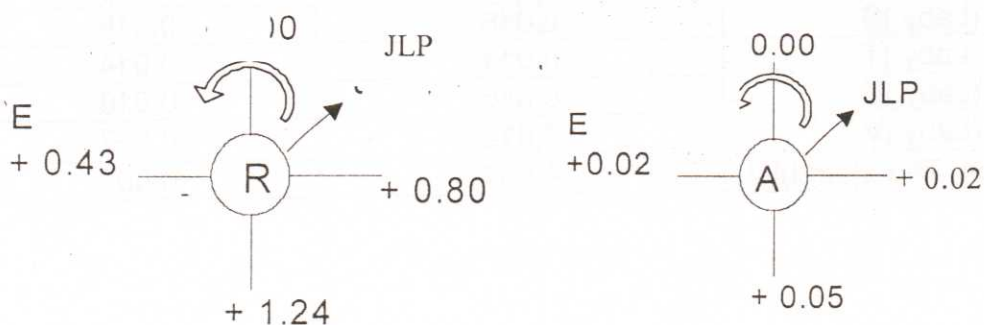
ALIGNMENT READINGS OF 103-JAT-JLP

During startup after completion of Annual Turnaround of the plant, 103 J train was started on 25th of June' 2005 and Synthesis Gas Compressor was put on slow roll. The vibrations were measured and were found to be normal at 4000 RPM. The speed was further increased and while passing through the range of 6500-6700 RPM, high shaft vibrations were experienced on panel. The machine was tripped immediately and on inspection, coupling between Back Pressure Turbine (103-JAT) and LP Case compressor (103-JLP) was found to have got slipped and subsequently seized on the shaft of the turbine.

- New rotor kept in position and labyrinth clearance checked
- Top casing placed in position and bolts tightened
- 103-JLP coupling fixed
- Nozzle clearance checked and found to be 2.00m.and to reduce to 1.00mm new shims were used. New shims had to be surface grinded from thickness 10.00mm to 8.50mm.

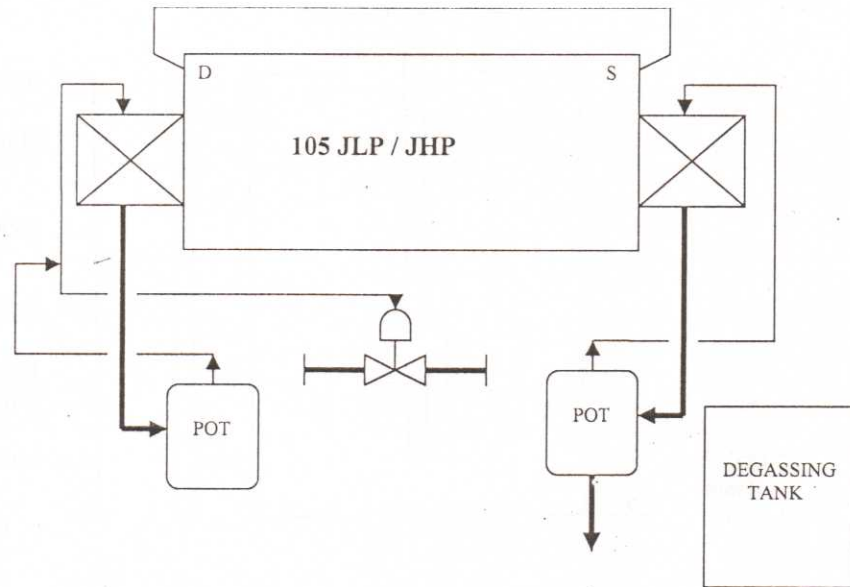
105 JLP/JHP SEAL OIL DRAIN TRAP SYSTEM (OLD):

As the existing floating ball type seal oil trap size was inadequate and oil was ingressing into the compressor, new electronic seal oil trap, procured from the OEM of the compressor (M/S Delaval) installed and commissioned for LP Inlet, LP discharge, HP Inlet & HP discharge (4 Nos..)

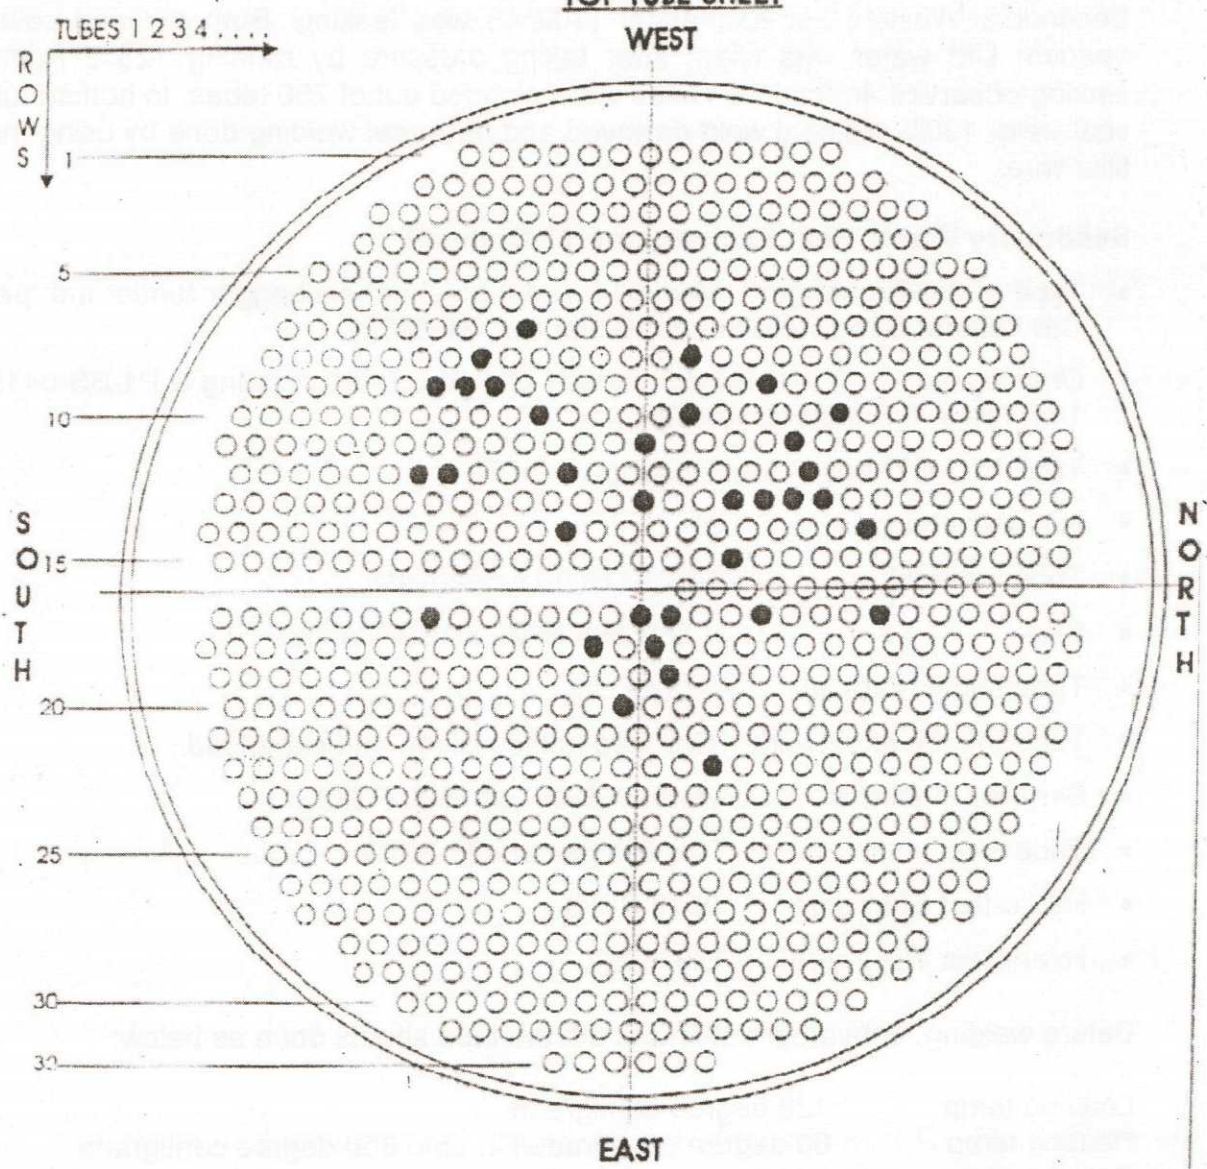
TOP TUBE SHEET
WEST

Total 34 nos. of tubes plugged during Annual Plant Turnaround, May - June 2005

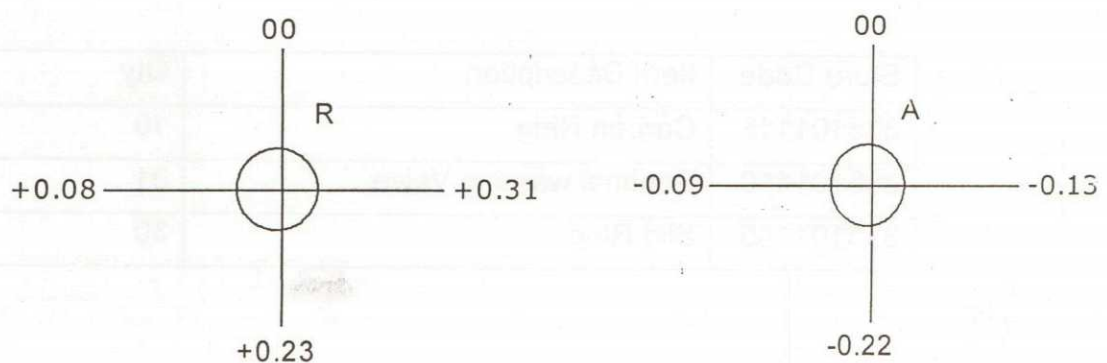
Alignment Readings: Pump To Turbine (Before Preventive maintenance) Clamp on Pump & Dial on Turbine

- Cleaning of Radial & Thrust bearings.
- Checking radial clearances of bearings using lead wire.
- Alignment readings were checked and found that alignment is disturbed.
- During re-alignment of turbine, one foundation bolt (governor end side) of turbine was found broken inside casing leg. The bolt was removed by welding of metal piece.
- Same bearings were assembled after polishing and cleaning.
- Install coupling spacer with reference to match marks.
- The oil cooler covers were opened and hydro- jetting was carried out.
- Cleaning / replacing oil filters and oil in the oil console.
- Checking oil line, water line for leaks.
- Suction filter of the MOP was cleaned.
