MTC / REPORT / 01
REPORT NO. 26 / 2006

KALOL UNIT

PLANT TURNAROUND REPORT
(APRIL - MAY - 2006)

INDIAN FARMERS FERTILISER CO - OPERATIVE LIMITED

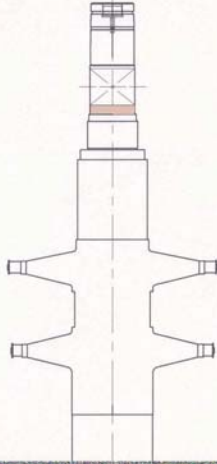
GROUP FOR 103-JAT
(SER. NO. 444)

During Preventive maintenance of 103 JBT and 103 JAT Turbines, gear coupling between 103 JBT and 103 JAT was checked for its free float. While the inspection of the coupling it was noticed that very less float in the spool piece. Opening the spool piece it was found the hub of 103JAT shaft slipped out and overhung by 6-7 mm.

On measurement, the coupling Hub face was found projected by 7.1 mm from shaft face. This excessive projection of coupling Hub from the shaft face clearly indicated slippage of coupling Hub from the shaft. (Normally the Hub face should be flush with shaft face OR it may be ± 0.5 mm after hydraulically fit up) The hub could not be removed with expander pressure up to 35000 psi. The hub was taken out by cutting with hand grinding machine. The coupling shaft area found badly damaged due to the metal flow by the coupling hub slippage. (Rotor Sr.No.TR 444)

Earlier High Velocity Oxygen Fuel Thermal Spray Process suggested it to repair the damage. But the depth of the damage was more than 1 mm deep which is not repairable by HVOF as there is possibility of peeling off the material deposited, due to torsion stress during running of the turbine. Hence it was decided to repair the damage area by welding process as per API-687, Rotor repair.

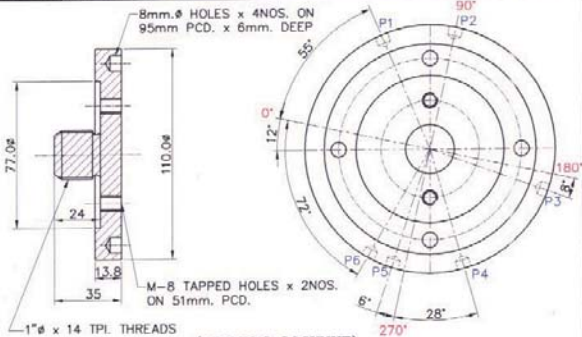
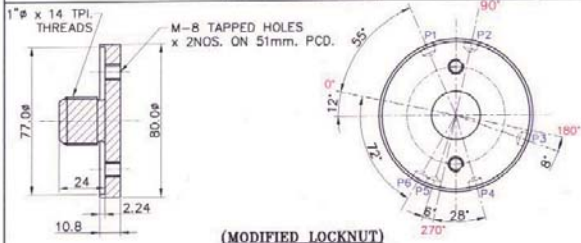
DETAIL OF DRILL HOLES PROVIDED ON PERIPHERY FOR BALANCING

Hence, Revised depth of holes was calculated as follows:-

Weight Removal by 7 Ø hole and 1mm depth = 0.3 Grams therefore for 1.86 Grams with 7 Ø new depth required = $1.86 \div 0.3 = 6.2\text{mm}$

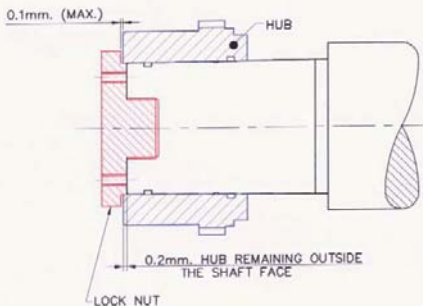
**"LOCKNUT" ARRANGEMENT
FOR SHIM PACK COUPLING HUB TOWARDS 103-JLP SIDE
(FOR SHIM PACK COUPLING BETWEEN 103-JAT TO 103-JLP)**

- The **LOCK NUT** of shim pack coupling (103-JLP side) provided on 103-JAT rotor could be retained with out any modification.

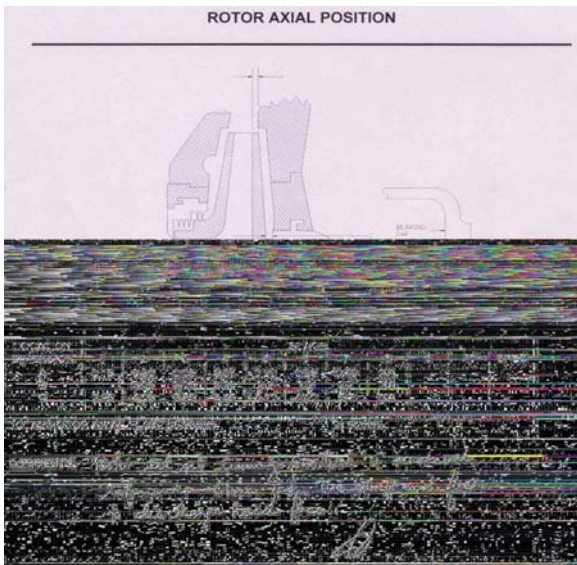
In-Situ Machining of Bearing Housing at 103 JAT Exhaust end

During coupling conversion from gear coupling to John Crane shim pack coupling, it was noticed that due to larger diameter of NEW shim pack coupling, the outer face of hub was fouling in the coupling tunnel at turbine bearing housing. To facilitate proper clearances between the coupling with existing bearing housing, in-situ machining was done. A cut of approximately 2 mm had been taken with the help of pneumatically operated Portable Machine developed by workshop.

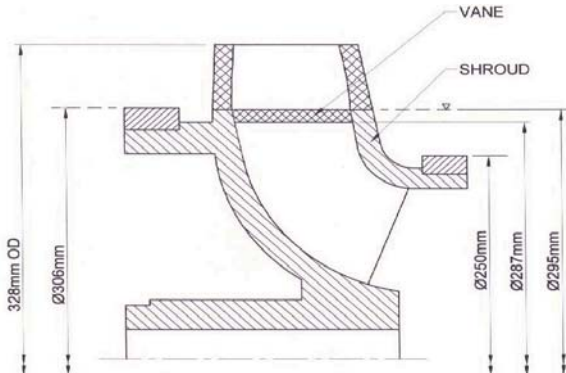
TRIMMING OF IMPELLER OF 116 – J (TURBINE DRIVEN)

Opened the pump for impeller trimming. The impeller was machined to trim to reduce the head as under

- Shrouds OD was machined to **295mm (Original OD = 328 mm)** as per sketch.
- The vane OD was machined to **287mm**
- The sharp corners of vane were removed.
- After machining the impeller was balanced.
- Finally the rotor was installed and casing boxed up

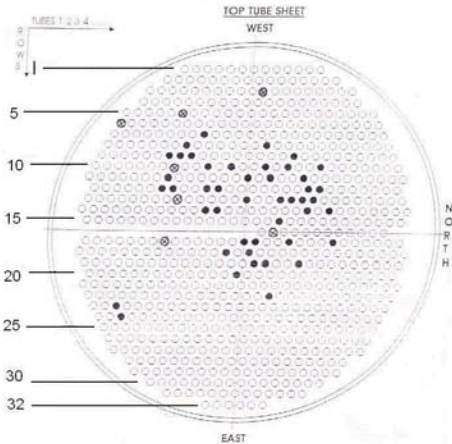
Status of the repair is recorded as under

TOTAL NO OF TUBES : 750

NO OF TUBES PLUGGED: 45 ●
