MTC / REPORT / 01  
REPORT NO. 27 / 2007

## KALOL UNIT

# PLANT TURNAROUND REPORT (APRIL - MAY - 2007)

INDIAN FARMERS FERTILISER CO - OPERATIVE LIMITED

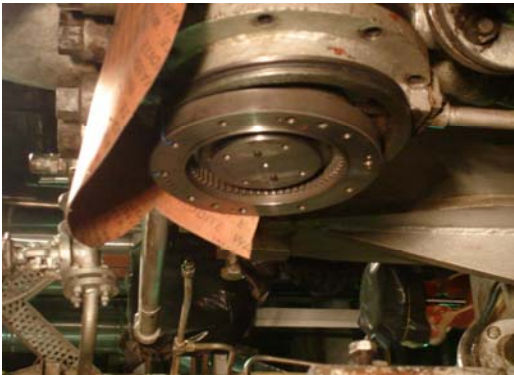
**Photograph showing Locknut installed on the 105-JHP Rotor Shaft**

Locknuts on shaft for all the hydraulically fitted coupling hubs were installed. The locknut sketch is given below:

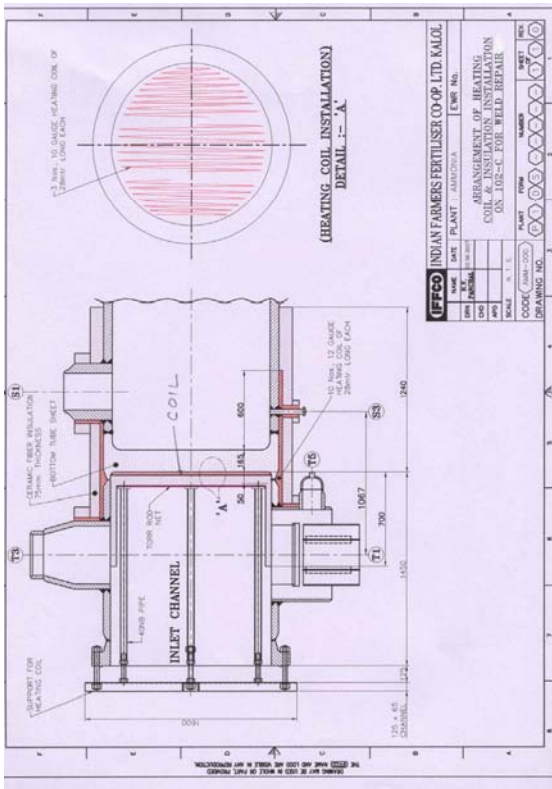
Sketch for arrangement of heating coil and insulation

102-C was taken for Plugging of leaky tubes and welding of leaky tube to tube sheet welding. Contract for the above job was awarded to M/S Skywin Erectors, Ahmedabad. 102-C is being used in Hydrogen service. Dehydrogenation of the tube sheet was required for proper welding of plug and tube to tube sheet seal weld leak. Bottom support fabrication for heating coils was done and installed in the bottom tube sheet with the help of bottom channel cover flange. Schematic / Photograph arrangement of heating coils and insulation showing the arrangement is as below:

Following materials were used for Dehydrogenation and PWHT for each Tube Sheet:

- Thermocouples: 10 Meter long wire of 17 Gauge thickness – 1 No.
- Heating Coils: 25 Meter long wire of 10 Gauge thickness – 3 Nos.
- Heating Coils: 25 Meter long wire of 12 Gauge thickness – 10 Nos.
- Recorder: 3 Nos.
- Control Panel: 2 Nos.
- M10 X 1 ½ " long CS Bolt with nut: 50 Nos.
- Ceramic Blanket (Cera Felt): 10 Bundles.

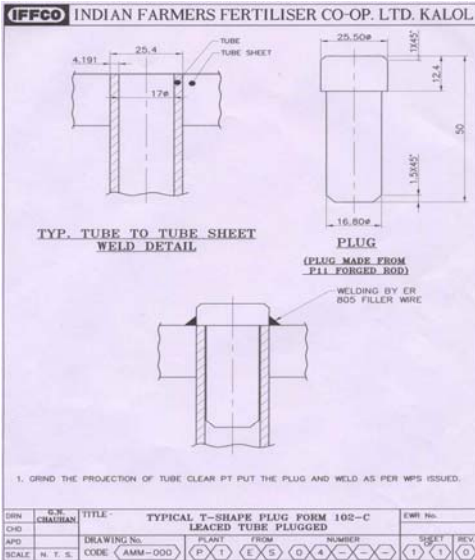
T-Shape' plugs

Accordingly 13 Nos. tubes were plugged with T-Shaped plugs (see attached drg.) and 74 Nos. tube to tube sheet seal welding was done. To avoid dissimilar weld for tube and tube sheet weld, plug was made from same material (F-11) as that of tube sheet. For welding of plugs, filler wire ER 80SG, 2.4 MM was used. Sketch of 'T-Shape' plug is shown below:

After completion of above welding on both the tube sheets, the equipment was rehydrotested at 125kg/cm<sup>2</sup>g. In this hydrotest, 18 Nos. old plug weld leak were noticed in Top tube sheet and 22 Nos. tube to tube sheet seal weld & old plug weld leak were noticed in Bottom tube sheet. The same was attended. DP Test was carried out in both the tube sheets completely.

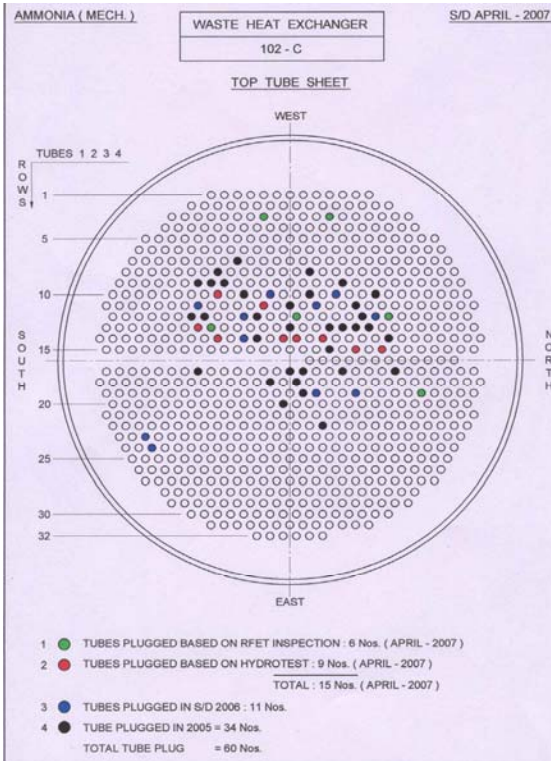
### Layout of tube sheet

At present a total of 60 Nos. tubes are plugged out of 750. The final layout of tube plugged is as below:

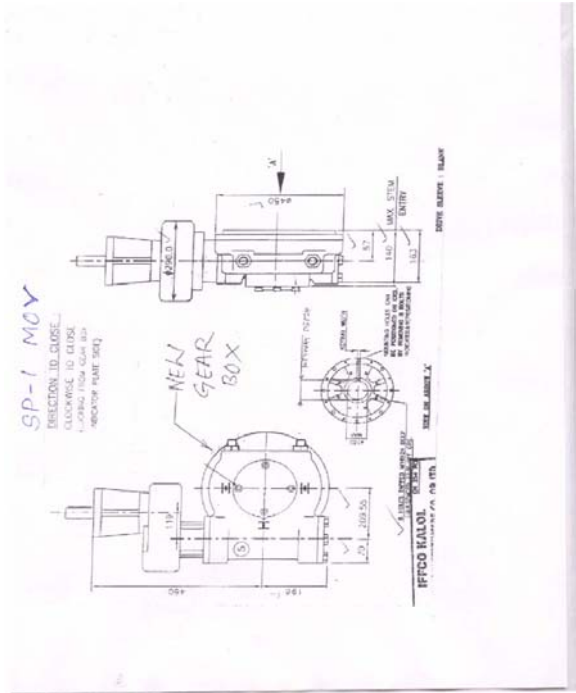
## SKETCH FOR SP – 1 MOV GEAR BOX

The gear box of the motor operated valve SP - 1 had long cracks and hence new gearbox was procured from M/S Rotorks Control Ltd. for replacement. During the Shut down the gear box was replaced successfully.

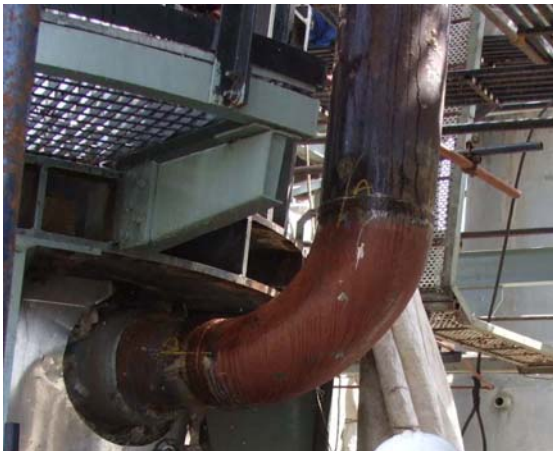
**New Synthesis Gas Converter (108-D) Elbow  
(14" NB x Sch120, P22 material Elbow)**

- New Synthesis Gas Converter (108-D) outlet to MP boiler inlet Elbow (14" x Sch 120) had developed a crack in the parent metal and the same was attended during running plant. In addition old Synthesis Converter (105-D) elbow (8" x Sch 120) was having lamination defect. Both the elbows were replaced during shutdown by purging the Synthesis loop, proper de-hydrogenation and PWHT.

As the elbow was in the Hydrogen service, Dehydrogenation of both the edges was carried out. After welding, PWHT was also carried out. Curve attached below:

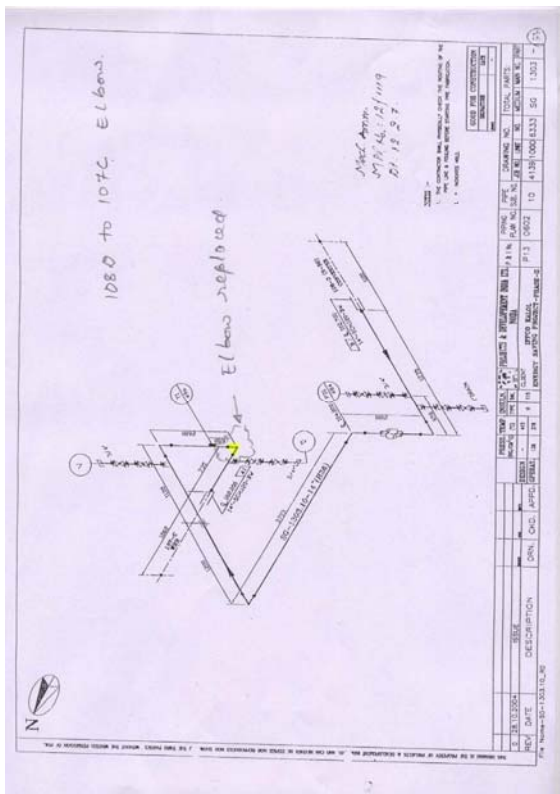
### Sketch for Isometric of S-50 Elbow

Position of the Elbow is as shown below in the Isometric:

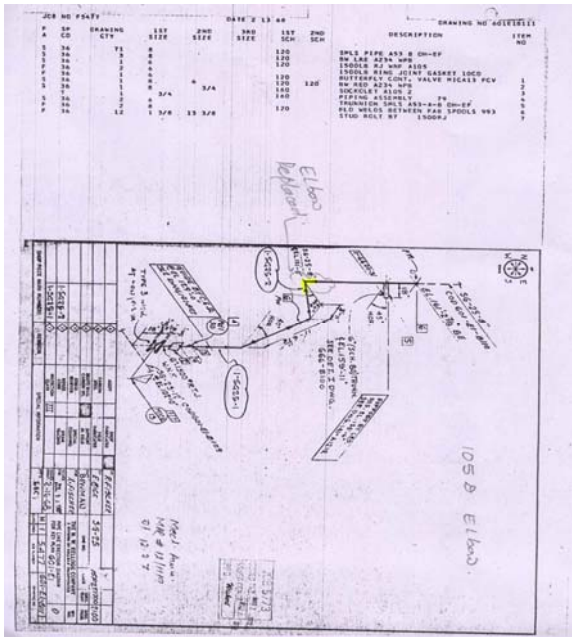
Sketch for Isometric of 105-D Elbow

Position of the Elbow is as shown below in the attached Isometric:

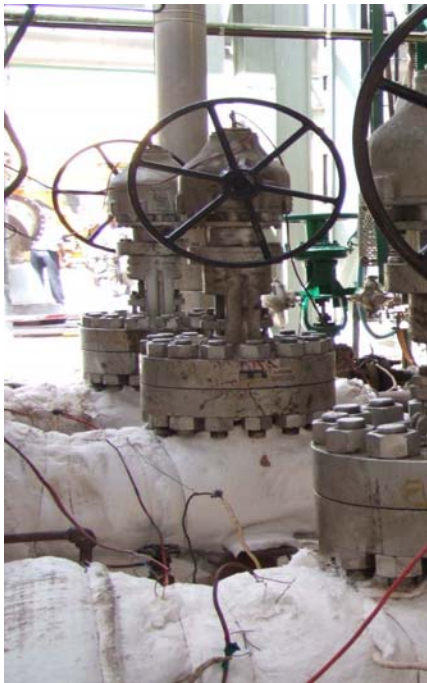
**Photograph of Letdown station**

Photograph of Letdown station showing replaced valves:

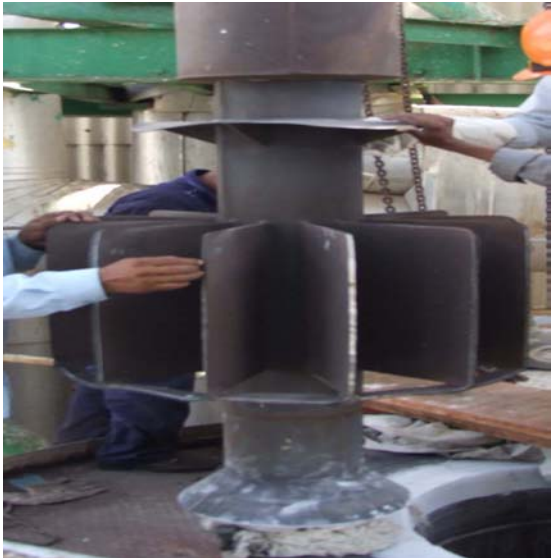
103-D Top cover (Air Nozzle) was removed for internal inspection. While taking out the Air Nozzle, it was stuck and fouling with the liner. Air nozzle was removed with the help of chain pulley blocks with care. After removal, it was found that the liner was slightly bulged at certain locations. Grinding was done to remove the bulging. Air Nozzle fins were also trimmed 5 to 6 mm by grinding.

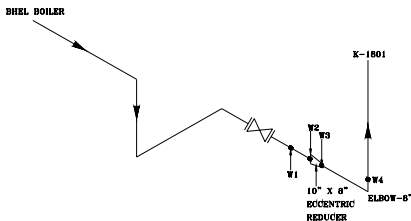
**V-1811 (1st Stage Separator):**

- (1) Bevel edges of weld joints W2 and W3 were found to be heavily magnetized leading to difficulty in welding.
- (2) Gauss measurement was carried out on the bevel edges of W1 and W3 and was found to be around 200 gauss.
- (3) Degaussing was carried out with coil method & electromagnet Yoke method and was reduced to 28 - 30 gauss.
- (4) As further degaussing could not be achieved, root and hot pass welding was done with E-6013 electrode. DPT and root radiography was carried out.
- (5) Final fillup was carried out with E-7018. DPT and radiography of final weld was carried out.
- (6) Welding was carried out using AC transformer.
