MTC / REPORT / 01
REPORT NO. 30 / 2010

KALOL UNIT

PLANT TURNAROUND REPORT

INDIAN FARMERS FERTILISER CO - OPERATIVE LIMITED

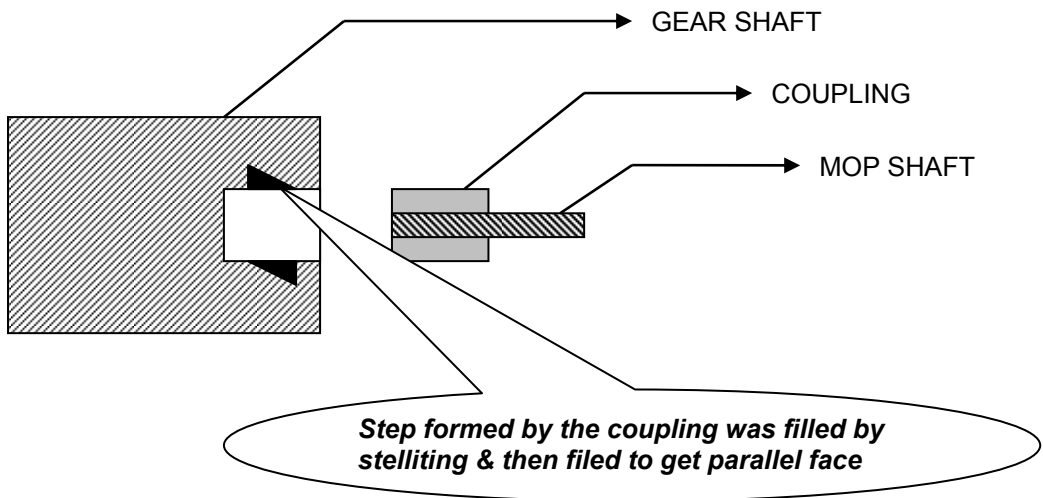
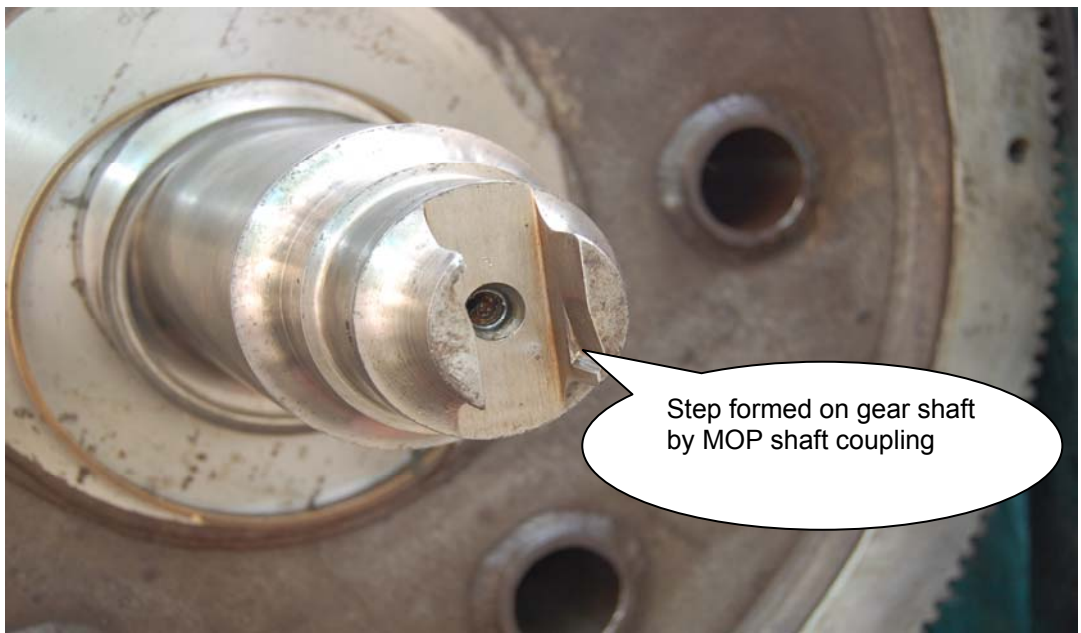
Damage on 101-BJR Gear shaft end

The gear box was taken for major overhauling as abnormal noise was reported during plant operation. The top cover as well as gear and pinion were removed and closely inspected. It was observed that there were deep hitting marks on the gear shaft end due to the main oil pump coupling. This had resulted in a clearance around the coupling causing the noise during running condition. These deep scorings were filled by stellite and filed to get the plane surface.

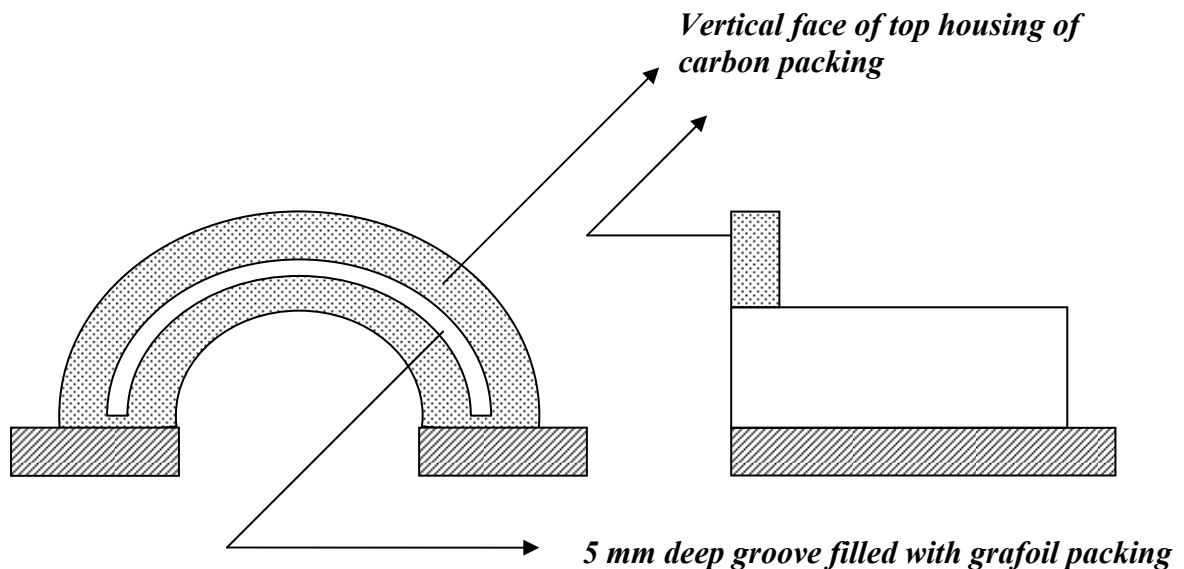
104-JT (ELLIOT) Carbon Packing Housing

Both ends journal bearing clearances were measured and found within limit. The non drive end carbon packing top cover was removed to check the cause of excessive steam leakage. It was observed that cover's vertical sealing face had a 5 mm deep groove that had no packing. Using manual's instruction, this groove was filled using grafoil packing. During running least leakage was observed.

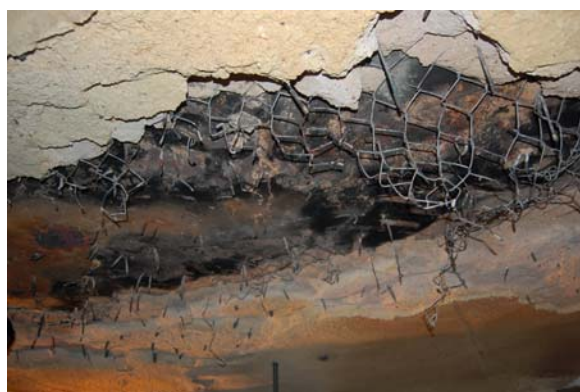
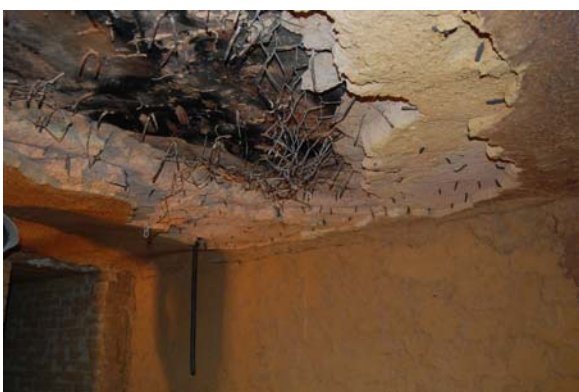
Damaged Roof Insulation of HT Convection zone

- Ten nos damaged burner blocks were replaced by new one.
- Cerafelt insulation on bottom header was replaced.
- All Primary air registers were made free.
- Tunnel burners were overhauled.
- Lever for Foot valve of all burners were fixed properly for easy operation.
- Ceramic fiber module insulation on roof was replaced wherever, the module were opened. "Supermax" End Modules were used to roof insulation.
- On roof insulation, gap was filled, wherever required.
- As before shut-down, the high temperatures was observed near Peep Holes. Hence the area around all Peep Hole was covered with 2 layers of 1425 Deg Centigrade Ceramic Fibre Blanket fixed with SS 304 "U" Pins and Rigidizer was applied. Total 18 nos peep holes were attended.

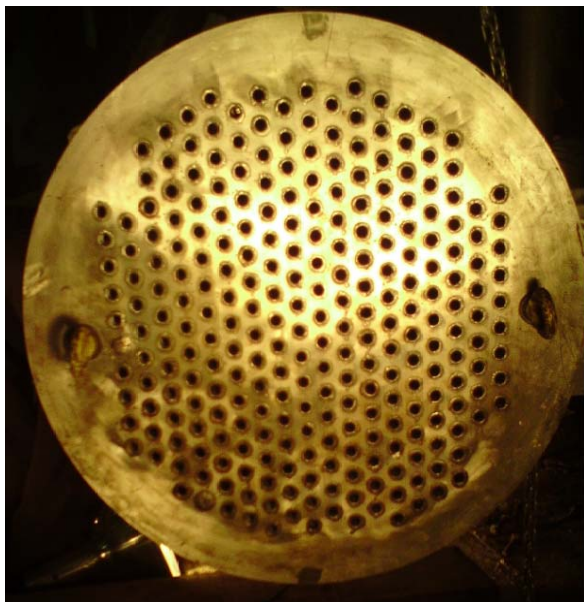
Details of Tube Plugged on 129-JC

The tube Bundles of 129-JC & 130-JC was pulled out and Hydrojet Cleaning was carried out. During Plant Start-up activities, when cooling water was charged, water leakage was observed from shell side of 129-JC and 130-JC. After lowering the water level, both the Intercoolers were isolated and Tube Bundle was pulled out. The tube bundles of 129-JC and 130-JC were assembled in Hydrotest shell and Hydrotest was carried out.

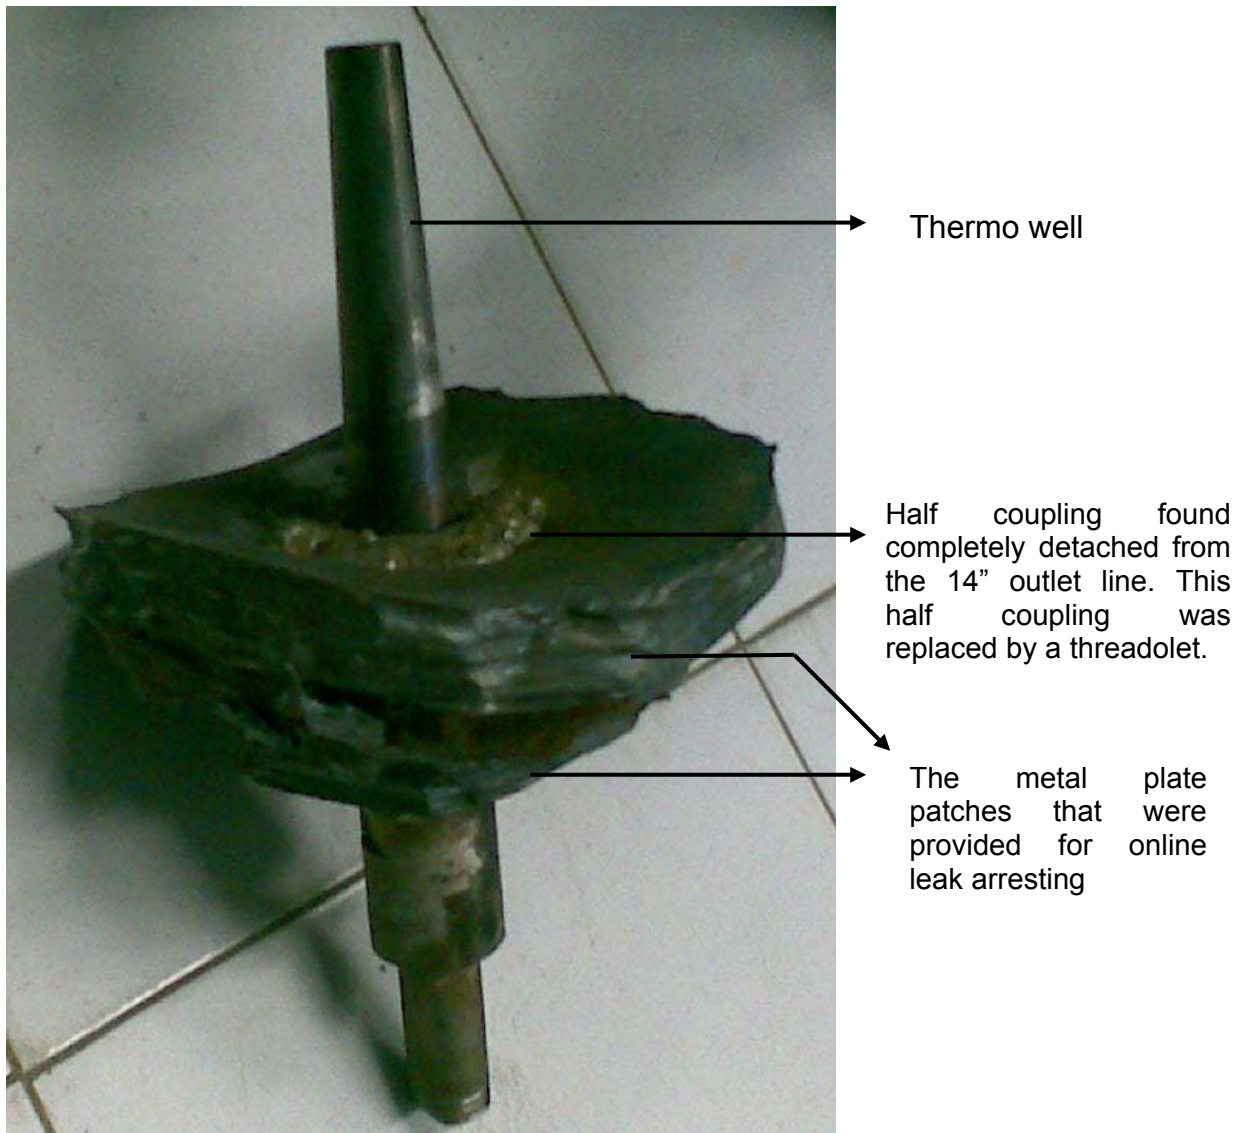
Detached TI-496 Thermo well Root Tapping

The complete converter was purged with nitrogen and handed over to the maintenance by the production department. The metal plate patches along with the half coupling and the thermowell were removed by grinding. As per standard practice, a threadolet was provided in place of the half coupling. Over this threadolet the threaded thermowell was tightened followed by welding. Dye penetration test of the root and the final joint was carried out while radiography of the final joint was carried for all the weld joints. Dehydrogenation before welding and post weld heat treatment of these joints was also carried out.

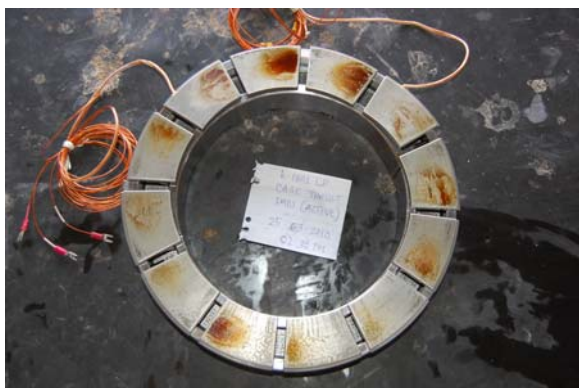
Bearing Description	Before O/H (mm)	Design value (mm)	After O/H (mm)
Journal bearing clearance on Turbine side	0.16	0.11 ~ 0.15	0.16
Journal bearing clearance on Gear Box side	0.16	0.11 ~ 0.15	0.16
Axial Thrust	0.34	0.28 ~ 0.38	0.34
Observations	Brownish deposits observed on active thrust pads.(Fig 1)

FIG 1, LP Case active side thrust pads

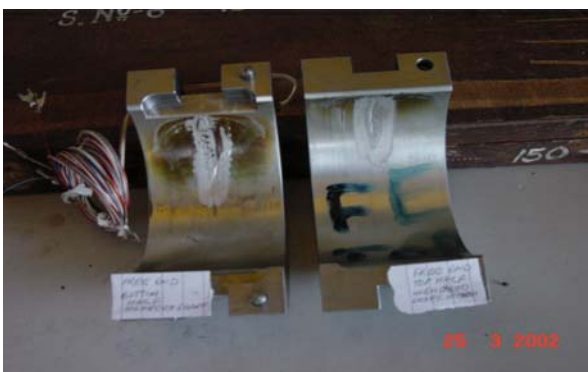
Description		Before O/H (mm)	Design Value (mm)	After O/H (mm)
Low speed shaft	Journal bearing clearance on LP side	0.17	0.125 to 0.185	0.17
	Journal bearing clearance on HP side	0.18	0.125 to 0.185	0.18
	Thrust bearing clearance	0.40	0.38 to 0.61	0.40
High speed shaft	Journal bearing clearance on LP side	0.24	0.15 to 0.21	0.24
	Journal bearing clearance on HP side	0.24	0.15 to 0.21	0.24
Gear backlash		0.48	0.383 to 0.608	0.48
Observations	Minor brownish deposition observed on bearings. (Ref Fig 3 & 4)

FIG 3, GB High speed shaft Free end top and bottom half

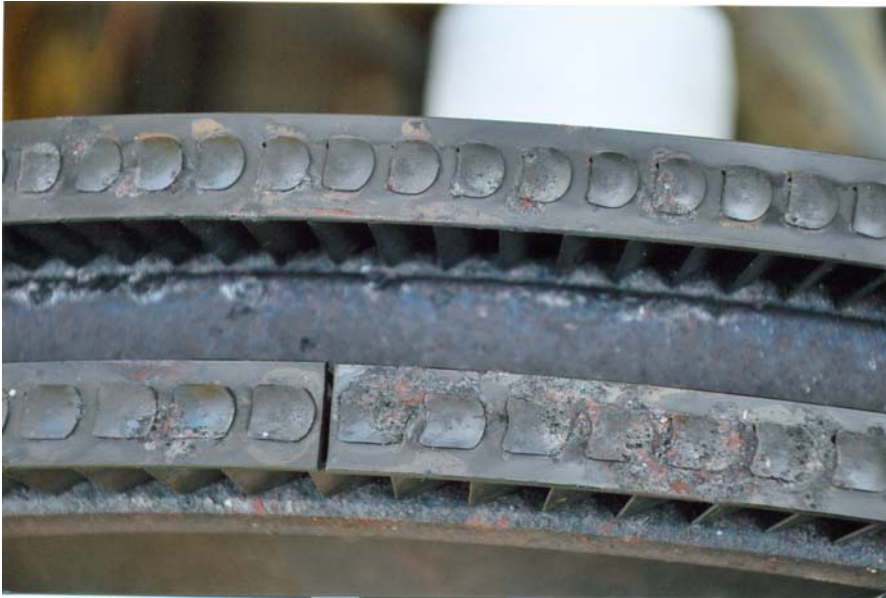
- Removed the rotor and sector.
- Shot blasting of old rotor was carried out.
- Diameter at bearing portion of rotor at both sides of wheel was observed reduced due to the normal wear. Pitting marks were also observed on the blades and shrouds. Hence it was decided to replace rotor with new one. Please refer Fig 7 shroud with pinholes.

FIG 7, – View of wheel of removed rotor of turbine

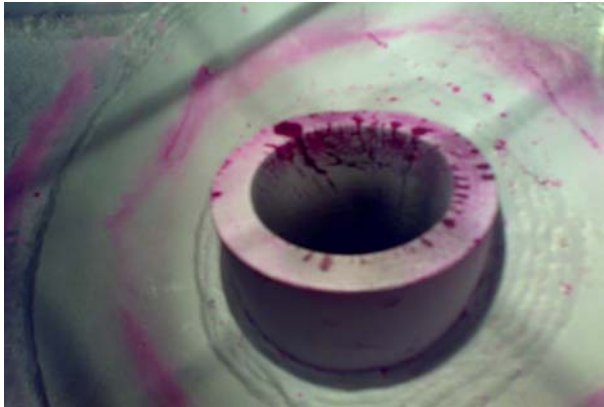
- 8" NB Carbamate inlet nozzle (from East) was found having 1 no. corrosion cavity. Downcomer Fillet weld was found to have 3 nos. crevice cavities/undercut. These spots were repaired.
- 3" Ammonia inlet nozzle sleeve was found to have cracks at its face, OD & ID in Dye penetrant test (Ref Fig 8). Repairing was done at face and OD of nozzle sleeve by welding (Ref Fig 9). No repairing was done at ID due to improper access for welding. The nozzle will have to be replaced during forthcoming shutdown-2011.

FIG 8, C3 Nozzle DPT of cracks

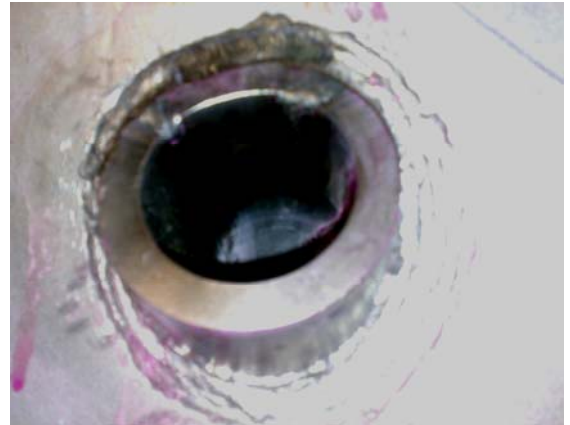
FIG 9, C3 Nozzle after repairing of face and OD

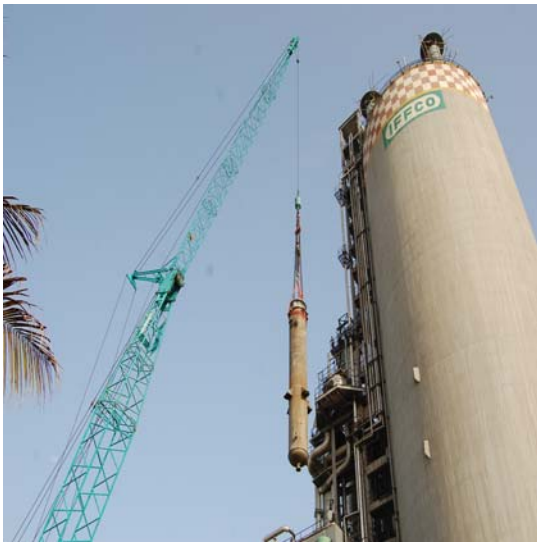
FIG 10, Tube bundle with old shell lifted by Kobelco Crane

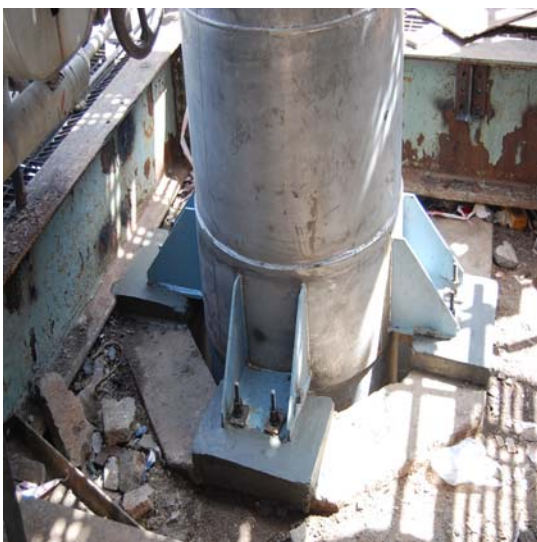
FIG 12, Foundation of new shell

- Tube bundle was placed in new shell by Kobelco crane
- For checking the leakage between girth flange of new shell with old tube bundle, hydrotest was done at 1.2 kg/cm² g and found ok.
- Tightened all connected piping flanges of shell.
- Steam inlet pipe for injection (10" x 150#) was cut for easy installation of ejector, P-1423
- Ejector P-1423 was lifted by Kobelco crane and it was installed in position.
- The steam inlet pipe line was welded.
- All connected flanges for P-1423 were tightened.
- Placed the top cover and piping connected to H-1421 by Kobelco crane.

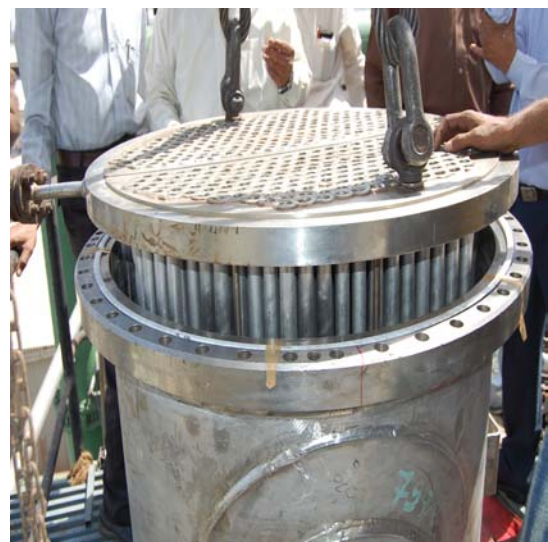
FIG 13 Tube bundle being inserted in new Shell

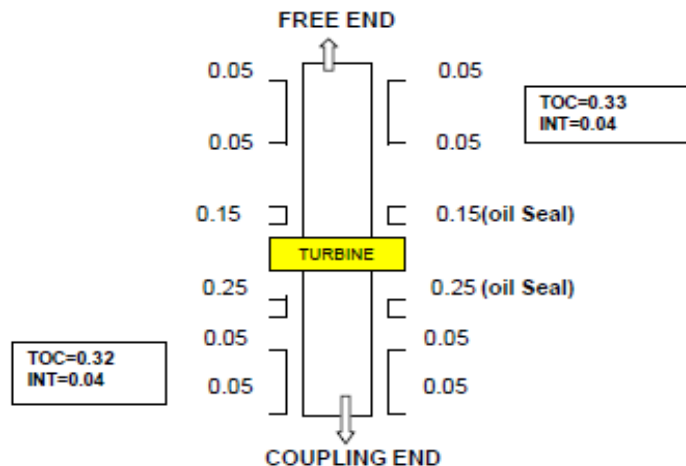
- Turbine both ends bearings were opened cleaned properly and clearances were measured using lead wire.
- Clearances of Turbine Bearings were checked and found on higher side i.e 0.33 MM and 0.32 MM at free end and coupling end respectively. (As Shown in fig.)

- As the clearances of bearings were on higher side, both ends bearings were replaced. (Item Code NDE Bearing: 142110203400, DE Bearing: 142110203410)
- Clearances of Turbine Bearings were again checked after replacement of bearings and recorded.

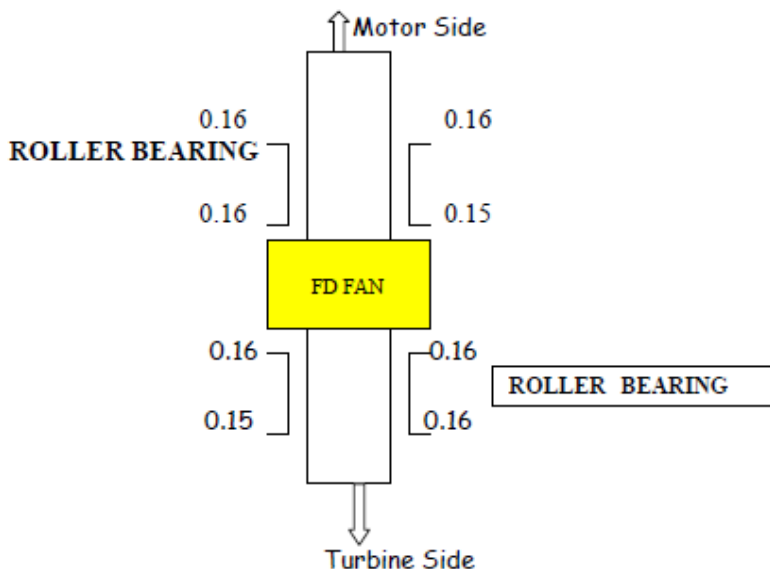
- On turbine side roller bearing pedestal end cover hair crack was observed which was sealed with M-seal.
- Bearing Clearance Chart is as under:

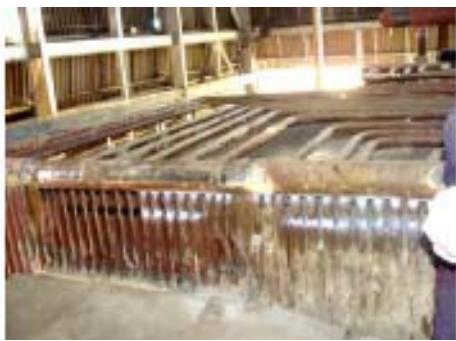
DPT on Top Front Header Stub joints

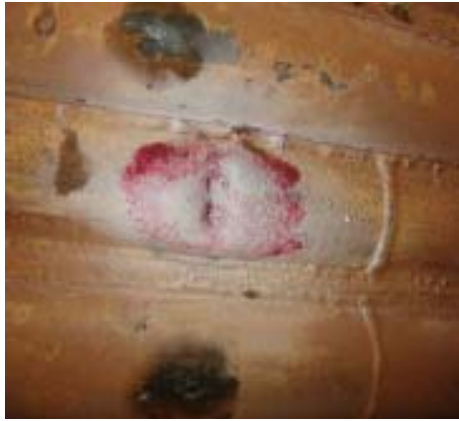
Dent mark observed in D-Panel Roof Tubes

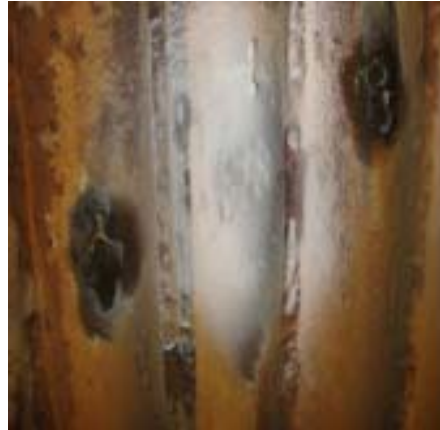
DPT at Dent mark

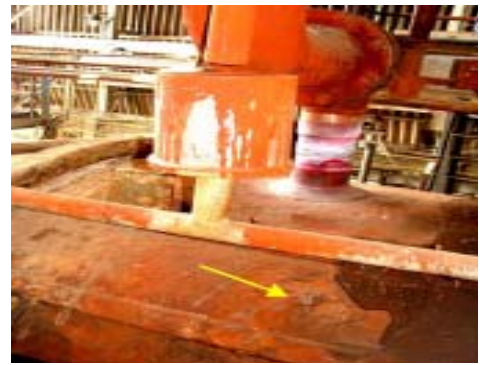
Corrosion spot on Steam Drum

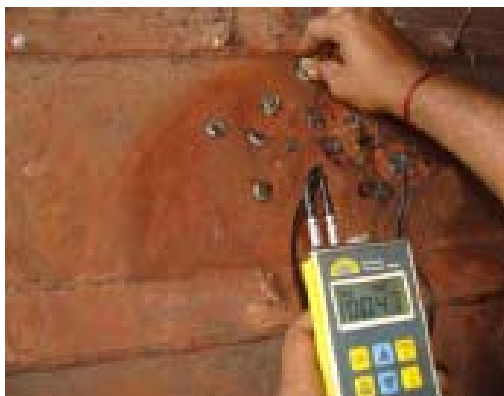
Thickness measurement at corrosion
