KALOL UNIT

PLANT TURNAROUND REPORT

(MARCH - APRIL - 2011)

INDIAN FARMERS FERTILISER CO - OPERATIVE LIMITED

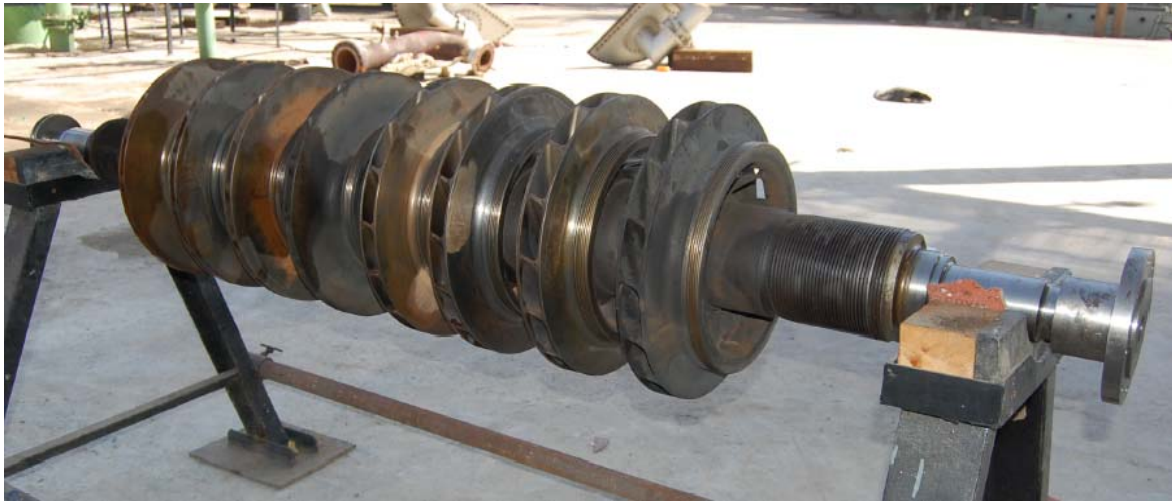
REMOVED 101-JHP ROTOR ASSEMBLY INSPECTION UNDER PROGRESS

The compressor was taken for major overhauling after a span of six years. The compressor was decoupled and the piping removed. The top casing was removed and various axial and diametrical clearances were measured and noted. The rotor assembly was lifted and taken for cleaning & inspection. Thick depositions were found on the vanes of the 1st & 2nd stage impellers. The complete rotor assembly was cleaned by hydro jetting and dye penetration test was performed and no defects were observed. The top and bottom casing were cleaned by hydro jetting followed by drying by plant air.

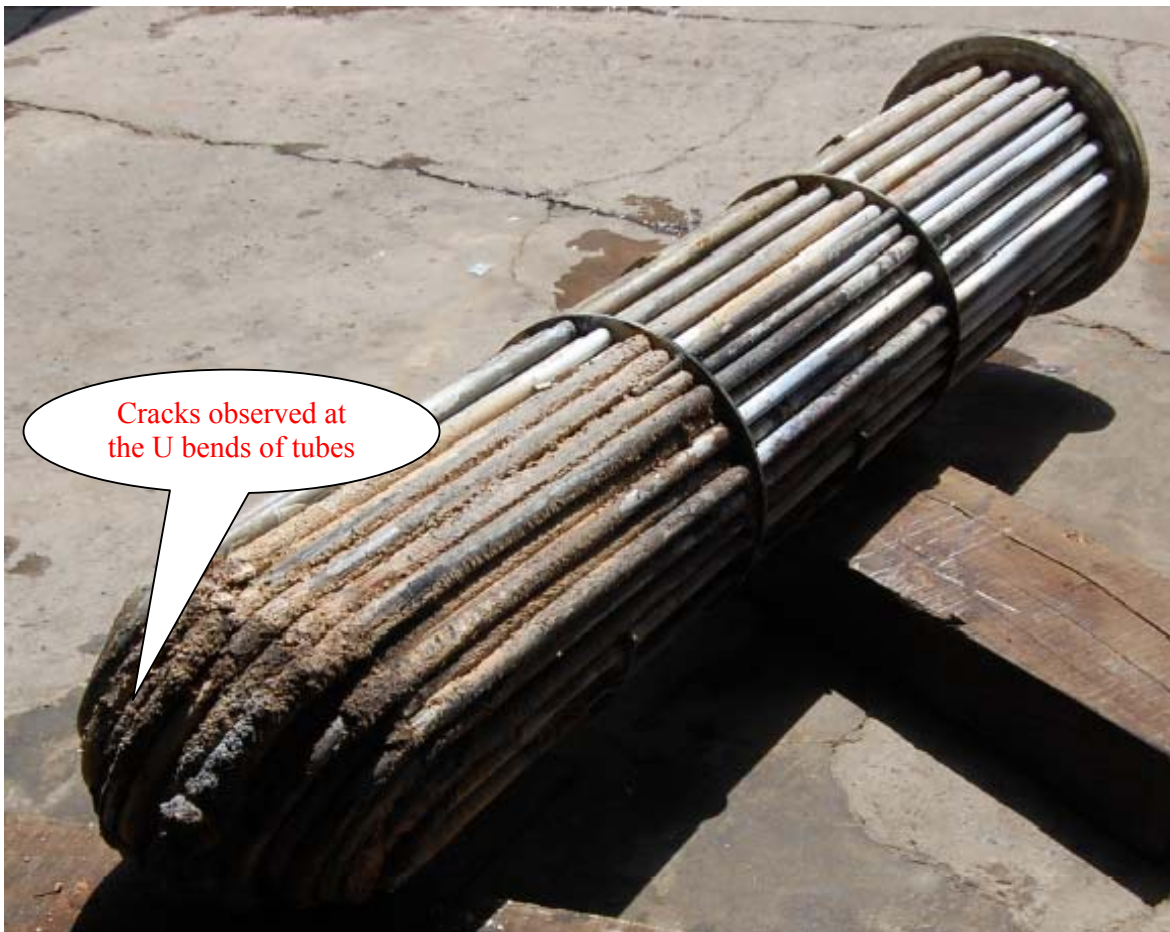
Before shutdown lot of water was observed in the oil console and hence the steam end gland housing was opened and the labyrinth packing clearance were measured which were found within limit. Simultaneously the gland condenser was opened and the tubes were found completely damaged. So it was confirmed that the reason of water in the oil console was primarily because the sealing steam was going into the bearing housing due to the leaking gland condenser. The tube bundle of this condensed was replaced by new in-house fabricated tube bundle with stress relieved U-Tubes.

DAMAGED U-TUBE BUNDLE OF 103-JAT/JBT GLAND CONDENSER

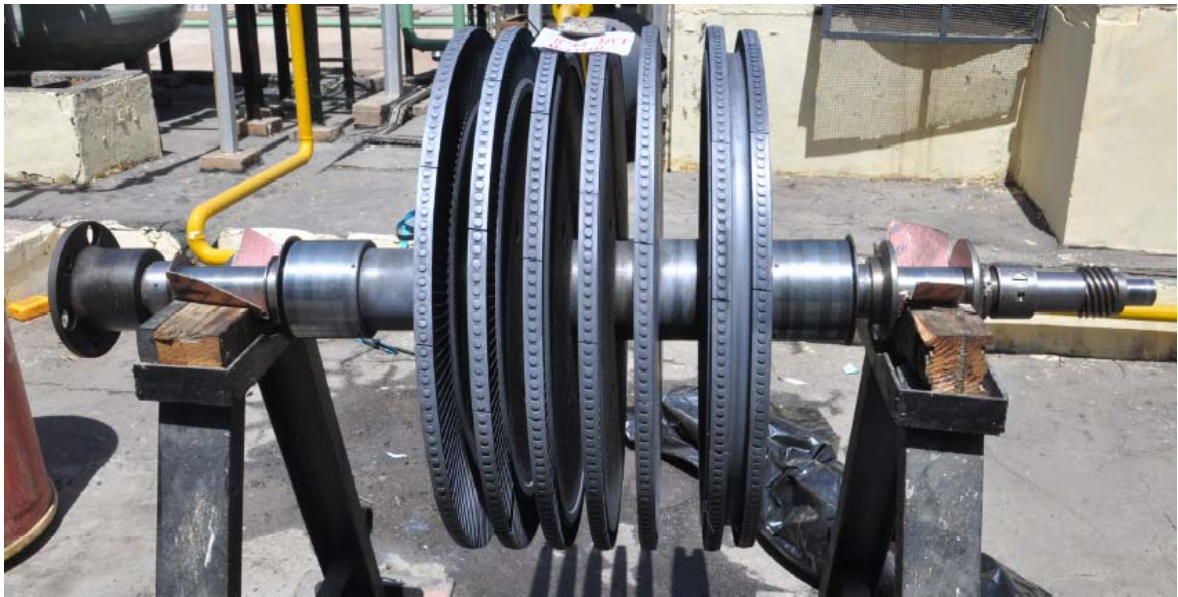
104-JAT ROTOR UNDER INSPECTION

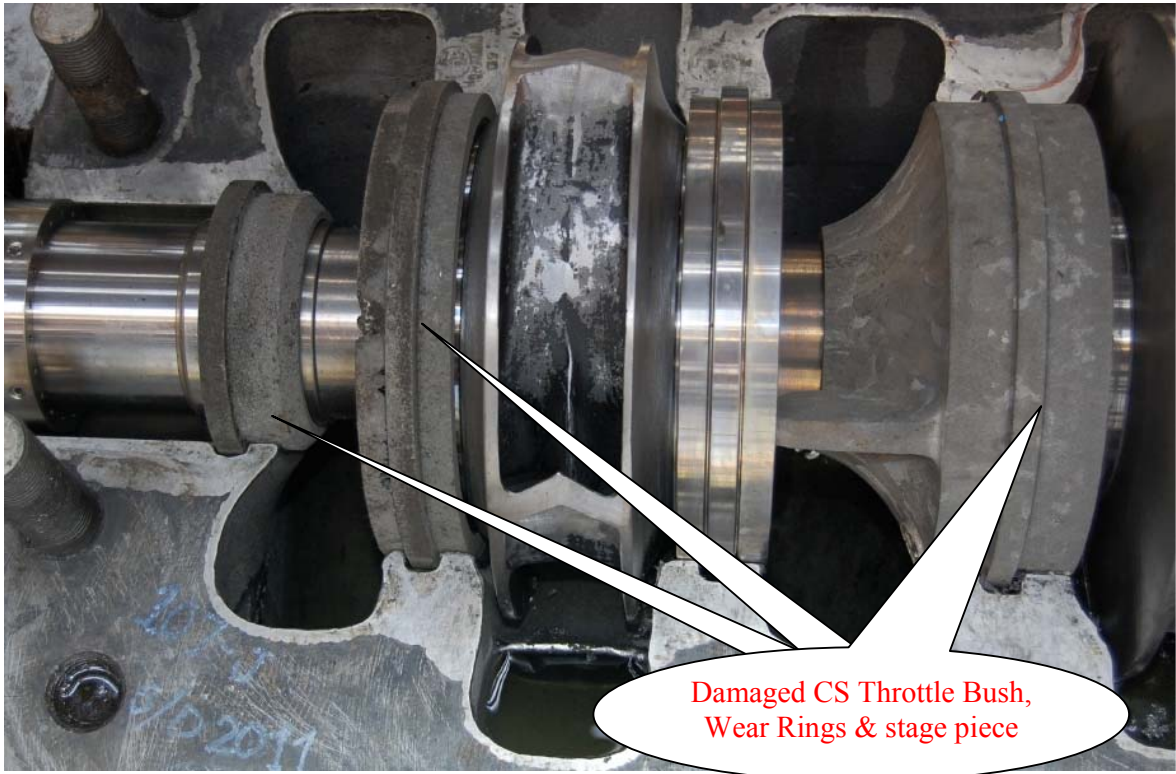
DAMAGED CARBON STEEL PARTS OF aMDEA PUMP 107-J

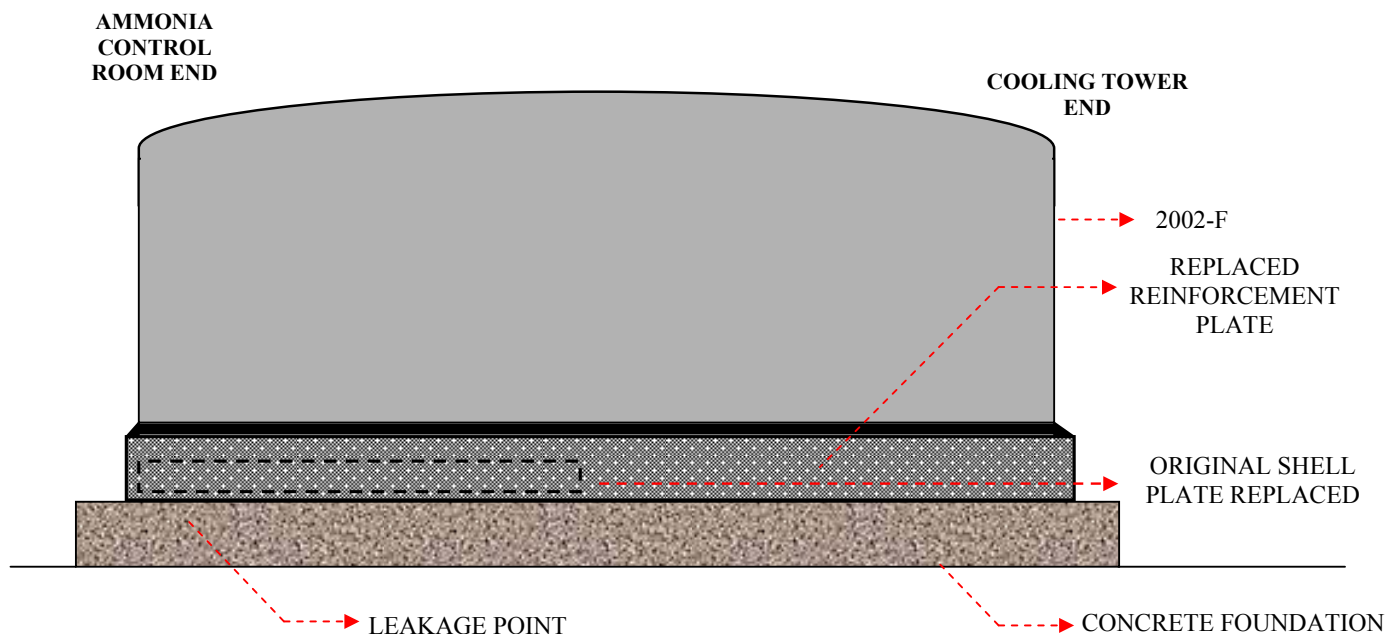
2002-F LEAKAGE REPAIR

- The surface was cleaned with a grinding machine and wire brush.
- One coat of 703 STANDARD ST PRIME was applied and was allowed to cure for 2 hours. The total QTY. consumed was 8 liters.
- The first coat of 1311 CORROKOTE was applied and was allowed to cure for 8 hours.
- The second coat of 1311 CORROKOTE was applied and was allowed to cure for 8 hours. The total QTY. consumed was 24 kilograms.

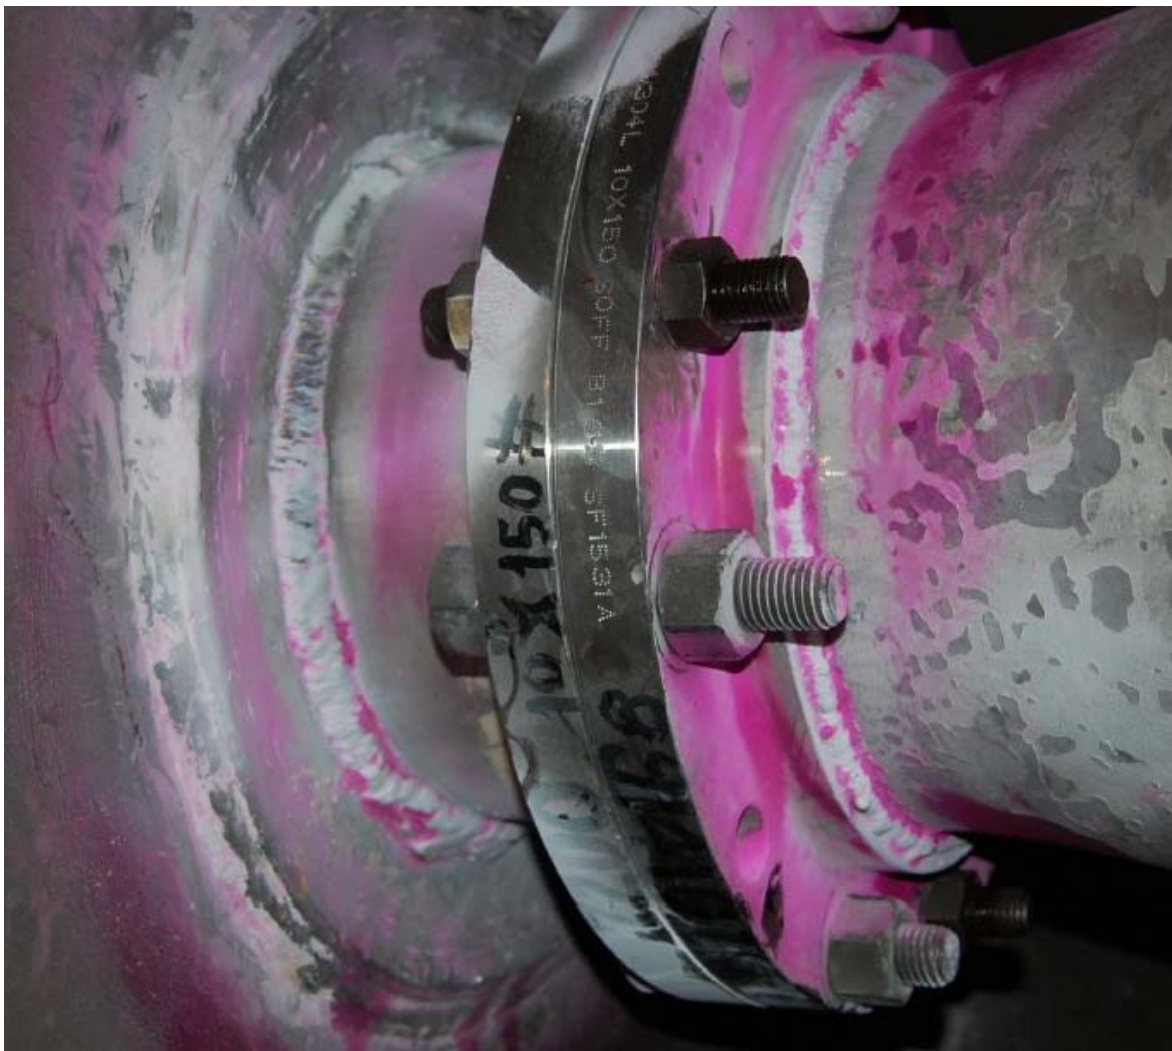
NEW 10" X 150# FLANGES ON THE INLET NOZZLE INSIDE THE VESSEL

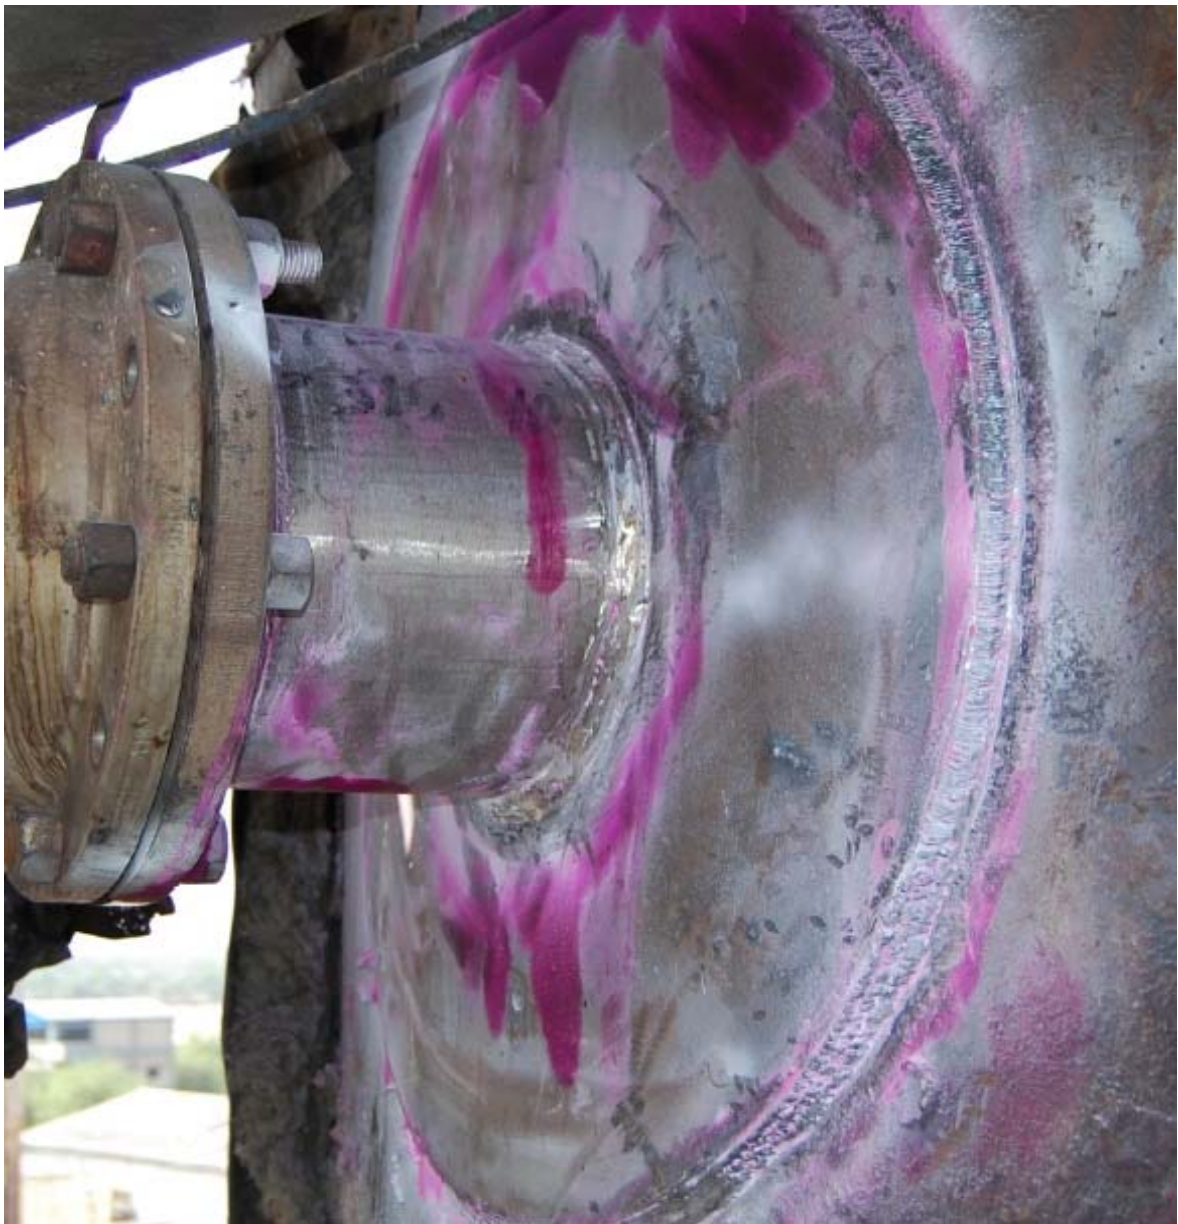
NEW REINFORCEMENT PAD ON THE INLET NOZZLE OUTSIDE THE VESSEL

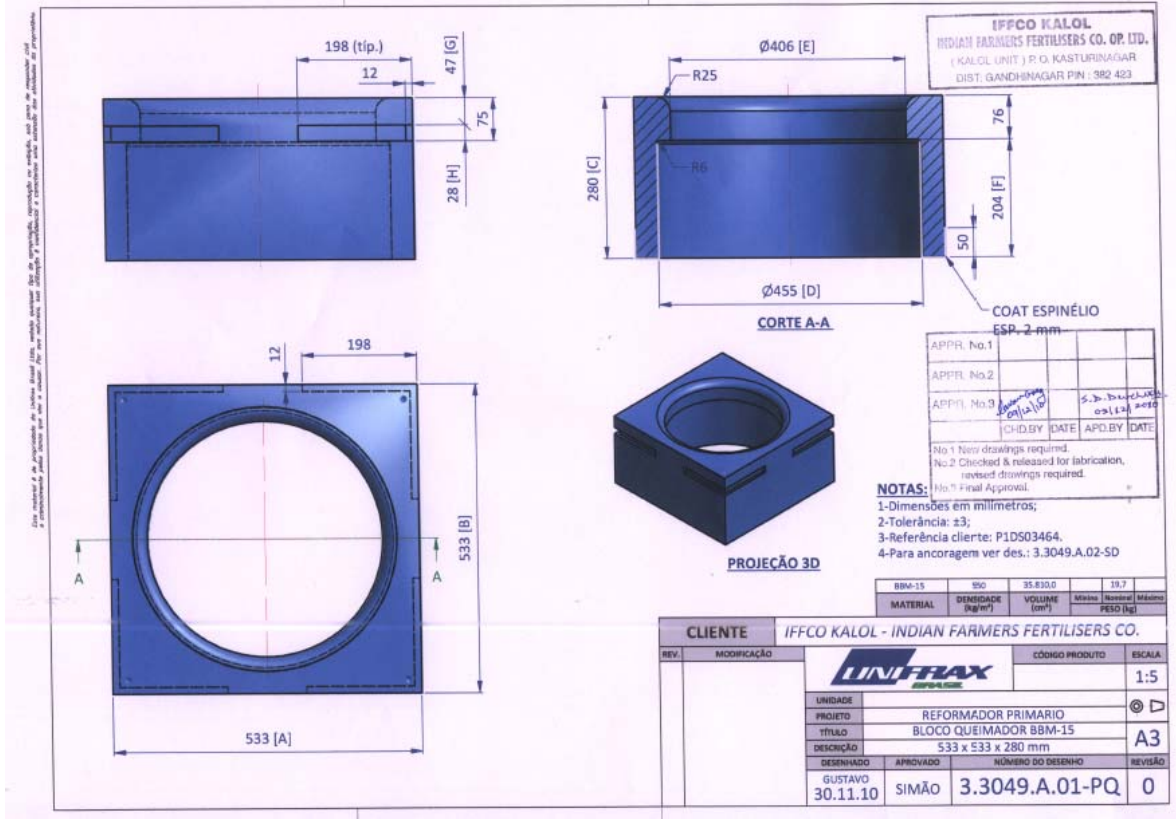
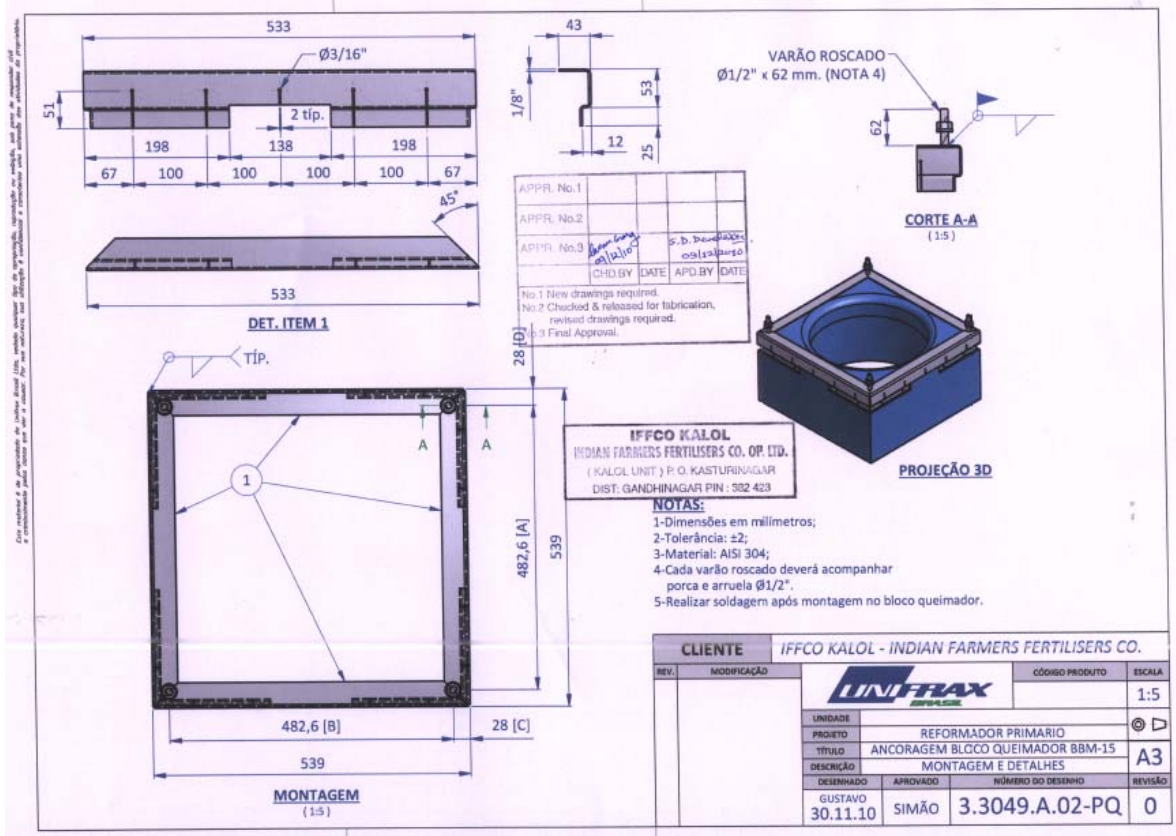
NEW INDEGENOUS BURNER BLOCK OF 101-B

New indegenised burner block was also installed for burner number 510. This burner block was procured from M/s UNIFRAX vide purchase order No 20100767. The burner block was specially designed with stainless steel reinforcement all around the block at the top to avoid development of cracks.

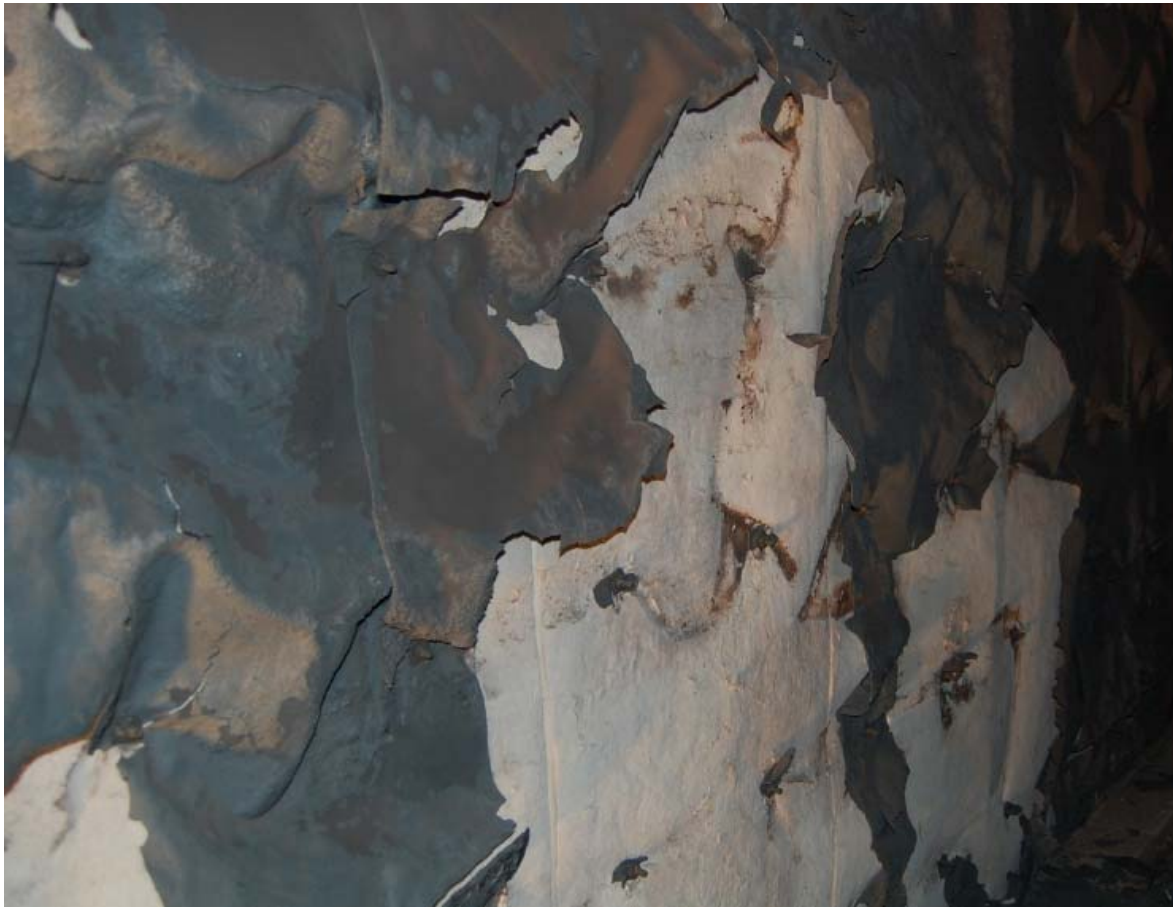
BEFORE: DAMAGED INCOLLOY 800-H LINING

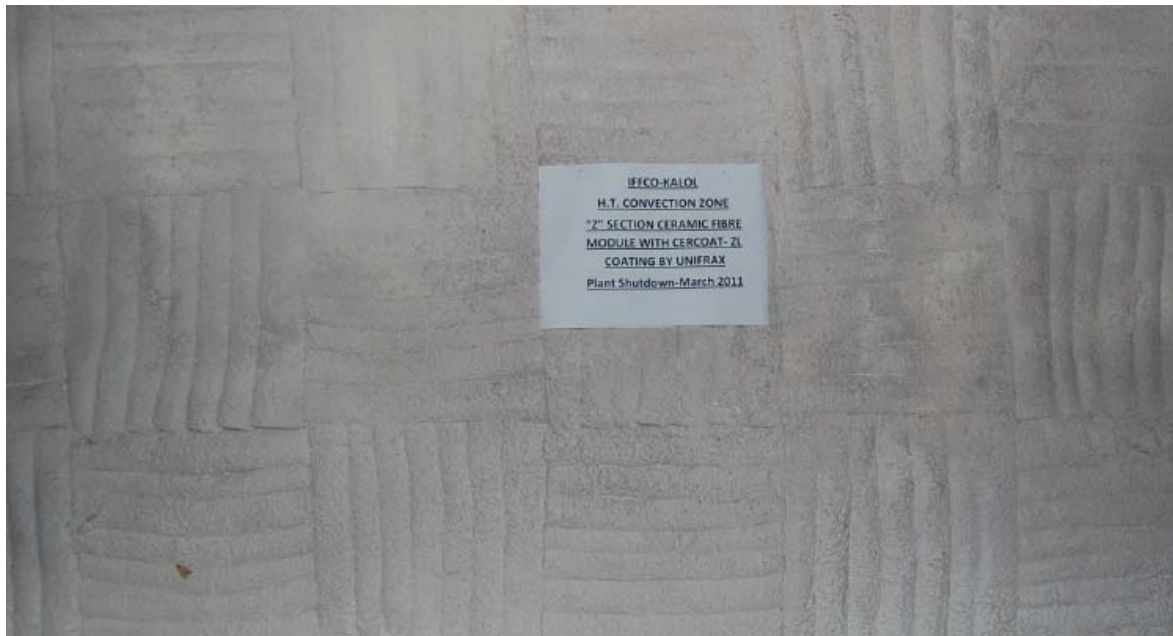
AFTER: NEW CERAMIC 'Z' SECTION INSULATION & CERCOAT ZL COATING

- Zirconia Based Low Temperature Setting Product
- Maximum Service Temperature of Product : 1700 Degree C
- Product: Cercoat ZL of M/s Unifrax or equivalent.

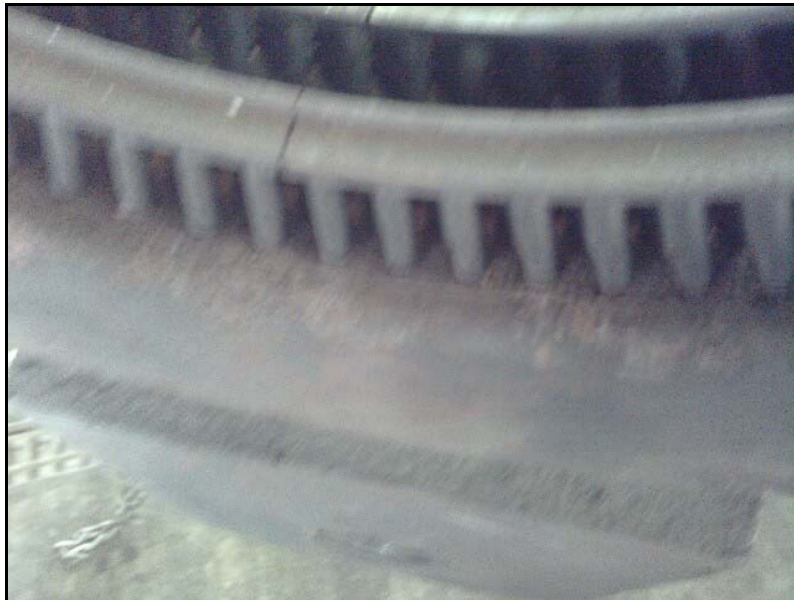
- GBC -2 was found to have minor pitting (as shown in figure-7)

Figure -7: Pitting observed on GBC-2

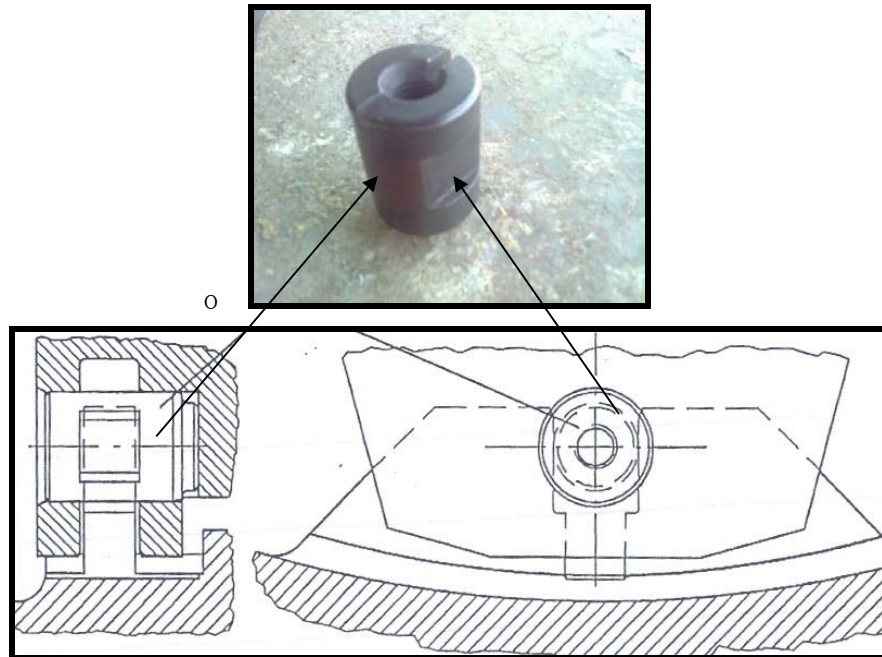
Figure -10

- It was observed that, all labyrinth clearances at right side in GBC 1 and 2 were more than at left side. Hence GBC 1 and 2 are required to shift towards left side for proper centering of rotor. Laby clearance for GBC -3 was within acceptable limit in both sides. In left side of nozzle block chamber, shaft gland clearance was 0.05mm; it also required to shift towards left side for proper centering of rotor
- Following activities were carried out for centering of bottom of GBC-1 w.r.to rotor in a horizontal plane:
 - Labyrinth clearances were 0.35mm at left side and 0.65mm at right side.
 - Lifted the Guide Blade carrier and removed the guide pin. The guide pin are positioned in slots as shown in figure- 10

- For shifting the bottom of GBC towards left, tack welding was done at right side of guide pin of appx. 0.15/0.20mm height. On the slot at left side, metal was removed by grinding by same amount.
- Placed the guide blade carrier no. 1 and clearance was found OK.
- Similar procedure adopted for shifting GBC-2.
- Following activities were carried out for centering of bottom of nozzle block w.r.to rotor in a horizontal plane by adjusting eccentric guide pin and sleeve. :
 - Removed the flange from the bottom of casing (out side).
 - Locking bolt was removed from eccentric guide pin assembly.
 - Eccentric guide pin and sleeve were removed by providing jack bolts using the same flange.
 - The guide pin was slightly rotated for repositioning the bottom steam chamber and lock bolt was tightened.
 - After placing rotor, clearance was checked and found OK.

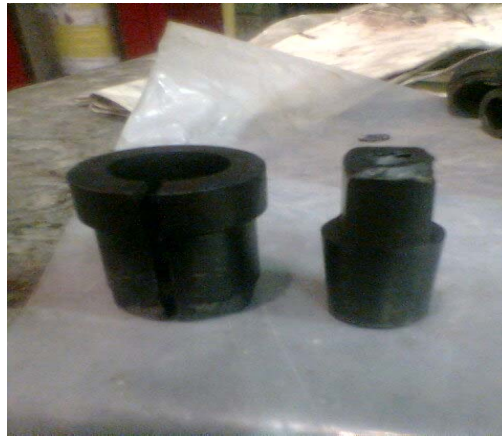
Figure -12: Eccentric guide pin and sleeve in dismantled condition

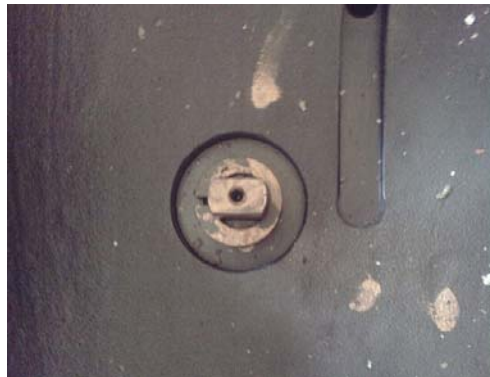
Figure -13: Top view of Eccentric guide pin and sleeve in position

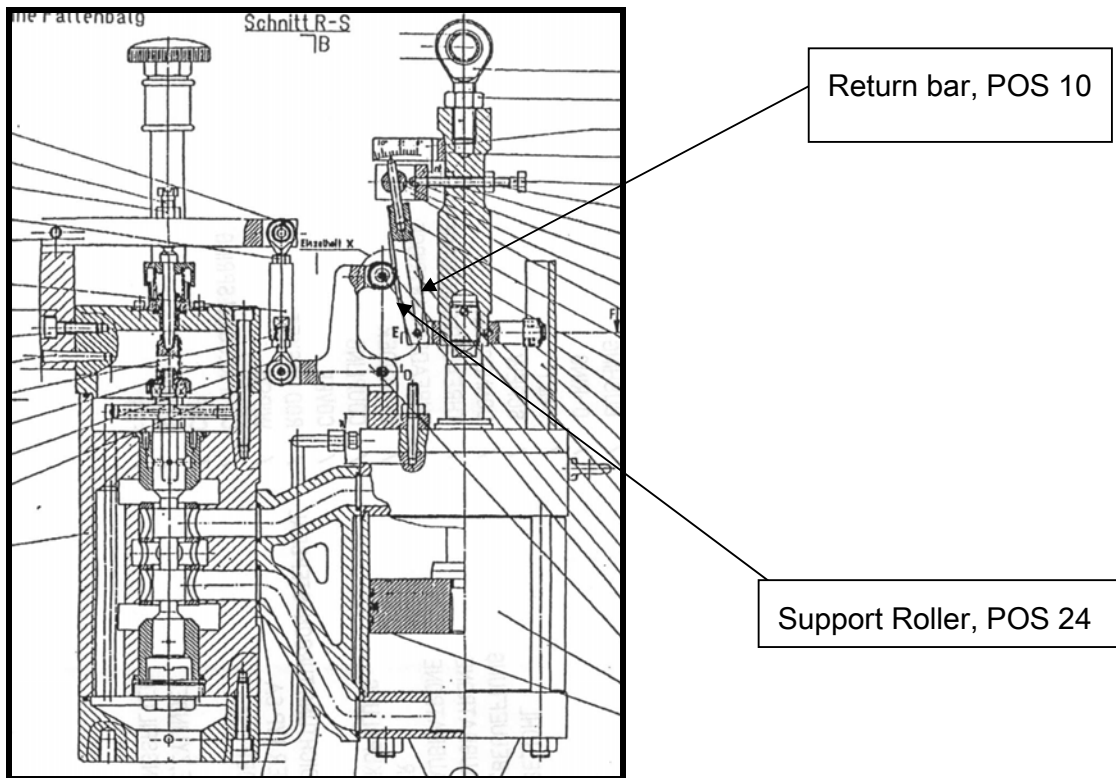
Figure – 18

- 23 ata servo cylinder and Pilot valve were opened and cleaned.
- Approx 2mm deep step observed in return bar, POS 10 and wear observed in support roller, POS 24. Replaced the support roller with new one. The wear out portion was built up by TIG welding using SS 410 filler wire and finished by filing.

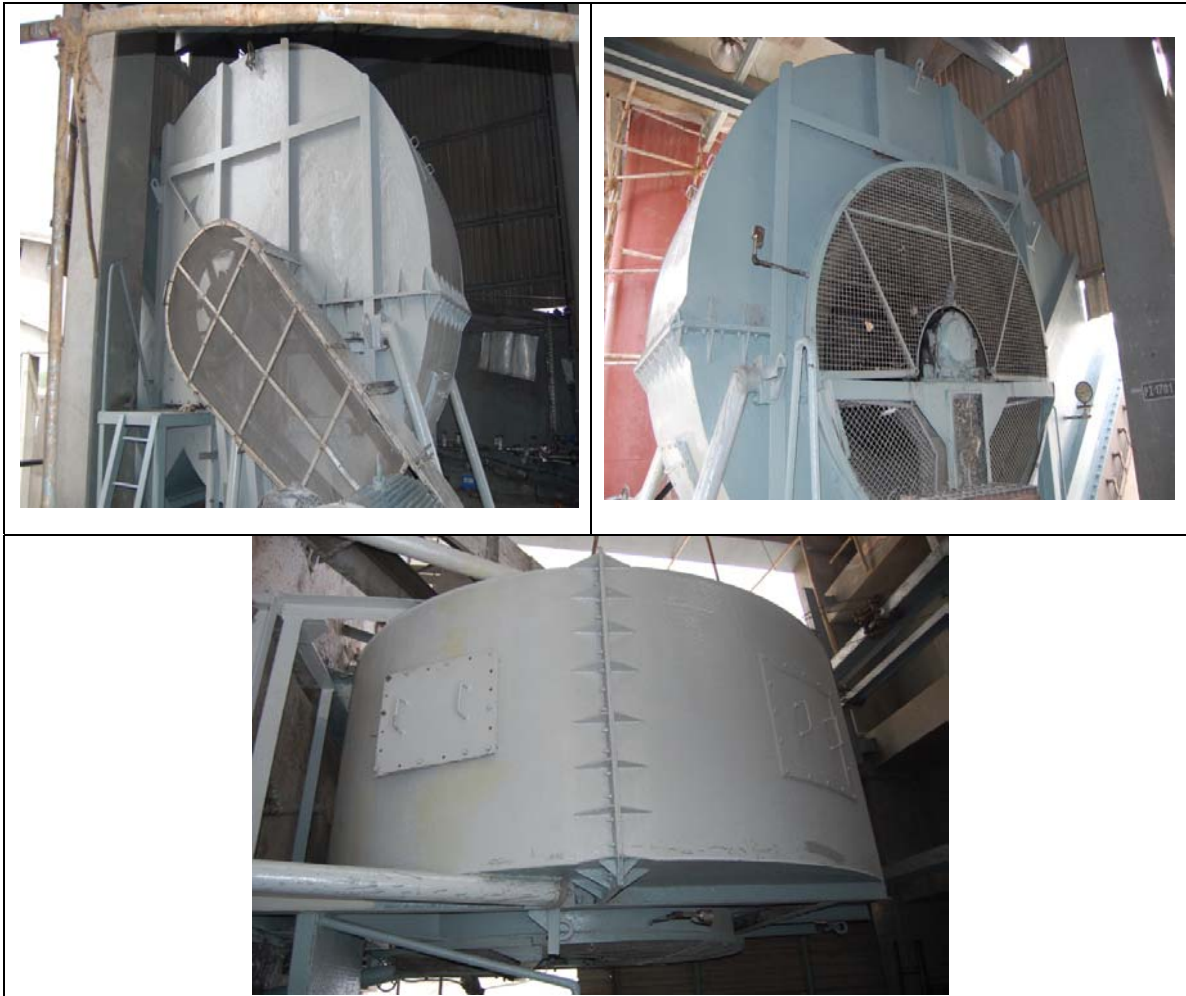
Figure – 32 : K-1701, After application of Chemical resistant coating

Loctite chemical resistant coating compound was applied on fan casing after sand blasting. Sand blasting was done by M/s Vaidehi and application of coating was done by Loctite. 2 coating of compound was applied as shown in figure – 33. Bearing oil of fan was flushed.

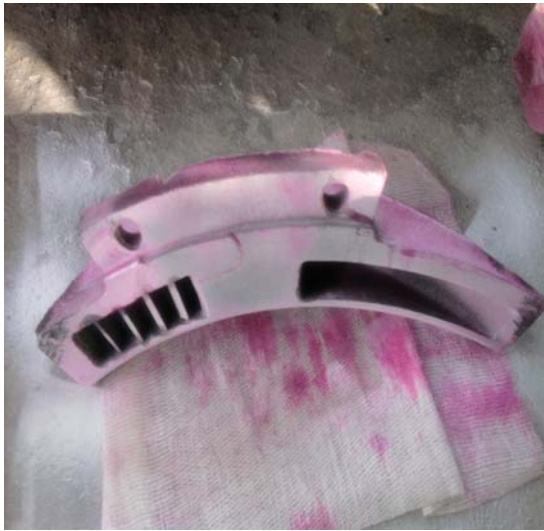
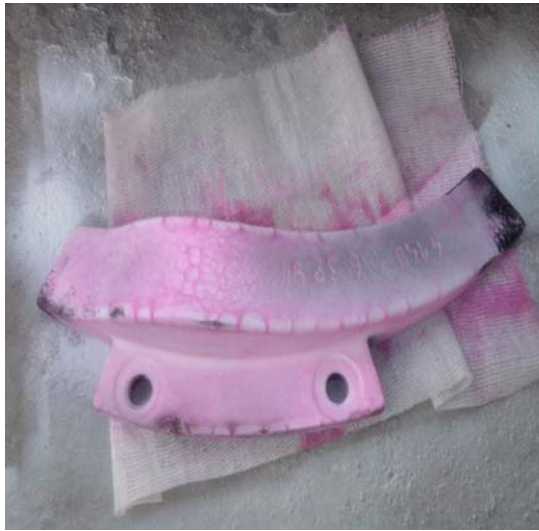
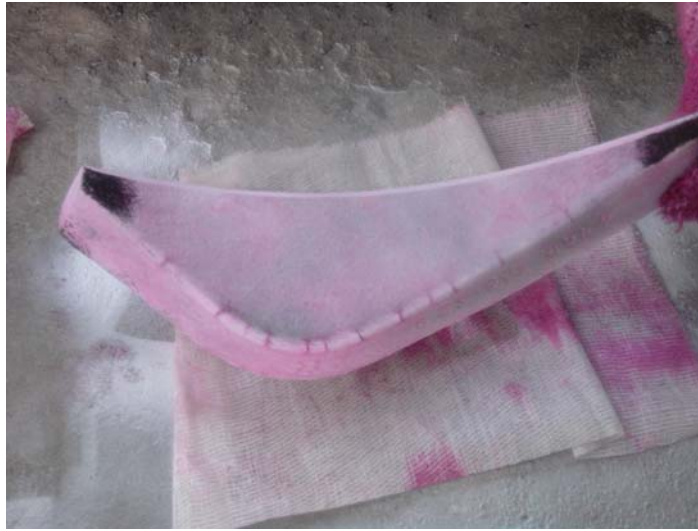
- Turbine was completely dismantled.
- Turbine wheel was found in good condition.
- Surface cracks were observed on Turbine front side reversing chamber and the same was revealed in DP test also.

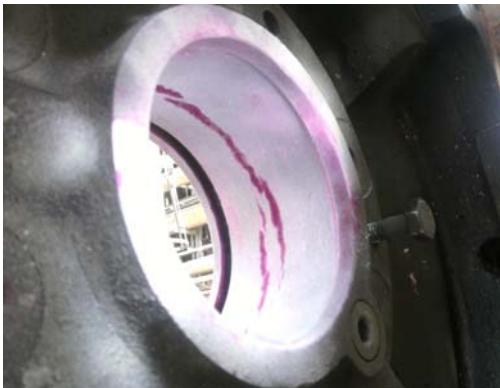
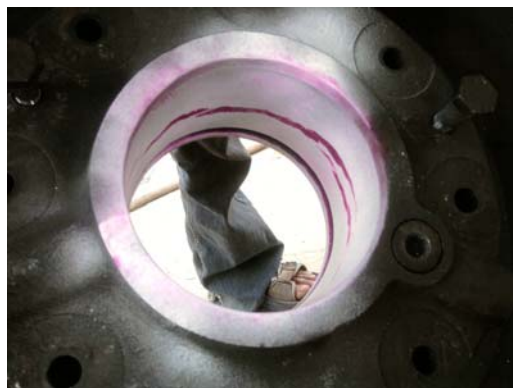
- Removed the old carbon rings & chamber rings from stuffing box.
- Crack was observed on the inside surface of shaft stuffing box. Severe crack was revealed in DPT.

- All 05 nos of new carbon rings were installed in the stuffing box. Clearance of carbon rings were maintained as given below :
 - Carbon Ring No.1 : 0.15 MM
 - Carbon Ring No.2 : 0.15 MM
 - Carbon Ring No.3 : 0.15 MM
 - Carbon Ring No.4 : 0.20MM
 - Carbon Ring No.5 : 0.20 MM
- Gear box top cover was also opened to check the internals of gear box.
- Gear box bearings were opened one by one, checked, cleaned and found OK.
 - Bearing clearances of Gear Box was checked.
