MTC / REPORT / 01
REPORT NO. 33 / 2013

IFFCO

KALOL UNIT

PLAN TURNAROUND REPORT

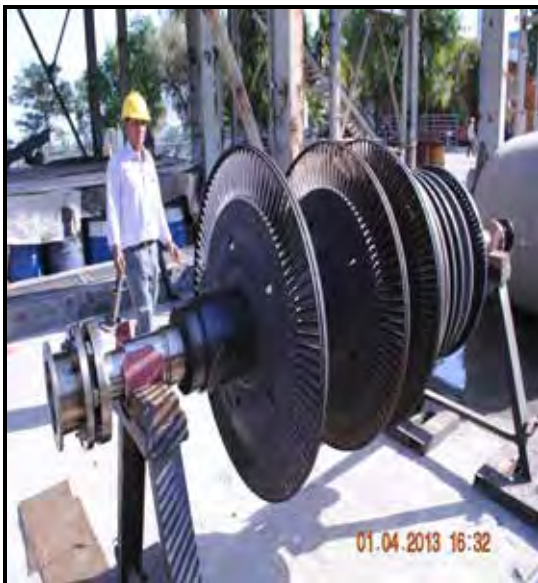
101-JT ROTOR BEFORE CLEANING

The turbine was taken for complete overhauling after a span of three years to attend heavy gland leak at the steam inlet end. Turbine was decoupled and exhaust pipings were removed. The top casing was removed and all internal radial as well as axial clearances were noted. The bearing clearances were measured and removed for inspection. The rotor was removed and cleaned by sand blasting. The coupling hub rear flange was found to be having a number of bends which may have occurred during rotor float /thrust measurement. These bends were repaired. The top and bottom diaphragms were removed and cleaned by sand blasting. Sand used for cleaning was Kurunda Sand having negligible magnetism level of 0.01 gauss. Heavy erosion was found at the welding joint of one of the reinforcement rods for the diaphragm holders in the bottom casing. This was repaired by welding.

All the inter stage labyrinth clearances were found on higher side and hence were replaced by new ones. Both ends Journal bearings and Thrust bearings were taken for inspection. One of the active side thrust bearing pads (having thermocouple) was found with 70 % white metal removed. Hence the complete set of active thrust pads was replaced by new one. Magnetism level of all major components was found within limit. All drain pipes were cleaned and drain valve roused. The governor end bearings and gear drives were visually inspected and found in good condition. The movement of the OST plunger inside the shaft was checked and found to be satisfactory. The diaphragms were reinstalled and the rotor was placed inside the bottom casing. All internal radial as well as axial clearances were measured and found to be satisfactory. The top casing was reinstalled and the bearing clearances were measured along with rotor free float and trip plunger clearances. The Governor was reinstalled and all linkages were greased. The coupling's flexible elements were locked and the turbine was taken for OST. The turbine tripped in a single attempt at 7460 RPM

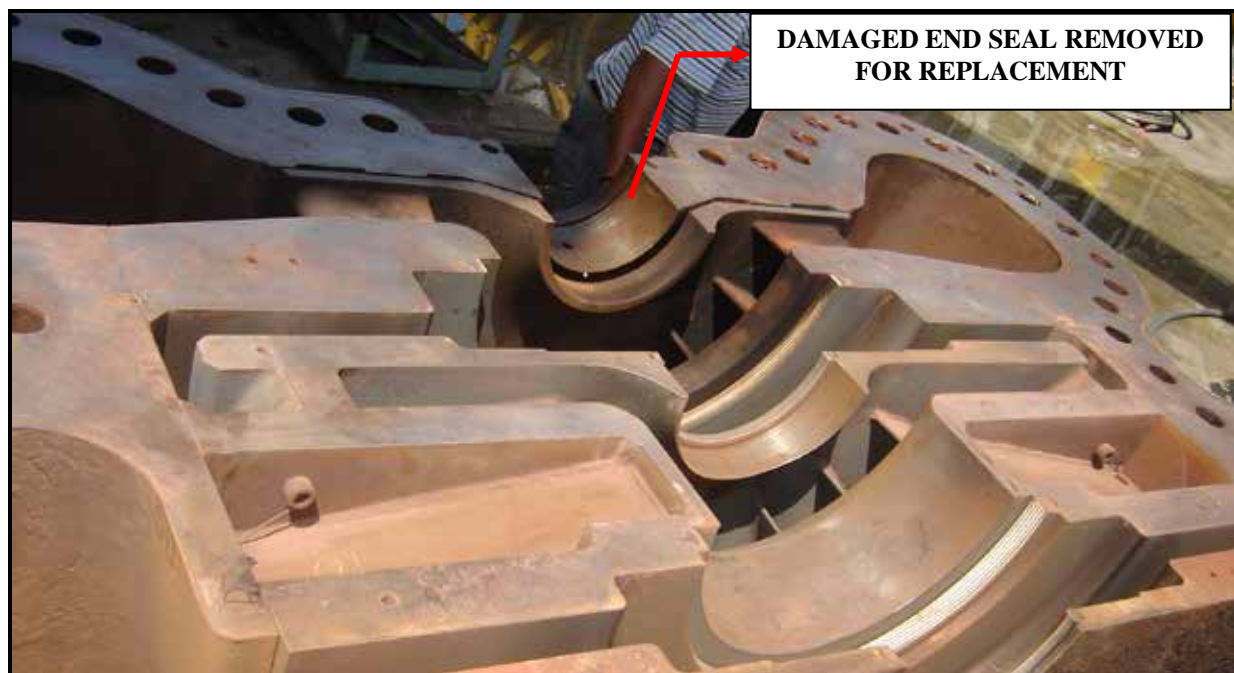
101-JLP BOTTOM CASING

lifted and taken for cleaning & inspection. Thick depositions were found on the vanes of the 1st & 2nd stage impellers. The complete rotor assembly was cleaned by sand blasting and dye penetration test was performed and no defects were observed. The top and bottom casing were cleaned thoroughly.

The journal bearing clearances were measured on mandrel and found within the design range. The journal & thrust bearing pads and their base rings were dye penetration checked and no defects were found. Magnetism level of complete rotor assembly as well as the bearings was under limit.

The rotor assembly was lifted and placed inside the bottom casing with bearing in place. The axial and diametrical clearances were measured and noted. The clearances of the end seals (CF 2041 V) were found to be on higher side and hence were replaced by new ones. The top casing was boxed up and the rotor end float, bearing clearances were measured and found within limit.

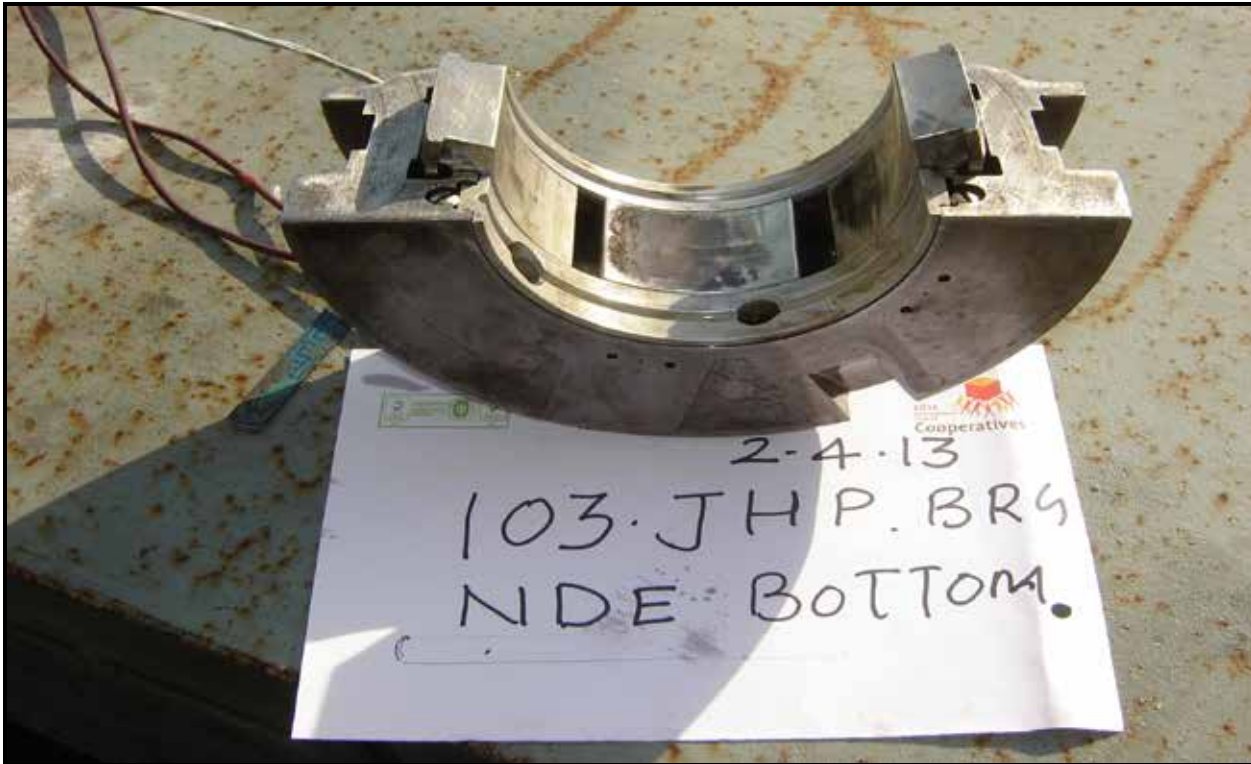
The compressor was decoupled and thrust bearing and both ends Journal bearing which were visually inspected and found O.K. The active end thrust bearing pads which were showing high metal temperature were found to be having thick oxide deposition. These deposits were cleaned. One of the non active pad thermocouple was not working and hence it was replaced by new one. Magnetism level of the bearings were checked and found within limit. All pads were Dye Penetration tested and found to be OK.

THICK BLACK DEPOSITS ON BEARING PADS OF 103-JHP

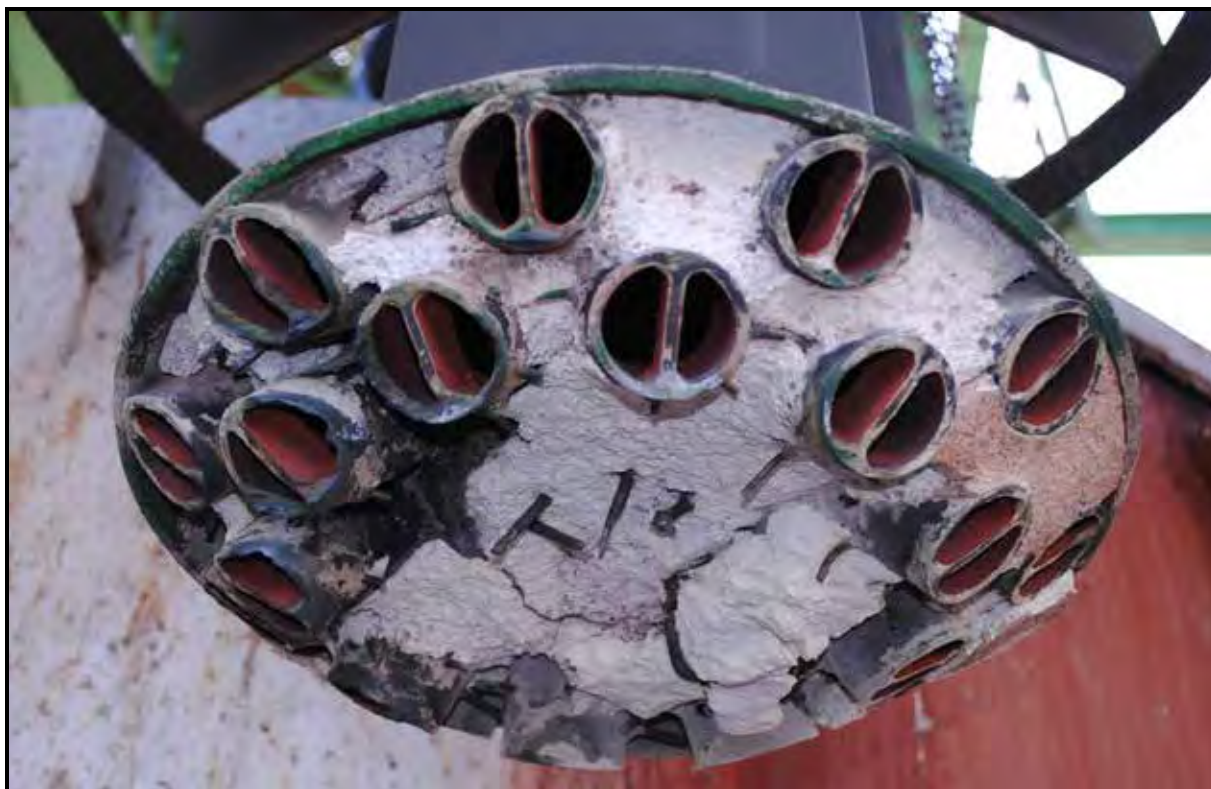
103-D NOZZLE

Top cover with Air distributor was opened & removed. Refractory of Air distributor was found peeled off. Also, erosion/corrosion was observed (shown in fig.) in the Air distributor nozzle. Air distributor was replaced by spare distributor. Damaged refractory (Cracks & peeled off) was repaired. Top cover with Air distributor boxed up with new gasket.

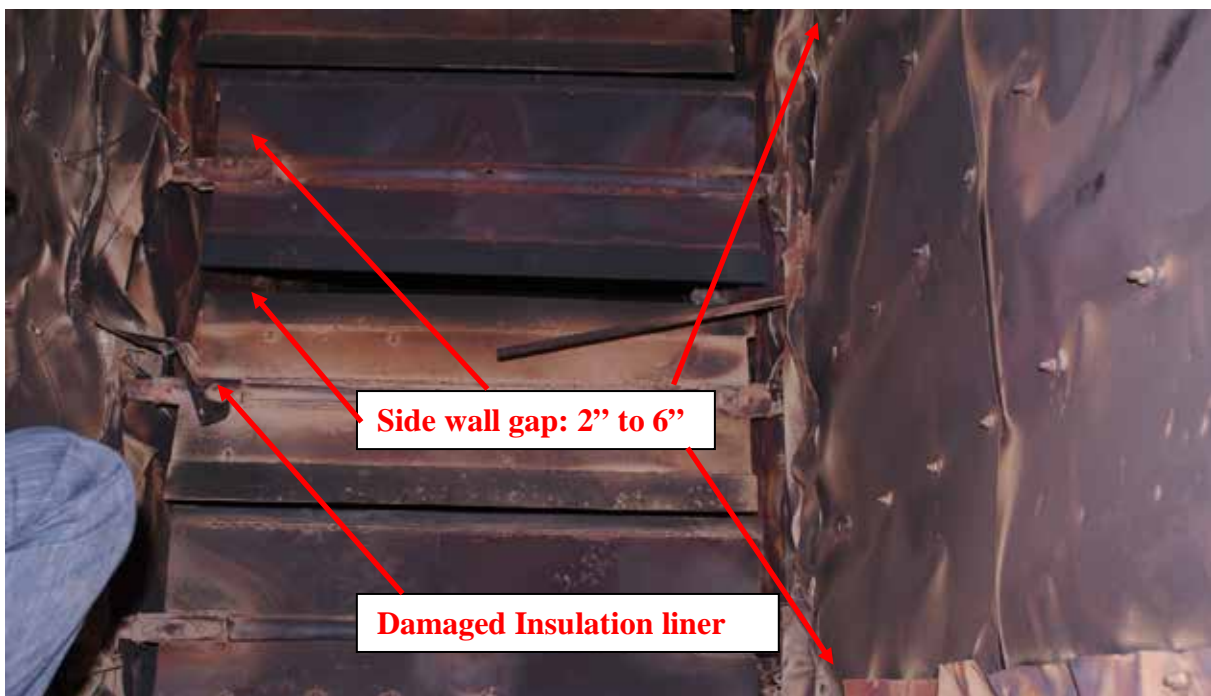
PRC-23 DAMPER

- Damper nearby Incolloy liner of side wall insulation was found detached & bend the same were repaired.

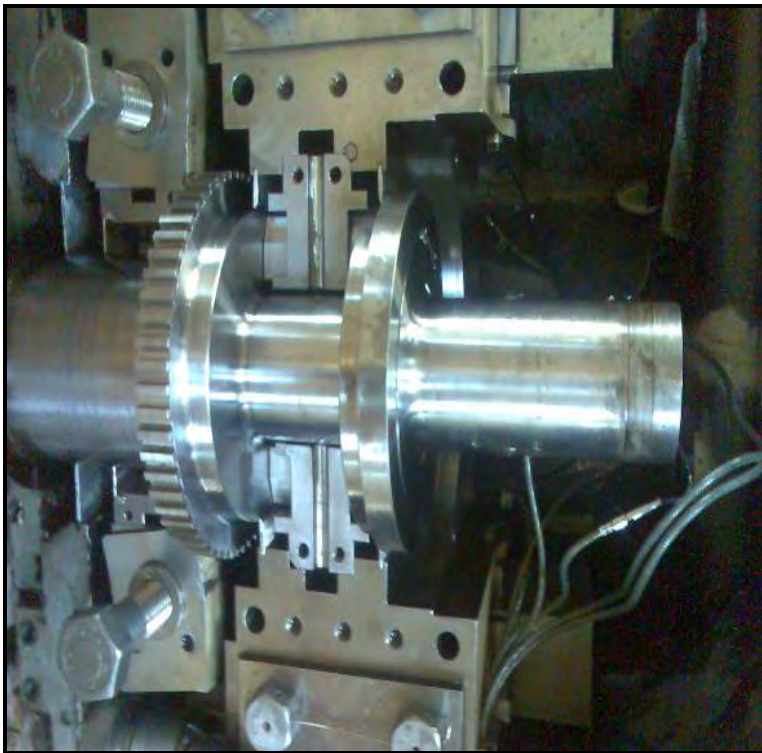
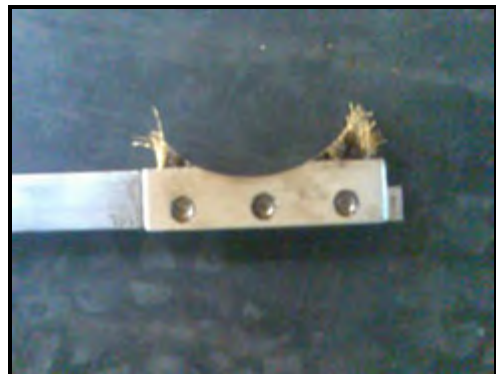
Earthing brush was found worn out completely & made a step at contact area on the rotor.

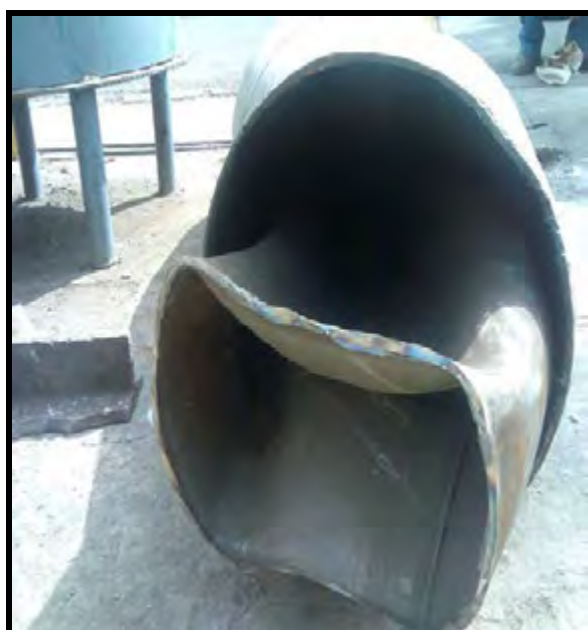
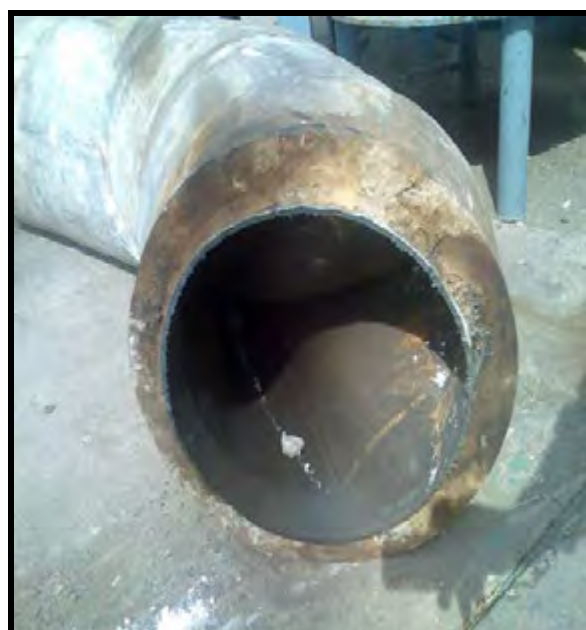
In short shutdown 9-12 January, 2013 during cleaning of H-1424 vessel, choking was observed in suction pipeline of P-1408 pump connected with the H-1424 nozzle. It was tried to clear the choking by rod poking & flushing by hot condensate but not succeeded. When the steam jacketed Pump suction line 1st segment connected to H-1424 nozzle (Flange size: 12" X 150#) above sight glass was removed, it was found completely collapsed & steam jacket found choked badly by urea solution.

Then, it was replaced by temporarily fabricated segment of SS 304L without jacket.

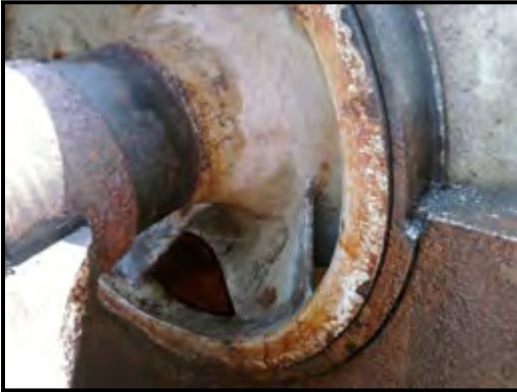
Corroded Cooling water Pump Impeller

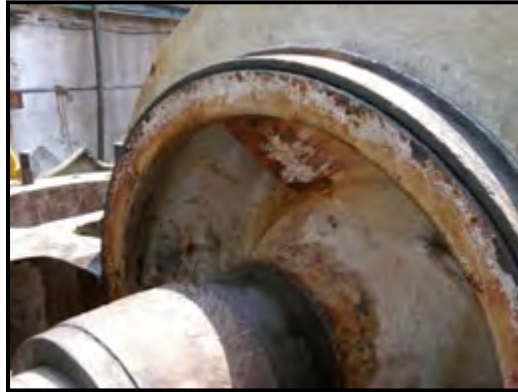
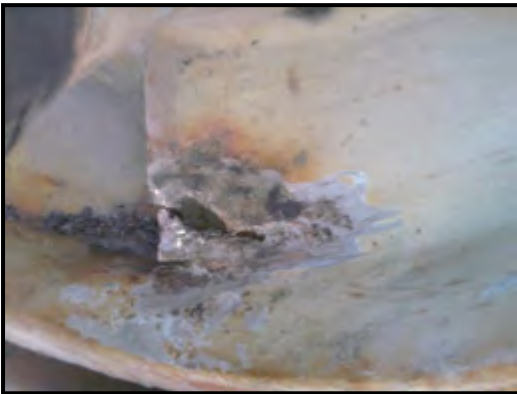
Corroded Wane

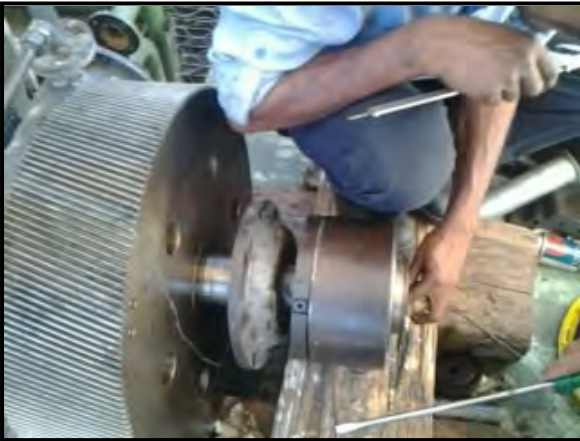
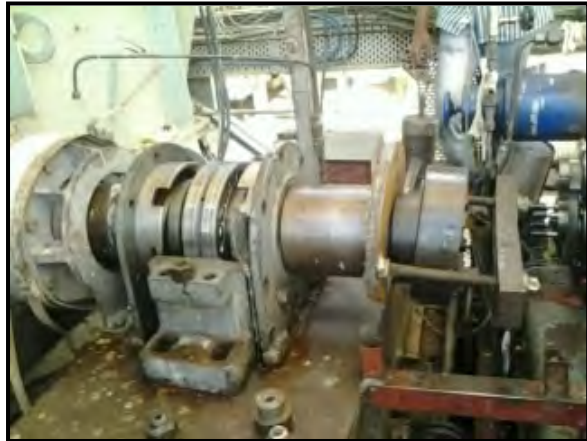
- Turbine side clutch bearings were found in damaged condition (SKF 16021) hence bearings are removed by using hydraulic jack.
- Motor side fan radial bearing was removed with gouging.
- Clutch bearing was removed by gouging.
- Clutch rollers removed and thoroughly cleaned and overhauled.
- Turbine side clutch oil seal replaced with new ones.(105*130*12)
- Clutch bearings were Replaced with new ones (2 Nos). (SKF 16021)
- Radial roller bearings replaced with new ones on both the sides .(SKF 22230 CC/C3 W33)

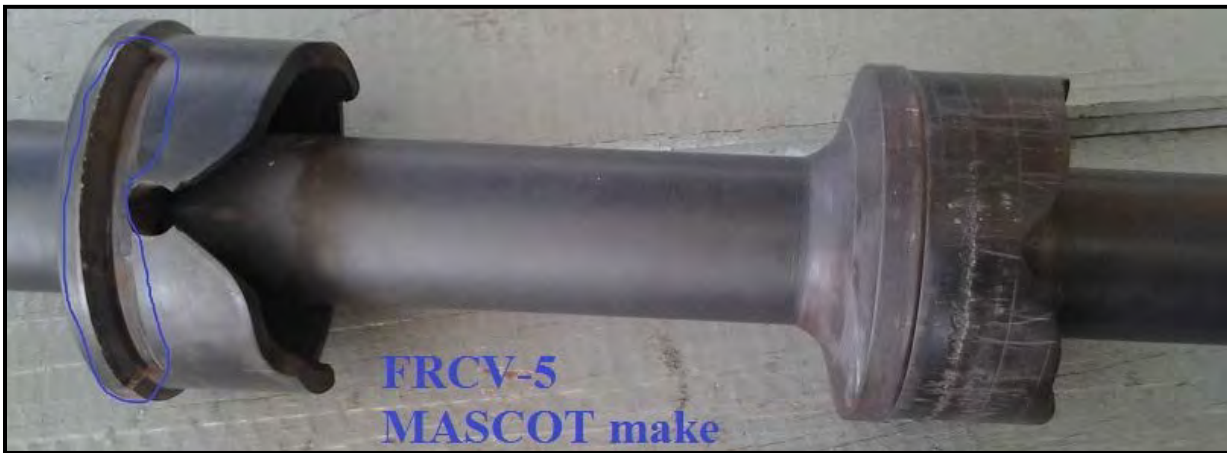
Damaged seating part of FRCV- 5

FRCV- 5: The control valve was opened from bonnet for inspection of trim parts. Found plug seating part was damaged so it was repaired in central workshop. Actuator diaphragm was opened, inspected & found ok. New gland packings had been provided. Finally Stroke was checked.
