MTC / REPORT / 01
REPORT NO. 35 / 2015

PLANT TURNAROUND REPORT

(MARCH – APRIL – 2015)

INDIAN FARMERS FERTILISER CO – OPERATIVE LIMITED

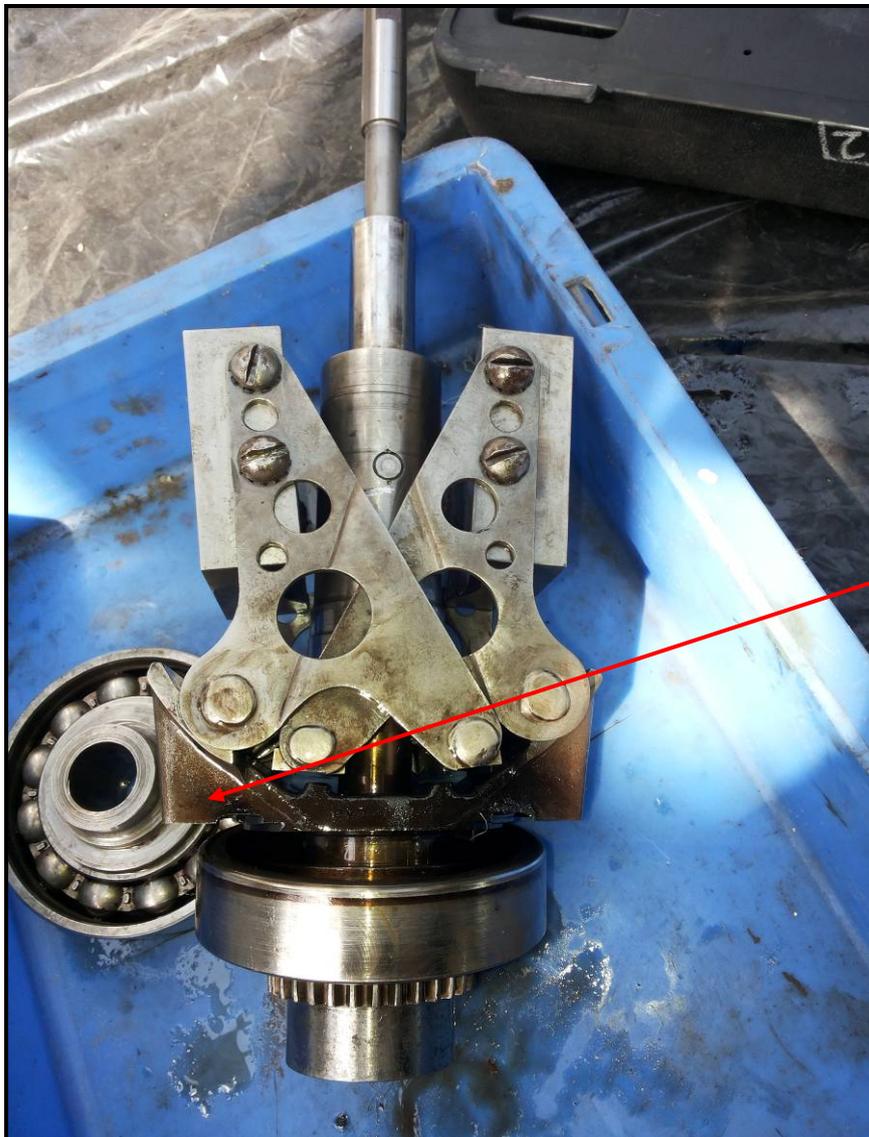
Governor of 101 JT was remaining hot during normal operation. Governor was opened for overhauling. It was observed that the bearing (No 7309 BECBJ, #2) was rubbing with Governor Valve Body (#5) due to which groove was found in Governor valve body. The new bearings were assembled as per drawing. Governor Valve Body was also replaced with new one.

Groove was found
in Governor valve
body

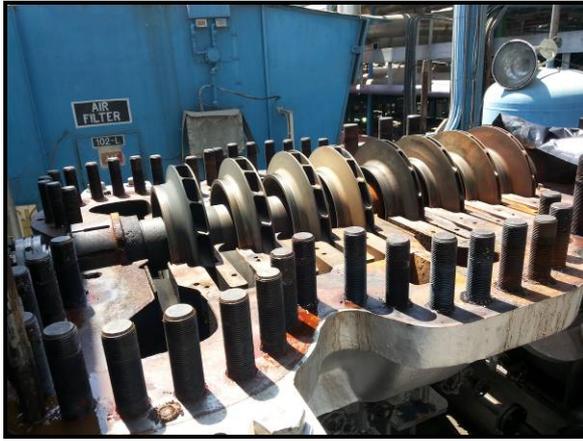
After removal of Top half of casing

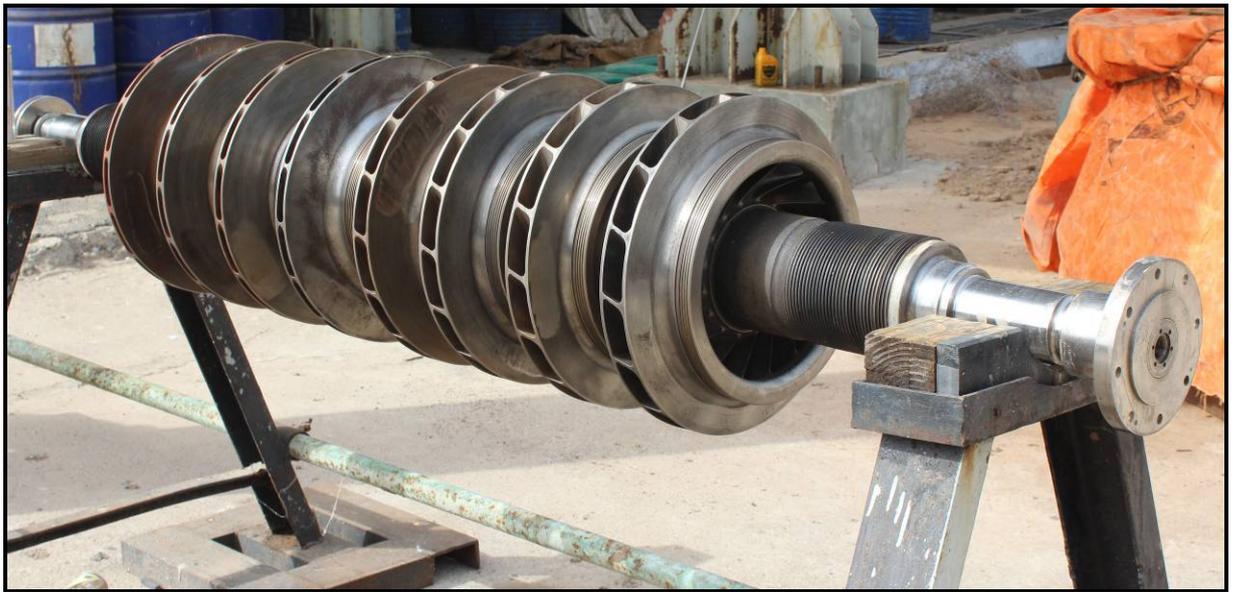
101 JHP Compressor rotor after cleaning

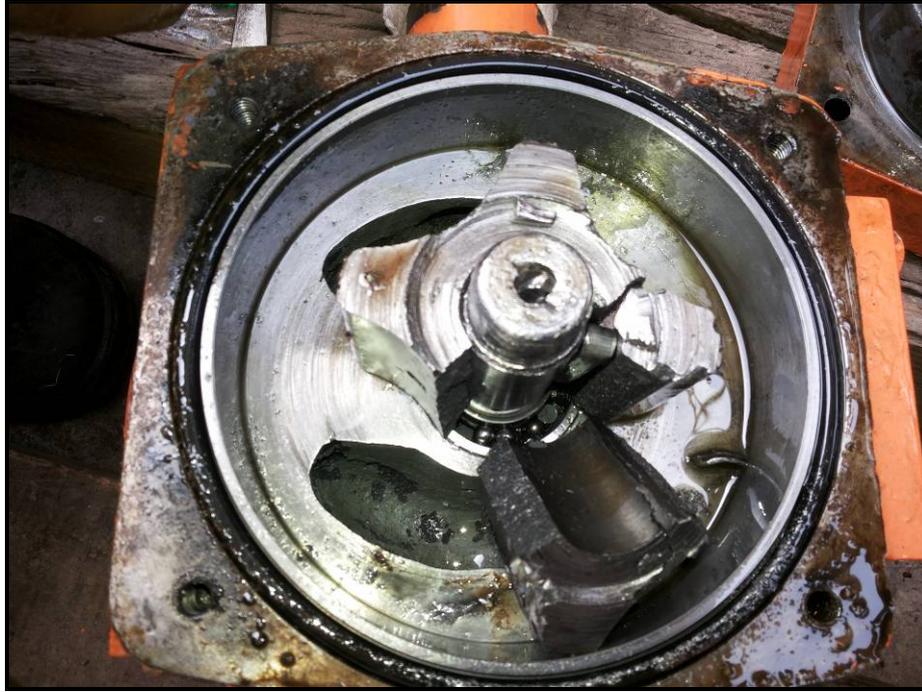
Damaged internal of MOP

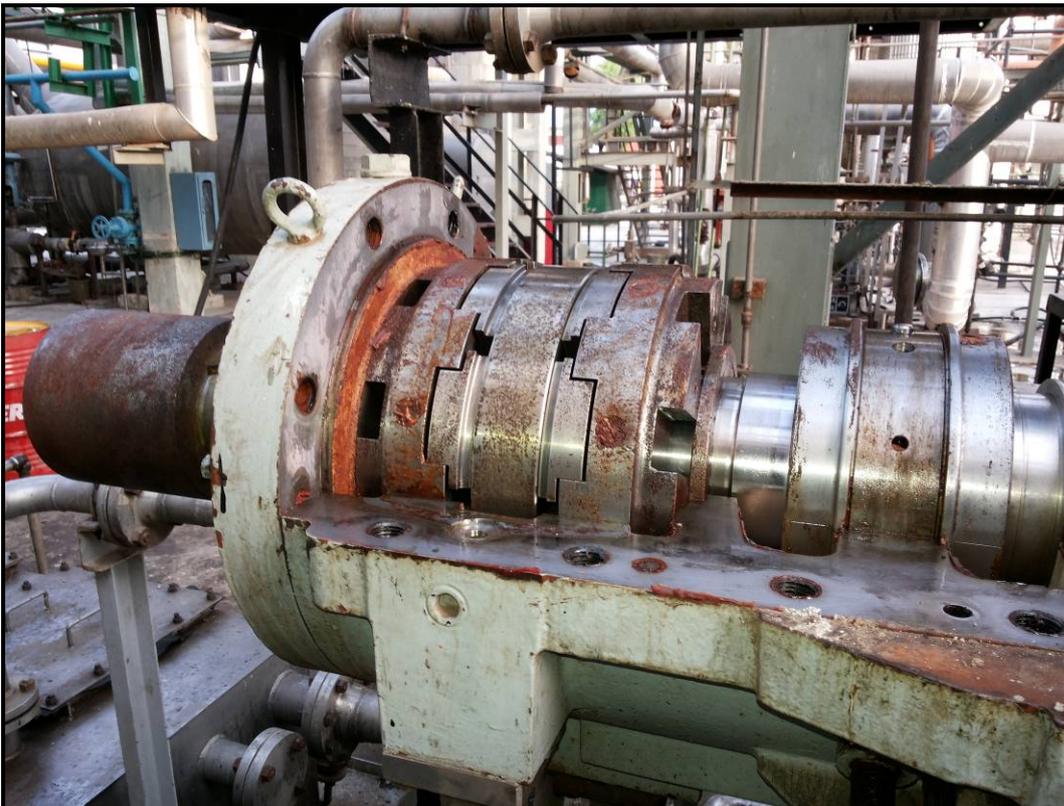
The bearing shell & housing of pump were found to be having rust

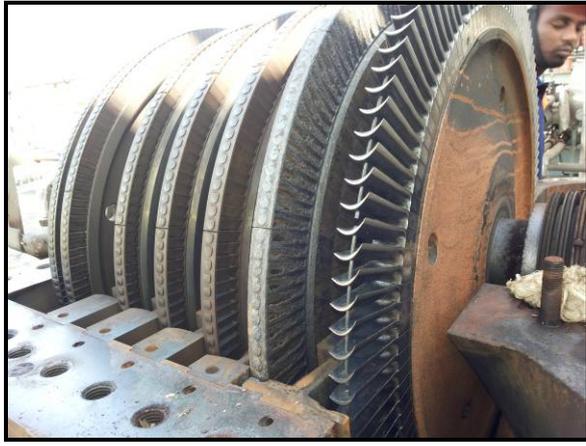
After removal of casing

5th stage blades was having deposits and it was choked badly

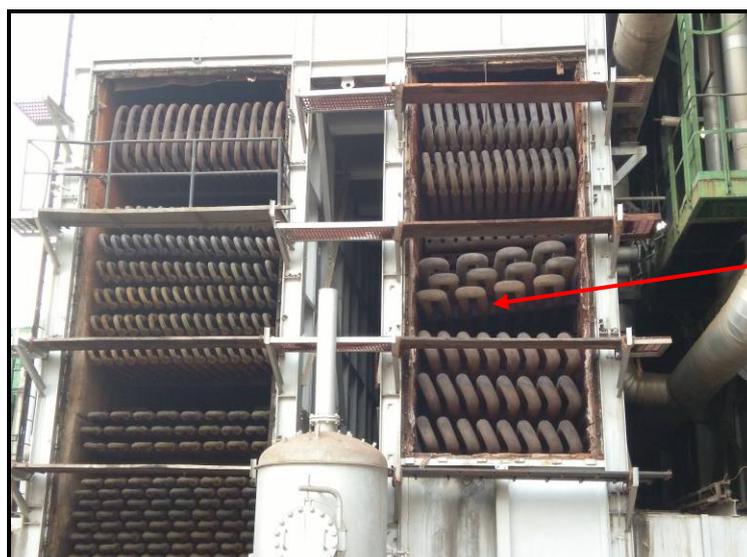
Steam air
Coil was
found
sagged

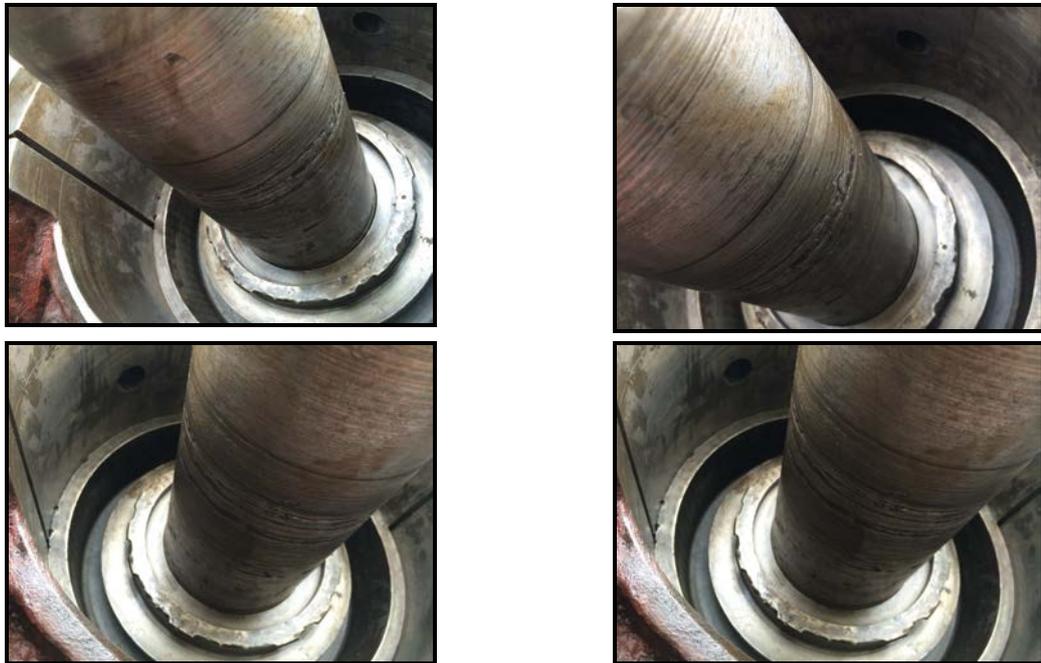
Frequent failures of Fan Drive End bearing were occurred in the month of Feb & March-2015 and all these failures are mainly due to looseness of Bearing adapter sleeve on the fan shaft. OD of shaft at the bearing portion is damaged and became undersize due to scoring on the shaft surface. (See pictures below)

So it was decided to replace the fan shaft in the shutdown.

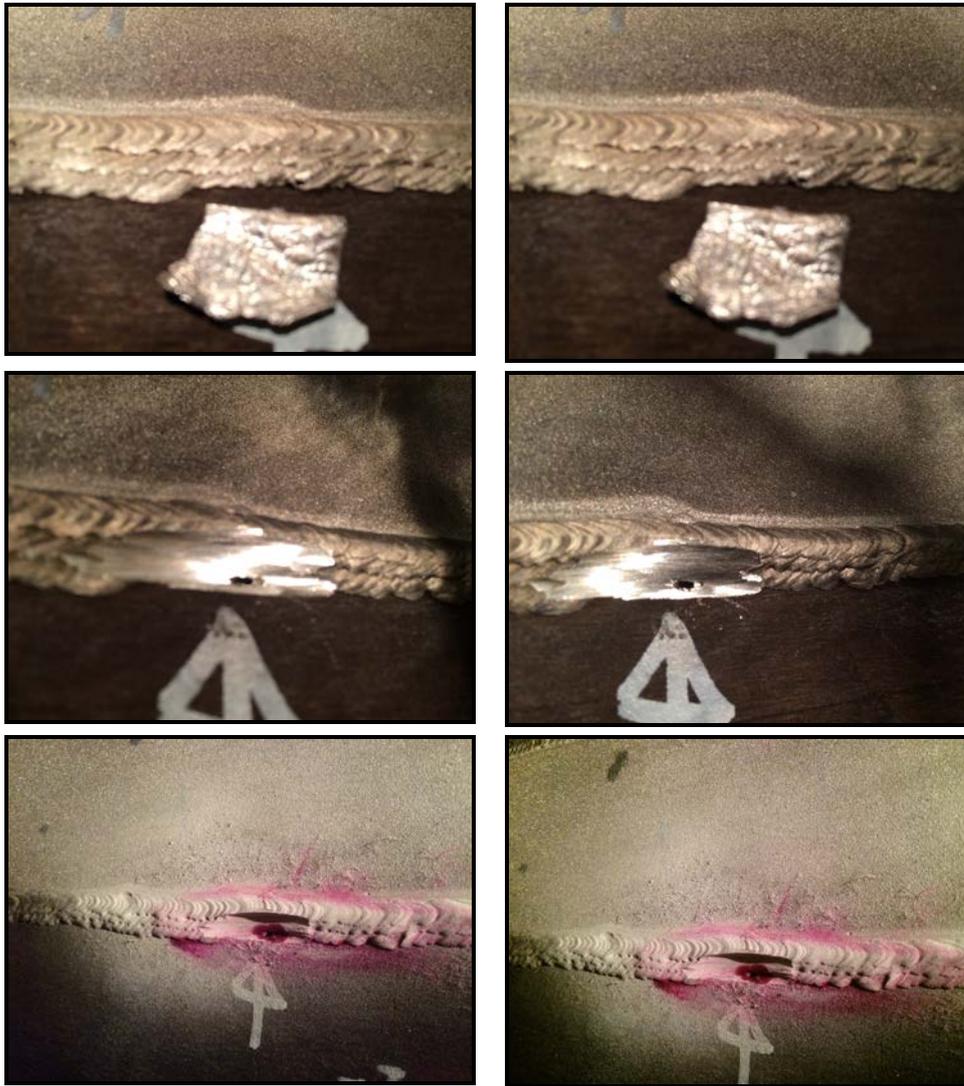
Observation: In Helium leak detection, a pinhole leak was observed in bottom C-seam of insert liner in the 10th compartment. See photographs below:

Repairing of Pin Hole Leak

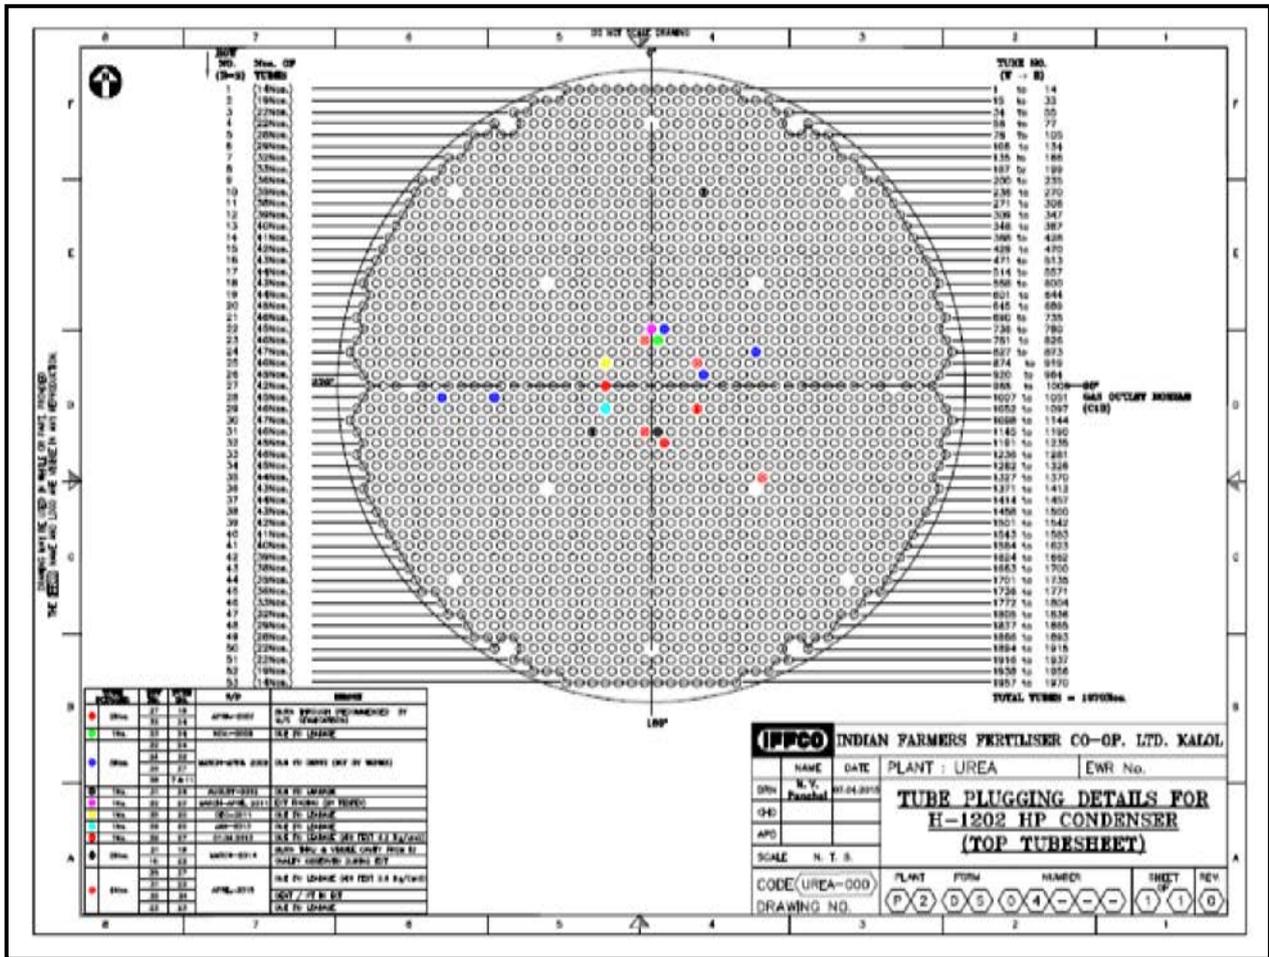
- Hydrotest of HPCC shell side was carried out at 11 Kg/cm² and one tube was found leaked (Row No. 23, Tube No. 23) which was plugged.
- Hence total 04 tubes were plugged shown in below picture

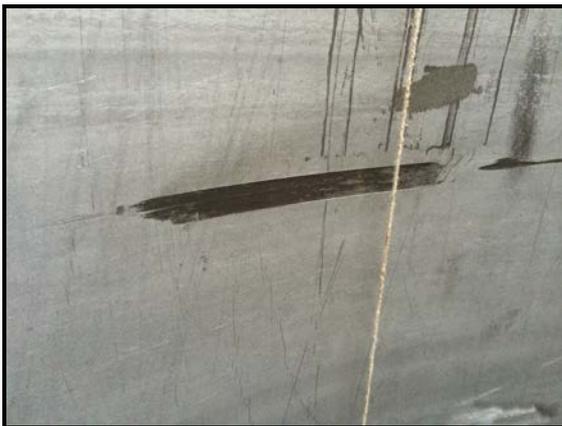
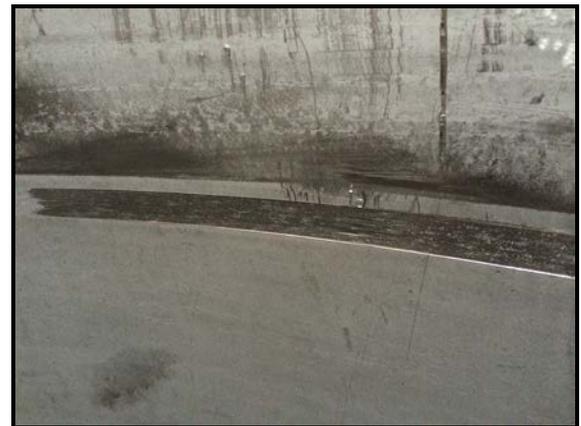
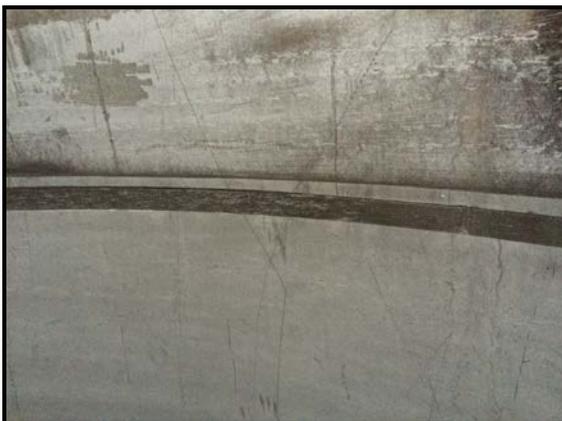
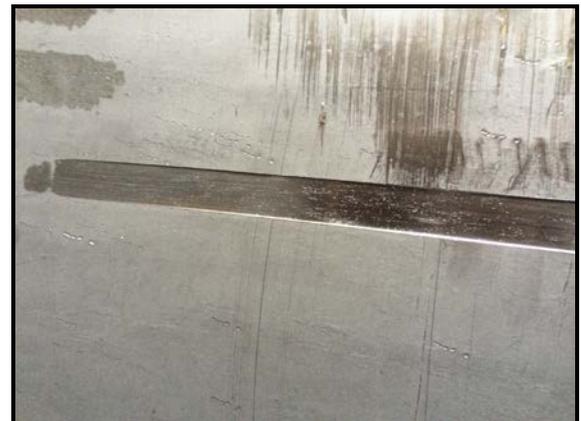
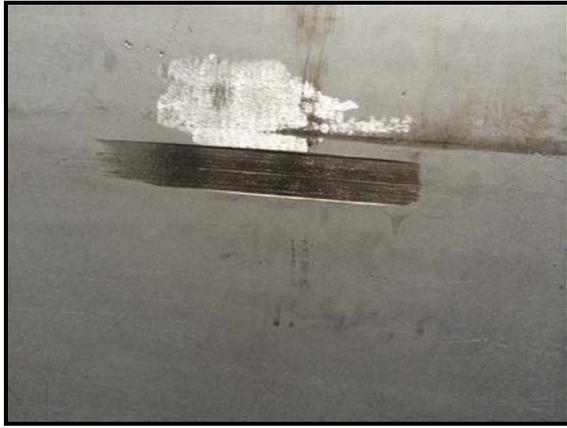
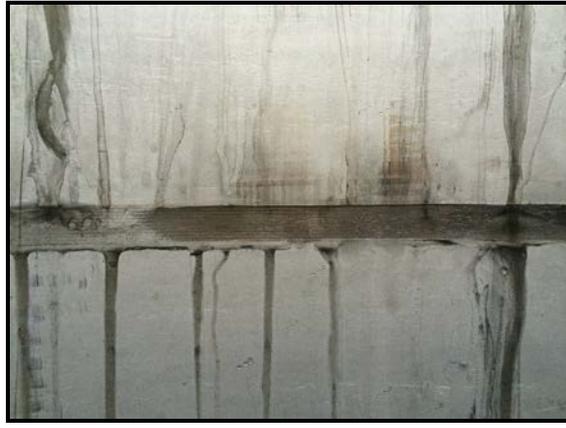
After removal of tube bundle internal shell was inspected and various rubbing marks of tube baffle and shell were observed. See the below attached pictures:

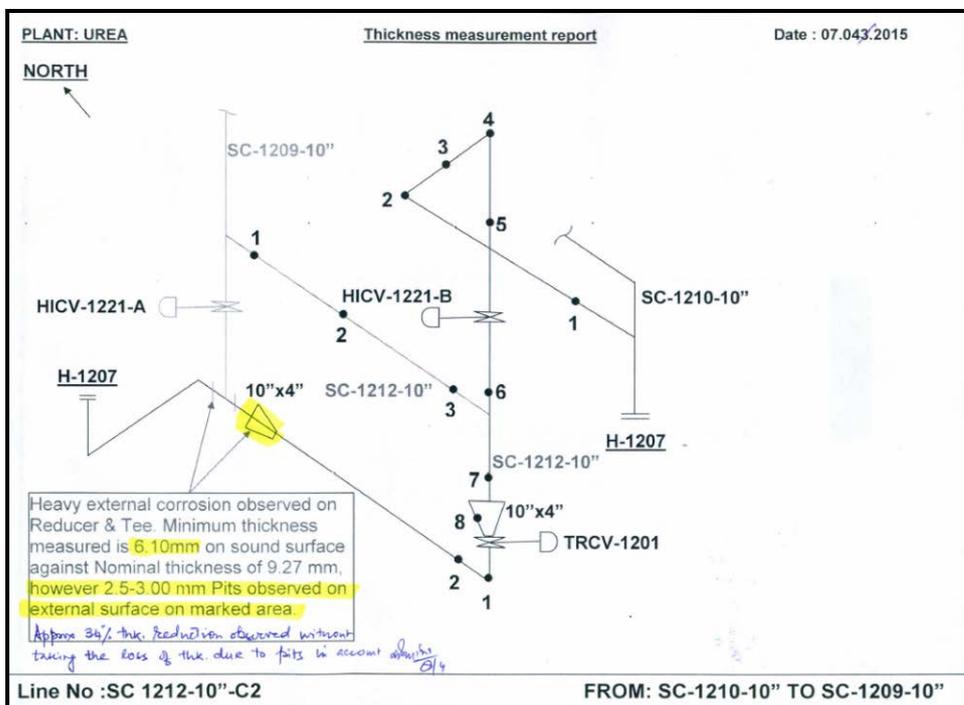
During thickness survey of line no. SC-1212-10"-C2, thickness loss was observed on some locations as marked in the attached sketch.

So the line portion from Equal tee of 10"X10" (Connected to HICV-1221A) to TRCV bottom flange was replaced with new one as shown in attached photograph.

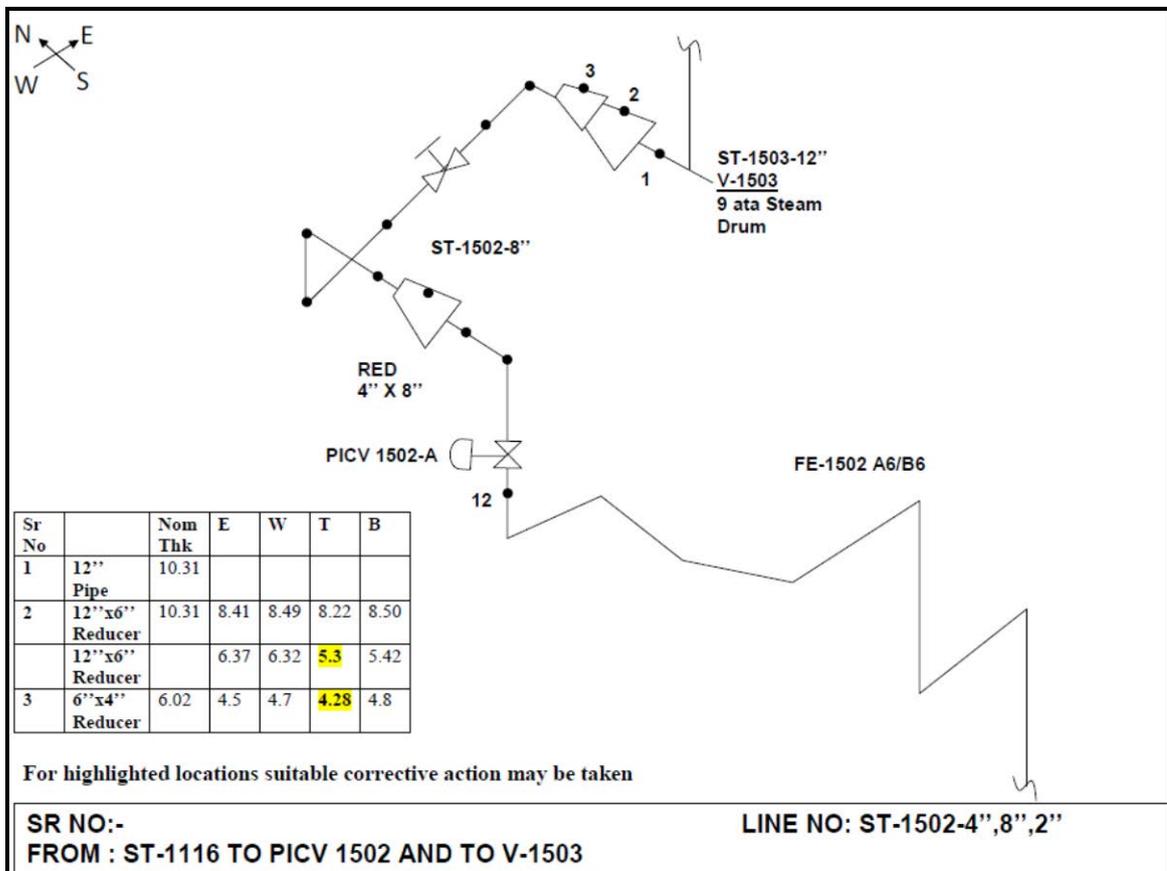
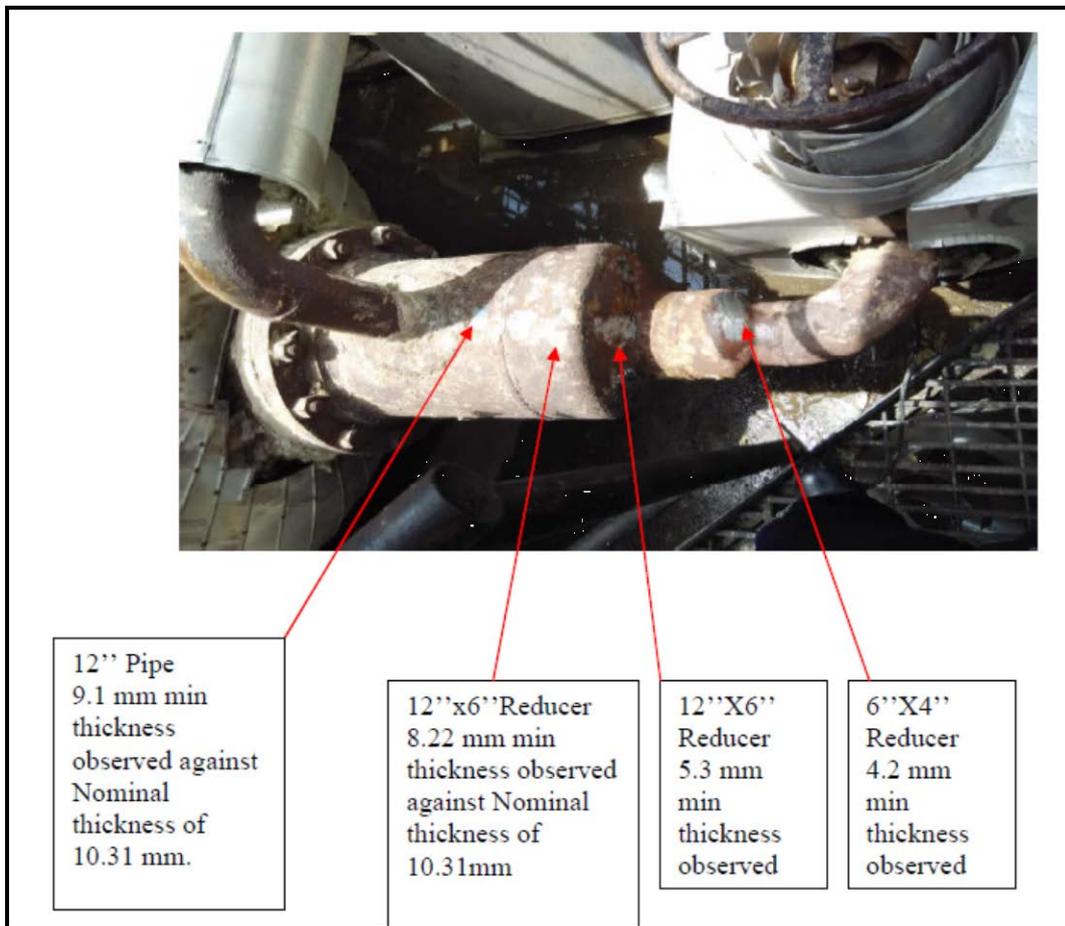
Thickness loss in Reducer of Line No. **ST-1502-4",8",2"**

Thickness loss in Eccentric reducer of 12" X 6" and 6" X 4" was observed in line No. ST-1502-4",8",2" i.e line from ST-1116 TO PICV 1502 AND TO V-1503 as shown in the attached report and pictures.

Since the major thickness loss was observed on the top half portion of 12"x6" and 6"x4" reducers and also new reducers of required sizes were not available with us , so patch plate in top half of both the reducers was welded.

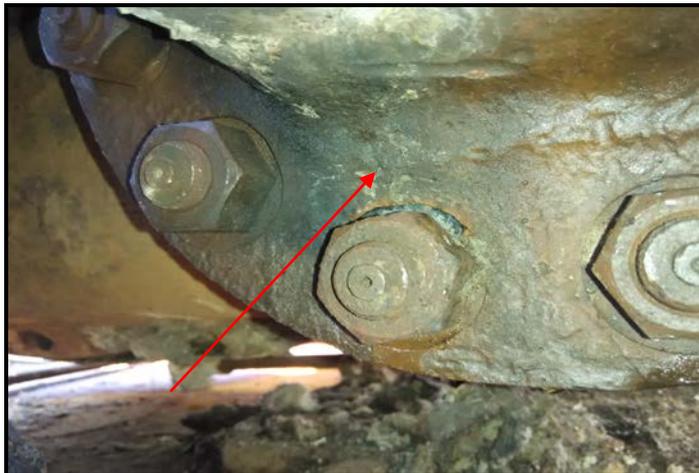
During start-up of turbine, leakage was observed from the one no. of bolt of steam chest flange to turbine (shown in figure below). Nut of same bolt was removed with the help of pneumatic tool. Copper washer was provided and bolt was tightened using pneumatic tools. Steam was charged in turbine, no leakage observed from the bolt, but there was heavy leakage from the steam chest body through the pin hole. To attend the leakage from the steam chest body, assembly of governor, quick shut-up & isolation valve were removed. Both flange bolts of steam chest were loosened using pneumatic tool. Connecting steam drain line was removed from its position. Steam chest was lifted using kobelco crane and shifted to workshop. Grinding was done in chest body throughout the pin hole. DP test was done to check the extent of pinhole. Pinhole repaired by TIG welding using 70S2 filler wire. Finally boxed up the dismantled assembly. Turbine was checked by steam charging no leakage was found.

Steam leakage through the bolt

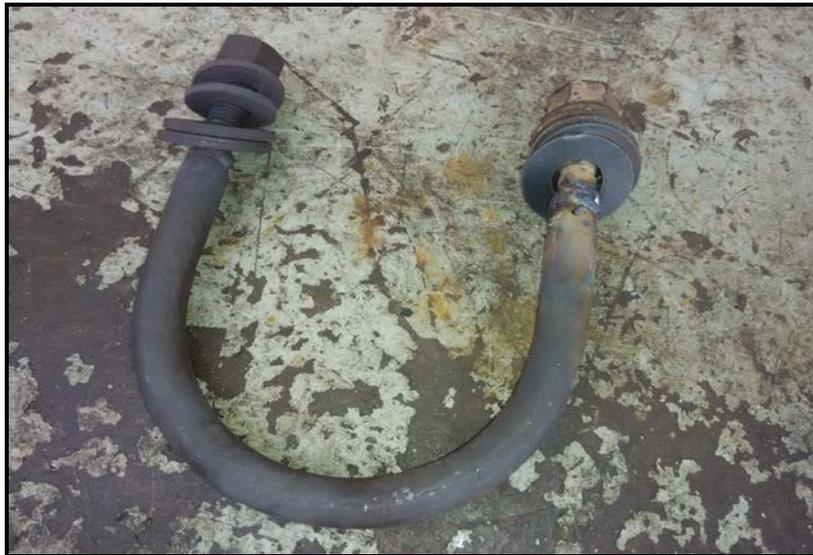
One no. of U-clamp of feed water inlet header (4") was found in damaged condition. The same was repaired shown in below figure. Two nos. of clamps of phosphate dozing line (1") were also found in damaged. New clamps were welded with pipe line and tightened it with fasteners.

Repaired U-Clamp

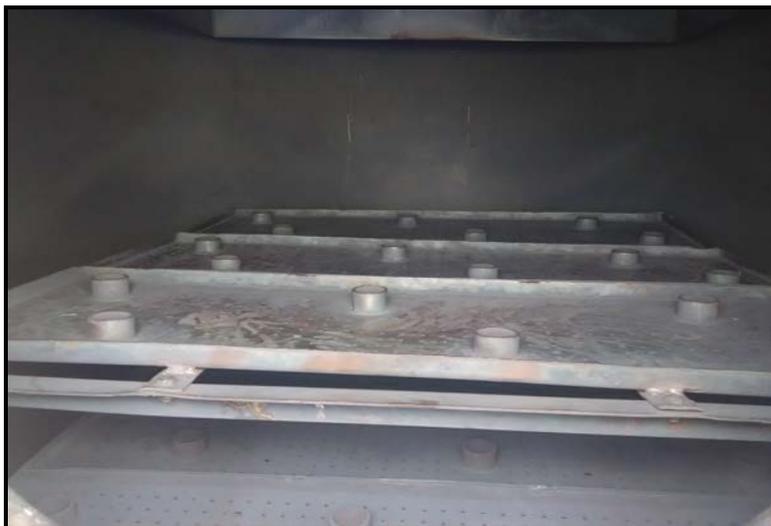
Bottom two tray segments were found displaced from its position. All tray segments were removed one by one from the top by cutting tack welding. From bottom, each tray segment was placed its position one by one. Tack welding of fasteners of each tray was also done for strengthening.

Tray position inside dearator

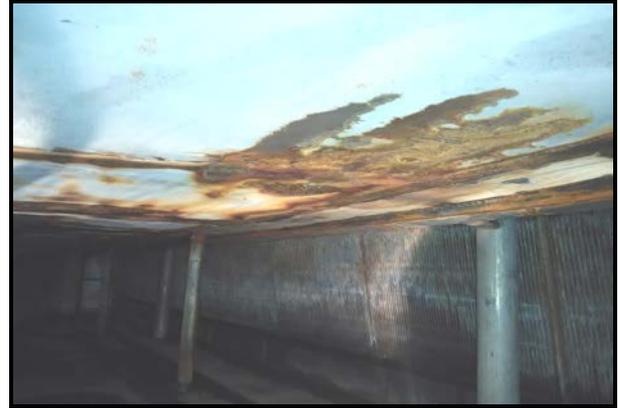
Corrosion and rusting area in flue gas outlet chamber

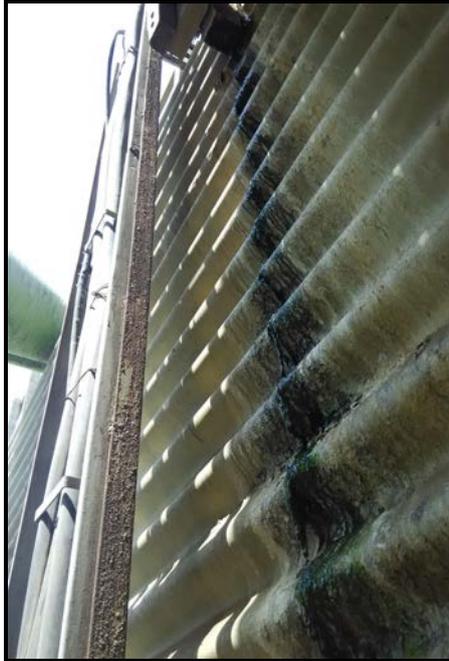
Leakage from end wall

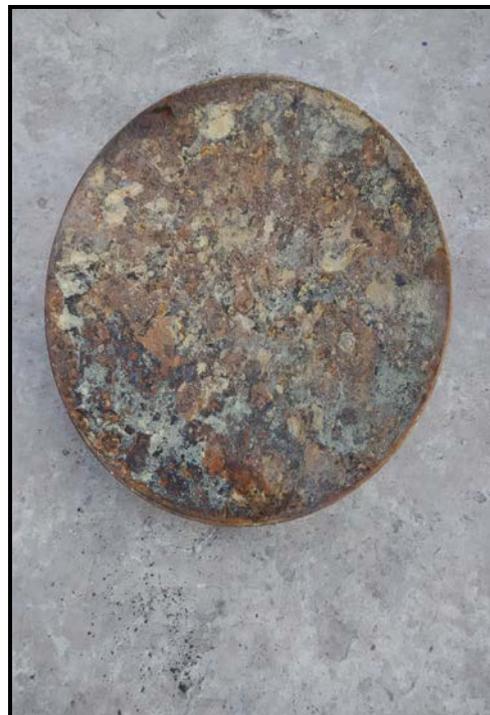
Check valve was dismantled. Corrosion & pitting observed along the disc seat portion, which seems unable to refurbishing. Body seat of valve is having heavy corrosion & pitting. Finally check valve was boxed up after using new gland packing and it is decided to procure new valve to replace existing one during next shutdown-2016.

Check valve parts after dismantling

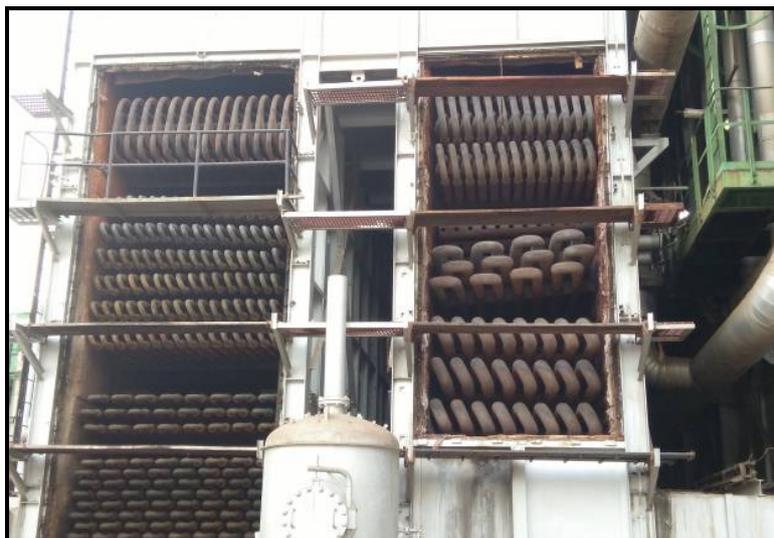
- South side all support found cracked/damaged. (1st support from of East side)
