MTC / REPORT / 01
REPORT NO. 40 / 2023

PLANT TURNAROUND REPORT
(APRIL – 2023)

INDIAN FARMERS FERTILISER CO.-OP. LIMITED

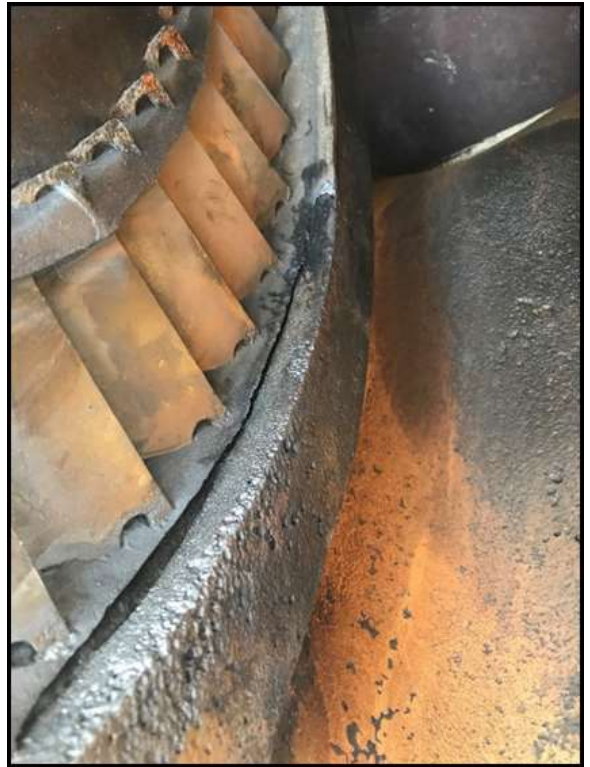
Pittings observed in stage

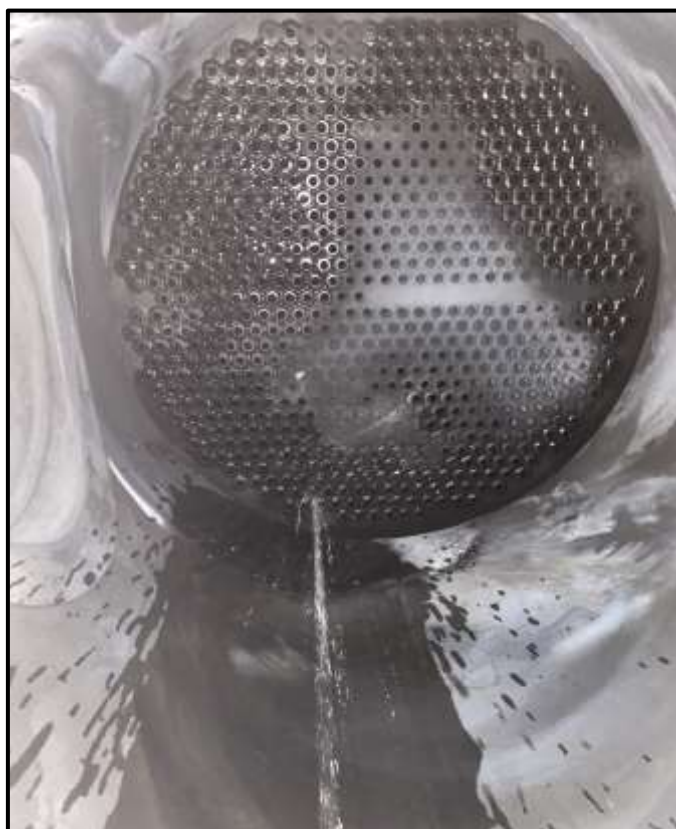
Leaky Tube #30/13

Water fill-up was carried out on shell side for identifying the leaky tubes. Leakage from one tube i.e. #30/13 was observed from full bore at bottom side of the tube sheet.

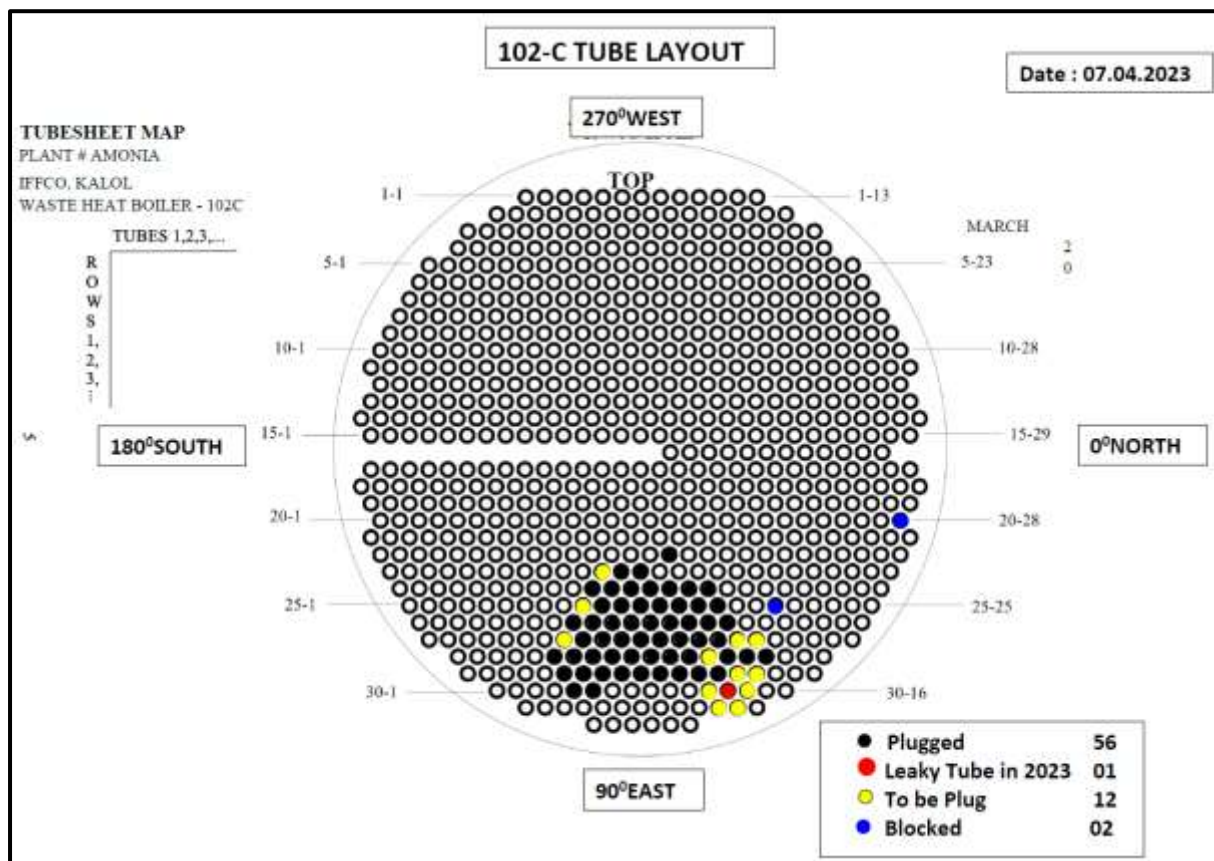
It was decided to plug 13 nos. tubes (1 no. leaked tube in red color and 12 nos. tubes in yellow color) as marked in the tubesheet map below:

Tube plugging of 13 nos. leaky tubes were carried out and the tube plugging procedure adapted was same as per L&T followed in the year 2019.

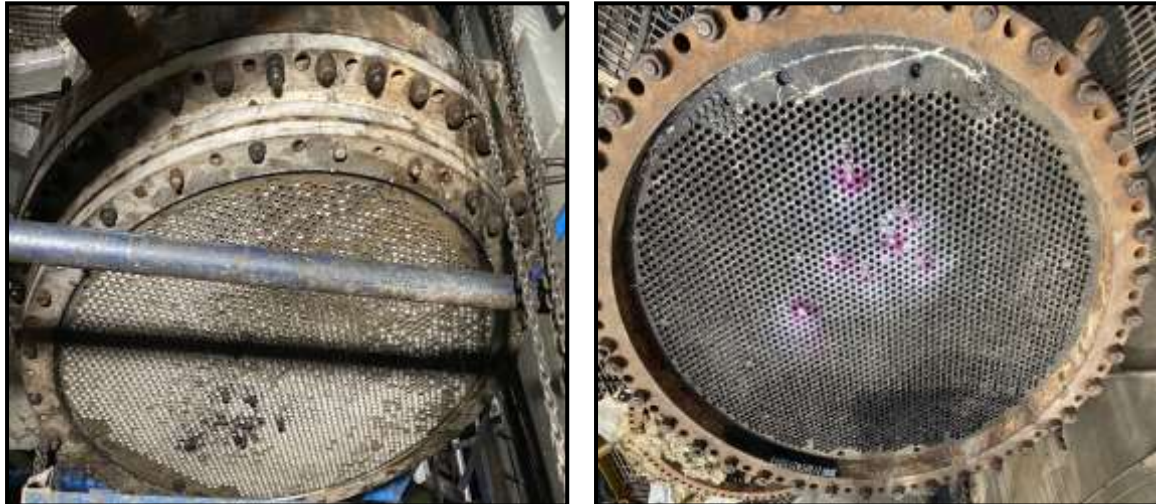
8 nos. leaky tubes plugged in 105-CB (Tube #51/14, #50/16, #49/24, #45/25, #44/30, #39/22, #39/26, #29/21. Rows marked from silo side

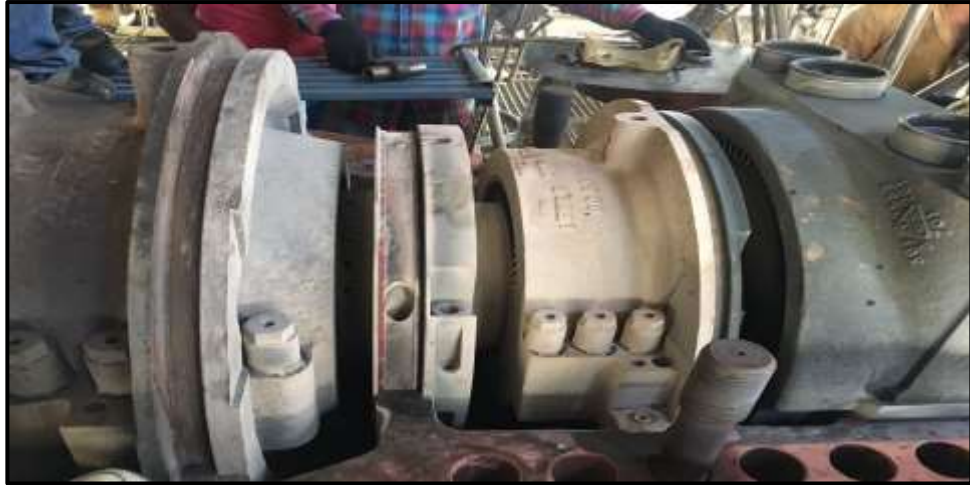
- Removed bottom halves of all three Guide blade carrier, steam chamber and inner gland one by one front side to rear side.
- Scaling was observed on fin area of rotor specially at area of 23 ata extraction steam.

Scaling observed in above picture

- Rotor, guide blade carriers, steam chamber (Nozzle block) and inner gland were cleaned by grit blasting at Auto yard.

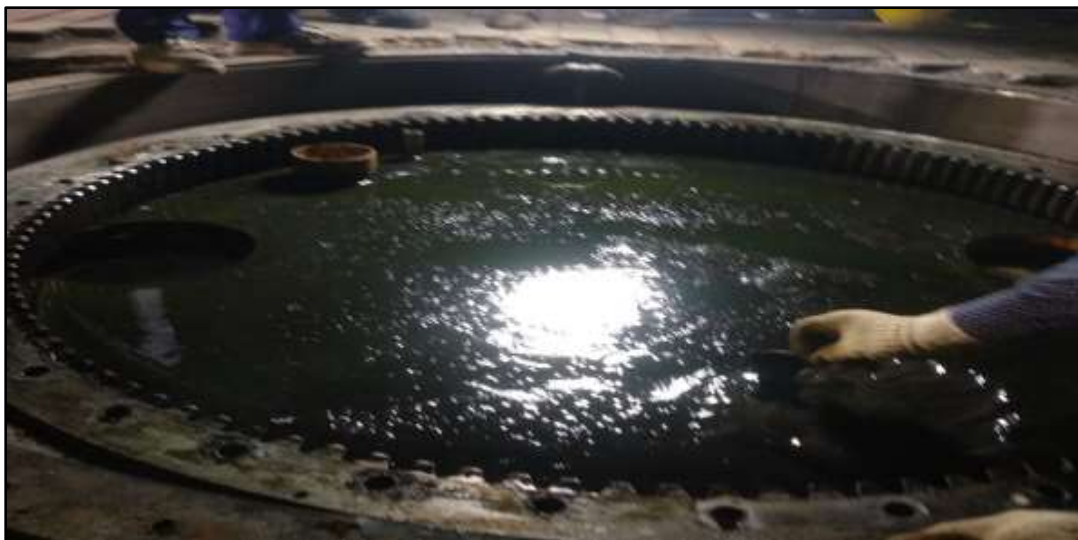
After removal of scrapper arm, condition of slewing bearing.

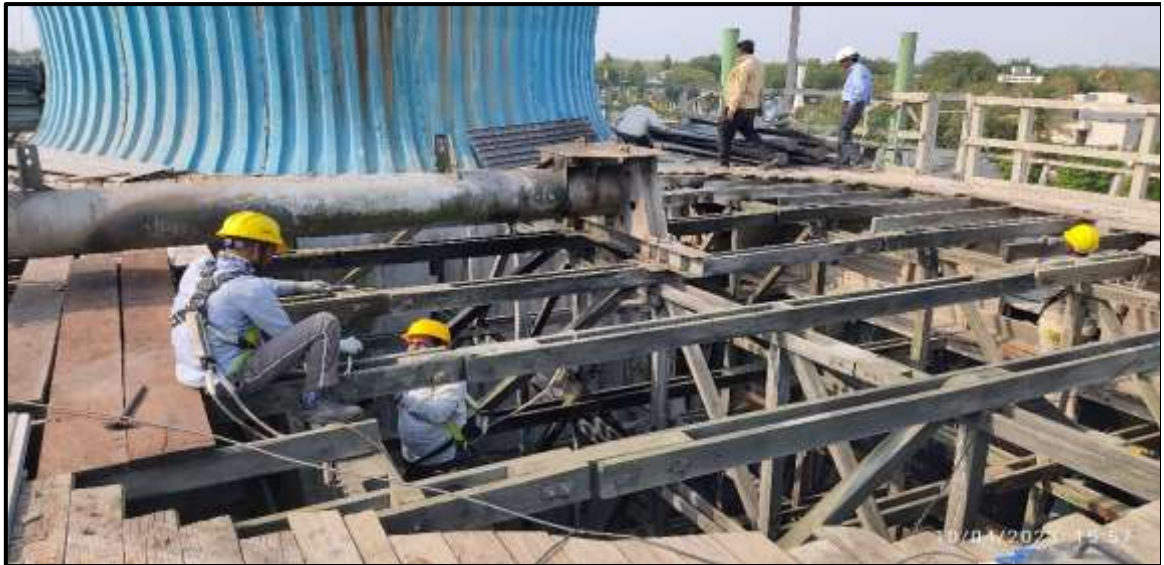
- M/s. Paharpur has done inspection of all cooling towers and found partition wall (Panels) in between Ammonia Cooling Tower cell 5 and 6 was dislocated. Also timber at some places in Ammonia CT between cell 4 and 6 found in bad conditions.
- Damaged timber is replaced with new timber as per inspection
- PVC partition panels were re-assembled between Ammonia CT cell 5 & 6.

Damaged timber replacement work

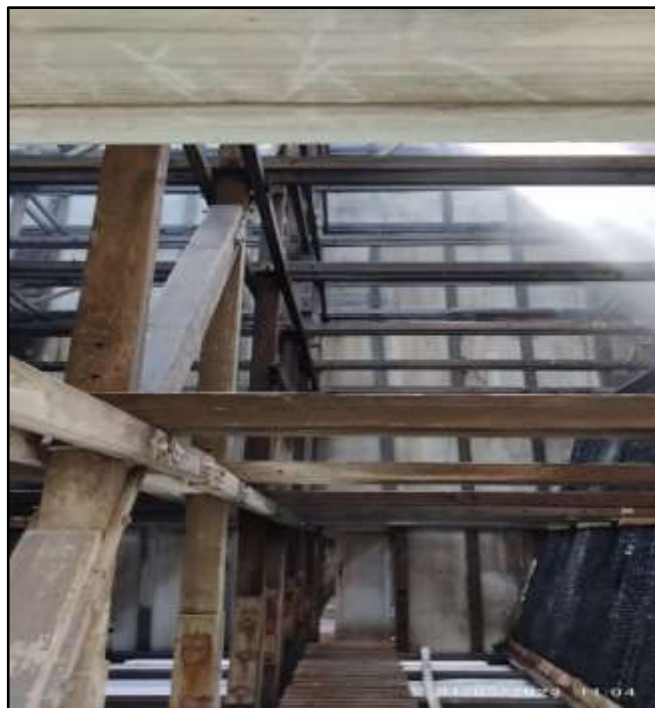
Partition wall rearrangement work

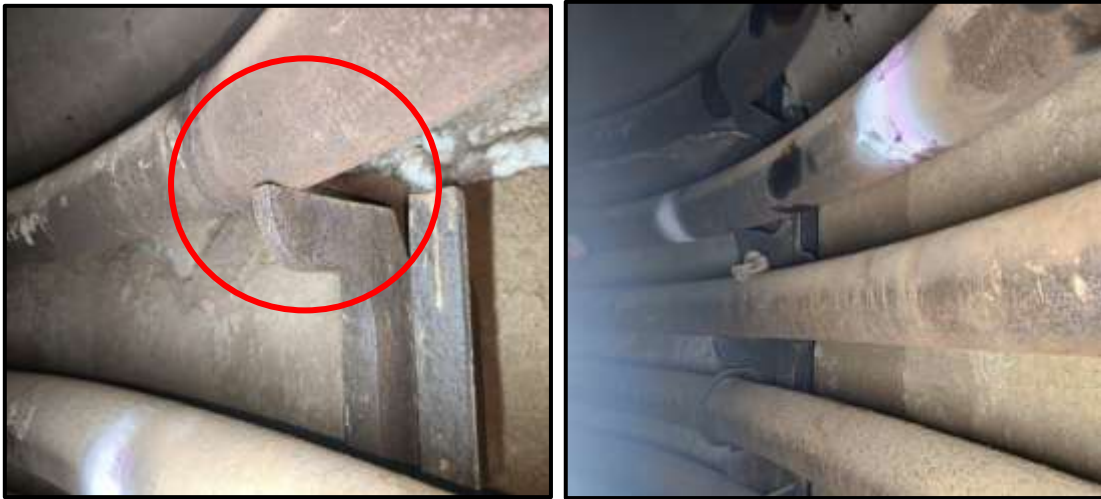
- Insulation was found missing in coils covering cap at top end of the coils.

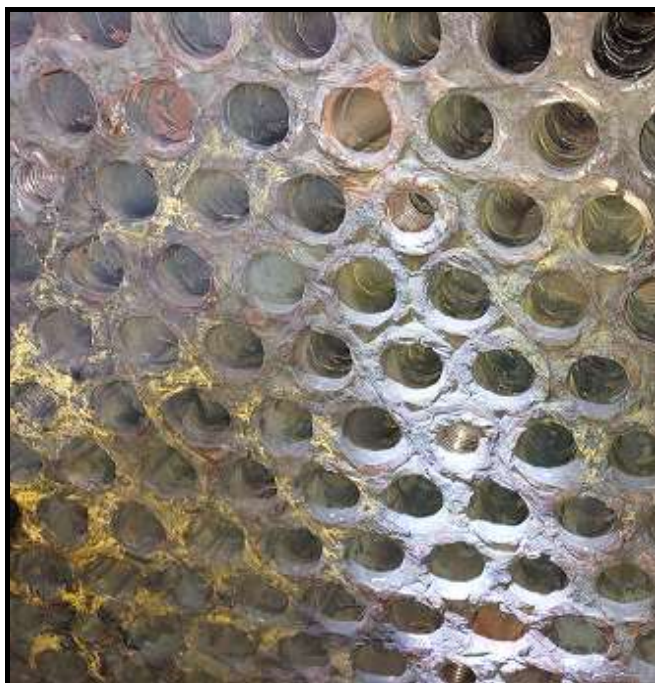
- Hard blackish scale observed inside the tubes from bottom tube sheet.

- Minor brownish scaling was observed inside the tubes from top tube sheet.
- Tube to tube sheet welding found satisfactory.
- Visual inspection carried out after hydro jetting.
