IFFCO
Kalol Unit

P & S Section
Maintenance Deptt
Report No.8/1986

RE V. A M P T U R N A R O U N D - 1986
(19th March 1986 - 3rd May 1986)

INDIAN FARMERS FERTILISER CO-OPERATIVE LIMITED

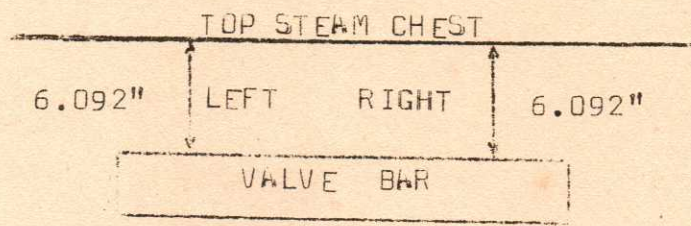
NOZZLE VALVE SETTINGS FOR 101JT

Valve No		1	2	3	4	5
Valve setting	A	0.690"	0.310"	0.100"	0.520"	0.890"
Cold Bar Clearance	B	0.100"	0.100"	0.100"	0.100"	0.100"
Valve seat error	C	0.011"	0.007"	0.004"	0.002"	0.000"
TOTAL	D	0.801"	0.417"	8.204"	0.622"	0.990"

Total Bar Lift = 1.200"
Bar Setting = 6.092" - 0.600" = 5.492"

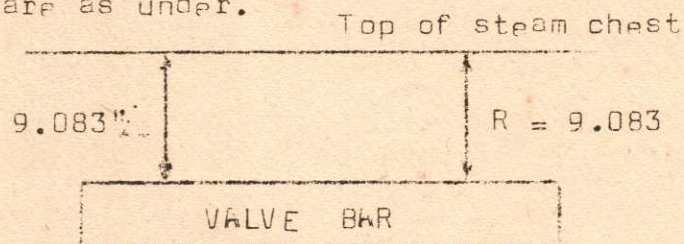
- ix) Nozzle valve assembly was put in position after setting the bar and valves. Valve setting readings are as under.

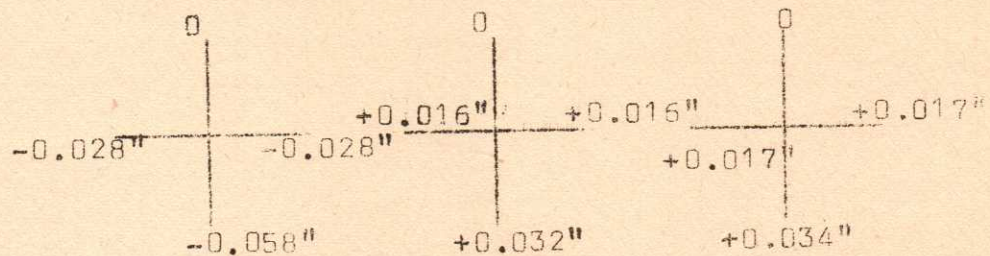
- (A) Bracket mounting on turbine, dial pointer on 103JLP, rotating both shafts together in clockwise looking towards turbine.

- i) As per 26.2-74 ii) As recommended by M/s Dresser Clark on 16.4.86 Telex iii) Final reading of cold set alignment 20.4.86 at 7.20 AM

NOTE: Previously 103JAT Turbine axis was in lower position. Now compressor 103JLP Shaft is in lower position.

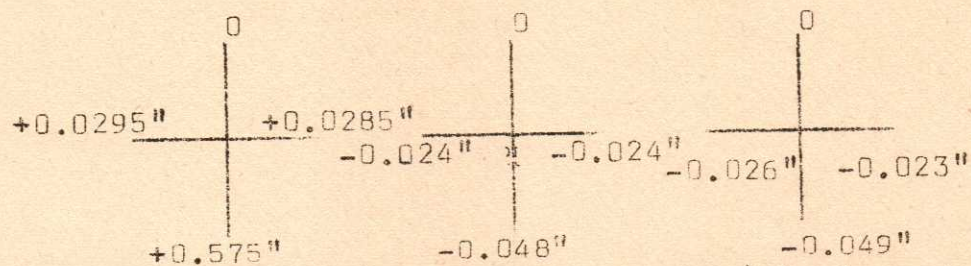
- (B) Bracket mounting on 103JLP, dial point on turbine shaft rotating both shaft together clockwise and looking towards turbine.

- i) As per 26.2.74 ii) As recommended by M/s Dresser Clark on 16.4.86 Telex iii) Final reading of cold alignment 20.4.86 at 7.20 AM

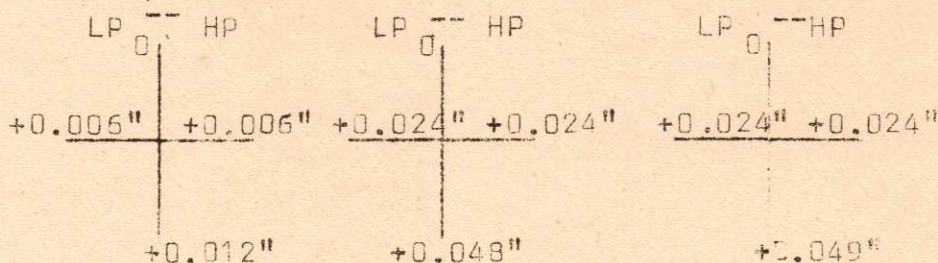
- (A) Bracket on 103JLP coupling, dial point on 103JHP coupling, Rotating both shafts in clockwise direction looking towards turbine.

- i) As per 26.2.74 ii) Correct as suggested by M/s Clark Dresser iii) Actual readings of cold set alignment on 22.4.86 at 05.00 AM

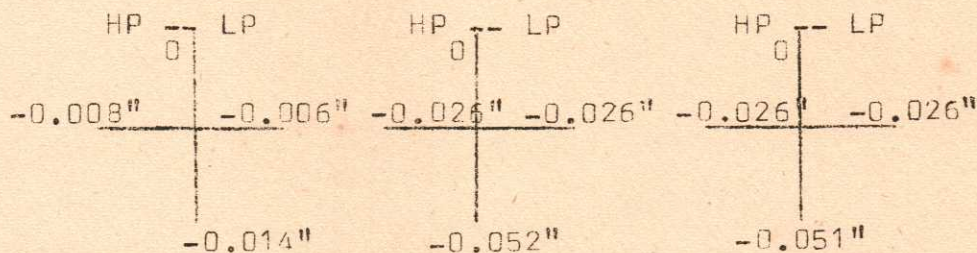
- (B) Bracket on 103JHP coupling, dial on 103JLP coupling, rotating both shafts in clockwise direction looking towards turbine.

- i) As per 26.2.74 ii) Correct as suggested by M/s Clark Dresser iii) Actual readings of cold set alignment on 22.4.86 at 05.00 AM

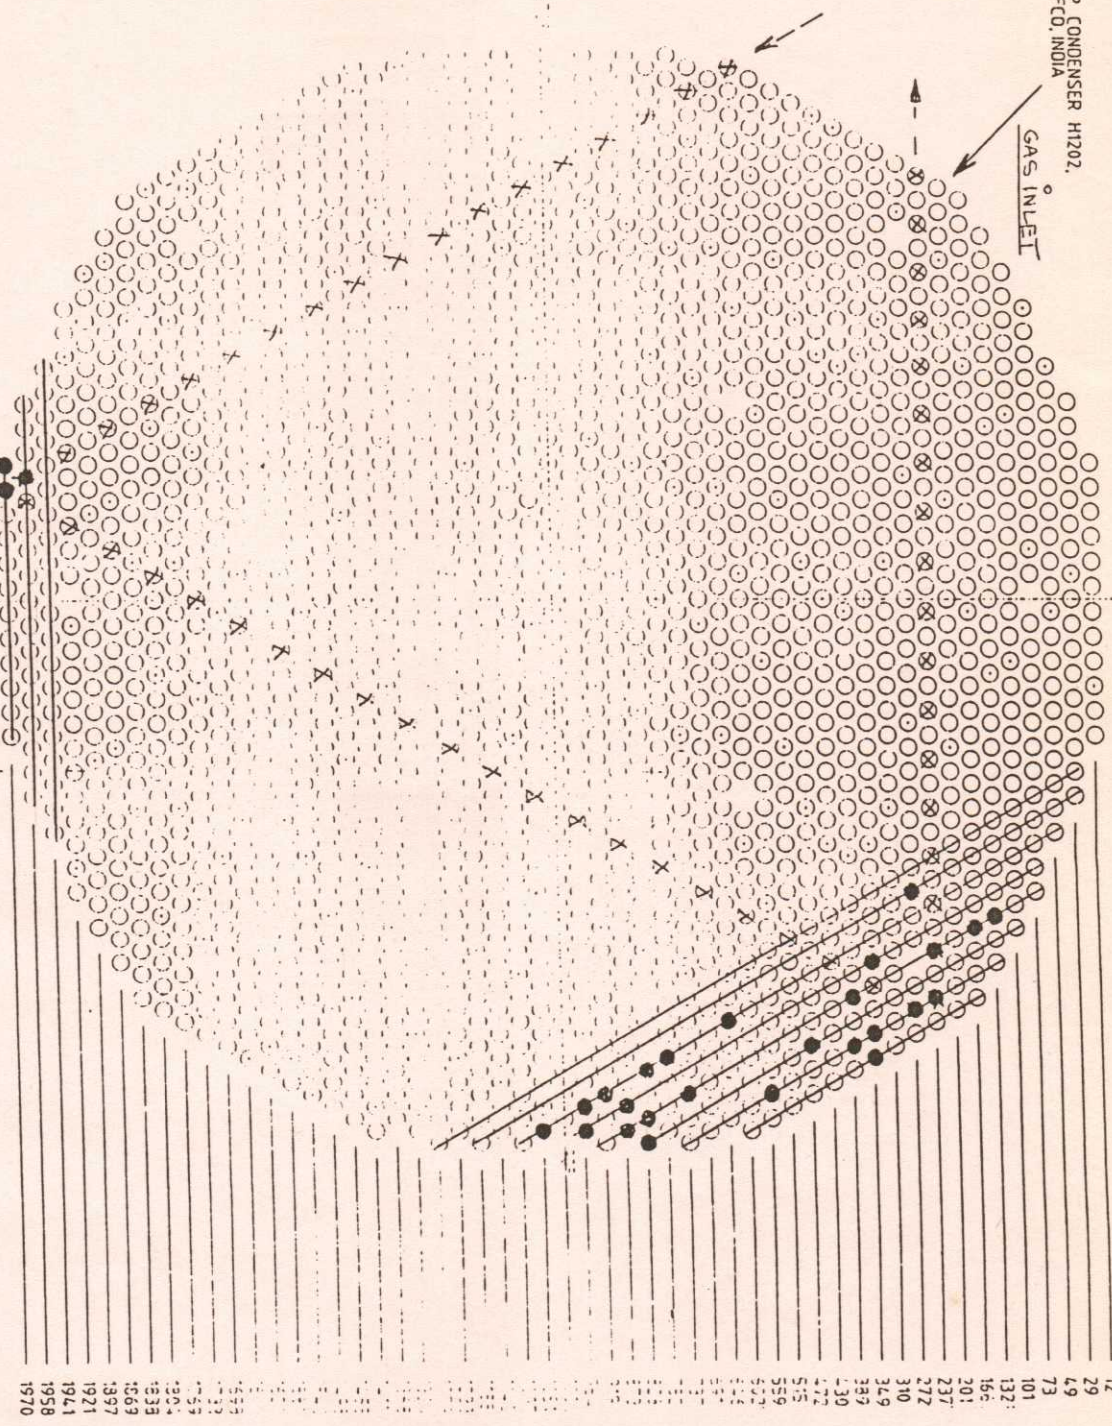
HP CONDENSER H1202.
IFFCO, INDIA

- ⊗ - measured tubes with freq. 1 KHz
- ⊕ - measured tubes with freq. 10 KHz
- - wall thickness in top tubesheet area ≤ 1.9 mm (2.8)

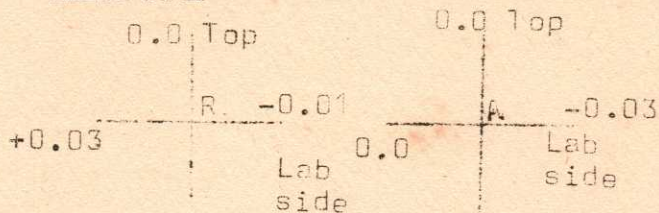
(A) P-4401/A (All readings are in mm)

- a) Journal bearing clearance (coupling side) (in board) :0.010"
- b) Journal bearing clearance (out board) :0.008"
- c) Thrust :0.018"

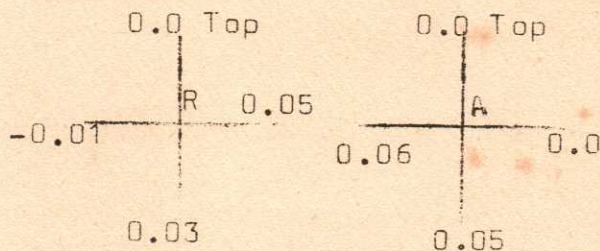
(B) P-4401/B

- a) Journal bearing clearance (in board) :0.010"
- b) Journal bearing clearance (out board) :0.009"
- c) Thrust :0.011"

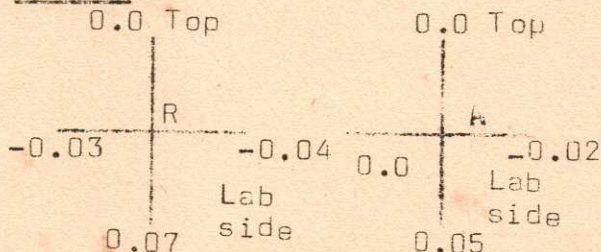
(C) P-4402

- a) Journal bearing clearance (in board) :0.010"
- b) Journal bearing clearance (out board) :0.009"
- c) Thrust :0.011"

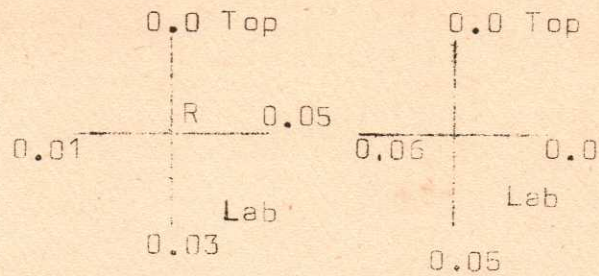
(D) P-4403

- a) Journal bearing clearance :0.011"
 (in board)
- b) Journal bearing clearance :0.010"
 (out board)
- c) Thrust :0.021"
