I F F C O - K A L O L - U N I T

PLANNING SECTION
MAINTENANCE DEPARTMENT
REPORT NO.13/1992

P L A N T T U R N A R O U N D - 1 9 9 2

INDIAN FARMERS FERTILISER CO-OPERATIVE LIMITED

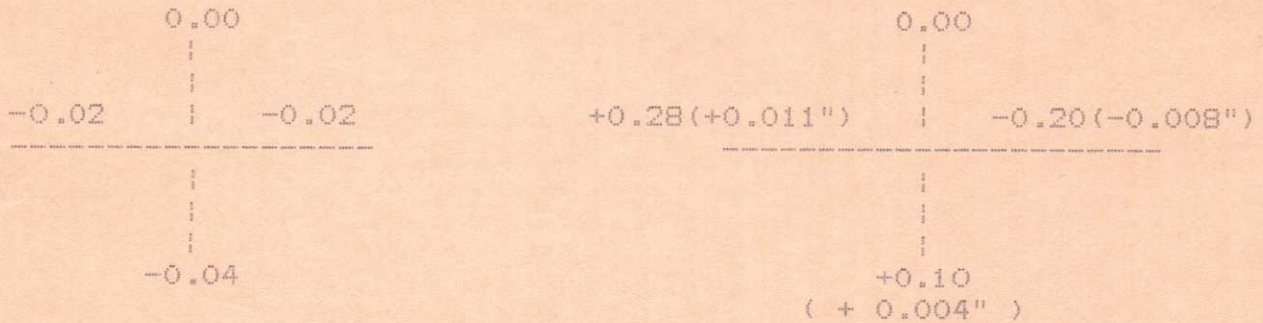
A N N E X U R E - IIAlignment Readings between JBT & JAT:

Dial Tip on JAT Coupling hub.

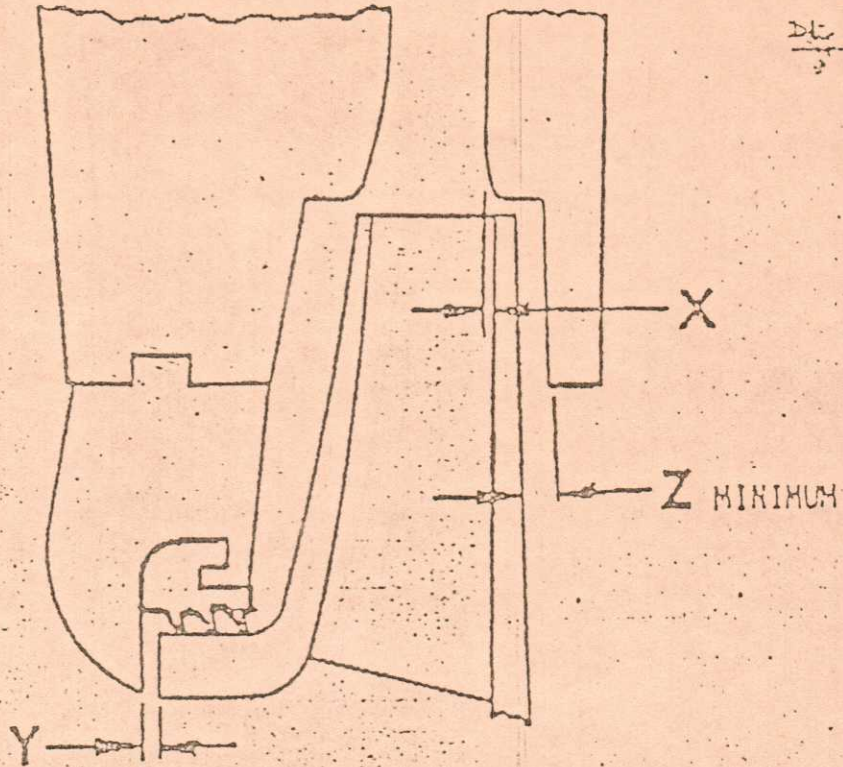
LP case bundle with New Rotor. 74

MINIMUM Readings taken after pushing the rotor 0.120" towards discharge.

Unit	2BC9			2BF9-8								
Dim.	X	Y	Z	X	Y	Z	X	Y	Z	X	Y	Z
Stage 1	.062	.100	.100	.062	.100	.100	(mm)	(Inch)	(mm)			
Stage 2	.062	.100	.100	.062	.100	.100	3.44	0.120"	6.40			
Stage 3	.062	.100	.100	.062	.100	.100	3.54	0.125"	6.20			
Stage 4	.062	.100	.100	.062	.100	.100	3.64	0.105"	6.24			
Stage 5	.062	.100	.100	.062	.100	.100	3.60	0.140"	6.30			
Stage 6	.062	.100	.100	.062	.100	.100	3.70	0.160"	6.20			
Stage 7	.062	.100	.100	.062	.100	.100	3.60	0.132"	6.30			
Stage 8	.062	.100	.100	SS	SS	SS	3.92	0.149"	6.20			
Stage 9	.062	.100	.100	.062	.100	.100		0.143"				
Stage 10

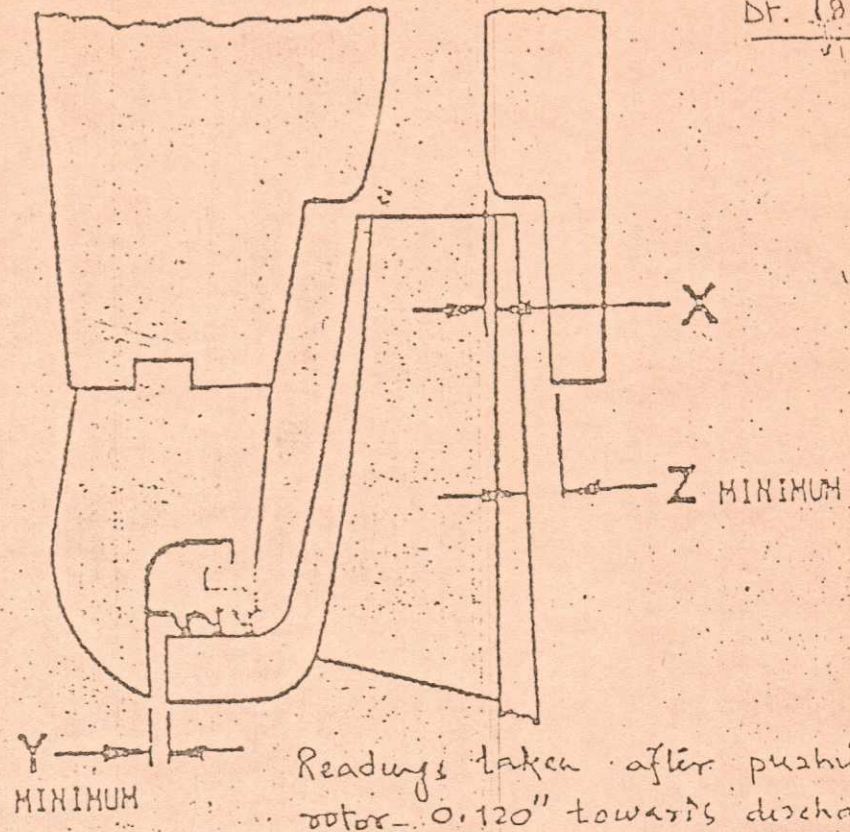
HP Case Bundle with NEW rotor, NEW Guide

Readings taken after pushing the rotor 0.120" towards discharge end

Unit	2BC9			2BF9-8							
	X	Y	Z	X	Y	Z	X	Y	Z	X	Y
Stage 1	.062	.100	.100	.062	.100	.100	2.8				
Stage 2	.062	.100	.100	.062	.100	.100	3.6	3.00	7.22		
Stage 3	.062	.100	.100	.062	.100	.100	3.22	3.00	6.58		
Stage 4	.062	.100	.100	.062	.100	.100	3.34	3.22	6.58		
Stage 5	.062	.100	.100	.062	.100	.100	3.54	3.50	6.36		
Stage 6	.062	.100	.100	.062	.100	.100	3.60	3.52	5.98		
Stage 7	.062	.100	.100	.062	.100	.100	2.56	3.28	5.98		
Stage 8	.062	.100	.100	SS	SS	SS		3.70	5.50		
Stage 9	.062	.100	.100	.062	.100	.100					
Stage 10
