KALOL UNIT

PLANNING SECTION  
MAINTENANCE DEPARTMENT  
REPORT No.14/1993

R E P O R T  
O N  
P L A N T T U R N A R O U N D  
S E P T E M B E R - O C T O B E R - 1 9 9 3

INDIAN FARMERS FERTILISER CO-OPERATIVE LIMITED

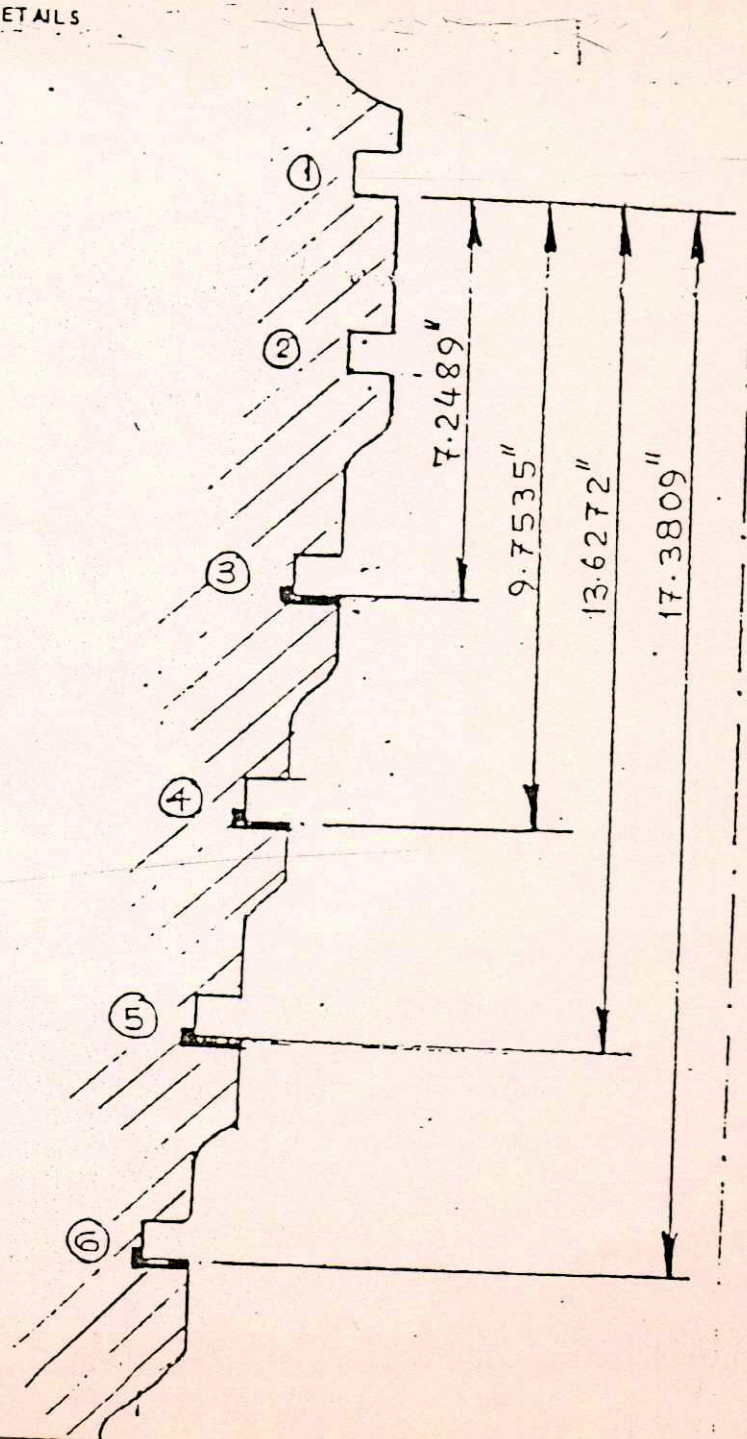
REF. L & T. INSPECTION REPORT ANNEXURE - D

Groove width measured - as follows.

- Groove NO. 3 → 0.744" to 0.758"
- Groove NO. 4 → 0.749" to 0.753"
- Groove NO. 5 → 0.751" to 0.752"
- Groove NO. 6 → 0.750" to 0.752"

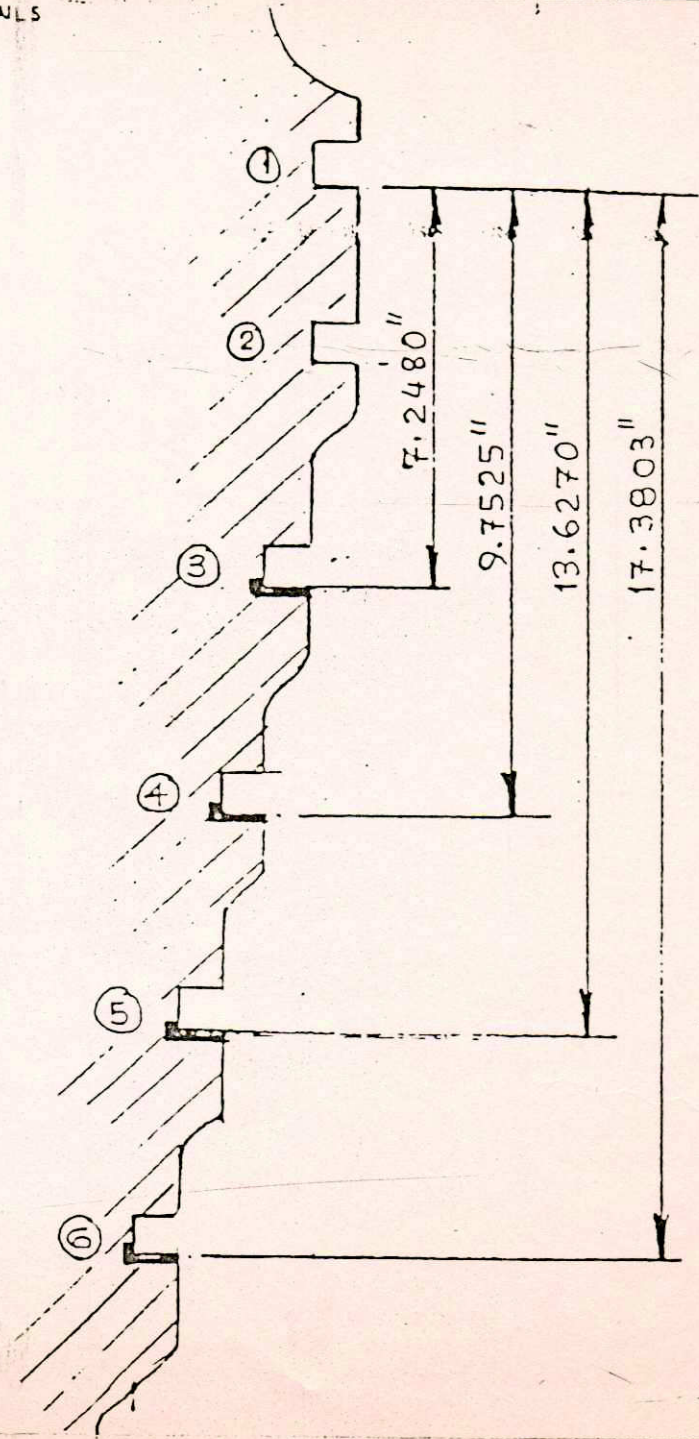
REF. L&T. INSPECTION REPORT ANNEXURE - F

Groove width measured - as follows.

- Groove No. 3 → 0.746" to 0.759"
- Groove No. 4 → 0.751" to 0.753"
- Groove No. 5 → 0.750" to 0.751"
- Groove No. 6 → 0.749" to 0.751"

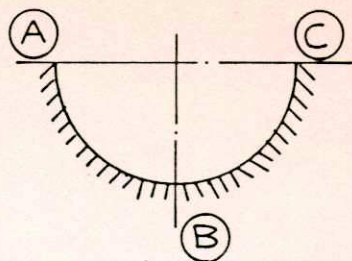
ANNEXURE - IV

BORE ALIGNMENT READINGS  
(LOOKING FROM OUTLET SIDE)

DIAPHRAGM NO.	(A)	(B)	(C)
1	00"	-0.0185"	-0.0067"
2	00"	-0.035"	-0.038"
3	00"	-0.0275"	-0.012"
4	00"	-0.0358"	+0.037"
5	00"	-0.038"	-0.024"
6	00"	-0.030"	-0.018"
7	00"	-0.039"	-0.0137"
8	00"	-0.018"	+0.004"
9	00"	-0.020"	-0.002"
