KALOL UNIT

PLANNING SECTION
 MAINTENANCE DEPARTMENT
 REPORT NO.15/1995

R L A N T - T U R N A R O U N D

J A N U A R Y - 1995

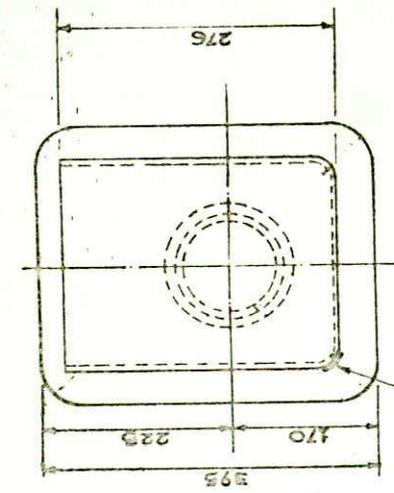
LEAKAGE DETECTED AT THIS LOCATION WITH AIR AND SOAP SOLUTION TEST (13TH JANUARY 1995)

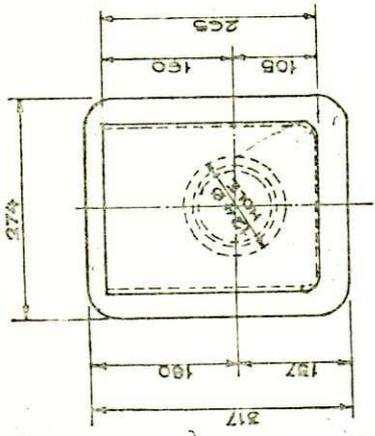
CRACKS DETECTED ON THIS HAZ AREA AFTER GRINDING THE BASKET FLUSHING WITH THE LINER AND CHEMICAL ETCHING (CRACKS ARE NOT THRU & THRU) (APRIL 1986)

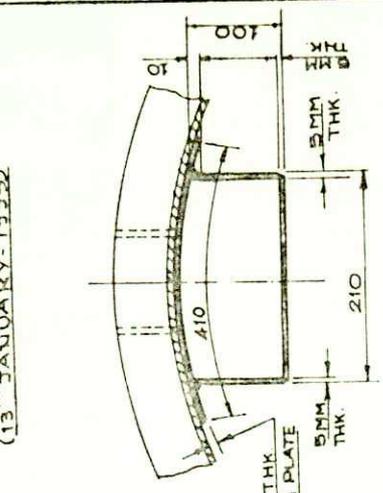
NEW BASKET AND NEW PATCH PLATE DETAILS FOR NOZZLE - C2 (JANUARY - 1995)

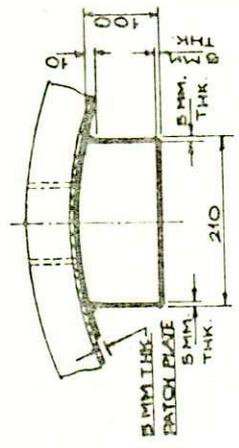
NEW BASKET AND NEW PATCH PLATE DETAILS FOR NOZZLE - C2 (APRIL - 1986)

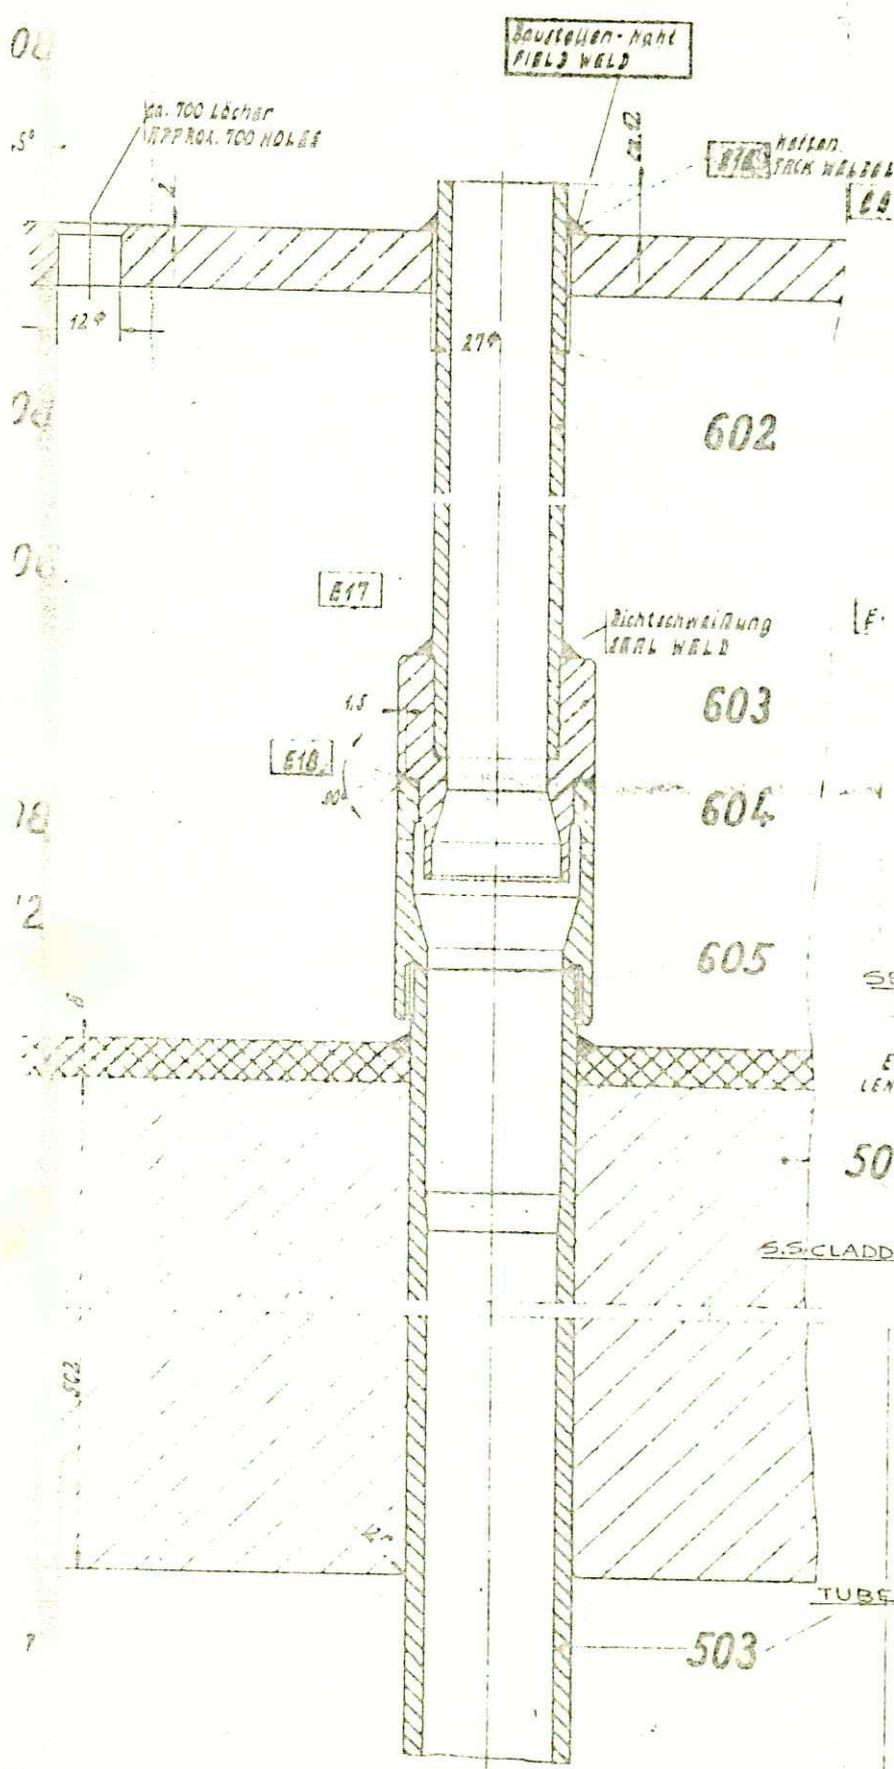
H-120 TUBE REPAIR DETAIL

- Tube No. 1712 was found leaking through a pin hole.
- 37 Nos. tubes were found severely eroded on tube to tube sheet seal weld joint.
- 04 Nos. tubes were having pin hole defect on tube to tube sheet seal weld joints.
- 05 Nos. tie-rods were having defect on fillet weld with tube sheet due to pin hole defect.

TUBE NO. 1712
 PIN HOLE WAS NOTICED IN
 THIS OVERLAY WELDING AREA
 THIS PORTION WAS GROUNDED
 AND REPAIRED BY WELDING
 ELECTRODE USED SANDVIK
 25; 22; 2 LWN.

Finally, hydrotest from shell side was carried out at 35 kg/cm² and no leakage from both the tube sheets was noticed. The stripper was finally boxed-up and Urea production was lined-up on 05.02.95 at 22.45 hrs.
