I F F C O

KALOL UNIT

PLANNING SECTION  
MAINTENANCE DEPARTMENT  
REPORT NO.16/1996

P L A N T - T U R N A R O U N D

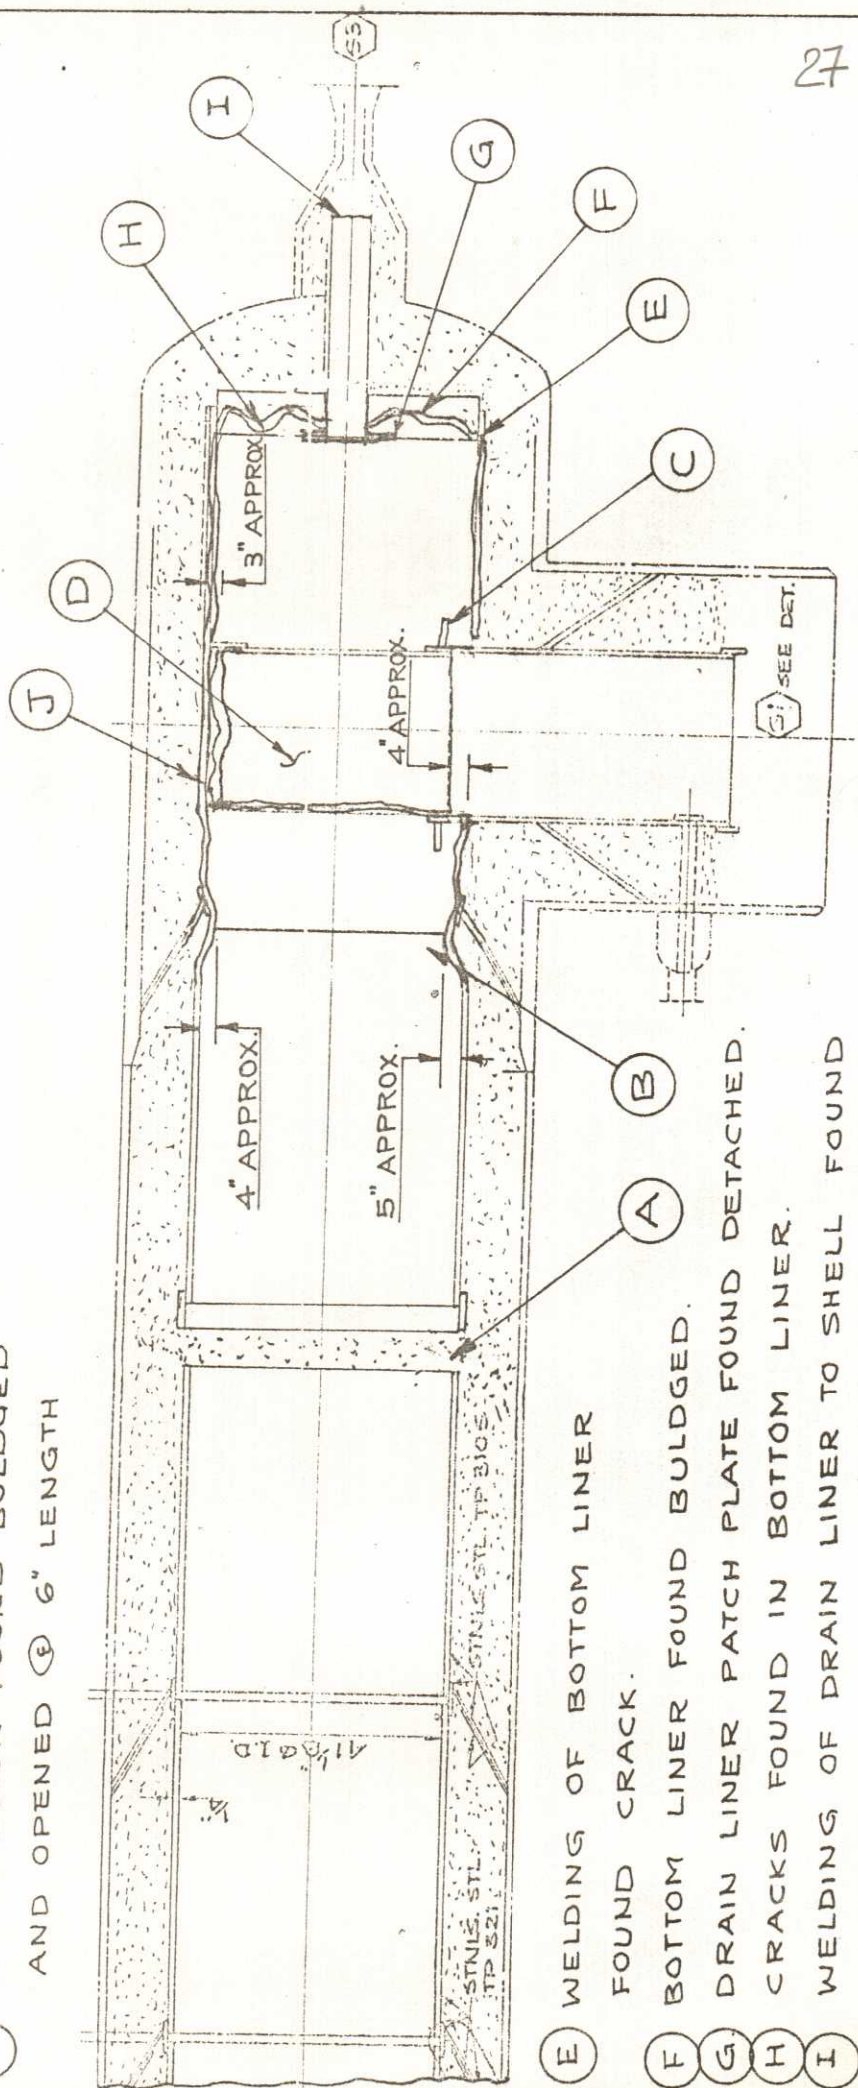
DAMAGES FOUND IN SHELL LINER OF 101-CA

After removal of bundle, inside of gas shell was inspected and the following damages were observed. (Refer FIGURE : 1)

- a) Vertical Gap of about 3" found between liners No.4th & 5th from top, which was exposing the refractory.
- b) Bulging of liner found in the area adjoining liners 5th & 6th and below it.
- c) Distributor found buldged and opened about 6" length
- d) Welding of bottom liner found cracked.
- e) Bottom liner found buldged
- f) Drain liner patch-plate found detached
- g) Cracks were found in bottom liners
- h) Welding of drain liner to shell found completely cracked.
- i) Distributer end plate found buldged and touching the shell liner.

- (A) GAP OF ABOUT 3" FOUND BET'N. TWO LINERS EXPOSING THE REFRACTORY.
- (B) BULGING OF LINER FOUND IN THIS AREA.
- (C) PATCH PLATE FOUND DETACHED FROM LINER.
- (D) DISTRIBUTOR FOUND BULGED AND OPENED @ 6" LENGTH

- (E) WELDING OF BOTTOM LINER FOUND CRACK.
- (F) BOTTOM LINER FOUND BULGED.
- (G) DRAIN LINER PATCH PLATE FOUND DETACHED.
- (H) CRACKS FOUND IN BOTTOM LINER.
- (I) WELDING OF DRAIN LINER TO SHELL FOUND COMPLETELY CRACKED.
- (J) DISTRIBUTOR END PLATE FOUND BULGED & TOUCHING THE SHELL LINER.

Repairing job of the shell liners started from 24th morning and completed on 1st July. The following jobs were carried out.

- 1) Placing the drain line to its position by hammering and then placing the sleeve on it. (Refer FIGURE : 1, 2 and 3)
- 2) Grinding of the cracks in bottom liner and welding it.
- 3) Cutting the 5th liner at the buldged portion along its periphery and shift it at its original position. (Refer FIGURE : 2 & 3)
- 4) New refractory is provided completely in the new liner area (Refractory material : Plibrico Plicast - 606)

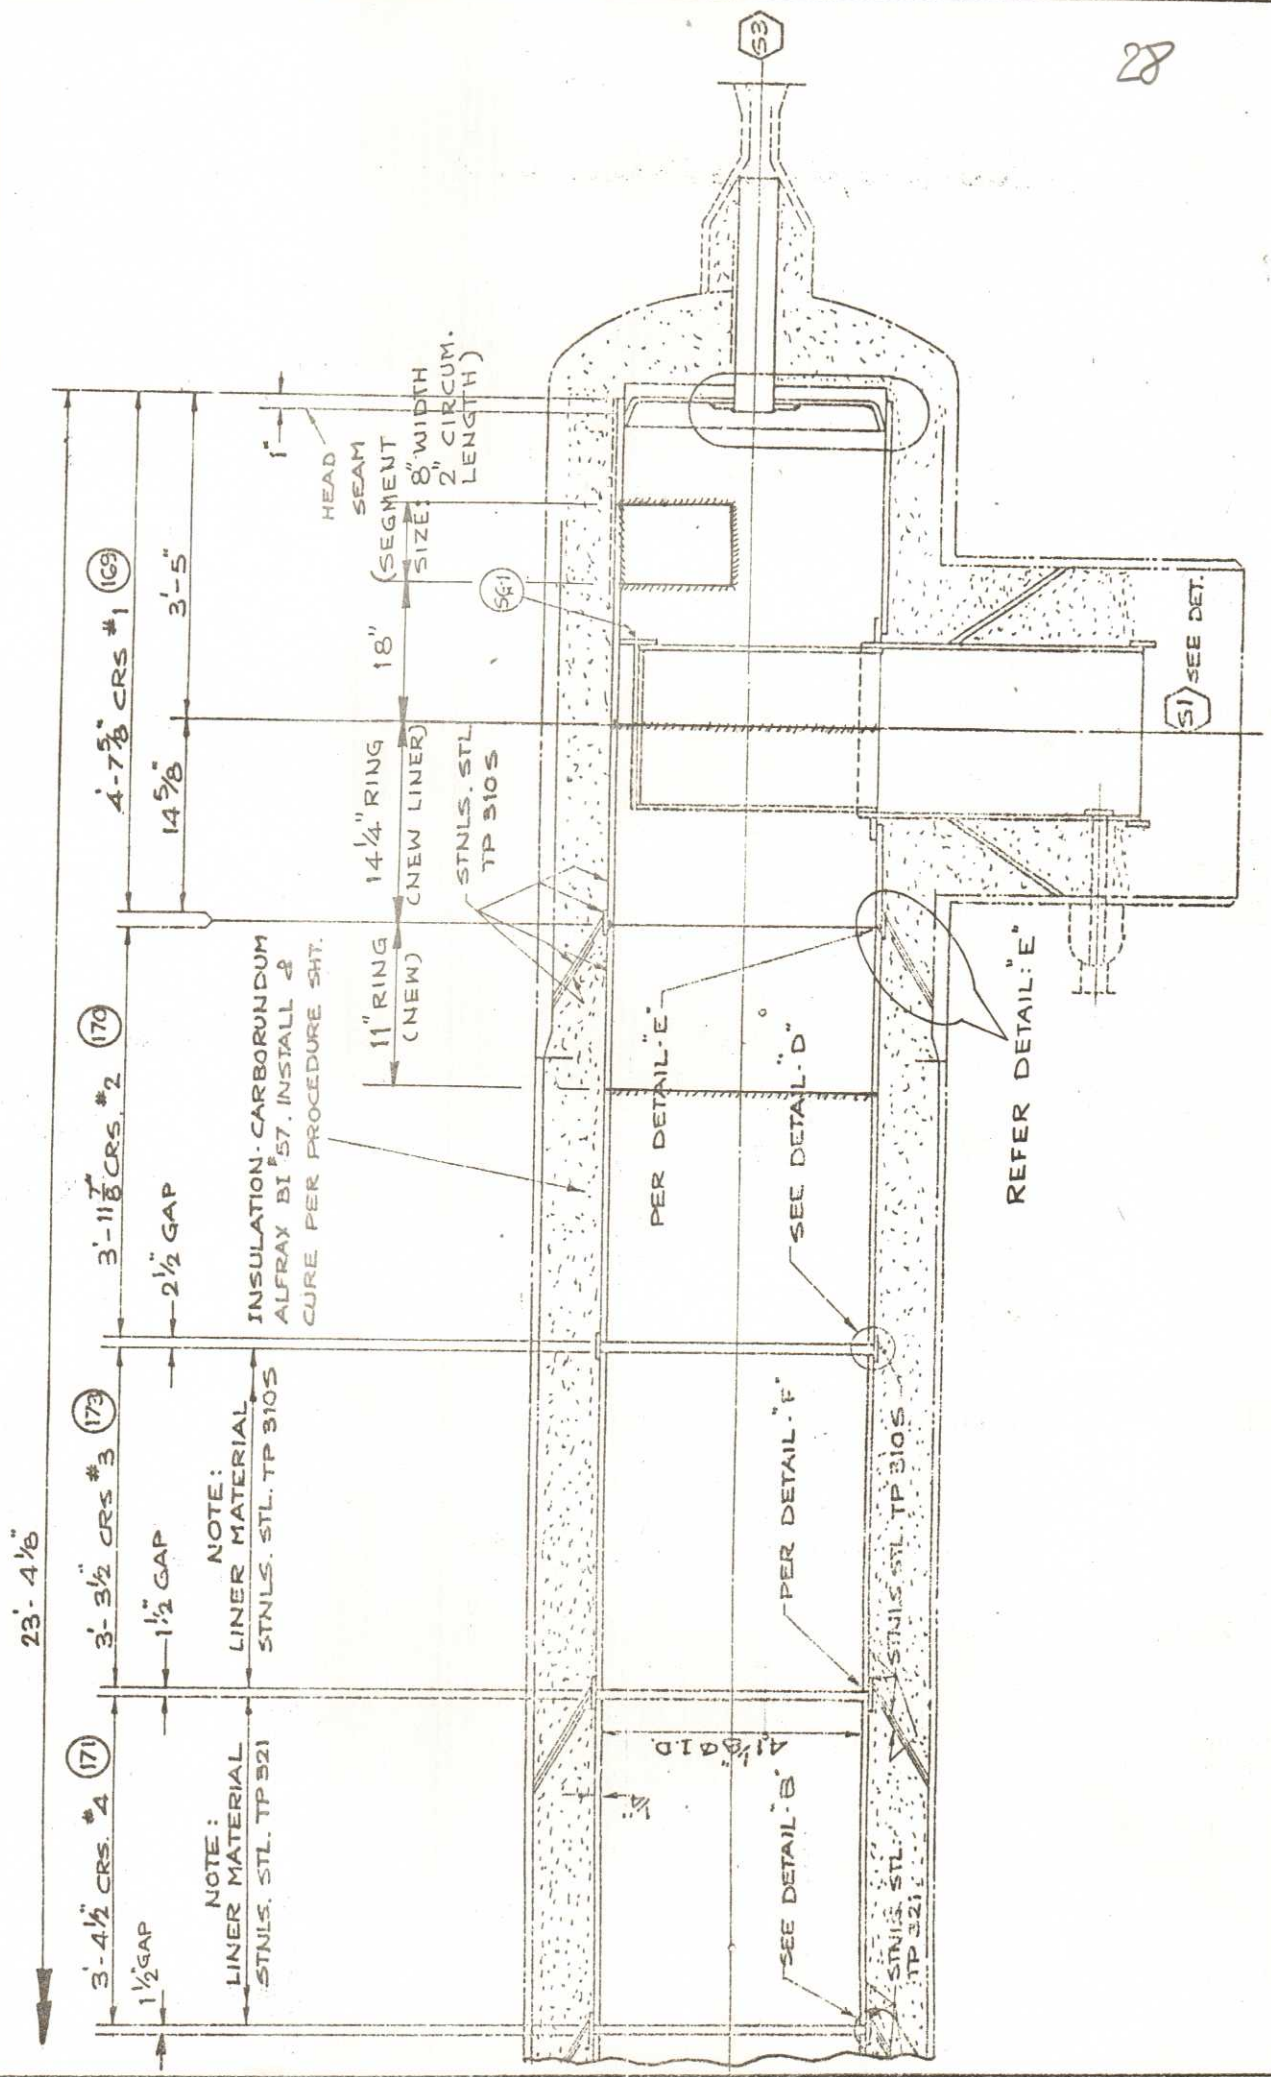
FIGURE: 2  
JUNE: 1996

DETAILS OF SHELL LINERS OF 101-CA

CODE NO	JOB DESCRIPTION
5)	Removing the bulged portion and providing two new liners of 11" & 14.25" between the 5th & 6th liners. (Refer FIGURE : 2 & 3)
6)	Cutting the spare gas distributor on both sides by 1" lengthwise as it was not fitted in position because of bulging.
7)	Providing new GAS Distributer with minimum clearance of 1.75" for thermal expansion. (Refer FIGURE : 2 )
8)	Providing a support for distributor.
9)	Replaced part No.214 with New one at Bottom Nozzle (Refer FIGURE : 4)
10)	Full welding done of part No.213 with the Liner. (Refer FIGURE : 4)
11)	All cracks were welded on part No.213. (Refer FIGURE : 4)
12)	SS 316L Material sleeve is welded at Bottom nozzle. (Refer FIGURE : 4 )

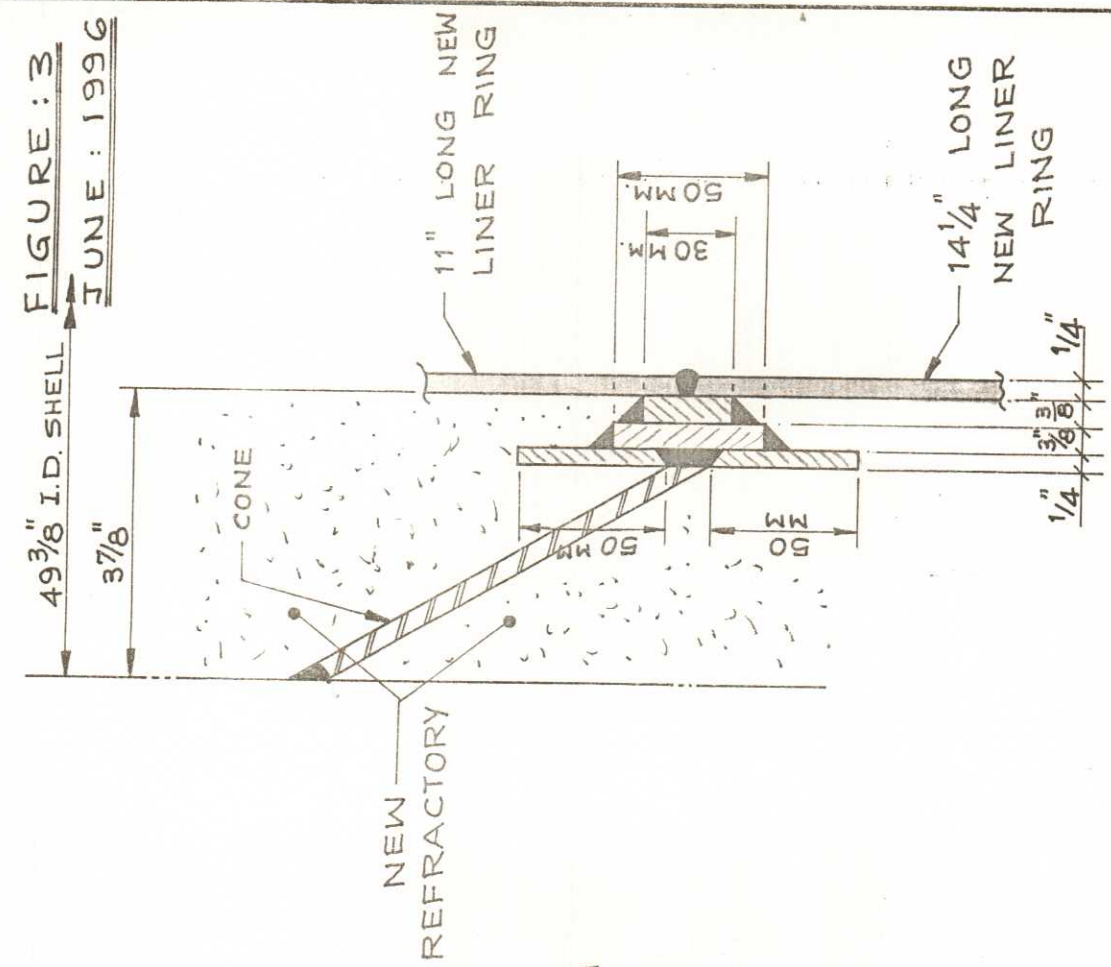
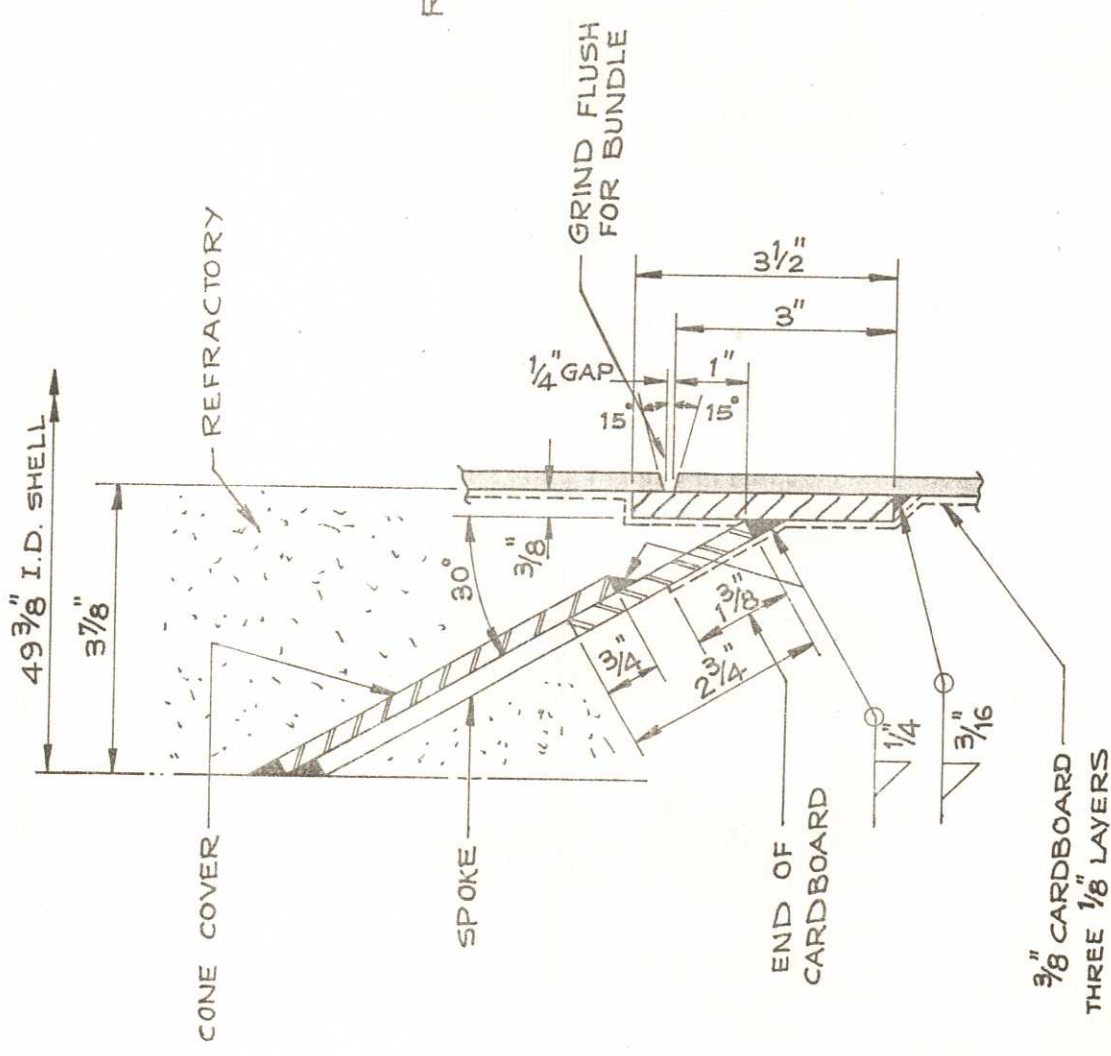
**FIGURE : 3**  
**JUNE : 1996**

EXISTING DETAIL: "E"

REPAIRED DETAIL: "E"

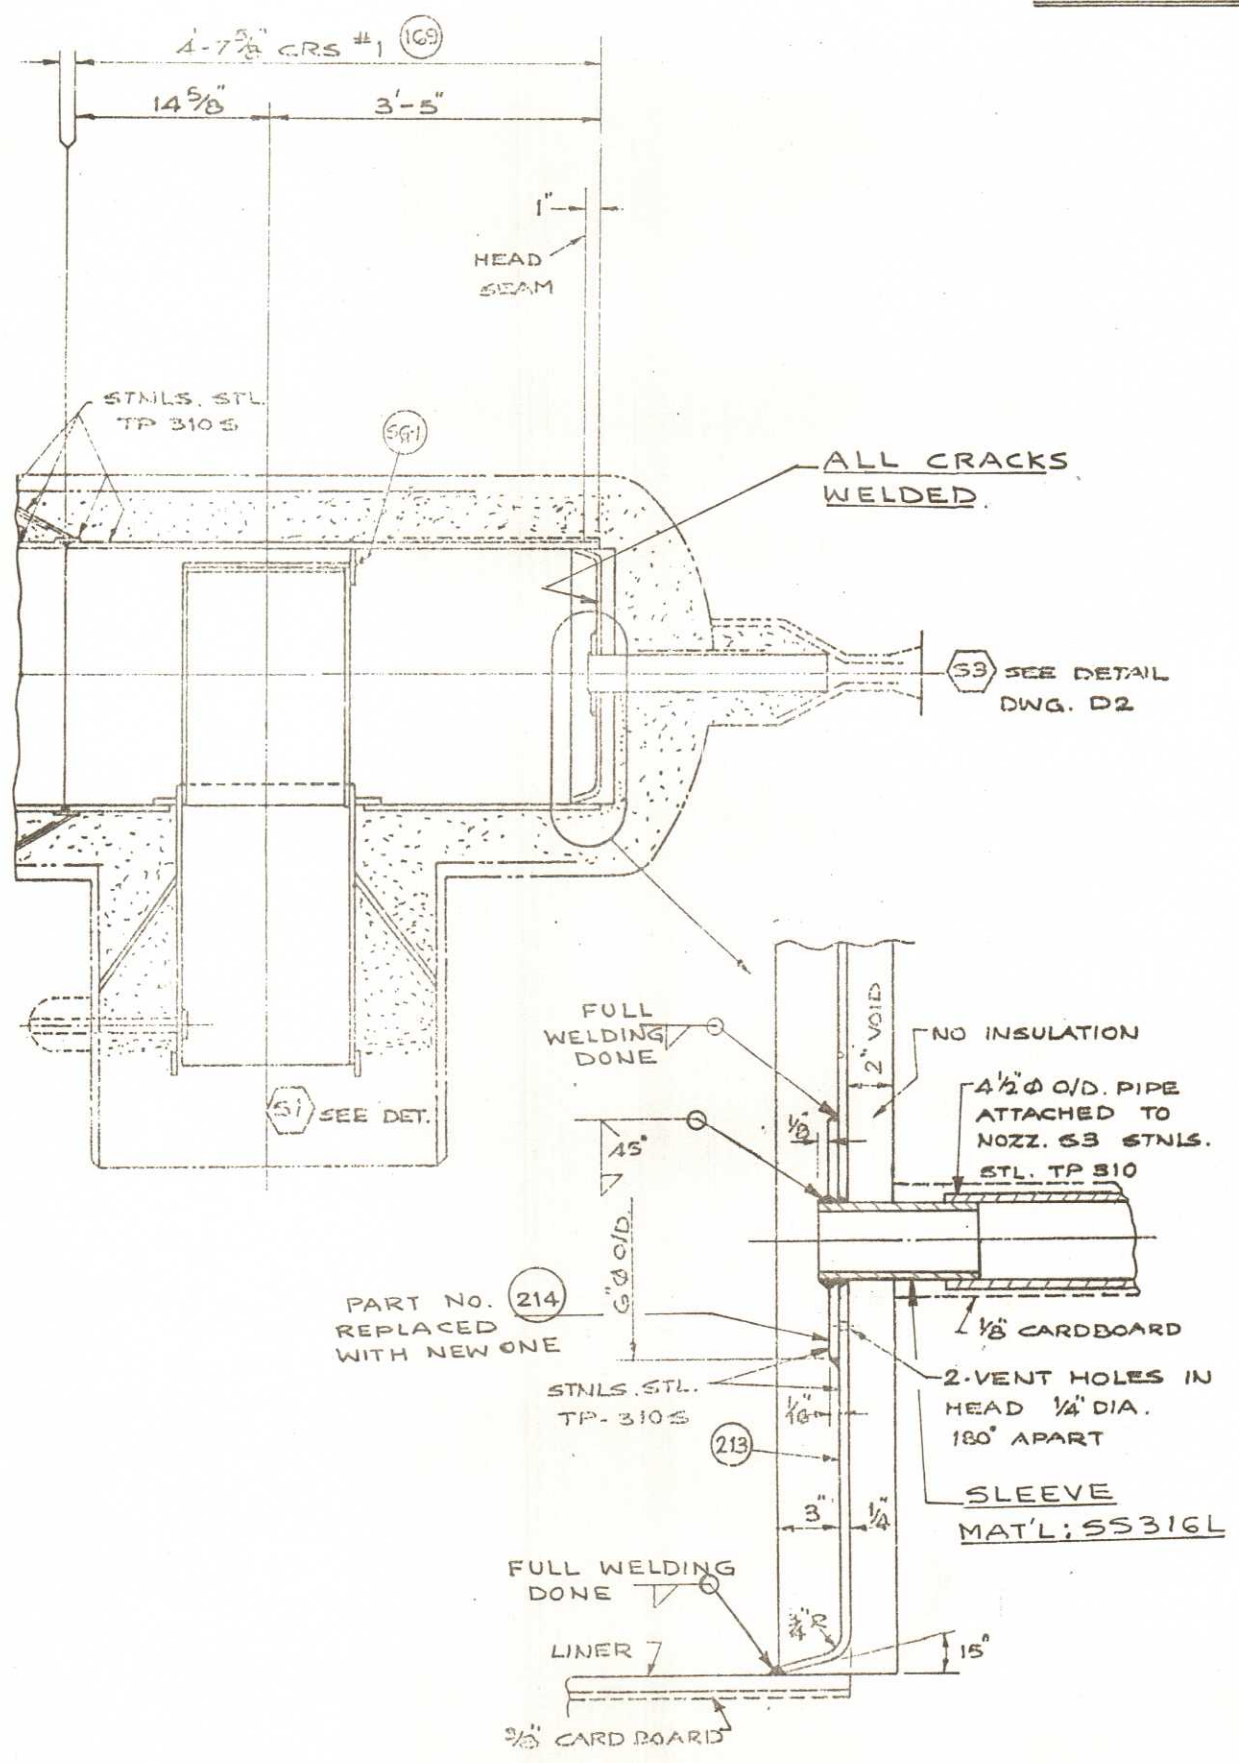
FIGURE: 4  
JUNE: 1996

DETAIL OF BOTTOM NOZZLE OF 101-CA

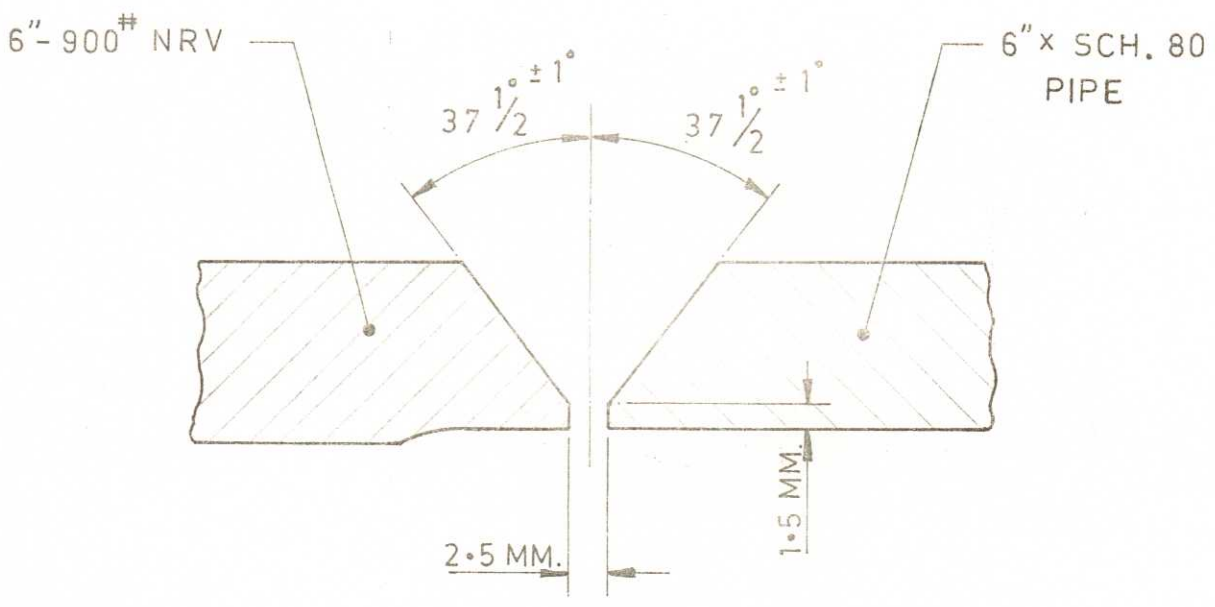
WELDED BEVEL DETAIL

104-J discharge NRV was replaced with a repaired one, due to passing problem. The old NRV was made ready in workshop by welding WNRF flange after maintaining ID of valve to suit ID of flange, by welding. Proper heat treatment of the weld joint in Workshop as well as at site for field joint were carried out as per the heat treatment procedure as shown in Annexure : A For weld bevel detail Refer FIGURE : 1
