IFFCO

KALOL UNIT

PLANNING SECTION  
MAINTENANCE DEPT.  
REPORT NO: 17/1997

REPORT  
ON  
PLANT-TURNAROUND

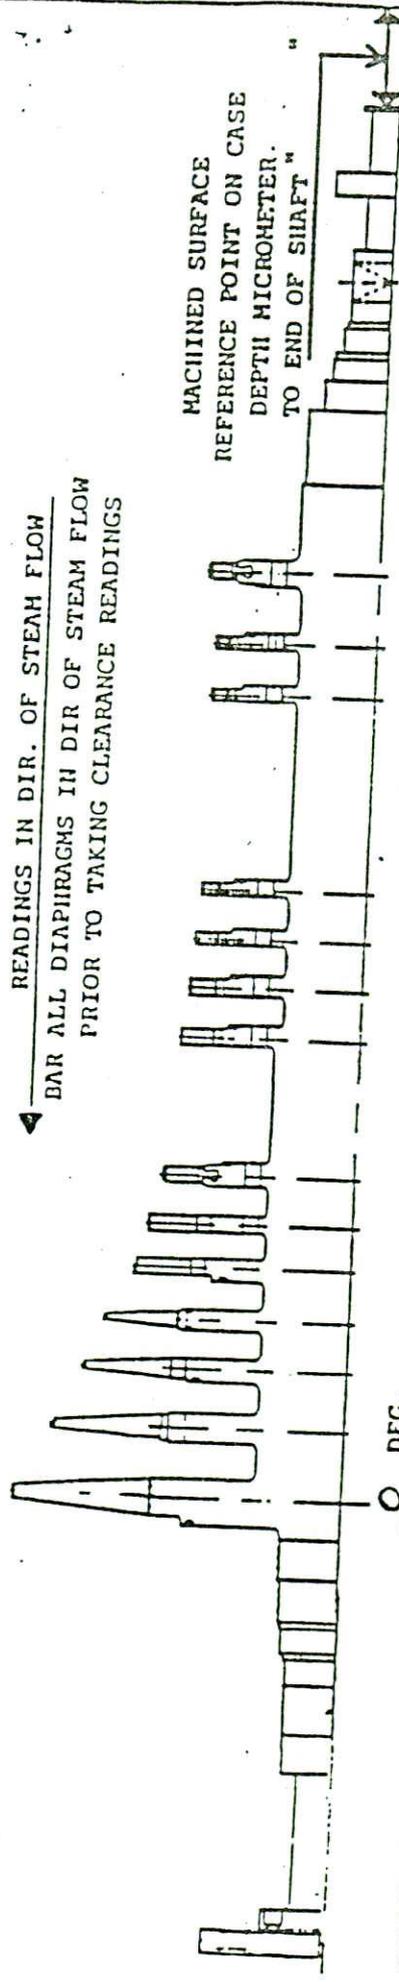
NOTE: ALL DIAPHRAGMS, WITH EXCEPTION OF NEW 2ND STAGE, ARE IN DESPERATE NEED OF REPAIRS TO SEAL FACES, HORIZONTAL JOINTS, SPILL RINGS AND SHOULD HAVE BLADING DRESSED AND POLISHED.  
TIGHT WIRE OR ALIGNMENT BAR REQUIRED AT NEXT SHUTDOWN.

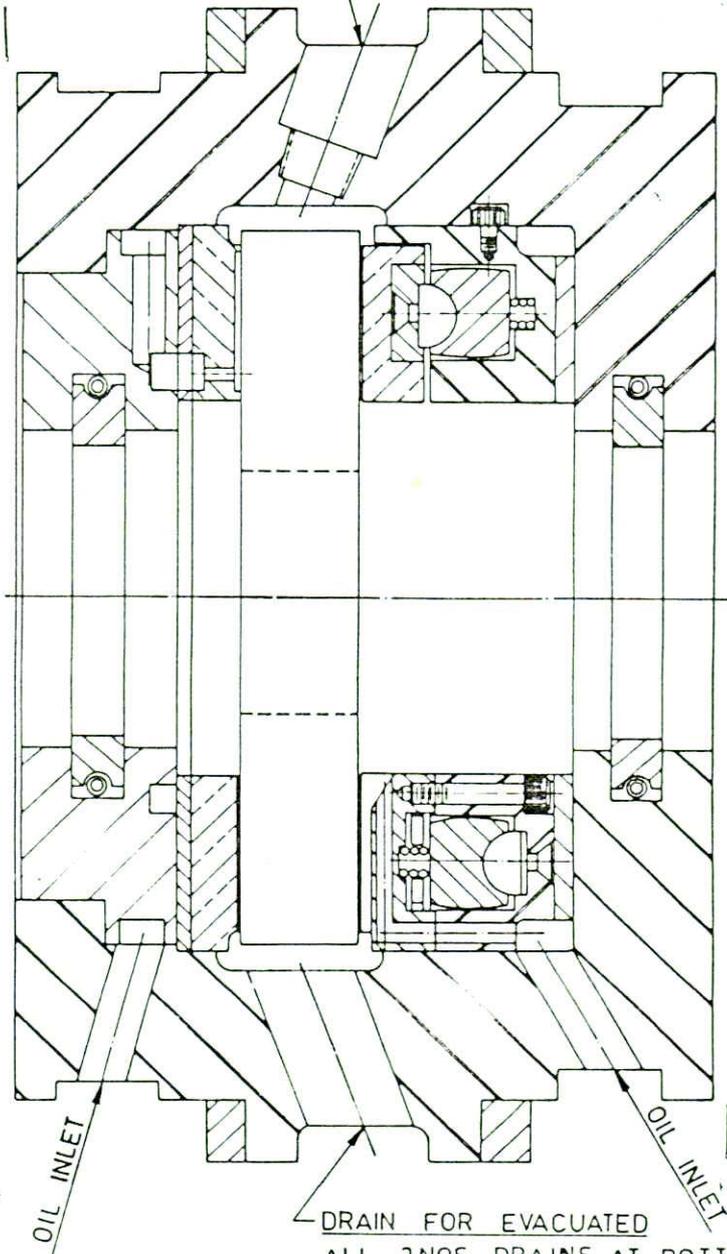
- c) Before revamping we were operating 101-J turbine in summer with thrust pad temperature reaching as high as 125 deg.C and with revamped conditions this will further increase. Hence M/s.DDTC was contacted and they suggested that for flooded operation of the thrust bearing the 3 Nos drain holes in the bottom of the bearing housing are required to be plugged. Accordingly the 3 Nos of drain holes were plugged.

DRAIN FOR FLOODED CAVITY  
OPERATION ONLY

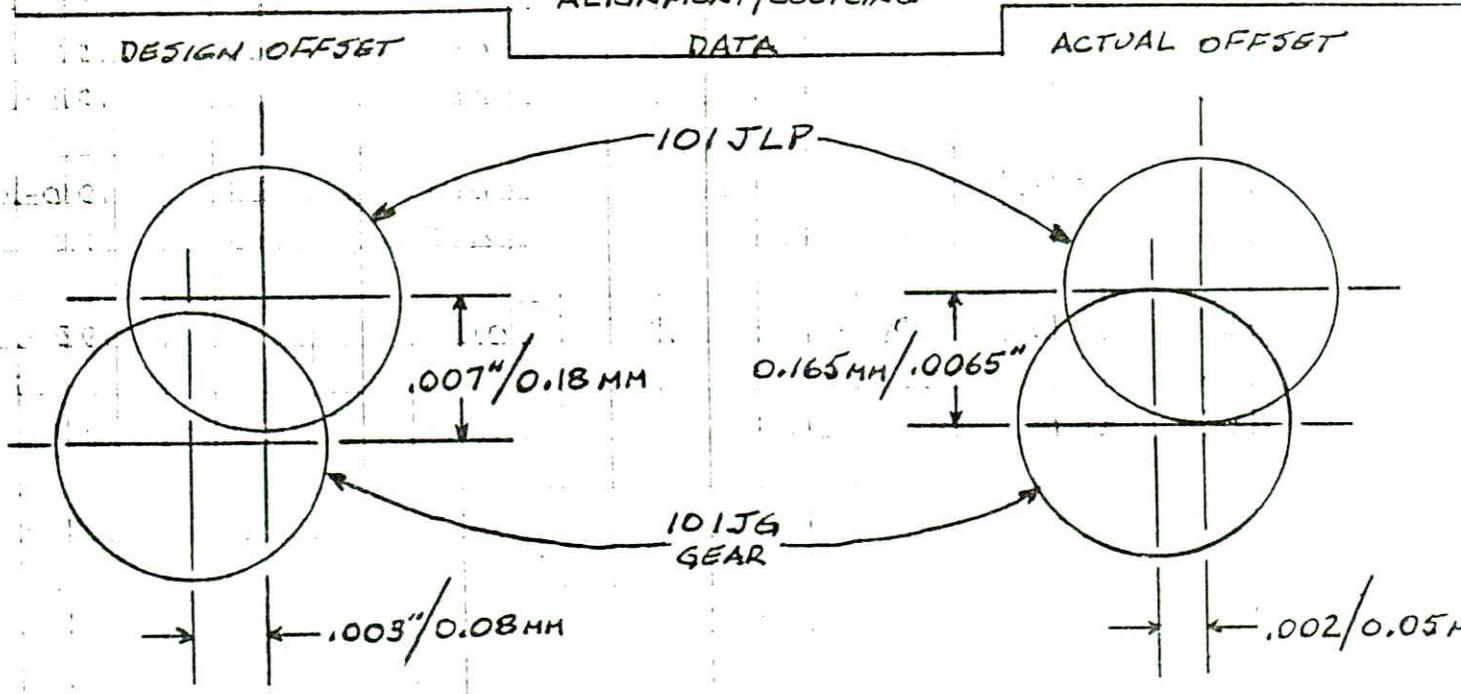
ALIGNMENT/COUPLING  
DATA

- NOTE:
1. REVERSE INDICATOR METHOD NOT USED. FACE AND RIM ONLY.
  2. ALIGNMENT DATA BY GANGOTRI TURBO TECH. ENGG. SERVICE
  3. FACE READINGS (PARALLELISM) SHOW FACES OPEN ON RIGHT SIDE .002" (0.05MM) AND TOP .0018" (0.046MM).
  4. LOOKING FROM COMPRESSOR TO GEAR.
  5. DIAL INDICATORS READINGS ON GEAR HUB;
  6. ALIGNMENT AND METHOD ACCEPTED BY D. INAMDAR-IFFCO.

ZURN GEAR COUPLING	DDTC - PM-1626
101JLP	101JG - GEAR
COUPLING HUB DRIVE	KEYED HUB
.231" DESIGN .214"-.244"	.002"-.003" INTERFERENCE FIT
5.88MM " 5.44MM-6.20MM	0.05MM-0.076MM "
HUB EXTENDING FROM END OF SHAFT	HUB FLUSH WITH END OF SHAFT
.118" 3.00MM	
HUB TO HUB SPACING	8.132" 206.55 MM
SHROUD/SPACER FLOAT	.350" 8.75 MM (APPROXIMATE)
DESIGN FLOAT	.300" 7.62 MM

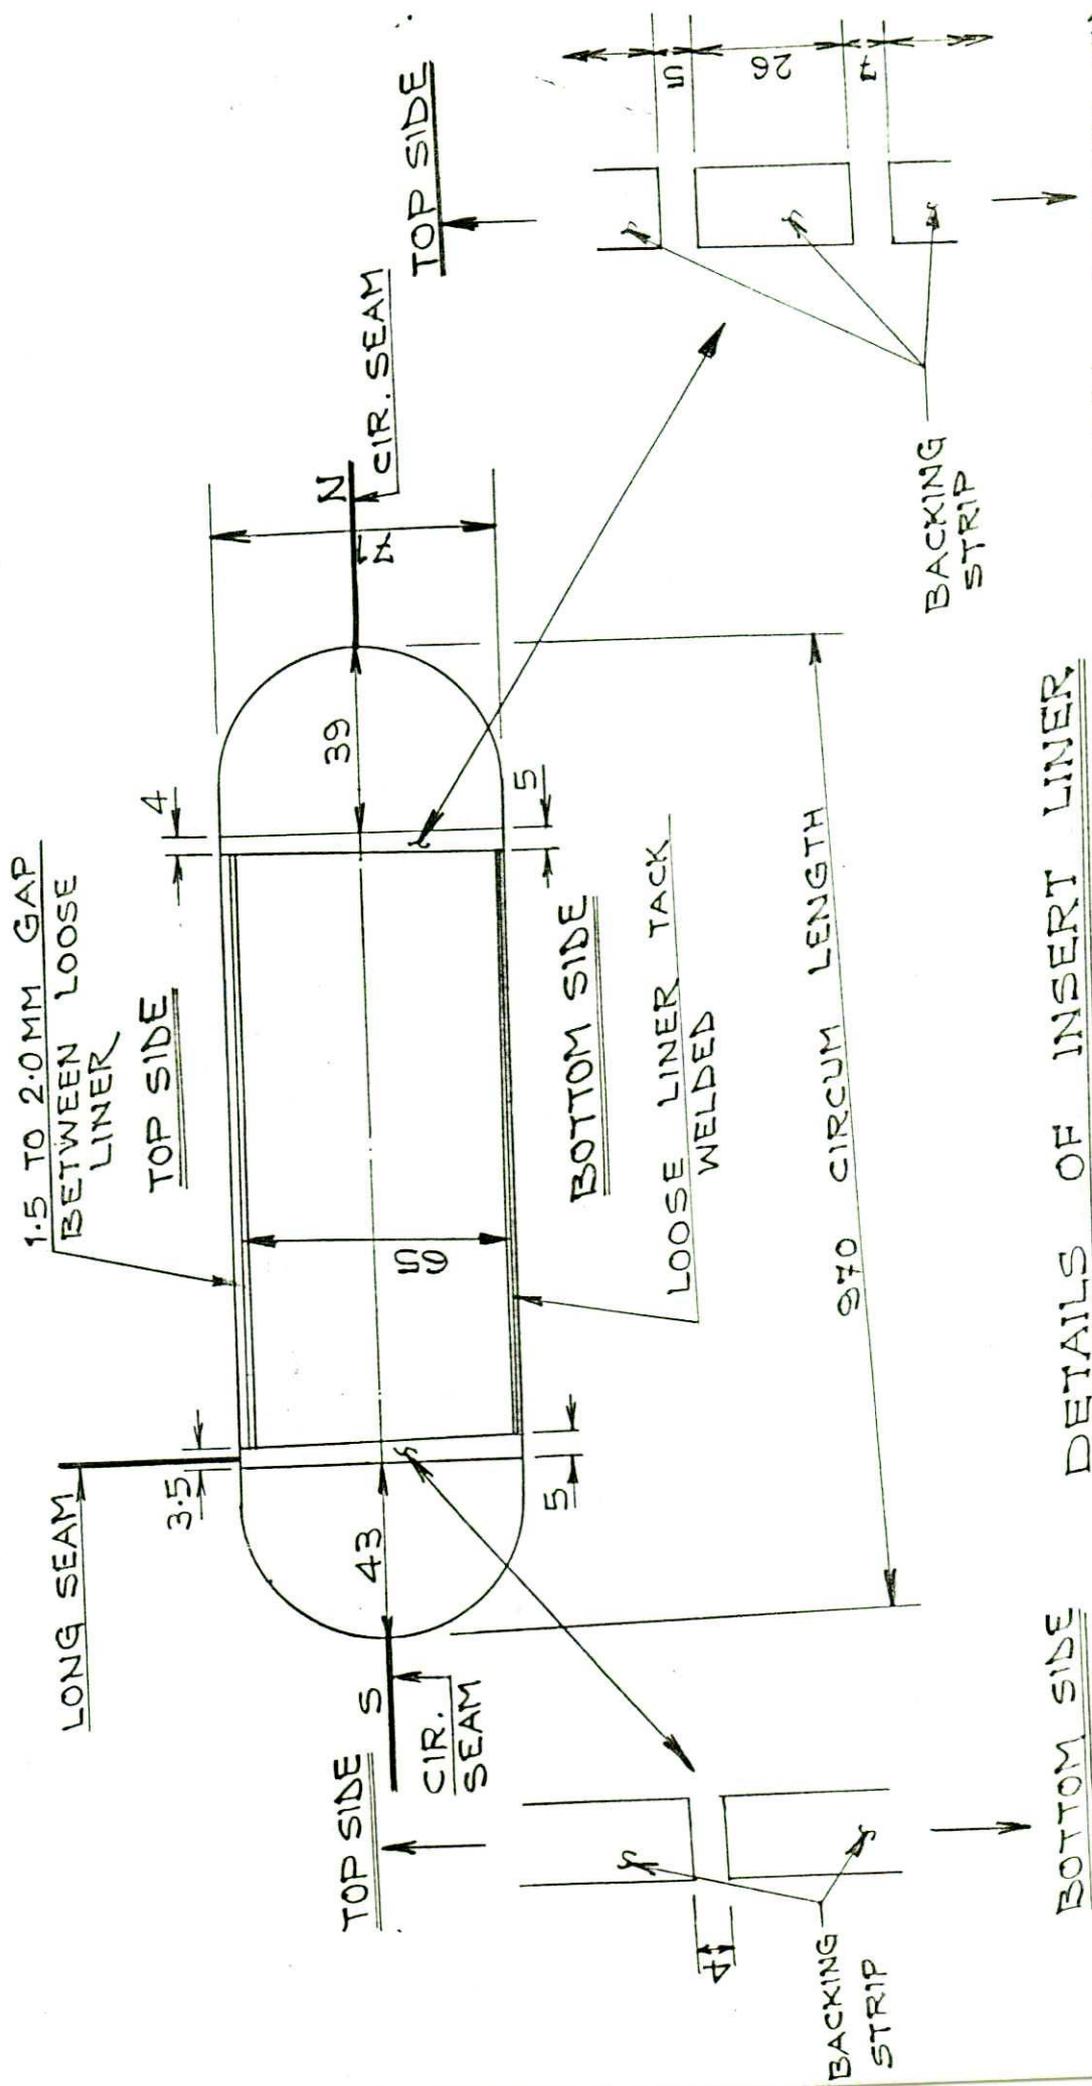
FIGURE: 2

DETAILS OF INSERT LINER  
BELOW 2ND TRAY SHELL LINER V-1201
