IFFCO
KALOL UNIT

PLANNING SECTION
MAINTENANCE DEPTT.
REPORT NO : 18 / 1998

REPORT
ON
PLANT TURNAROUND

(APRIL - MAY - 1998)

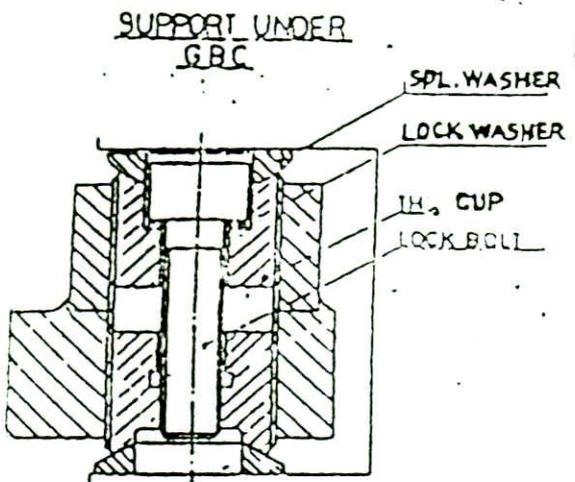
CARRIERS CENTERING

CARRIER NO		1	2	3	4	5	6
FEELER GAP	LEFT	1.15	1.05	1.03	1.37		
	RIGHT	1.15	1.11	1.03	1.37		
PP LEVEL	LEFT	-0.19	-0.15	-0.25	+0.05		
	RIGHT	+0.11	-0.15	-0.25	+0.17		
VERTICAL MOVEMENT	TOP						
	BOTTOM

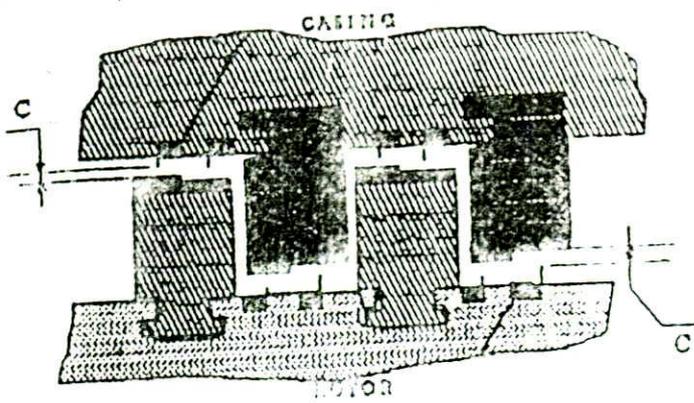
FIN/BLADE TIP CLEARANCES

STAGE	NOMINAL	+,- RADIAL			STAGE	NOMINAL	+,- RADIAL		
		LEFT	BOTTOM	RIGHT			LEFT	BOTTOM	RIGHT
106	0.20 to 0.40	0.30	0.30	0.35			0.35	0.30	0.30
110	"	0.25	0.25	0.20			0.35	0.30	0.20
113	"	0.30	0.30	0.30			0.35	0.30	0.35

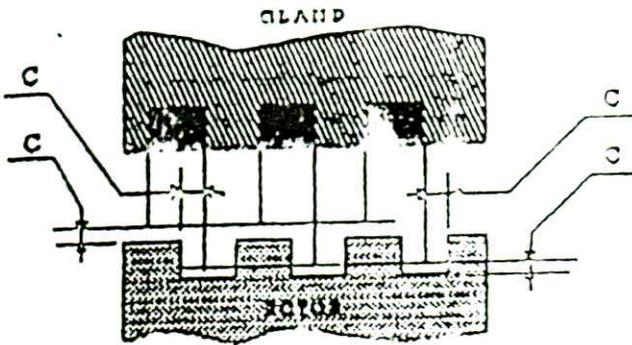
GLAND CLEARANCES

GLAND	RADIAL CLEARANCES				AXIAL CLEARANCES					
	NOMINAL	LEFT	BOTTOM	RIGHT	+ DIRECTION			- DIRECTION		
					L	R	NOM	L	R	NOM
FRONT	0.30 ^{+0.00}	0.30	0.25	0.25	2.20	2.20	2.25	1.65	1.65	1.50
		0.25	0.25	0.25						
B. PISTON	"	0.30	0.20	0.20						
		0.30	0.20	0.35						
INTER-MEDIATE		0.30	0.20	0.25	3.85	3.85	3.80 _{+0.20}	2.80	2.82	2.80 ^{+0.30}
		0.30	0.20	0.25						
REAR		0.35	0.35	0.35	4.00	4.00	4.00	2.25	2.25	2.25
		0.30	0.35	0.35

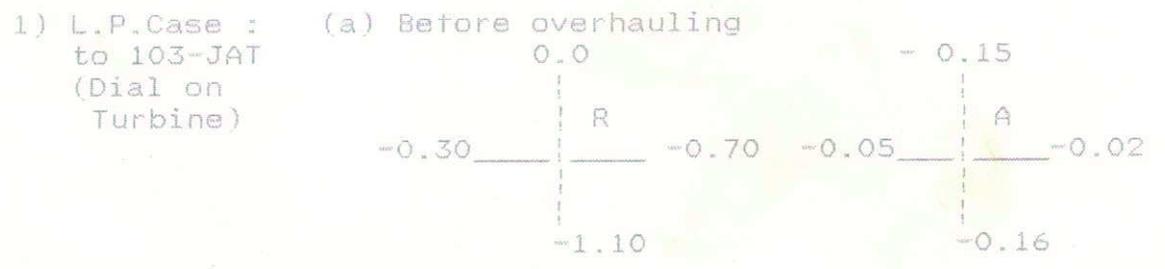
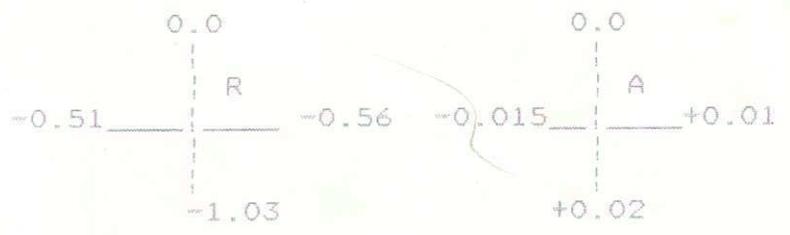
(B) Alignment Reading :

Before O/H	After O/H
1) L.P.Case : Float Shaft End to End	7.45 MM	5.2 MM
2) H.P.Case : Float Shaft End to End	4.77 MM	6.8 MM

- 13.31 Aligned both the compressor barrels with adjacent machines.
- 13.32 The suction & discharge piping were connected and the alignment was rechecked and found to be within the limits.

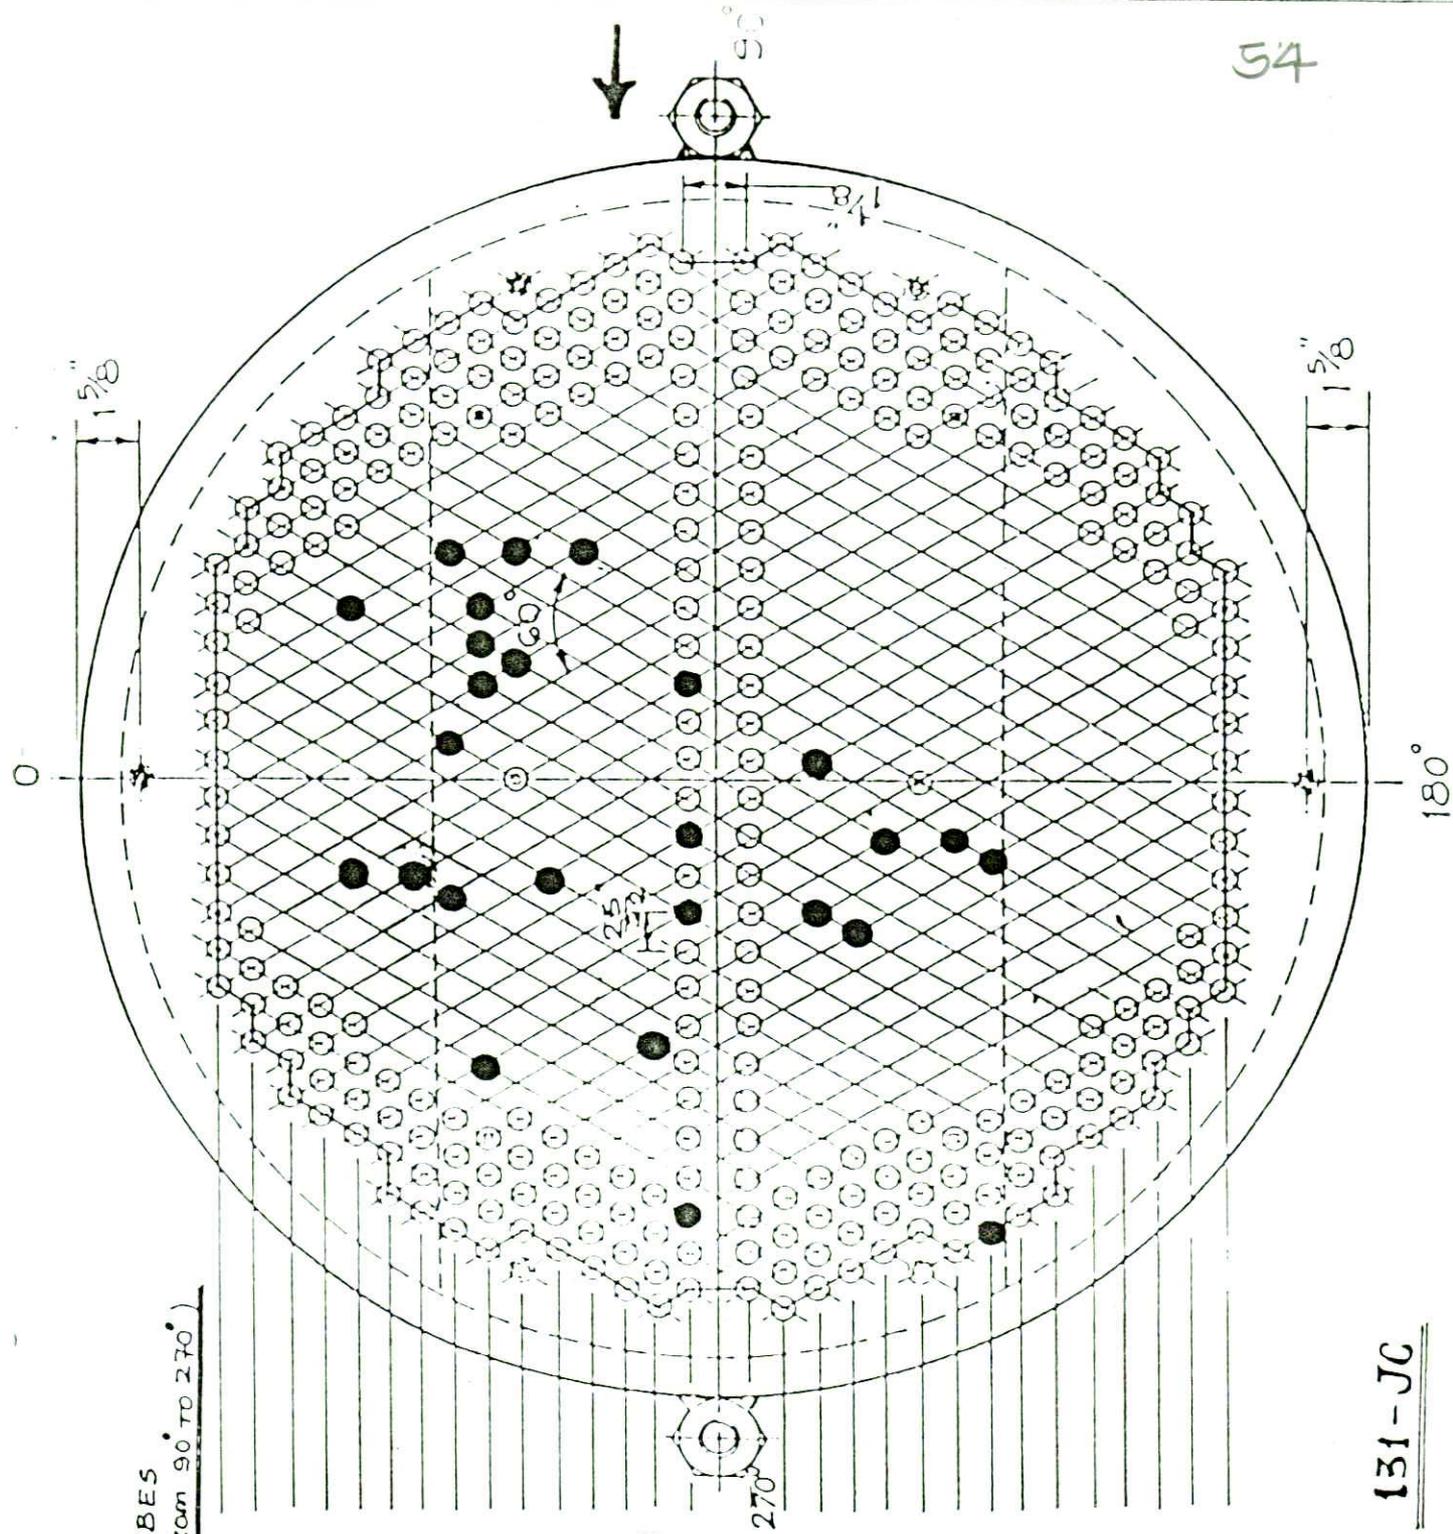
131-JC

ROW NO.	NOS. OF TUBES	NOS. OF TUBES PLUGGED (FROM 90° TO 270°)
15	12	
14	15	
13	18	
12	19	
11	20	6, 13
10	23	15
9	24	7, 12, 16
8	25	9, 10, 11, 21
7	26	7, 10
6	25	16
5	26	8
4	27	22 (OLD ONE)
3	28	12, 16, 18, 26
2	29	
1	28	
1	28	
2	29	
3	28	14, 18
4	27	18
5	26	15
6	25	15
7	26	15, 25
8	25	
9	24	
10	23	
11	20	
12	19	
13	18	
14	15	
15	12

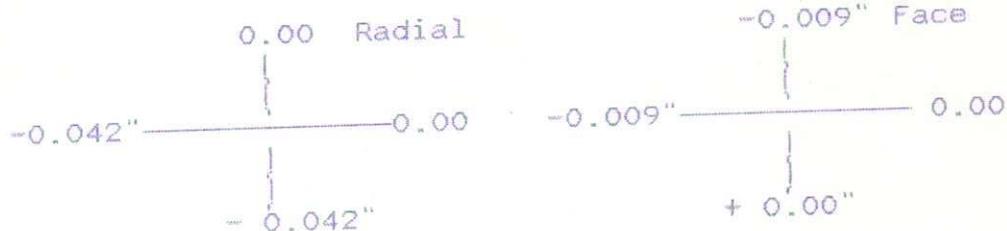
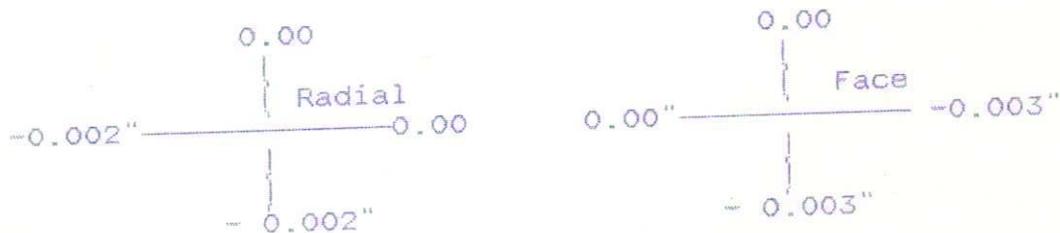
Alignment reading.

- a) Decoupled the coupling , cleaned and greasing done of pump coupling.
- b) Alignment checked found misalignment as below.

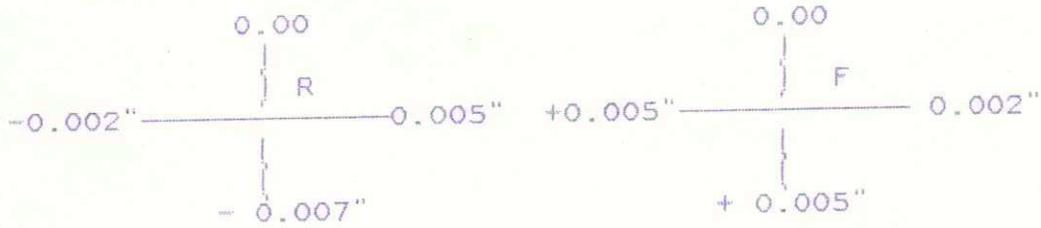
- c) Alingment checked and found misalign, hence alingment done.

- d) Parts changed :
1) Set of coupling sheems
