**IFFCO**  
**KALOL UNIT**

PLANNING SECTION  
MAINTENANCE DEPTT.  
REPORT NO.19 / 1999

**REPORT**  
**ON**  
**PLANT TURNAROUND**  
**( APRIL - 1999 )**

**INDIAN FARMERS FERTILISER CO - OPERATIVE LIMITED**

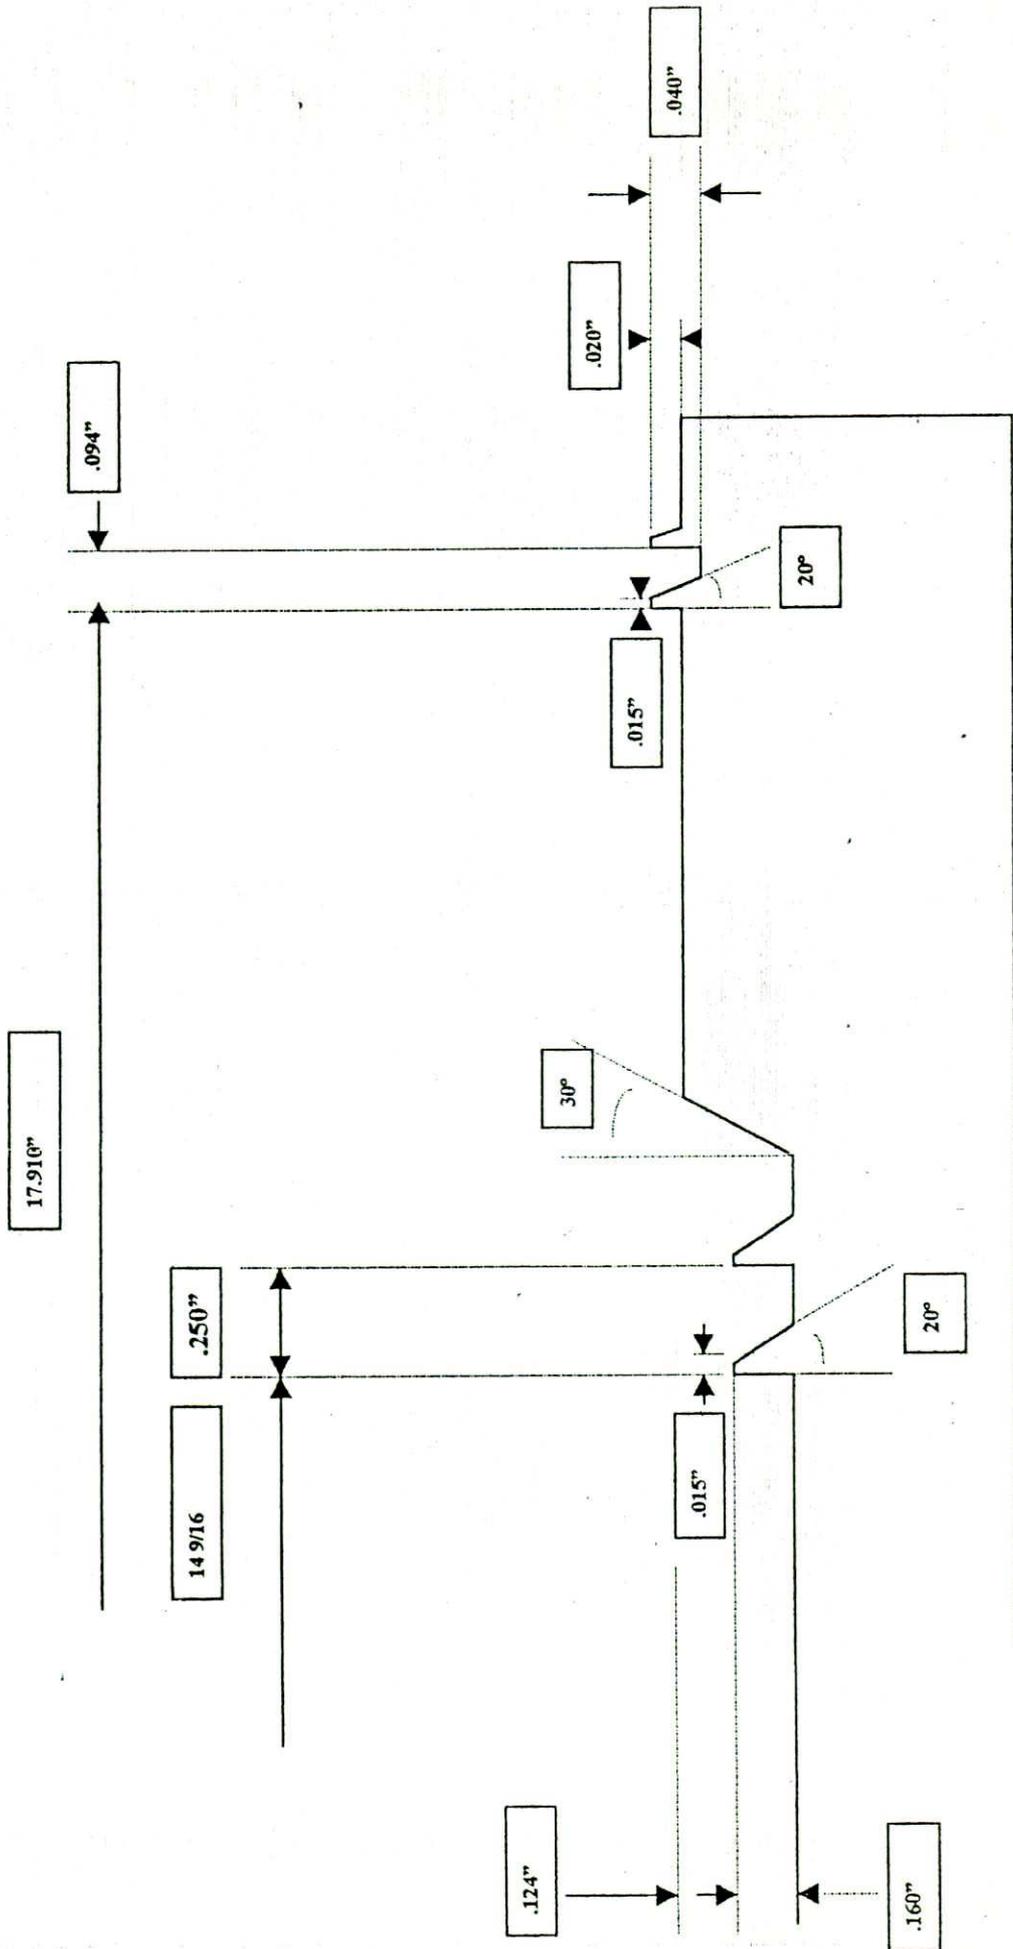
FIG. - 1

Removed the old ring cleaned and blue matching cheked and found almost 90 % matching. This rings holding allen screw tightened at 350 Ft.lbs torque.

IFFCO 103JAT NOZZLE MACHINING  
20 APRIL 99

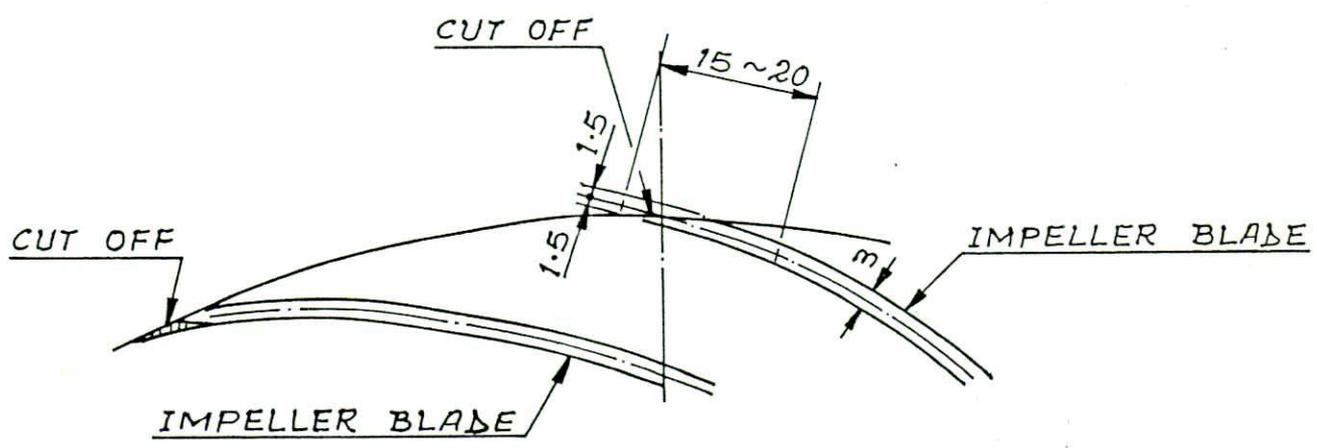
FIG.- I

- I) Each blad was cut to obtain more steep outlet flow angle to give increased head as show in Fig.-I.
- II) Outlet flow passage width was expanded by slightly grinding the wall by 0.3 MM with 4.0 MM length as shown in Fig. - II.

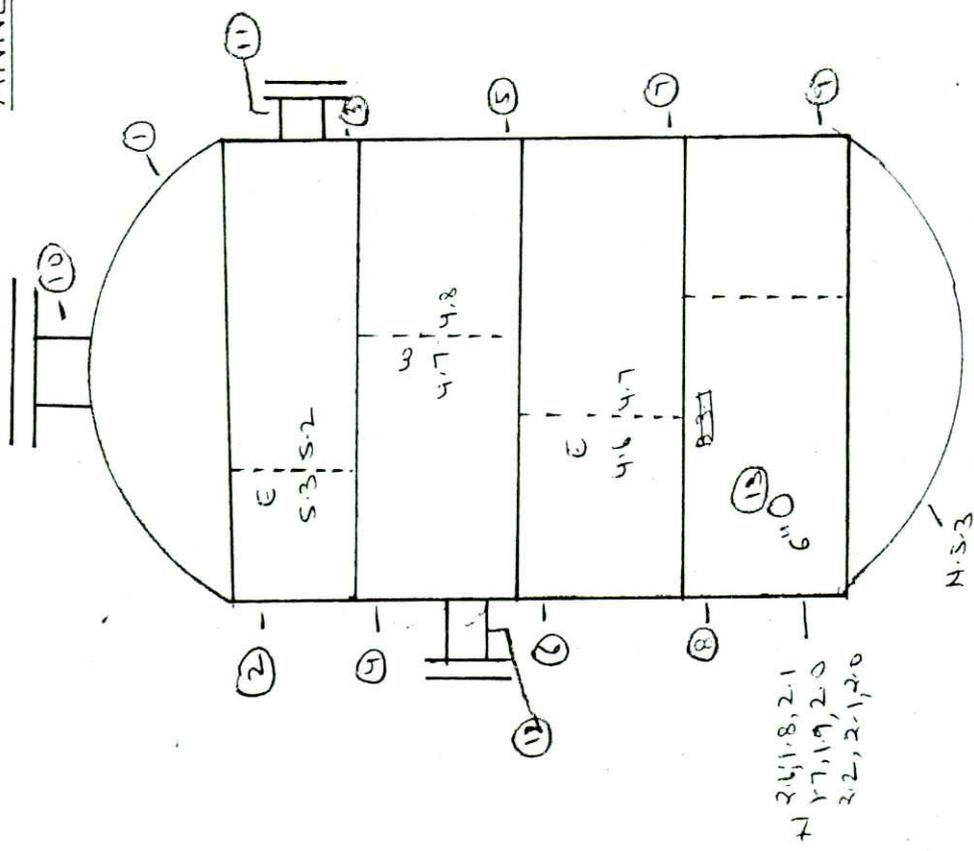
V-1206 ATM VENT SCRUBBER

SR. NO.	THICKNESS SURVEY					
	T	B	N	S	E	W
1			8.7	8.5	8.7	8.1
2			5.3	5.1	5.1	5.0
3			5.1	5.1	5.1	5.0
4			4.7	4.8	4.5	5.3
5			4.1	4.2	4.2	4.2
6			4.1	4.3	4.2	4.4
7			2.7		3.1	3.3
8			2.6		3.1	3.4
9			2.2		3.7	
10			4.2	4.1	4.1	4.0
11	5.2	5.2	5.1	5.2		
12	10.9	10.9	11.0	11.0		
13	3.1	3.1	3.0			
14						
15						
16						
17						
18						
19						
20						
21						
22						
23						
24						
25						
26						
27						
28						
29						
30						
Line V-1206 Plant UREA						
From ATM VENT SCRUBBER						
To

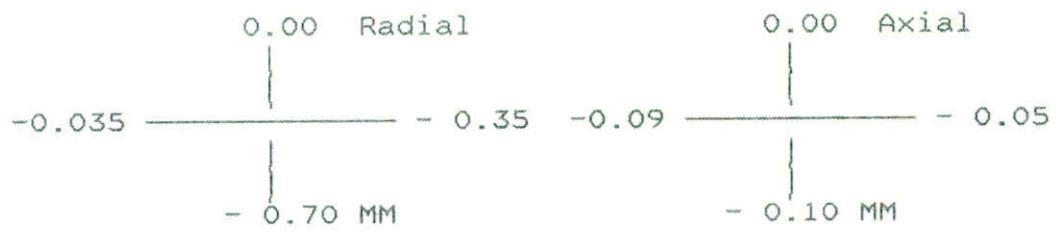
- a) Euroflex coupling between Pump and Motor was checked. Two shims of the Euroflex coupling was found cracked.
- b) Alignment was checked and found mis-align about 1 MM.
- c) Alignment was done and following are the reading.
