IFFCO
KALOL UNIT

PLANNING SECTION
MAINTENANCE DEPTT.
REPORT NO. 20 / 2000

REPORT
ON
PLANT TURNAROUND
(APRIL - 2000)

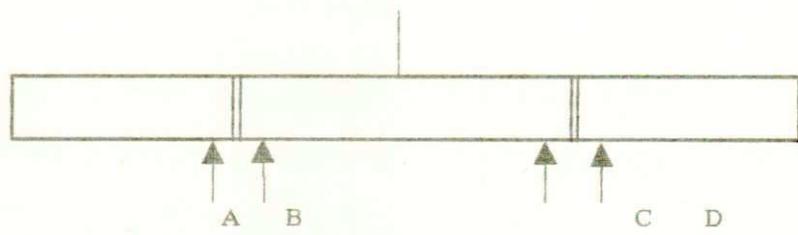
HEADER NO.	LOCATION							
	A		B		C		D	
	X-X	Y-Y	X-X	Y-Y	X-X	Y-Y	X-X	Y-Y
1	5.59165	5.59123	5.59591	5.59135	5.59485	5.59825	5.60521	5.60951
2	5.58685	5.58835	5.59315	5.59315	5.60509	5.58325	5.60509	5.59965
3	5.58531	5.58218	5.57912	5.59139	5.57975	5.58105	5.59315	5.58635
4	5.61489	5.61132	5.59815	5.60825	5.59535	5.60385	5.59435	5.59136
5	5.61325	5.61039	5.59316	5.58033	5.59437	5.59189	5.60834	5.60219
6	5.60116	5.60321	5.60415	5.61935	5.60151	5.60325	5.62015	5.60239
7	5.57915	5.59016	5.58913	5.59616	5.60323	5.59011	5.60993	5.60387
8	5.59131	5.59816	5.59183	5.60123	5.57869	5.59831	5.59873	5.59756

NOTE : (1) ALL DIMENSIONS ARE IN INCH.
 (2) MAXIMUM DIAMETER OF 5.62015" WAS OBSERVED WHICH
 CORRESPONDS TO 0.45 % CREEP.

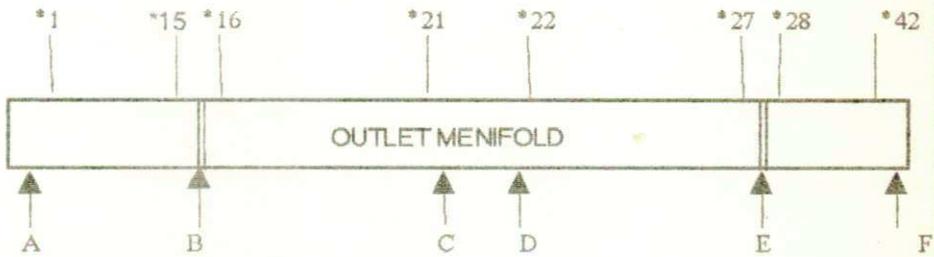
HEADER NO.	LOCATION					
	A	B	C	D	E	F
1	320	315	310	310	305	310
2	325	290	310	305	300	295
3	320	270	295	290	290	310
4	320	300	300	290	310	290
5	310	300	320	330	320	320
6	300	280	275	280	270	300
7	320	315	320	320	310	330
8	345	330	310	320	310	315

NOTE: (1) ALL DIMENSIONS ARE IN MM.
(2) ALL READINGS ARE TAKEN WITHOUT INSULATION.
