MTC / REPORT / 01
REPORT NO. 23 / 2003

IFFCO
KALOL UNIT
REPORT
ON
PLANT TURNAROUND
(MAY - JUNE - 2003)

INDIAN FARMERS FERTILISER CO - OPERATIVE LIMITED

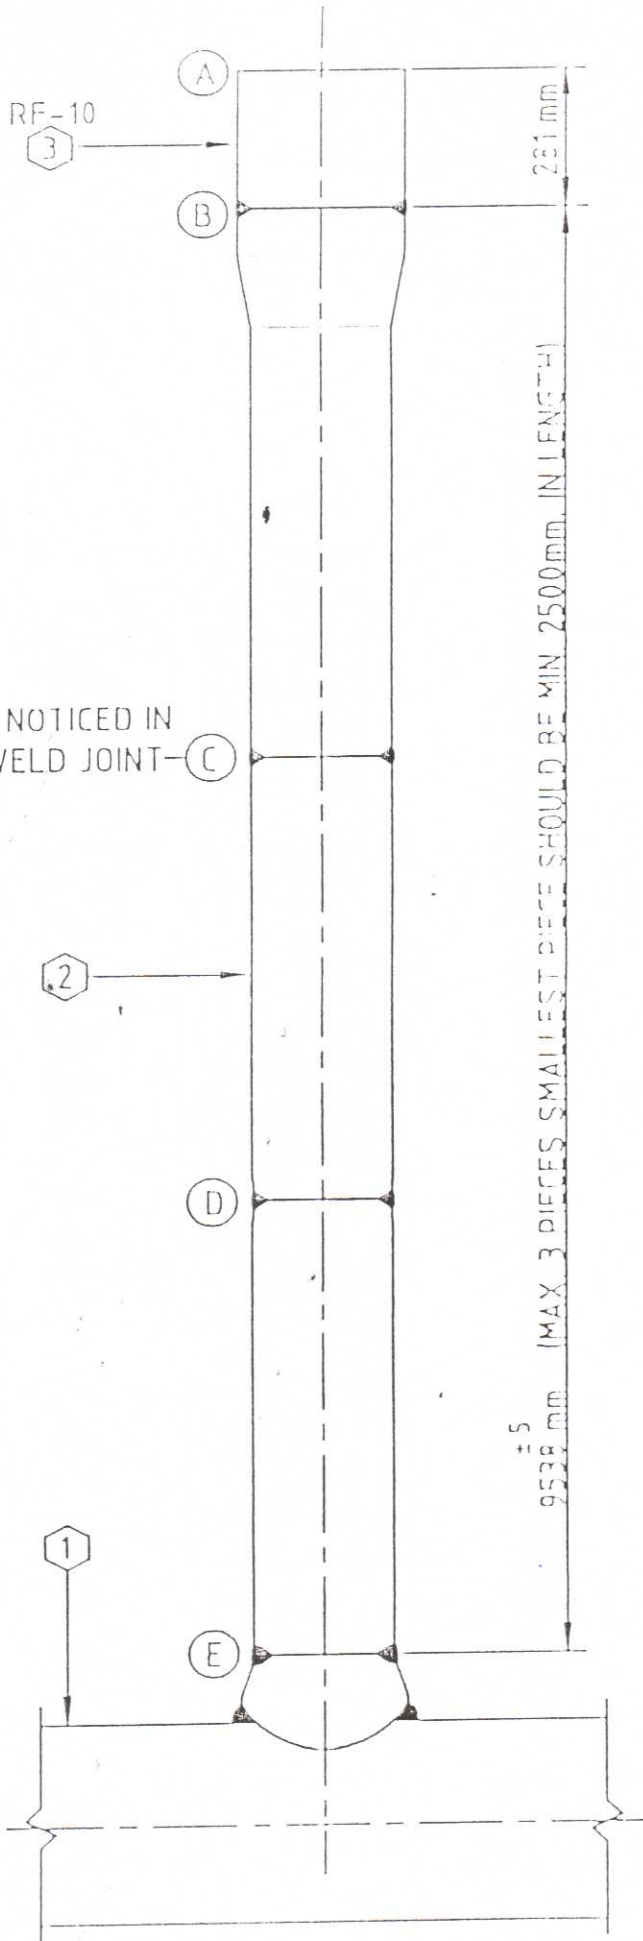
CRACK NOTICED IN THIS WELD JOINT

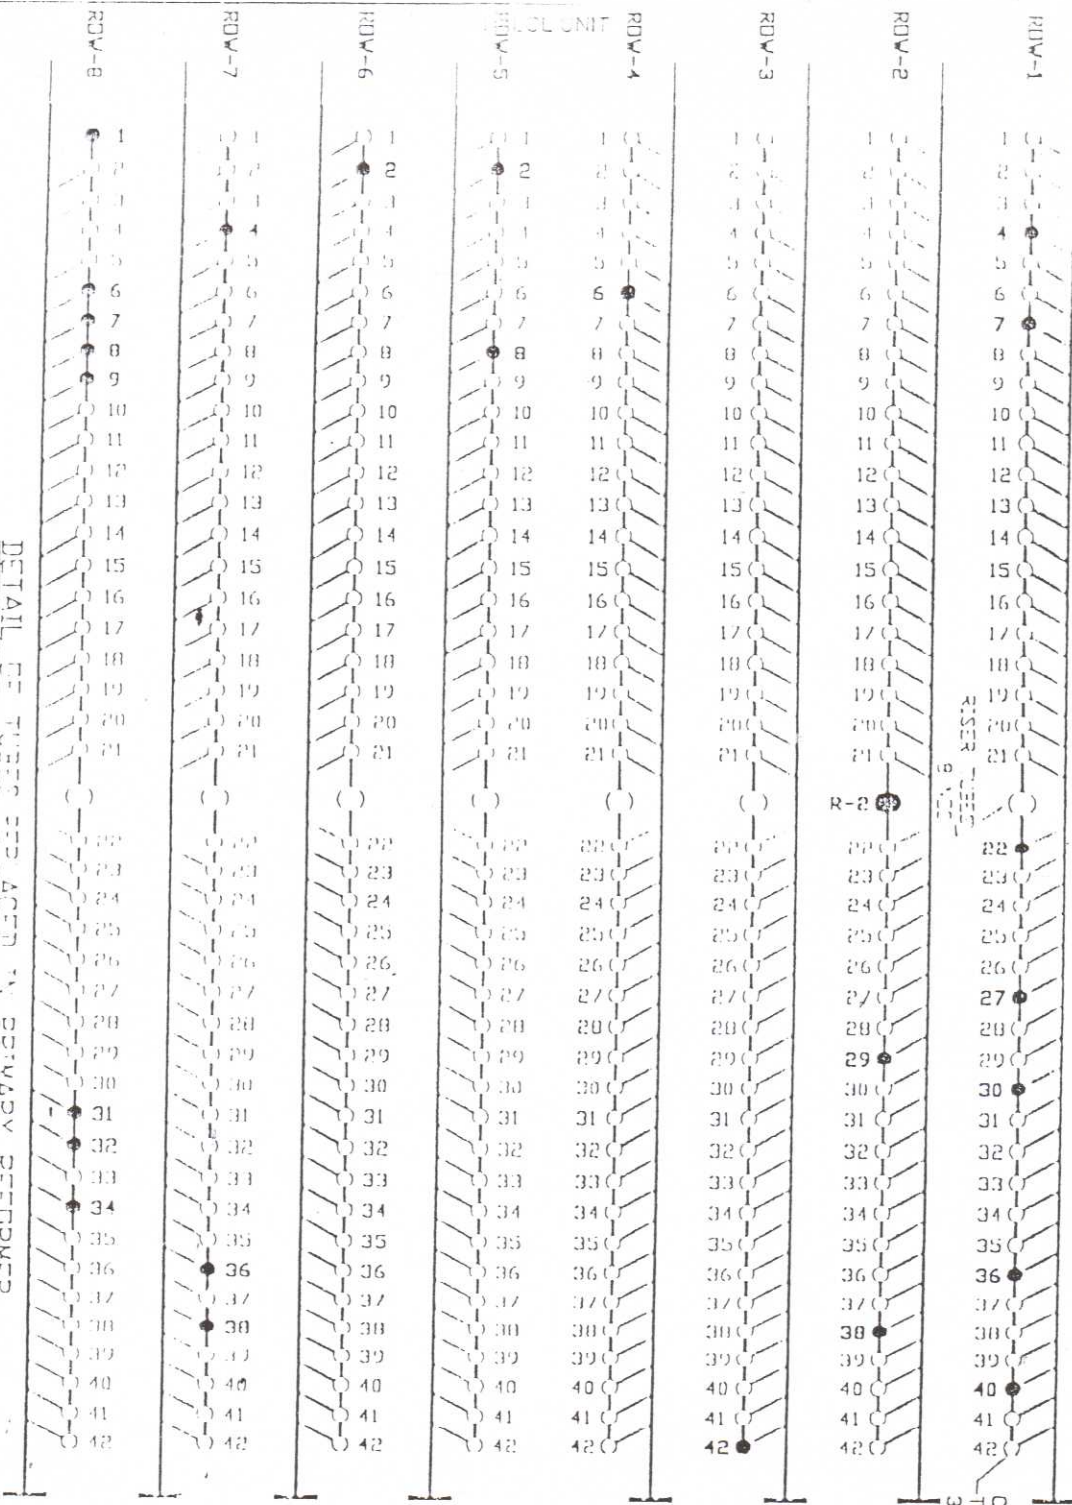
DETAIL OF TUBES REPLACED IN PRIMARY REFORMER
 BASED ON ON LINE DIAGRAM DURING SHUTDOWN
 13-JUNE-2003

ROW NO.	TUBES REPLACED
1	7 NOS.
2	2 NOS.
3	1 NO.
4	1 NO.
5	2 NOS.
6	1 NO.
7	3 NOS.
8	8 NOS.
TOTAL	25 NOS.

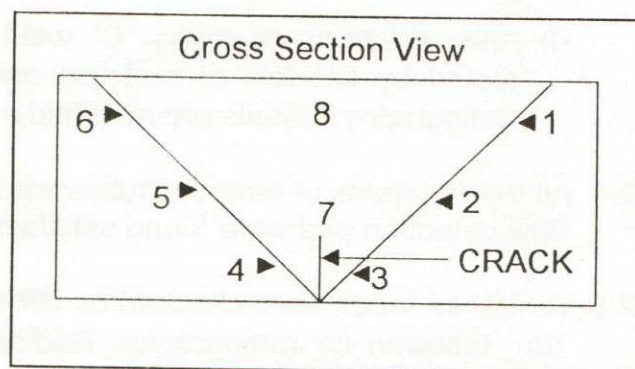
1.2.10 Surface hardness measurement of 3 defective tubes at weld seam and at HAZ was measured using ultrasonic hardness tester MIC-1 as under.

→ Tube No. ↓ Point No.	140	807	834
1	--	275 TO 285 HV	290 TO 310 HV
2	--	275 TO 285 HV	290 TO 310 HV
3	--	275 TO 285 HV	290 TO 310 HV
4	380 HV	285 TO 295 HV	280 TO 300 HV
5	380 HV	285 TO 295 HV	280 TO 300 HV
6	380 HV	285 TO 295 HV	280 TO 300 HV
7	375 TO 380 HV	285 TO 295 HV	285 TO 305 HV
8	370 TO 380 HV	295 TO 300 HV	265 TO 300 HV

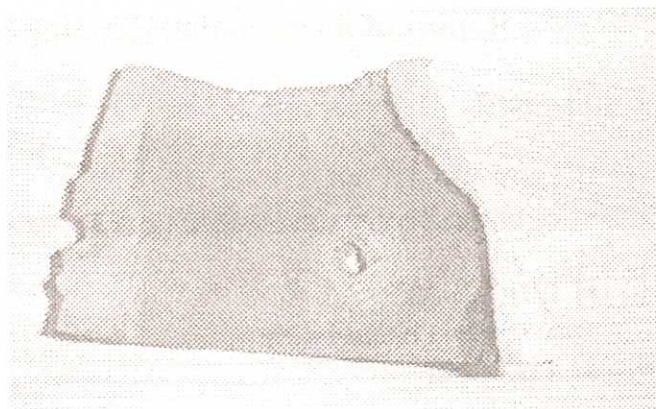
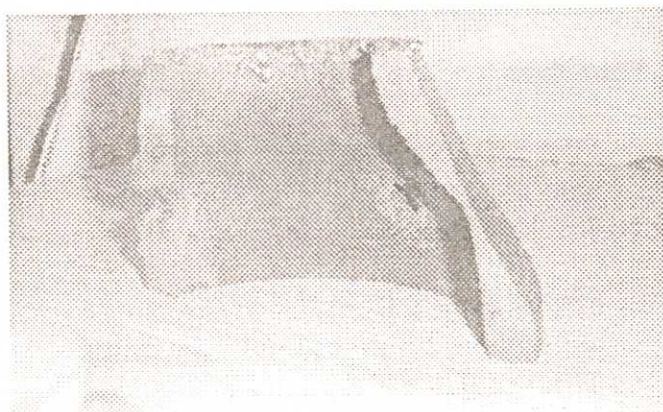
Photographs showing the thickness reduction of 6"X4" reducer of PB compressor final discharge line.
