# P R E F A C E

Plant Turnaround for the year 2004 was carried out from 20-05-2004 to 09-06-2004 for preventive maintenance of the plant equipment / miscellaneous jobs pending for the plant shutdown, including hooking up or taking tapings for the ambitious energy saving schemes of the Ammonia plant.

#### **AMMONIA PLANT**

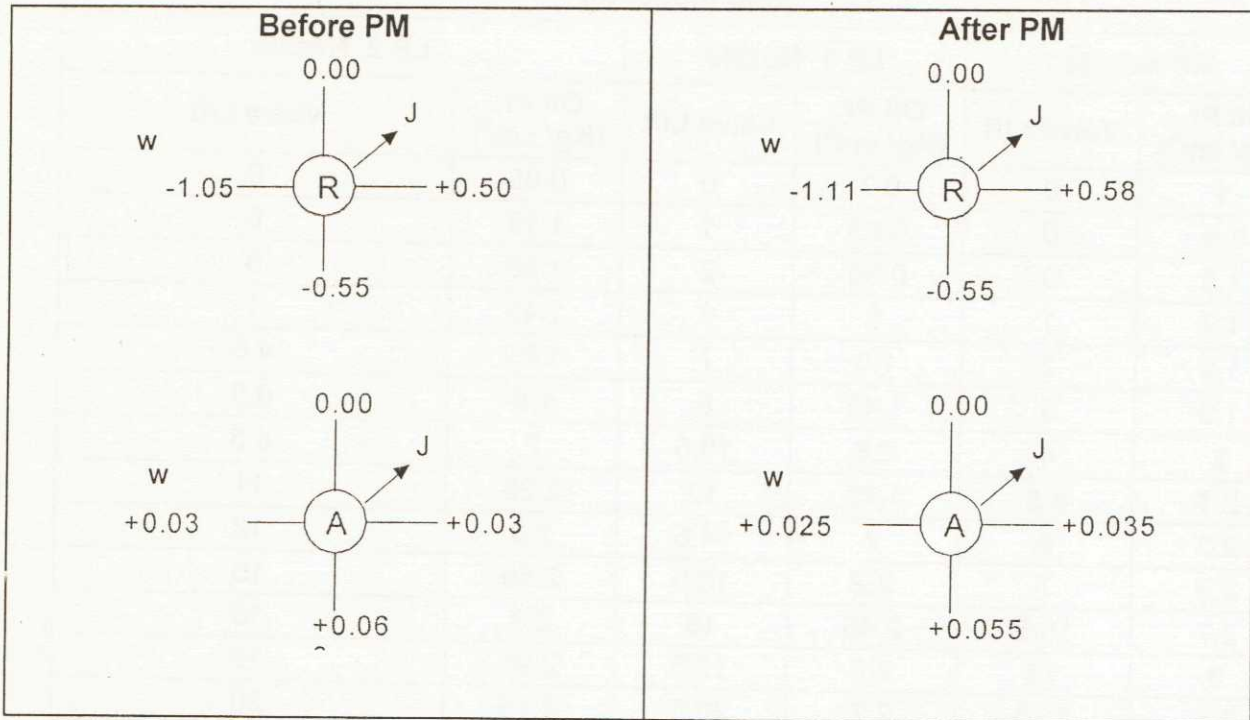
102 JT TO 102 J

After assembly of both bearings, it was observed that turbine rotation was not free. After decoupling front coupling, turbine rotation was found free. Front end coupling alignment reading was taken. It was found that alignment was disturbed and the same was corrected.

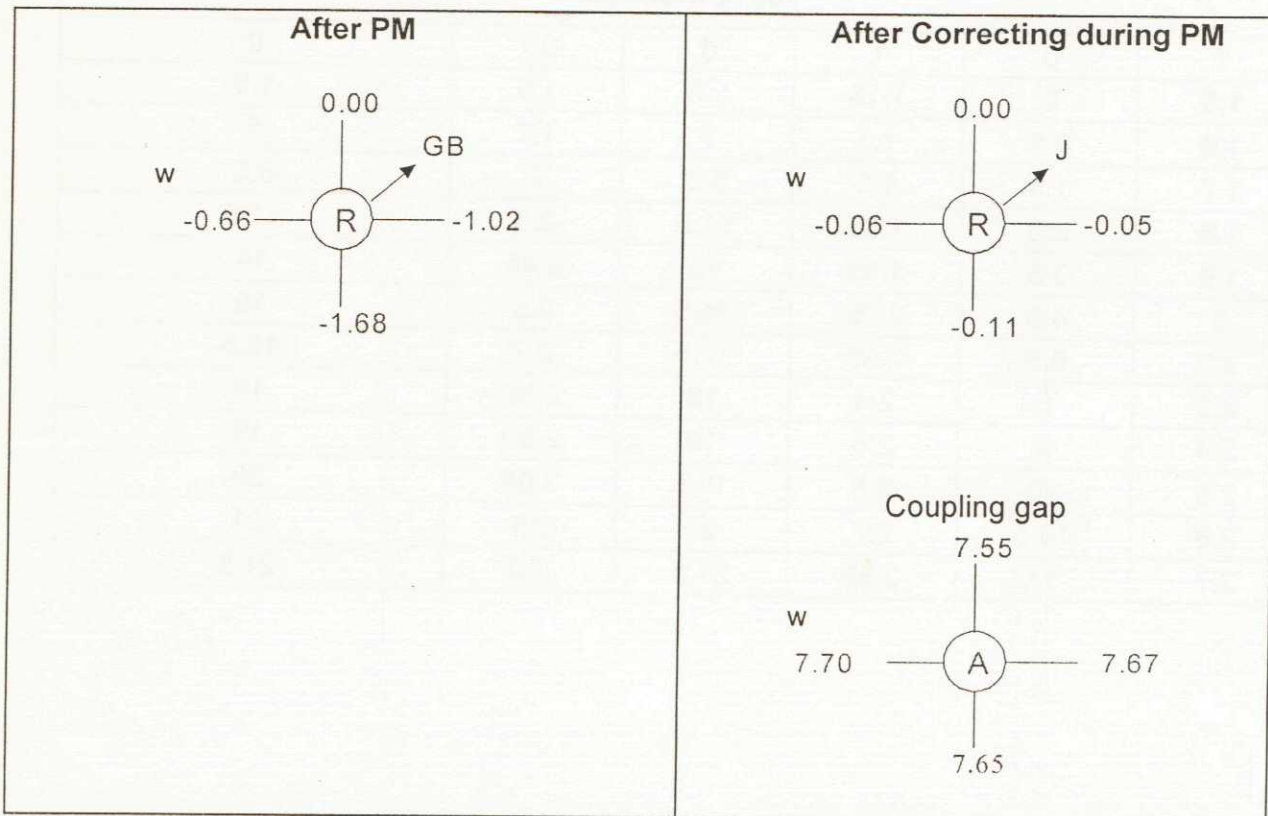
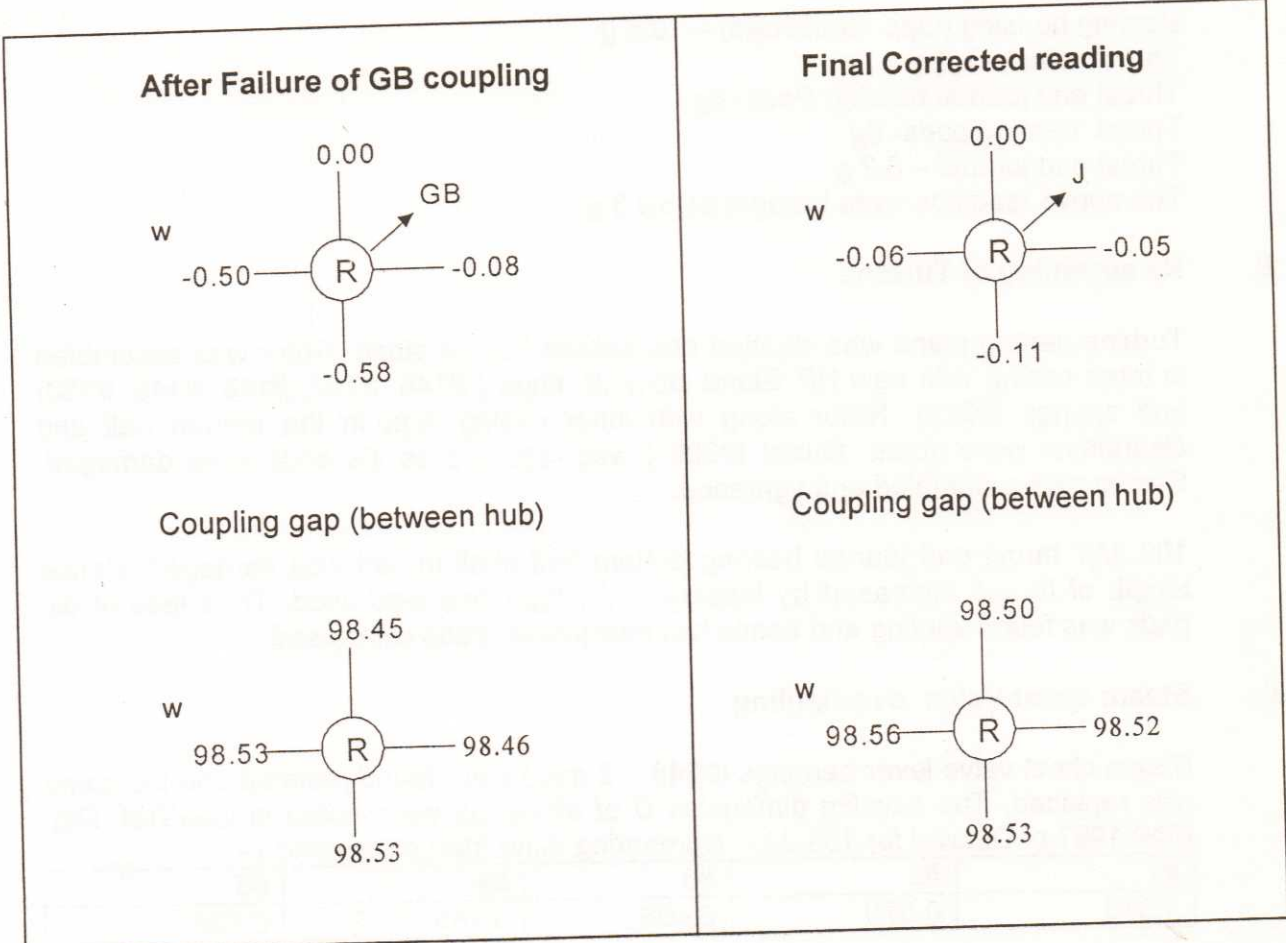
102 JT TO Governor Coupling

During start up, front end vibration was high and governor was hunting. Hence stopped turbine. Observed that governor worm gear was disengaged with worm wheel and governor coupling was free. Replaced coupling sleeve. Front end coupling was checked after opening top cover and found OK. Governor was replaced with the old one after checking calibration. 2 nos. dowels were made for governor.

Turbine was started and speeded up to 13500 RPM. Since vibration increased to an alarming level at front end and governor was hunting, turbine was stopped again. After opening it was observed that 2nos.of bolts of front end coupling at turbine end were sheared and broken. Marks were observed on spacer hub at turbine end due to rubbing with sealing strip which was also damaged. Thrust end journal bearings and thrust bearings were opened and found OK. Alignment of turbine with front end coupling was checked. It was found disturbed. It was corrected. Damaged coupling bolts, turbine end shim (5 nos.) and spacer of coupling was replaced with new one. Coupling hub shaft bolts (6 nos.) was also replaced. Turbine was started and found OK.

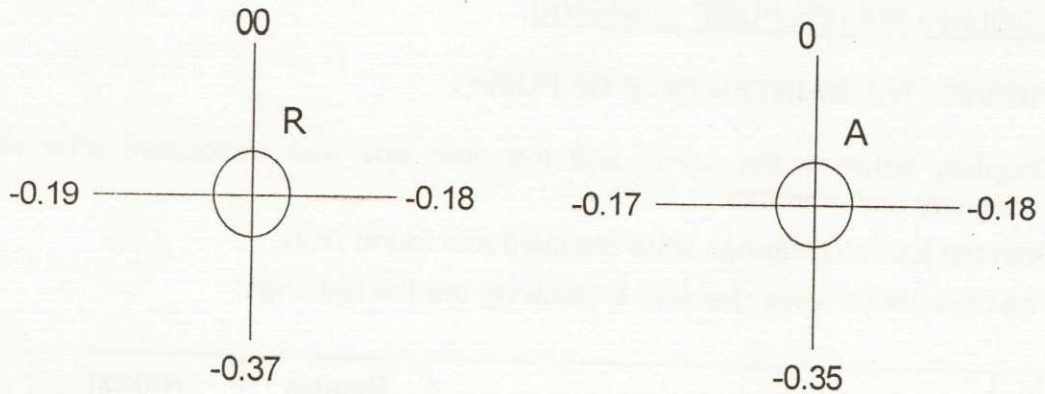
Following are the readings (Before PM):

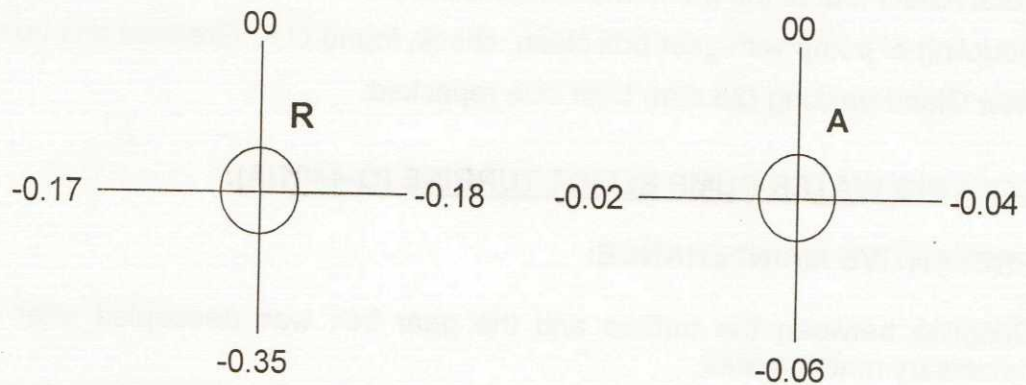
Turbine to Gear box Alignment was corrected, Following are the readings:
