MTC / REPORT / 01
REPORT NO. 28 / 2008

KALOL UNIT

PLANT TURNAROUND REPORT

INDIAN FARMERS FERTILISER CO - OPERATIVE LIMITED

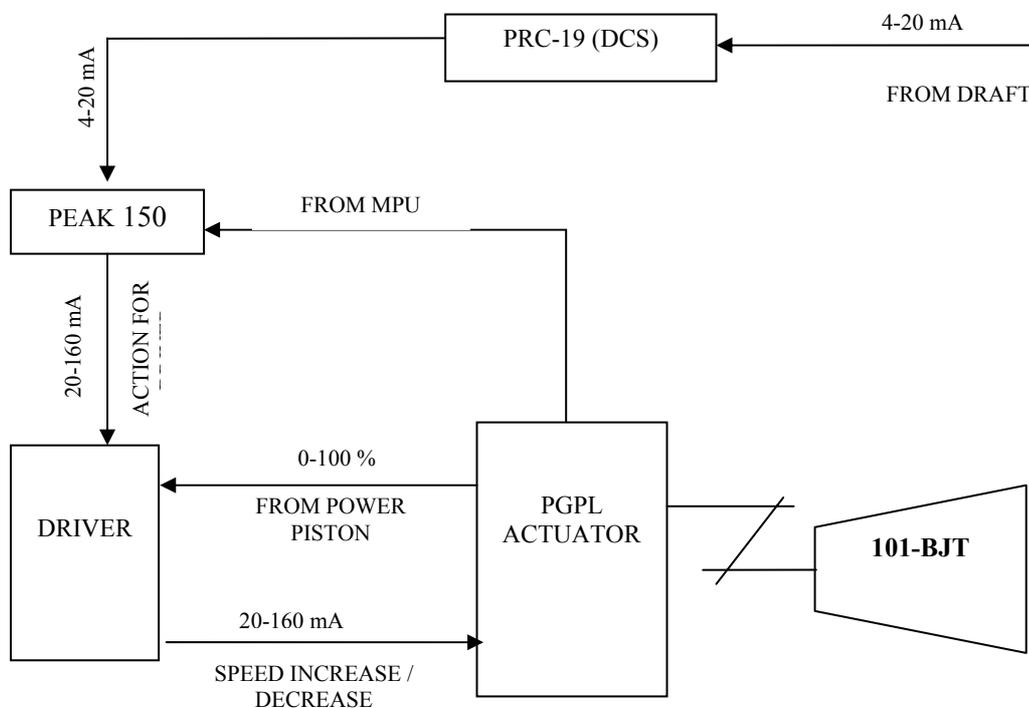
The existing PGPL mechanical governor was showing problem in controlling speed during start up and even in running plant. To have more precise speed control and improved reliability, this mechanical governor was replaced by new electronic governing system comprising of the following.

Sketch showing the working of the new electronic governing system for 101-BJT

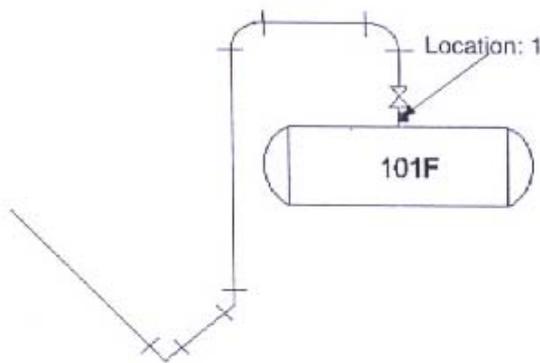
Fig.1

In-Situ Metallography conducted on Steam Drum (101-F) Main Steam Outlet Line during Shutdown Oct-2007 in which Microstructural grain boundary degradations in the form of voids & micro-cracks shown in Fig. 2, Fig. 3 & Fig. 4 was observed at the location shown in Fig.1. Hence, replacement of 610mm Length 300NB X SCH 100 pipe piece was carried out during Annual Shutdown April-2008.

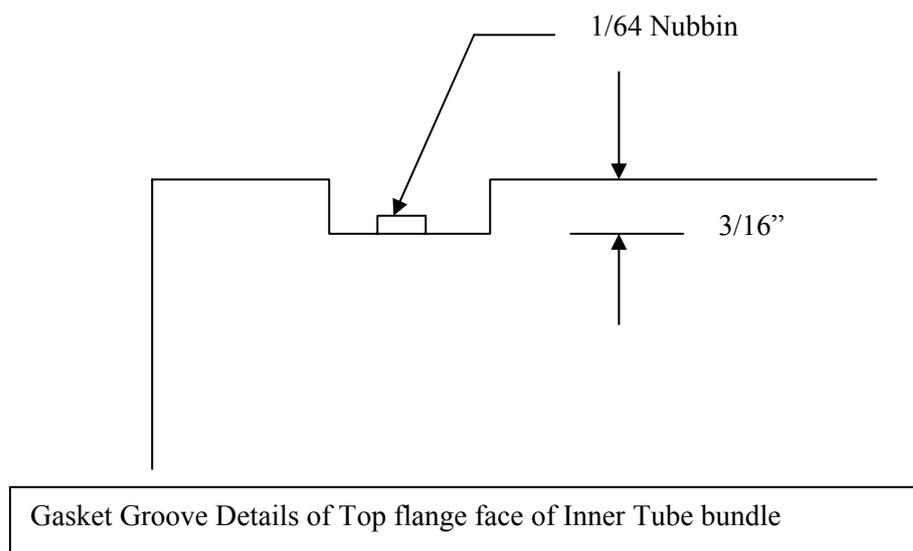
During internal hydrotest, the 101-CB i.e tube bundle no 1-72-04-3118472 was failed. This was replaced with spare available tube bundle no 13517 (1-71-04-31049-272). The Nubbin at Gasket groove of this bundle was found in good condition, hence top cover elbow was assembled with solid soft iron gasket.

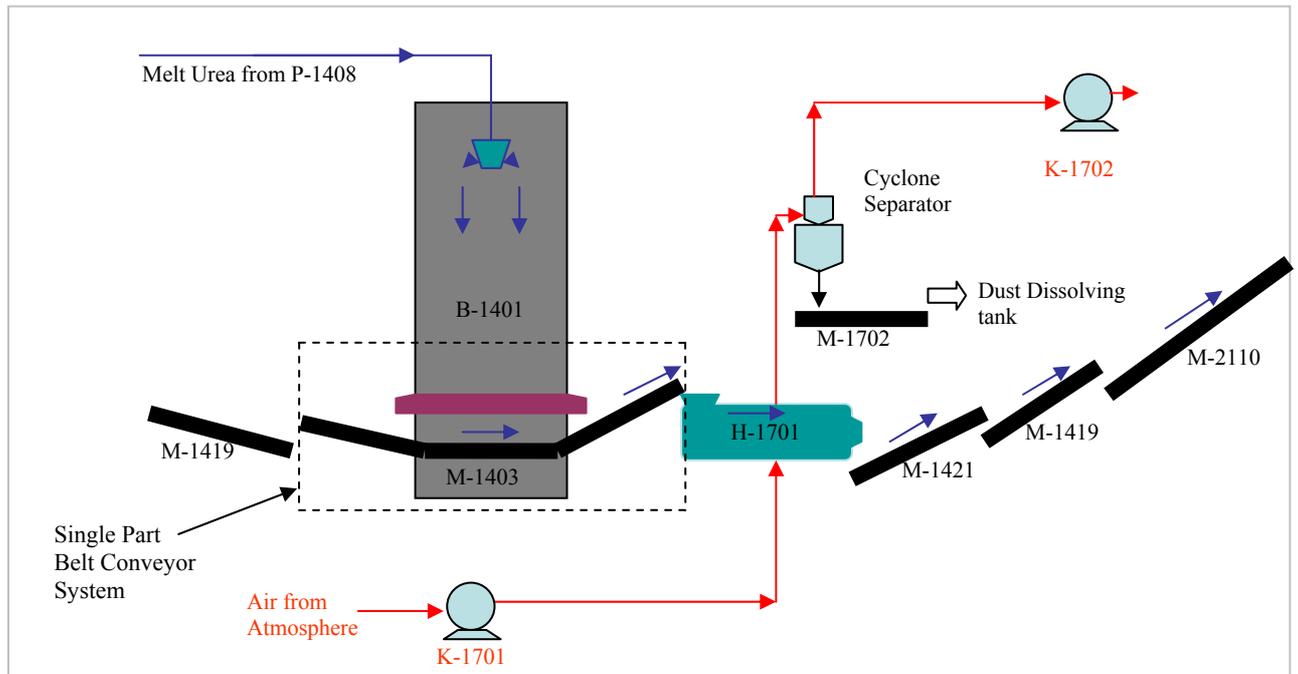
Old Belt Conveyor System: Single Part Belt Conveyor System

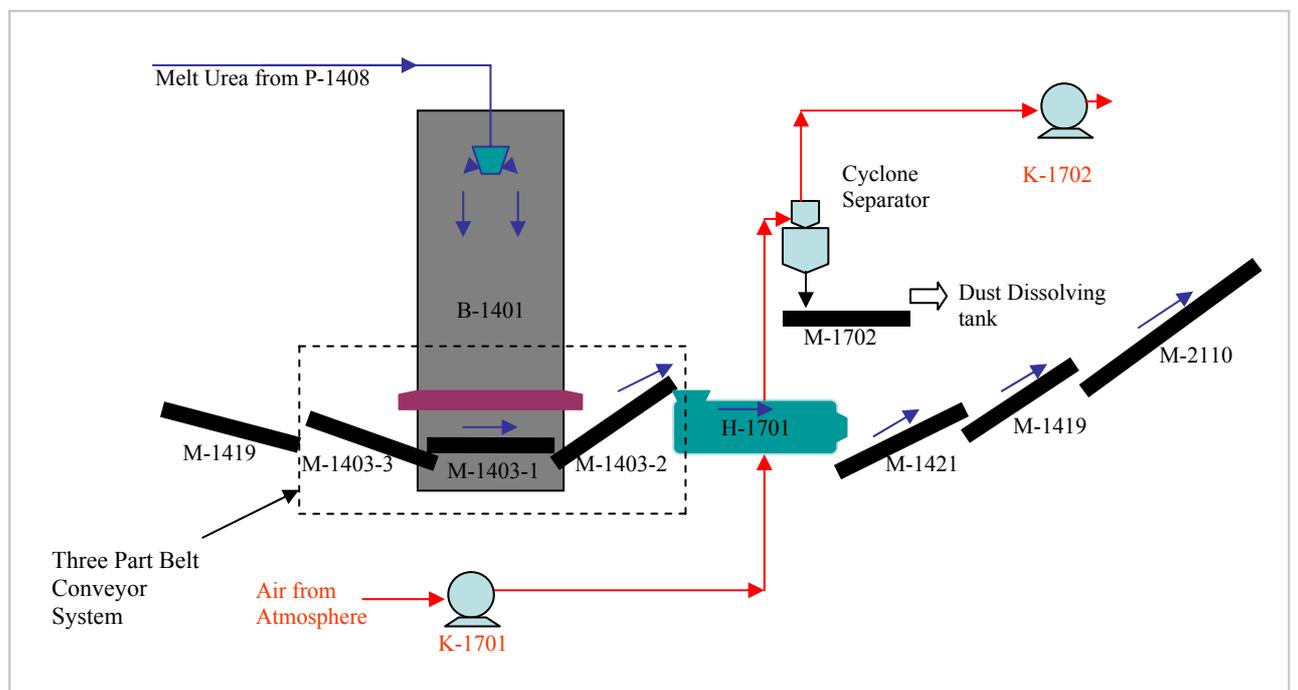
Modified Belt Conveyor System : Three Part Belt Conveyor System

The conveyors are operating satisfactory, after rectifications.
