MTC / REPORT / 01
REPORT NO. 29 / 2009

KALOL UNIT

PLANT TURNAROUND REPORT

INDIAN FARMERS FERTILISER CO - OPERATIVE LIMITED

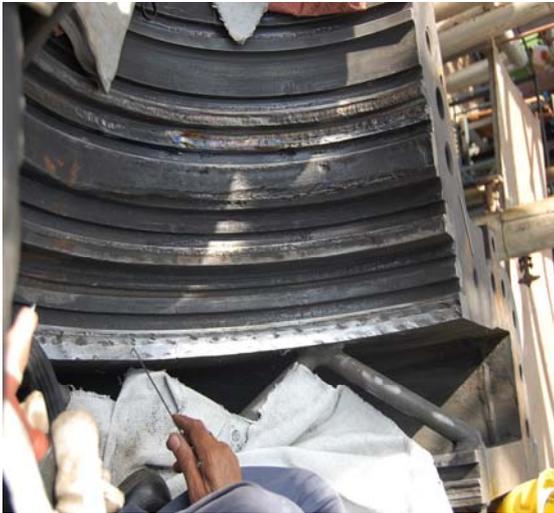
101-JT Casing Repair

Exhaust piping removed after locking the bellow in the exhaust piping. After de-coupling, it was recorded like clearances of Journal Bearing, Thrust Bearing, Axial float and coupling alignment readings. Floating front end bearing pedestal was locked by providing washers in the holding bolts before opening the casing bolts. Turbine casing bolts were loosened and removed the top cover. Recorded all internal clearances and Rotor was lifted by Kobelco crane. Removed all Diaphragms and observed severe erosion in the casing grooves at stage 3, 5 & 6 which lead to steam leak at the back of diaphragm seating surface of casing. It was repaired by weld built up. Repair methodology followed for weld repair is as below:

Pre Heat the repair area approx up to 150 deg. C by Gas Torch. Followed by weld built up by TIG process and slow cooling the welded area by covering under insulation cloth. Metal built up was done with ER-70 S filler wire. Final finishing of built metal surface by hand grinding and cleared by dye penetrator test.

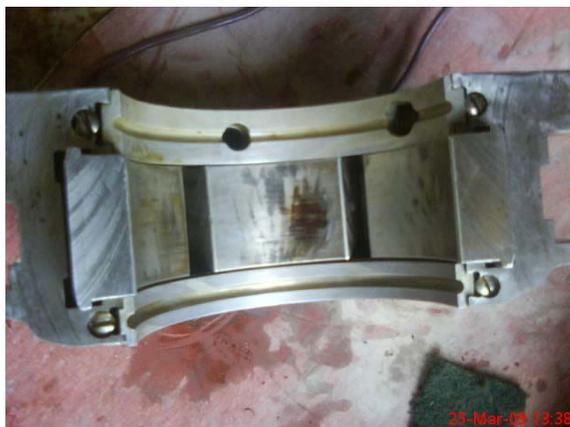
103-JHP Damaged Jr. Bearing Pad

The compressor was decoupled and thrust bearing and both end Journal bearing were inspected. Gauss readings of journal bearing pad and base ring, shaft journal area, thrust bearing and thrust collar was measured and found within limit. All pads were Dye Penetration tested. The non-drive end journal bearing clearance was found high and also burn marks were observed on pads. The journal bearing was replaced. The thrust bearing pads were observed slightly worn-out as shown in the photo; hence new thrust bearing was issued for installation. But the base ring of new thrust bearing was not having drill for RTD cables, hence new thrust pads with old base ring was used.

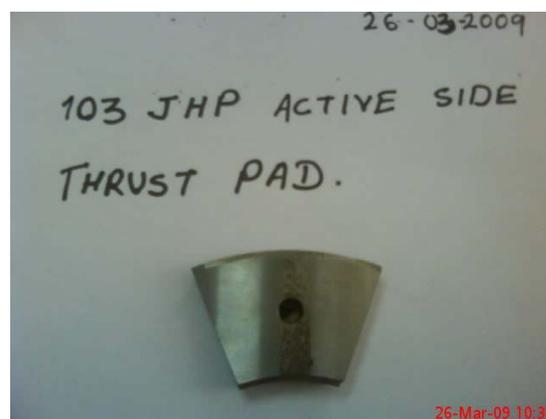
103-JHP Damaged Thrust Bearing Pad Seat

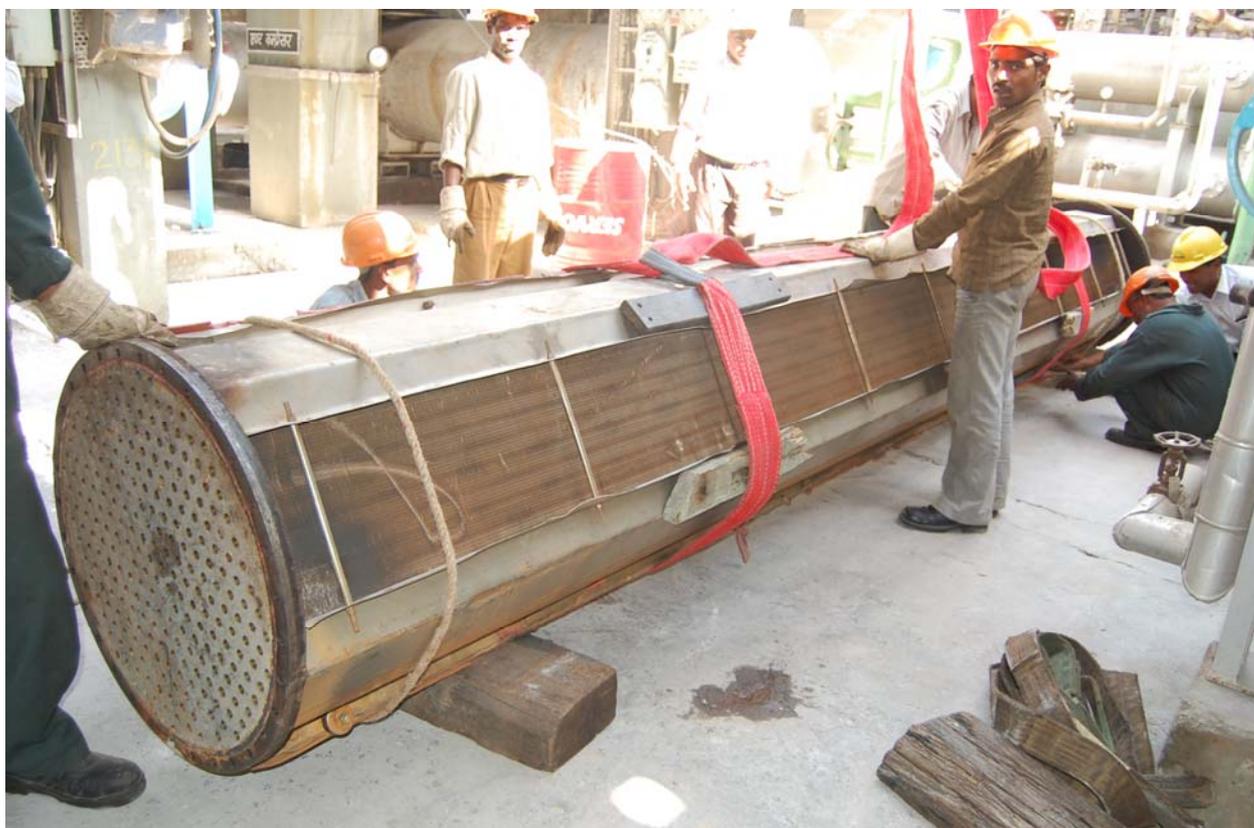
129-JC Tube Bundle Replacement Under Progress

The existing tube bundle was replaced by new tube bundle assembly procured from M/s Patel Airtemp, vide PO No 20080797 dated 24-10-08.

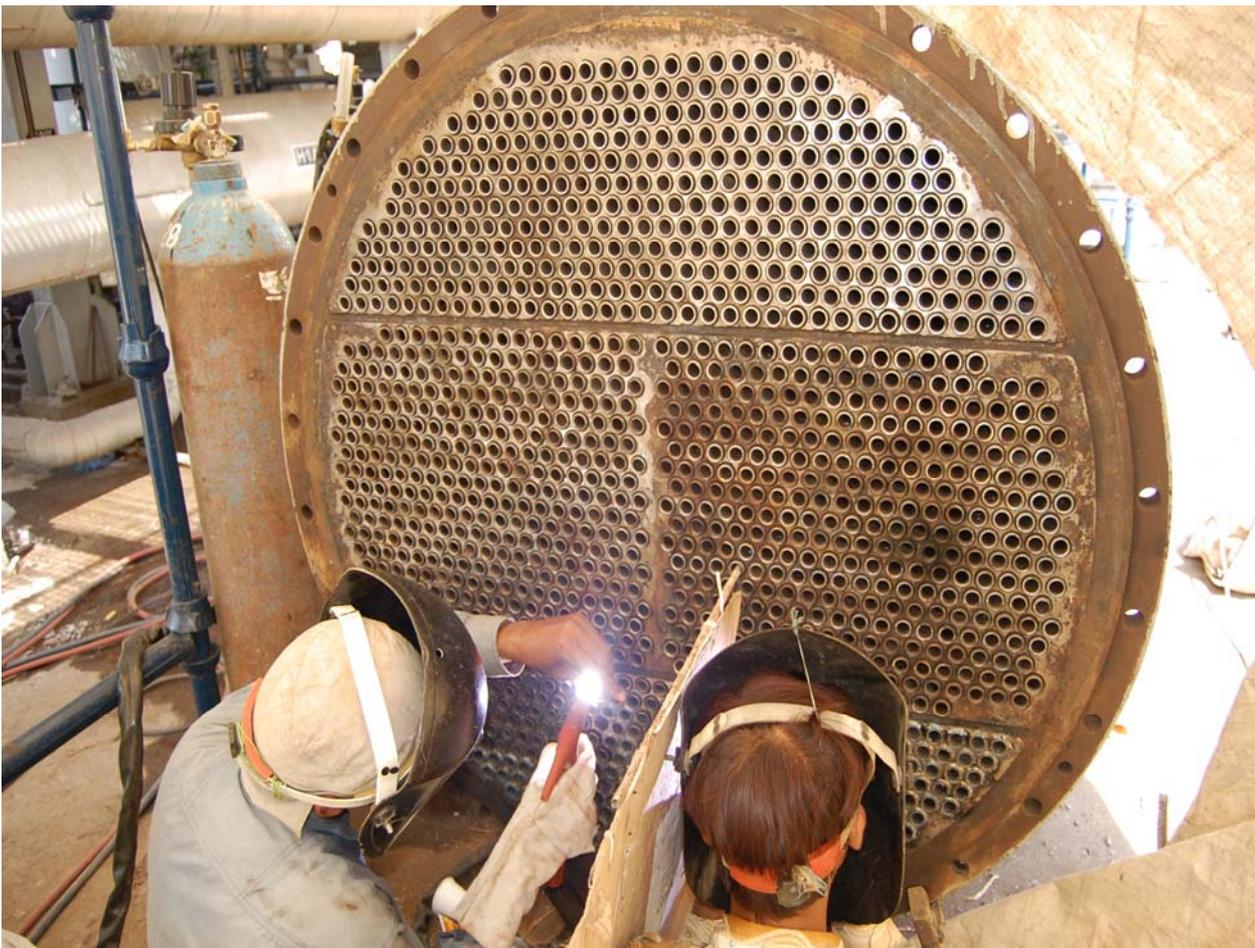
HE-2 Re-tubing Under Progress

The complete tube bundle assembly was taken for retubing of all the 1280 No of tubes. The complete tube bundle assembly with integral shell was removed from installation and brought down to ground floor. The tubes to tube sheet joint were removed by drilling and the tubes pulled out by hydraulic puller. Seamless cold drawn ASTM A-179, low-carbon steel tubes, were inserted and strength weld done using TIG followed by light expansion of 3-5 %. The strength weld was DP tested and found OK. Hydrotesting was done on shell side at 37.5 kg/cm² and hold time of 15 min. No leakage was observed. The retubing was done by M/s S.R.Engineering, vide PO No 20081303, dated 07/02/2009.

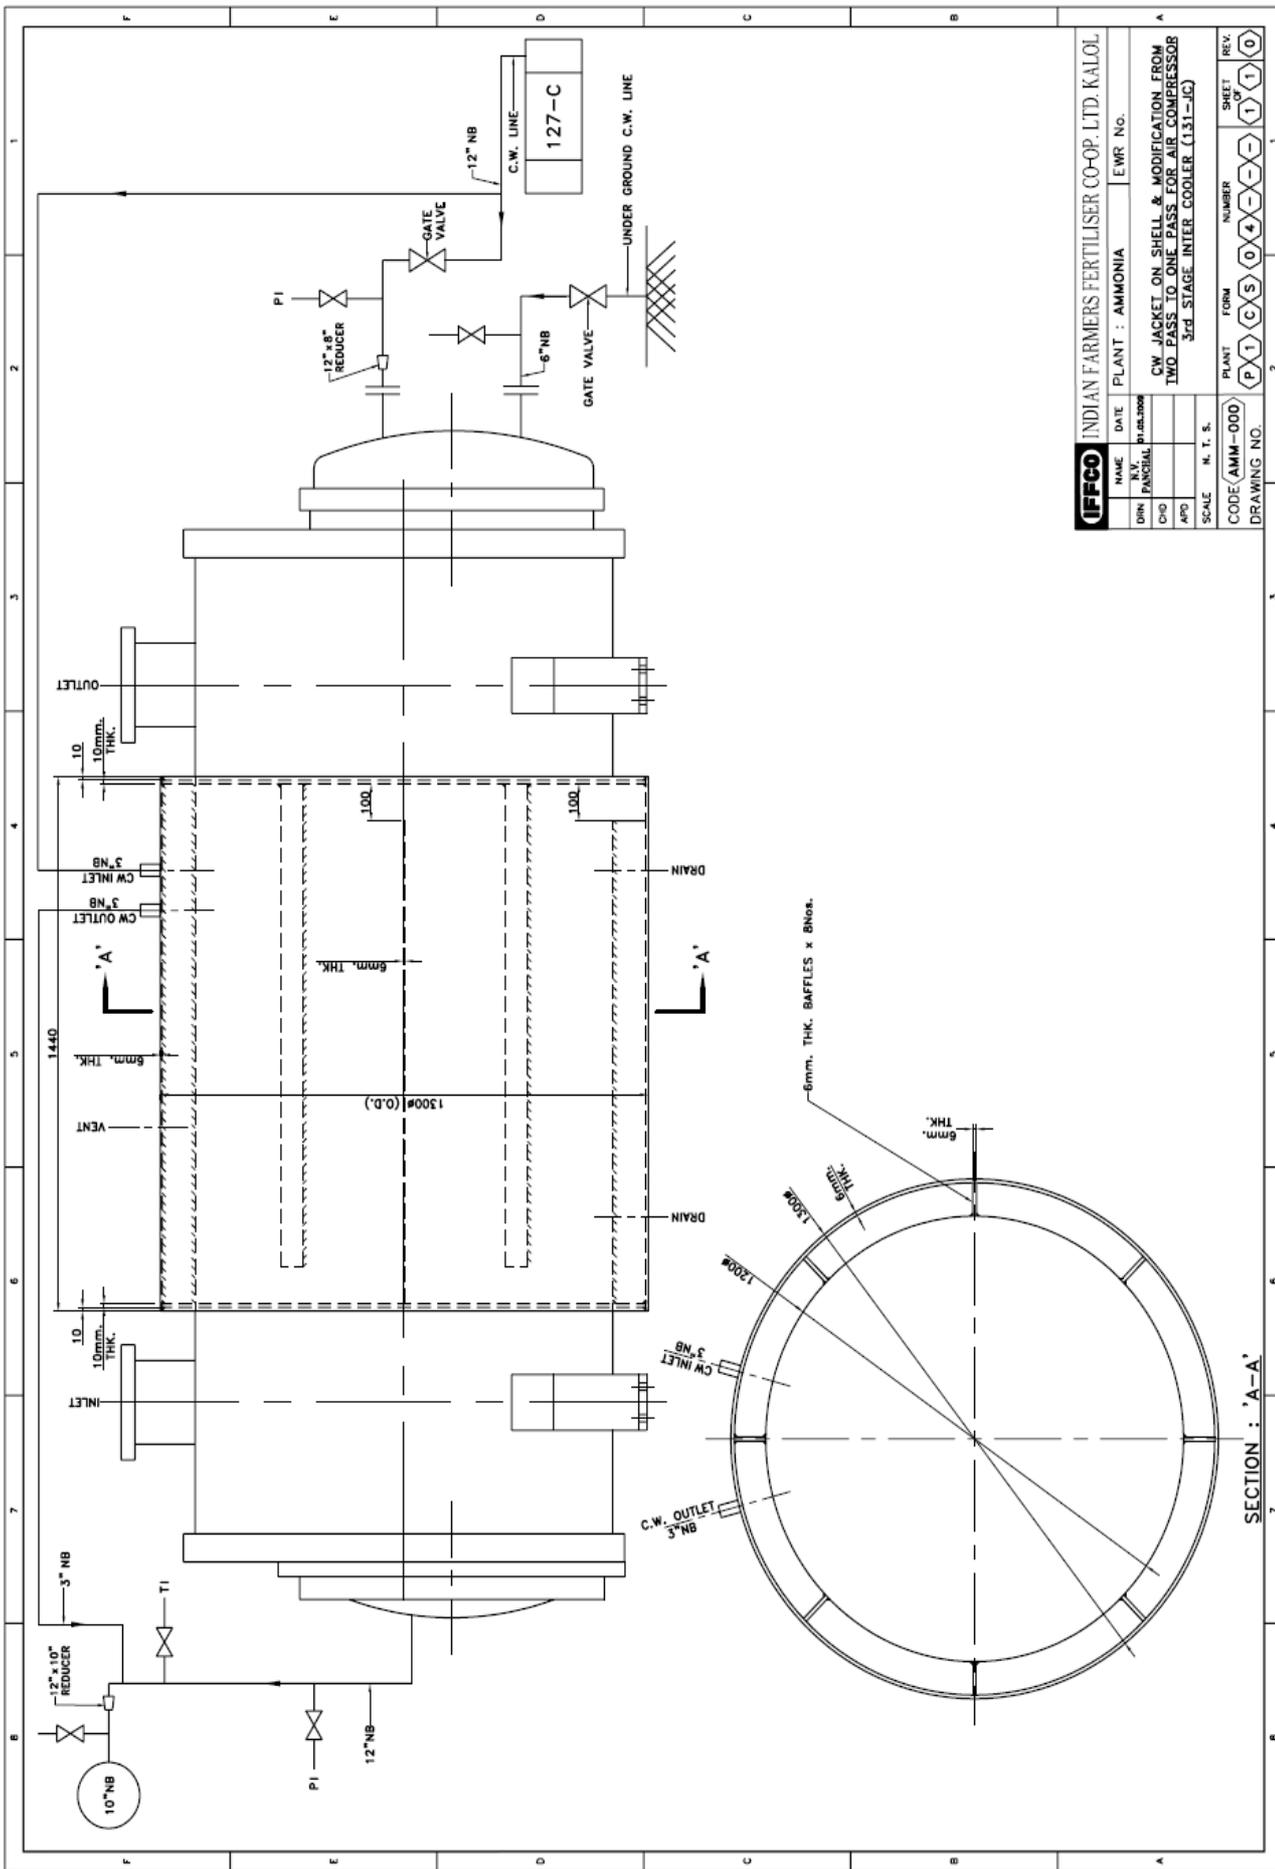
CW JACKET ON SHELL & MODIFICATION FROM TWO PASS TO ONE PASS FOR AIR COMPRESSOR 3rd STAGE INTER COOLER (1.31-JC)

- 131-JC leaky tubes were plugged and modified to single pass CW flow from two pass and provided additional jacketing at outside the shell for sufficient cooling effect, as more than 50% tubes plugged. Both the exchangers found working satisfactorily after the restart up.

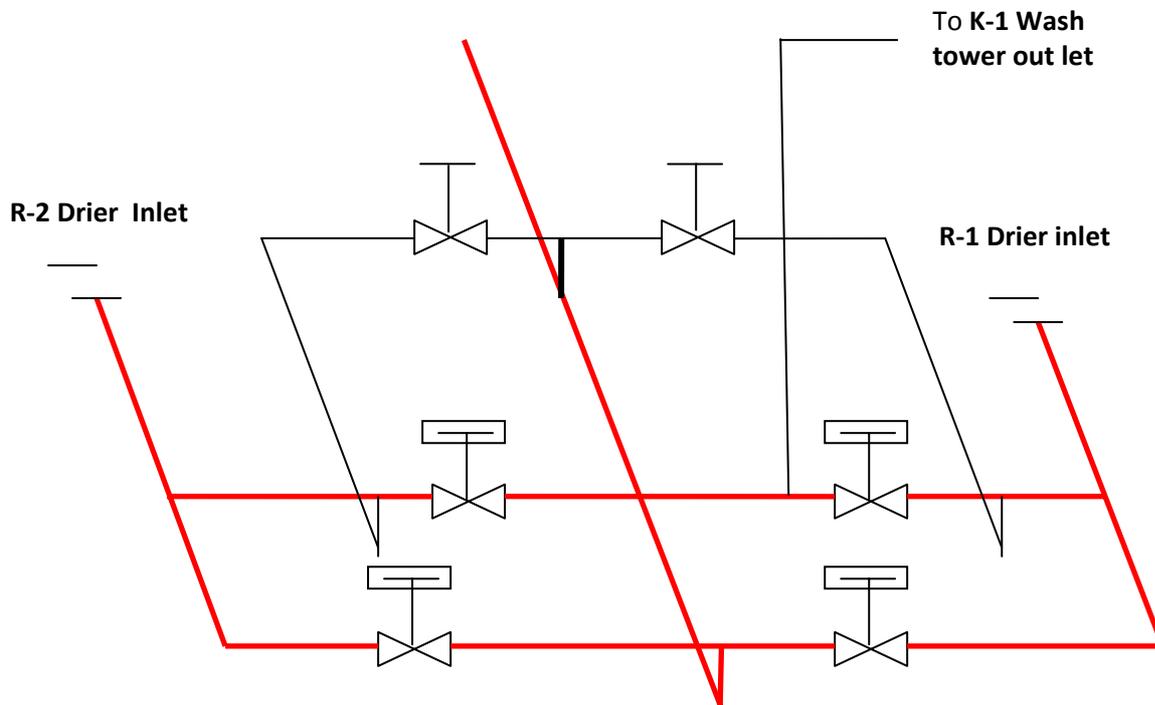
Replacement of Loop NO : 4" TG 04 in PGR

FABRICATION JOBS Replacement of piping in loop between K1 wash tower out let to R1-R2 Drier inlet 100NB X SCH 40 line No 4-TG-04 of PGR. The latest inspection report indicated that the thickness of the 4" line had reduced below acceptable limit. Hence the line was replaced with new 4" X 80 SCH line. Root DP and radiography of each joint was carried out and found OK.

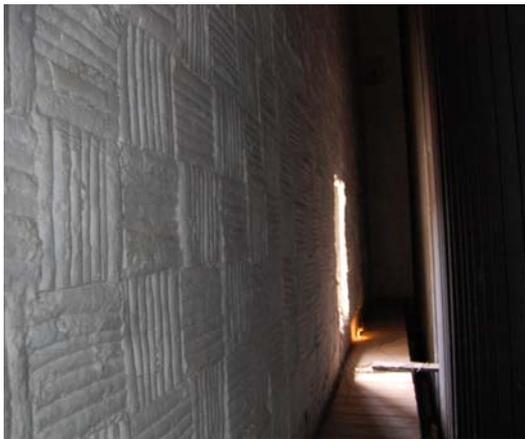
CF Module Insulation on Wall No 3

The Temperature survey was carried out on outside of wall of Primary Reformer after installation of CF 'Z' section Modules and found in the range of 90 deg C to 110 deg C.

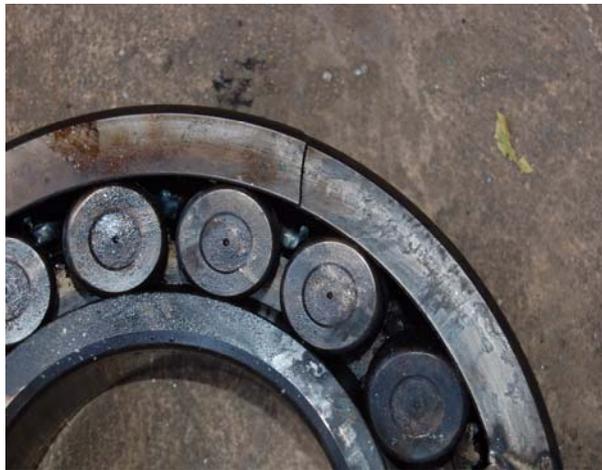
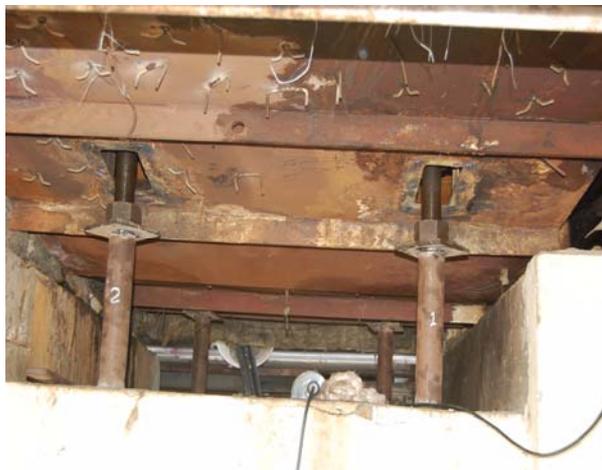
Fig. 26 (a), (b) & (c) Damaged RAH Hot End Bearing
