IFFCO

KALOL UNIT

PLAN TURNAROUND REPORT

(MARCH – APRIL – 2012)

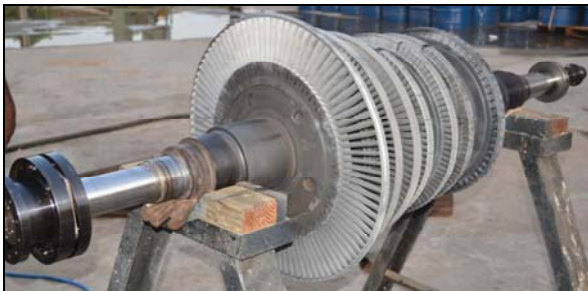
Turbine was decoupled and taken for major overhauling. The top casing was removed and all axial clearances were measured. The rotor was removed and taken for inspection. Very heavy silica deposits were found on the blades of the rotor as well as the diaphragms. These deposits were removed by sand blasting. Deep scorings were also observed on the parting planes of the diaphragms and on the top casing diaphragm seating area. These were repaired by welding and filing. The magnetism level measurement of the complete rotor assembly was carried out and found to be within limit. The hand valve spindles were made free and the total travel of each valve was measured and found to be in the range of 27-31 mm.

103-JBT ROTOR CLEANED BY SAND BLASTING

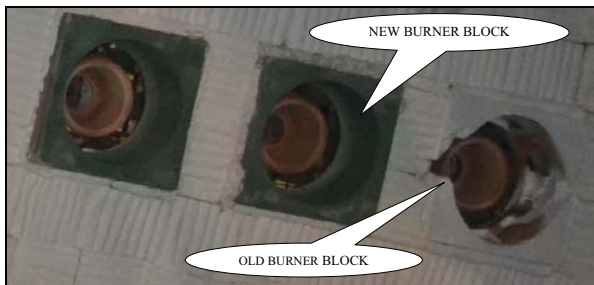
The roof insulations were inspected and damaged ones were replaced by new ones. The wall insulation was found to be in good conditions. 04 Nos. damaged Tunnel slabs were replaced by new ones. Damaged header insulation were replaced/ repaired. Preventive maintenance of all Tunnel Burners were carried out.

NEW BURNER BLOCKS

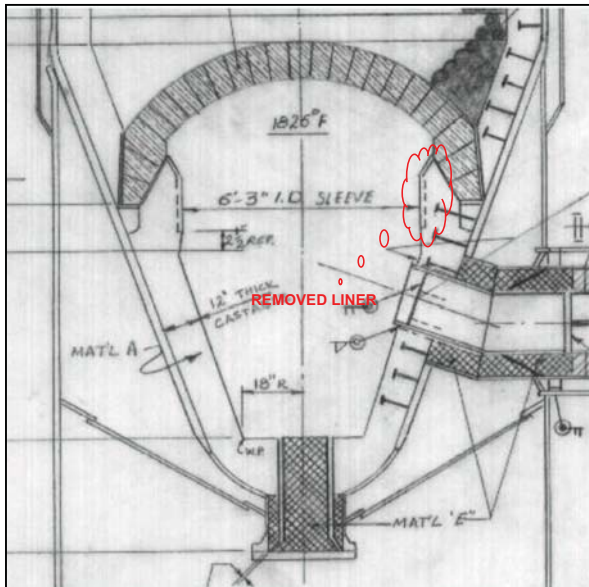
103-D BOTTOM REFRACTORY LINER

Bottom cover was opened for removal of the bottom refractory liner as highlighted in the sketch. This 6 mm thick incolloy liner were cut & removed completely.

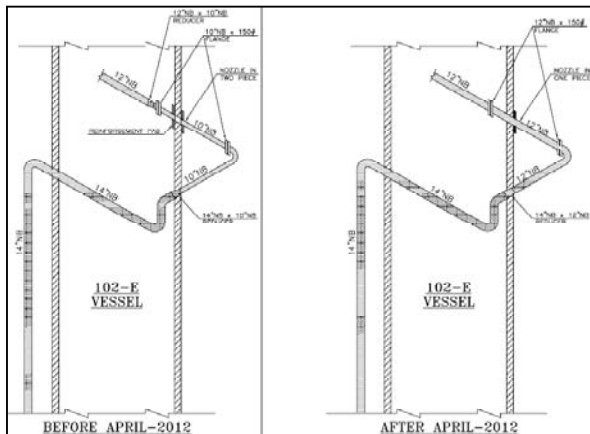
102-EB INLET NOZZLE MODIFICATION

nozzle of size 10". Inside the vessel the distributor was of size 12" which was reduced to 10" and connected to the 10" flanged end nozzle. Heavy vibration was being observed in the vessel due to this reduction in inlet line from 14" to 10". Further this nozzle was in two pieces and welded to the shell on either side leading to leakage. (Refer sketch). Hence the 10" inlet nozzle (Two piece) was replaced by new 12" (Single piece) nozzle. A larger diameter reinforcement pad was provided on the outer side of the shell. The shell had SS lining and to increase this nozzle opening diameter plasma cutting was used.

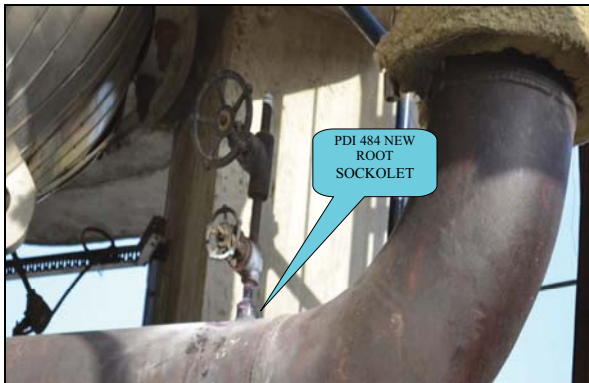
108-D outlet line "Drain Tapping" near 107-C

Root sockolets was leaking from weld joint and reinforcement pad had been provided to arrest the leakage. This pad was removed and DP was carried out wherein parent material failure was detected. Hence a 6" long pipe was replaced by new one. New imported sockolet was provided on this new pipe. De-hydrogenation, preheating & PWHT was carried out as as per the previous job.

Temperature : 704 to 760 ° C
Soaking time: 02 Hour minimum
Heating Rate : 200 ° C / hr. max
Cooling Rate: 200 ° C / hr. up to 300°C, then natural cooling under asbestos.
Loading : 200 degree C

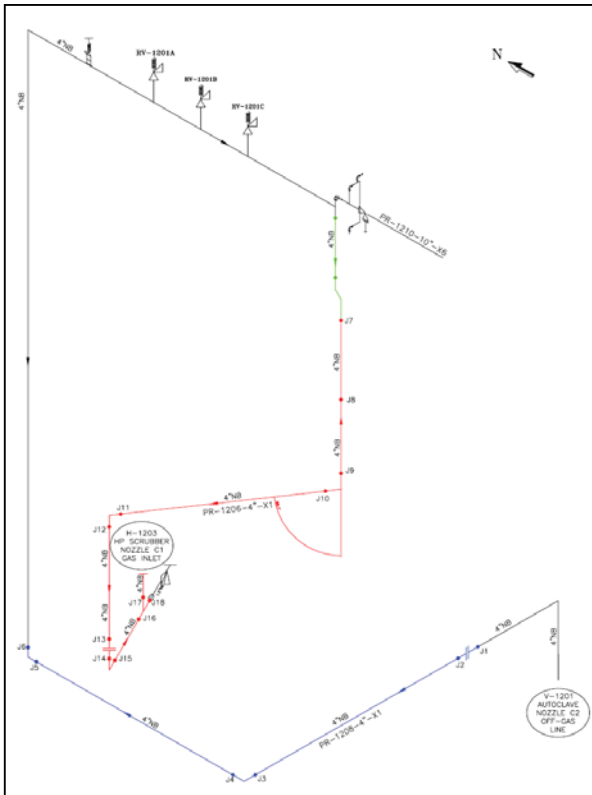
On 15th December 2012, offgas line of V-1201 (line no. PR-1206 - 4" - X1) was punctured at elbow (4" X 120 Sch, 45 Deg., SS 316L Urea Grade, 1st elbow from top marked with arrow) near HP scrubber (H-1203) due thickness reduction. Forced shutdown was taken for repairing the puncture due to its position. Line (shown by green color in figure) was replaced with new one.

It was decided to check the line thickness from off gas line of autoclave to H-1203 bottom during forthcoming shutdown-2012.

Due to thickness reduction, it was decided to replace line (PR-1206-4"-X1, shown by blue color) from J1 to J6 departmentally

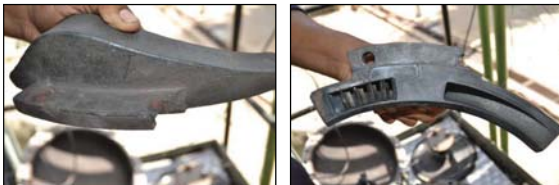
Old Cracked and damaged Reversing Chambers

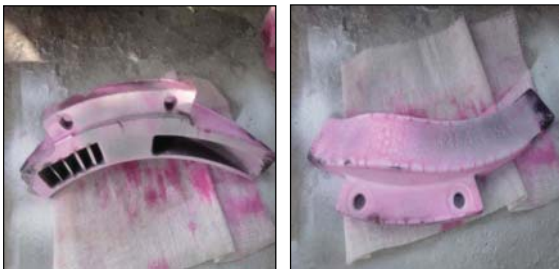
Old Cracked reversing Chambers

- Following clearances were maintained during fixing of reversing chambers
 Front top Reversing chamber & Wheel clearance = 0.90 mm
 Front top Reversing chamber nozzle clearance = 1.55 mm
 Front side Reversing chamber & Wheel clearance = 0.80 mm
 Front side Reversing chamber nozzle clearance = 1.80 mm
- Thrust cum journal bearing of the Gear shaft was found in minor damaged condition, so it was replaced with new journal cum thrust bearing and clearances were recorded.

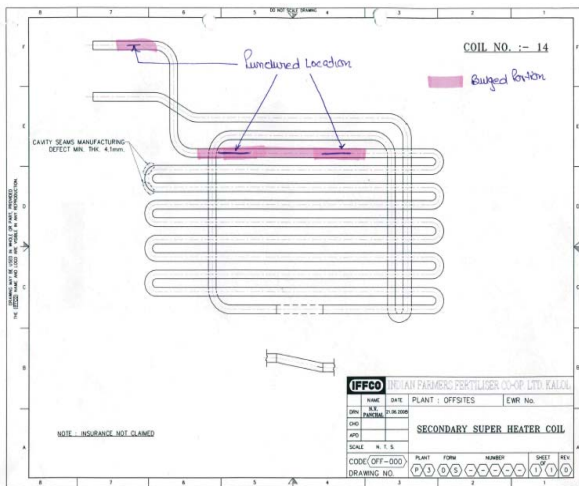
- Boiler was having suspected leak from past some months prior to shutdown. On opening the boiler, top most coil of the Secondary Superheater was found bulged and punctured at several location. (See below sketch)

- Due to leakage of steam, refractory of boiler drum and at some other places were also found damaged.
- So, punctured SSH coil was cut from its header stub joints and removed from the position.
- New spare secondary SSH coil was inserted by cutting one cut corner wall tube and welded with its header stub joints.

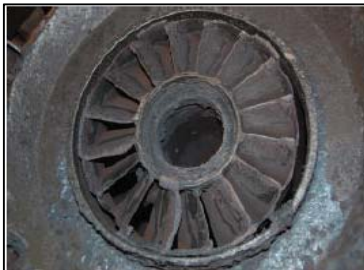
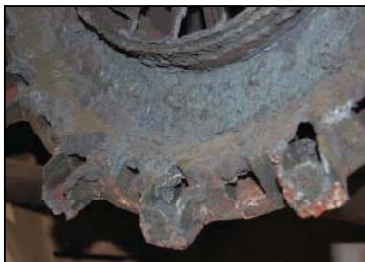
- During the visual inspection Boiler burners in last Annual shutdown-2011, burner impeller and nozzle tips of both top and bottom syn gas burners were found in burnout condition and the same was shown in the attached photographs

- Supplier of the burners M/s Thermax was contacted and finally M/S Thermax was agreed to supply the modified syn gas burner assembly free of cost to IFFCO.
- In the modified burner syn gas burner assembly, main syn gas burner was taken 144 mm back from the main burner level to reduce the heat impingement. Modified burner as per Drawing no. : L11-WR-93361, Rev-0 M/s. Thermax Limited, Pune.
- For the replacement of burn out components of burner, contract was awarded to M/s Thermax Ltd, Pune and for the removal and then re-application of burner refractory another contract was awarded to M/s Ace Calderys.

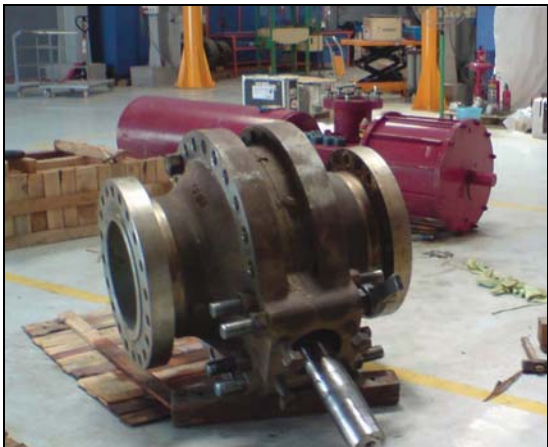
USV-933: Problem of passing was there; the valve was dropped from line and was send to M/S METSO Workshop, Baroda. Passing problem was solved by replacing internal gasket of seat ring. Also, lapping of plug and seat was done. Valve was tested by Air and Hydro-test was carried out. Finally Control Valve was Boxed up & found ok.

USV – 933 Control valve under dismantling

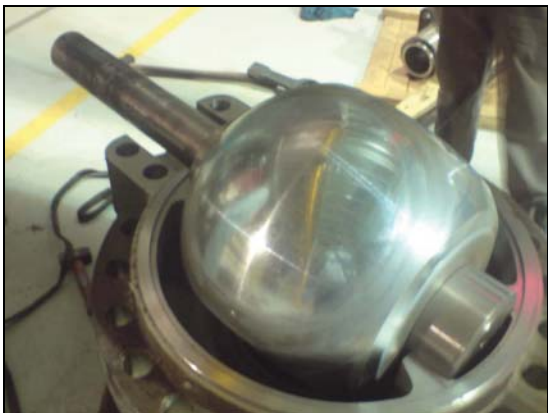
USV – 933 Control valve Plug and seat after dismantling
