IFFCO

KALOL UNIT

PLANT TURNAROUND REPORT

(MARCH – APRIL – 2014)

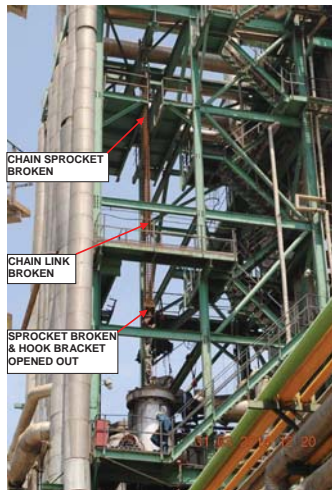
Detail of Chain Pulley Block

- Sprockets, hook holding plates was found opened out which had resulted in detachment of Hook of chain pulley block along with its holding pin.
- One of the links of load chain was found broken.
- Some of the chain guide sprockets were found broken.
- Tube bundle was found fallen inside its shell and when it was removed from the shell several tubes of this bundle as well as tube sheet seal face were found damage.
- Gasket sealing face of shell and tube bundle was found damaged.
- Top layer of cement plaster of two structural column support of the heat exchanger was observed cracked.

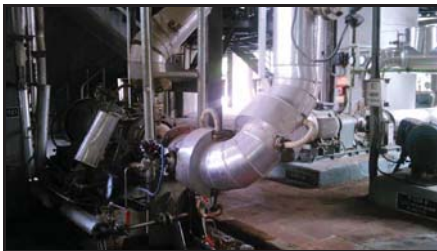
Jacket provision in Melt Pump (P-1408) suction line (liquid outlet of H-1424 to P-1408)

Flanges of suction line (6" x 10 sch line jacketed with 8" x 10 sch line) connected to melt pump (P-1408) was disconnected. Suction line was found in totally collapsed condition. New jacketed suction line was fabricated departmentally and mounted at existing position as shown in below picture.

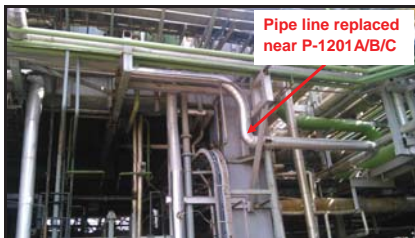
- Pipe line (ASTM A106 Grade B, Size: 6" x 160 Sch) from CO2 compressor to HP stripper (H-1201) was replaced due to the thickness reduction at 3 nos. of pipe clamp support. Pipe line is shown below in picture.

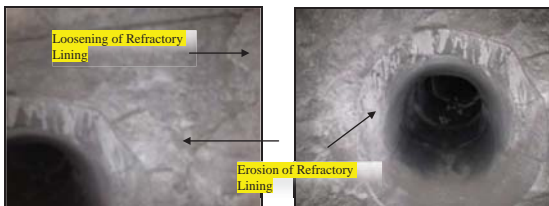
- Gap was observed between the 101-CA/CB gas inlet nozzle liner and the shell refractory joint. Gap of approx 2" was observed towards the 101-CB nozzle. The same was observed in previous inspection also.

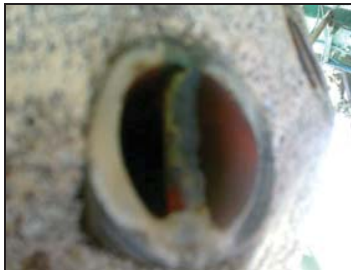
- Insulation cover weld with top cover liner found eroded.
