MTC / REPORT / 01
REPORT NO. 36 / 2016

PLANT TURNAROUND REPORT

(MARCH – APRIL – 2016)

INDIAN FARMERS FERTILISER CO – OPERATIVE LIMITED

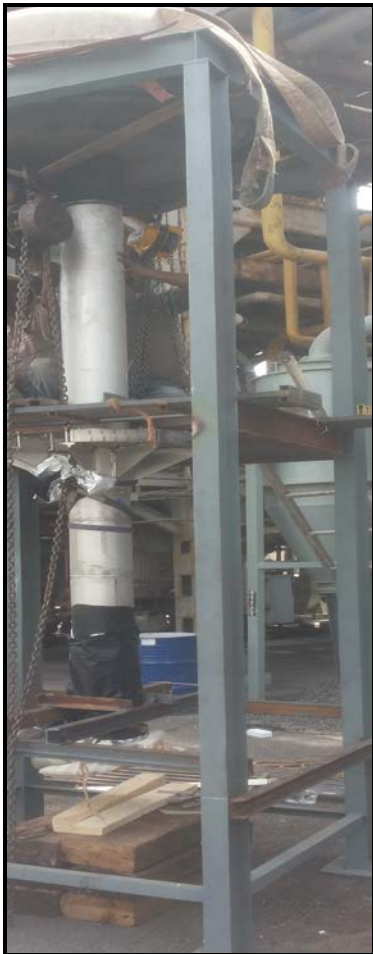
Circumferential ring in L shape welded on bottom of neck of 103-D

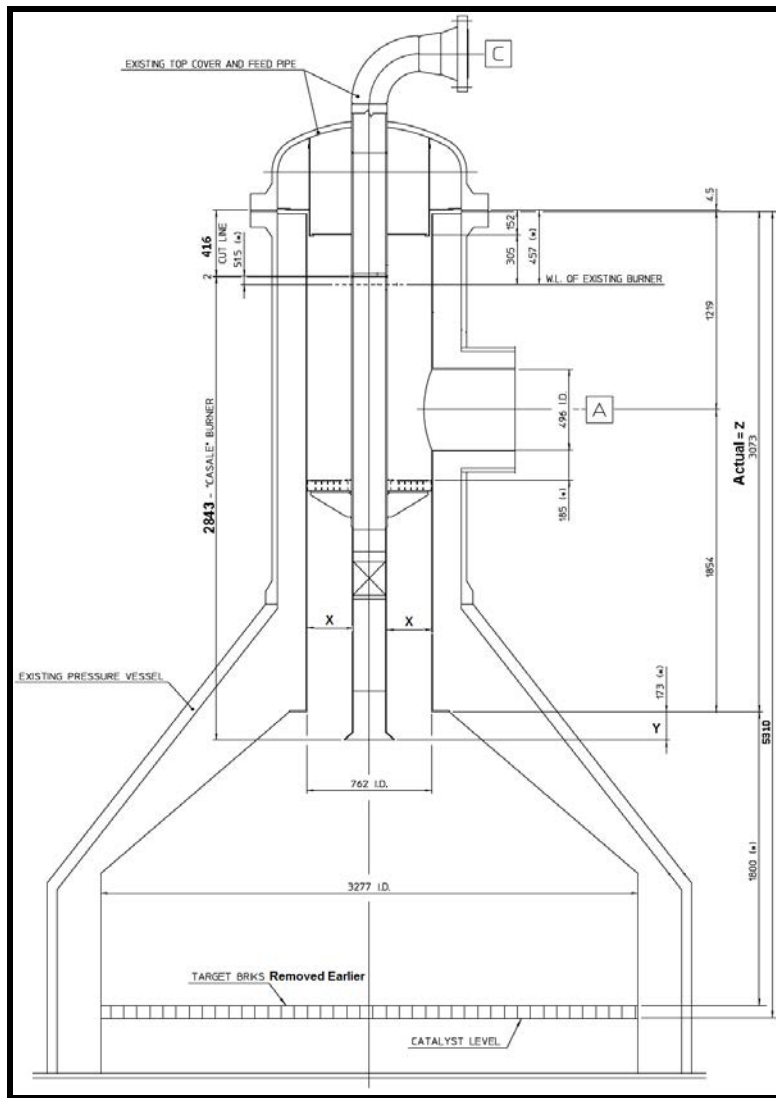
Sketch C - Checked Dimensions

- Then Lifted and positioned the burner at the top of secondary reformer 103-D. The verticality of the burner was checked from inside and following dimensions were noted. (Dimension "X & Y" in the Sketch C)

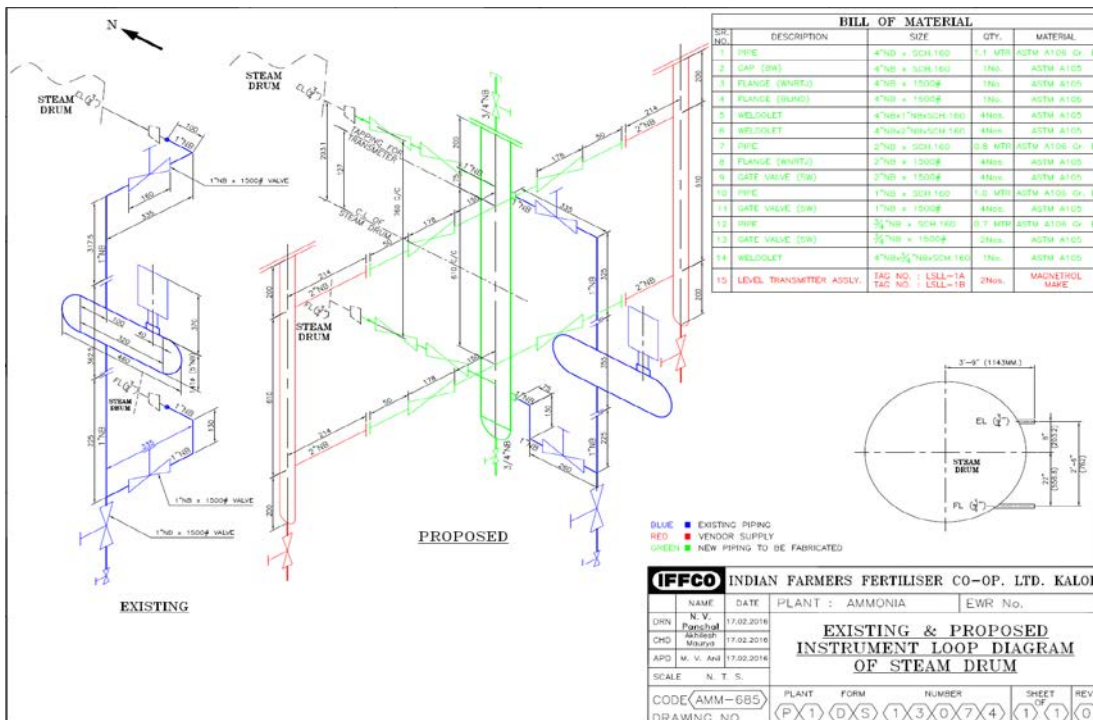
2oo3 Level Transmitter Assembly on Steam Drum, 101-F

- Fabrication of Stand pipe (MOC: Carbon Steel) and associated piping for installation of new Level Troll on Steam Drum, 101-F. Ref Drg. No. P1-DS-13074 the following jobs were done:
 - Fabrication of standpipe (4"XSch160) as per the Drg. No.P1-DS-13074 Rev.0
 - Dismantled mounted level transmitter,
 - Cut & removed the existing pipe connection with steam drum.
 - Connected pre-fabricated stand-pipe (4") with extended pipes from steam drum & installed 2 nos. new Level Transmitters & 1 no. old.
 - Modification of Platform carried out to accommodate the new installation. Inspection: Butt joints - Root & final DP; 100 % Radiography; Socket joints - Final DP.
 - Obtained all IBR certifications (i.e. Material Identification, Approval of Fabrication job, Approval of Final as built Drawing).

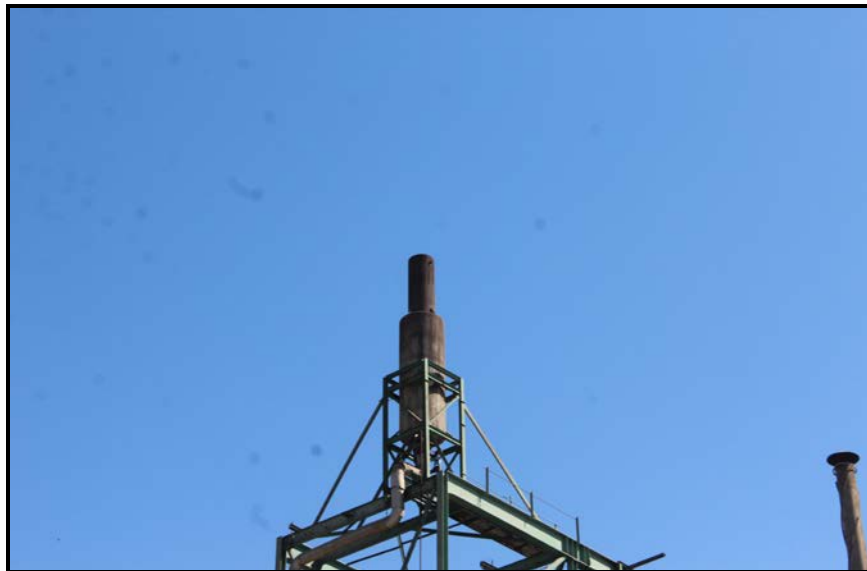
Old Vent silencer, SP-73 (Make: Burgess Industries, Texas, Model: BMSV-36) was brought down in Annual Turnaround 2015 for carrying out Aluminizing of external surface. During Inspection, internals of old Vent silencer, SP-73 was found damaged. Hence, New Vent Silencer, SP-73 was procured from M/s. Flo-Dyne Controls (India) Pvt. Ltd., Mumbai vide PO NO. 201004161033 Dated 09/12/2015 and installed in Annual Turnaround, 2016. The erection job was done by M/S J&J through contract for the opening & box-up of Heat Exchangers. Removal and erection was done using Kobelco crane. Top Canopy at the Silencer outlet was removed before erection as this may restrict the discharge flow.

OLD SP-73 INSTALLED AT SITE

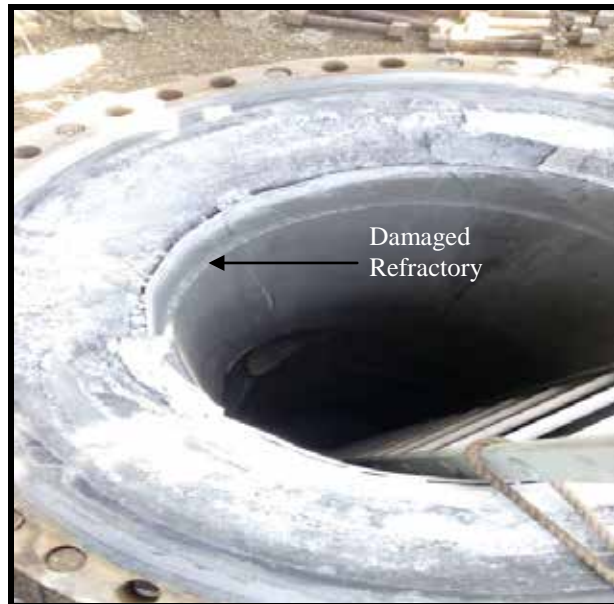
- Near top flange refractory found damaged creating gap between liner and refractory.

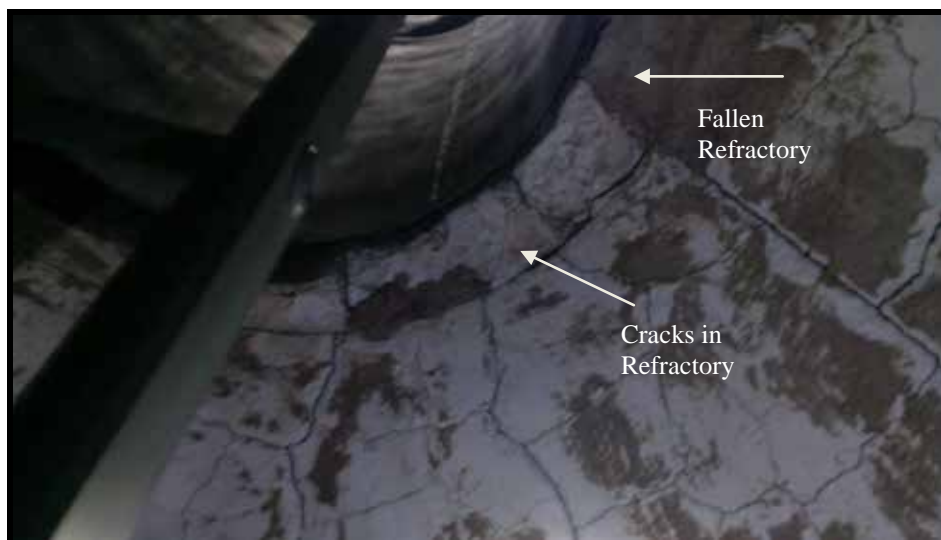
- At scattered locations cracks observed on refractory lining of the shell and cone.
- One segment of shoulder refractory on top of the cone to top-passage junction was found damaged.

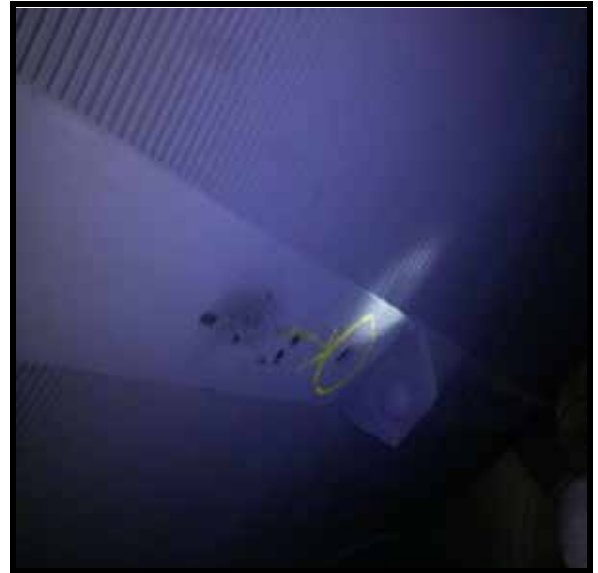
- 02 nos. Demister Pad holding plate found sheared at the top. (Same were marked with yellow chalk)

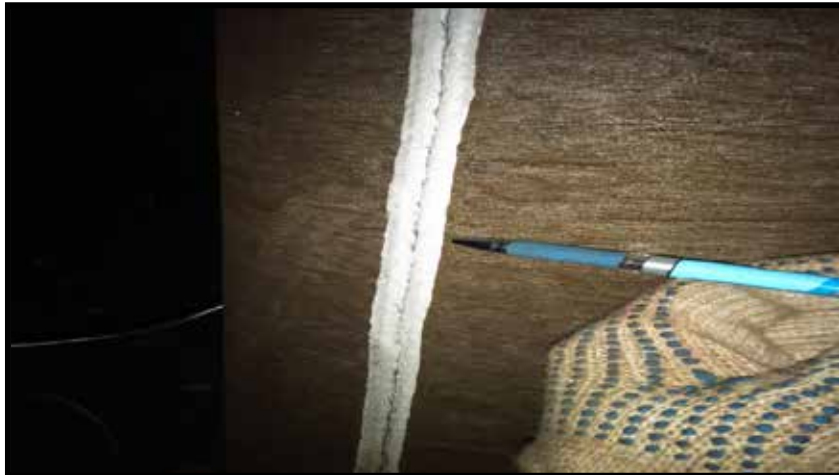
- Roughening of tray holding clits and grayish brown oxide layer was observed on bottom side of trays same was observed during previous inspection.
- 01 no. of tray holding clit was found blackish in color and having severe corrosion attack including its welds, same observed in last inspection.
- Due to corrosion / erosion of trays, cavities/gaps were observed between tray and it’s welding with annular shell liner plate.
- Overall tray corrosion is high in first compartment.
- Down comer found dark brown in colour and rough in surface.
- Sharp welding edges formed on down-comer welds due to its erosion.

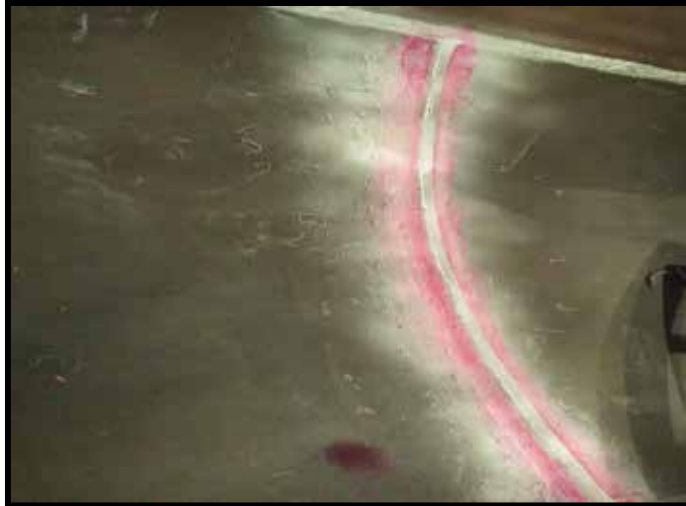
- 03 nos. petal welding observed rough /porous, marked with yellow chalk which were repaired by M/s Ganesh Engg. and found satisfactory in D.P test.

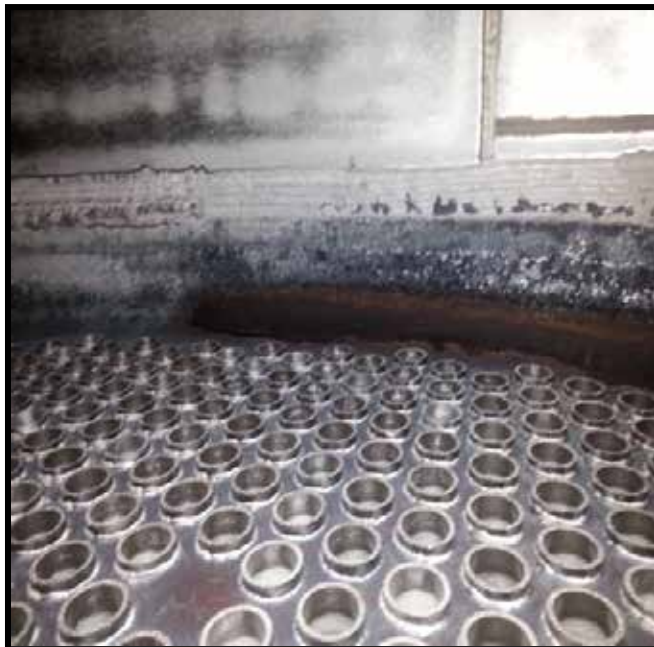
- The condition of sealing face was found satisfactory.
- The overlay welds in the man way were silver and slightly etched.
- Dark brown patches observed at periphery of tube sheet at scattered locations.

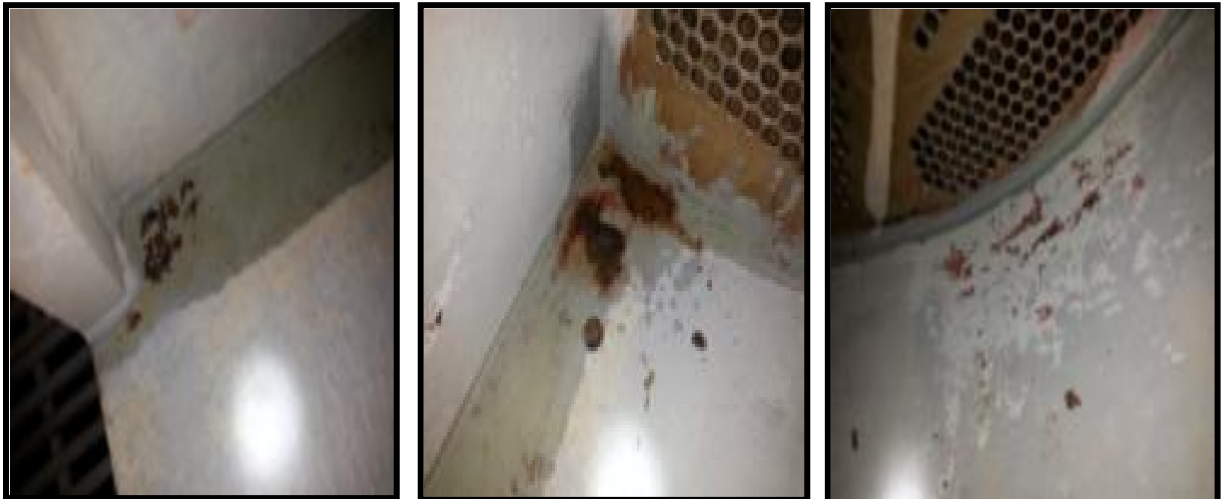
- Tube sheet was found in satisfactory condition.
- Epoxy coating was found peeled off at few locations and initiation of rusting/corrosion observed at such locations.

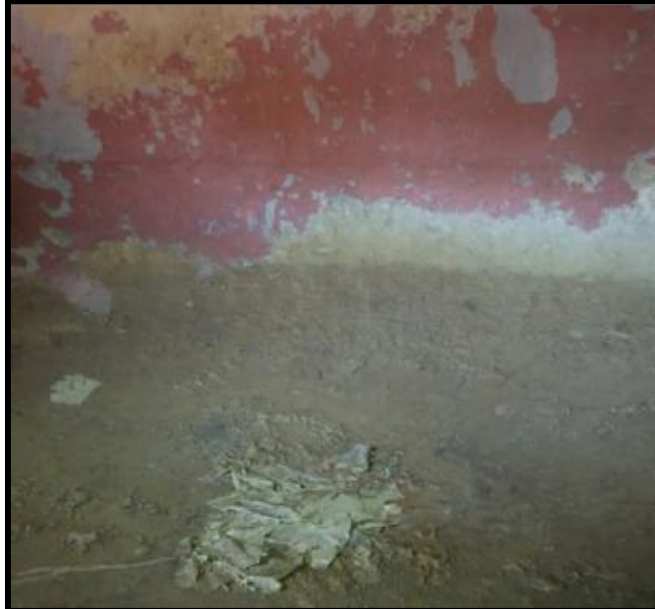
V-1101 (CO2 KNOCK OUT DRUM)

- Epoxy paint was found peeled off from few locations in bottom dish end and shell also.
- Demister pads were found satisfactory.

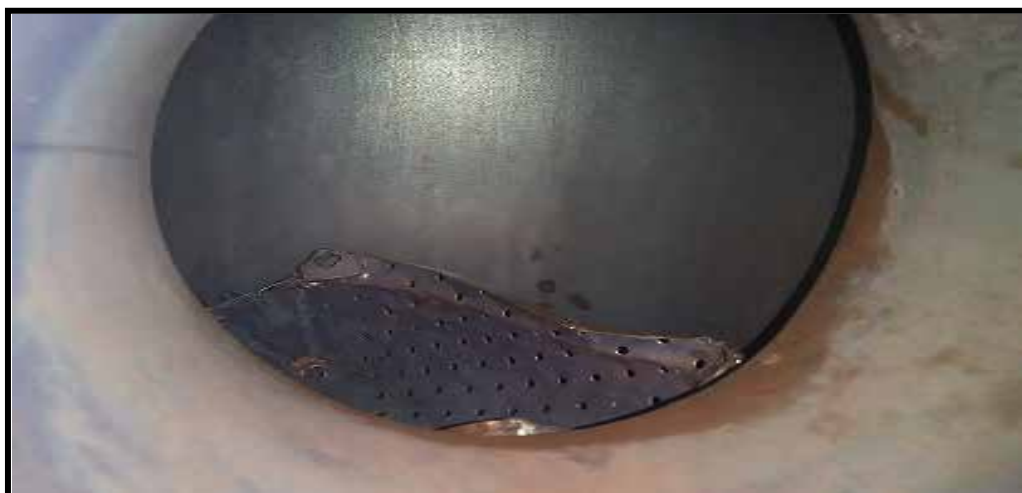
- Perforated tray observed detached & lying in-between / stuck-up in shell.

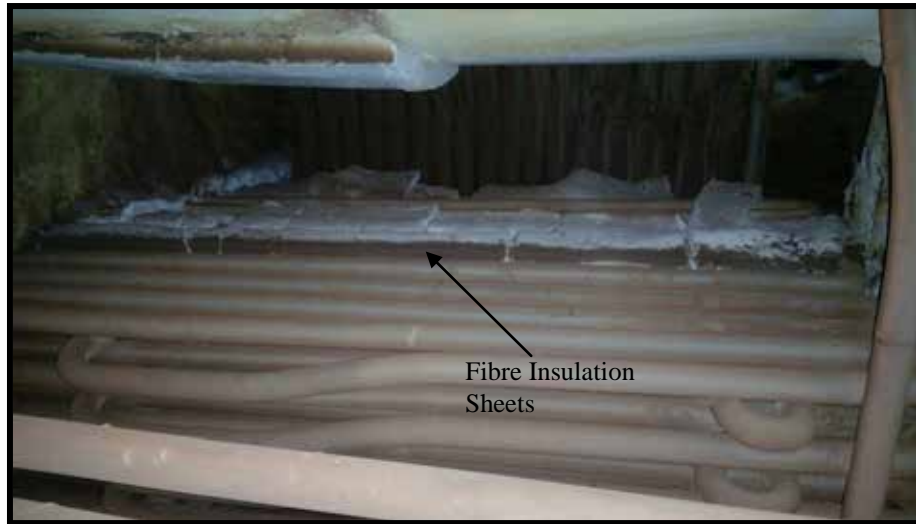
- Minor rust and scaling was observed on South wall, Front panel, Rear panel, Cut corner tubes and baffle wall tubes.
- Floor refractory was found damaged & loosened at some locations.
- Condition of thermo-wells found satisfactory.
- Condition of refractory around the burners was found satisfactory.
- Minor scaling was observed on Primary Super heater tubes.
- Insulation fiber modules placed on top of the Secondary superheater coil was found displaced from its location.

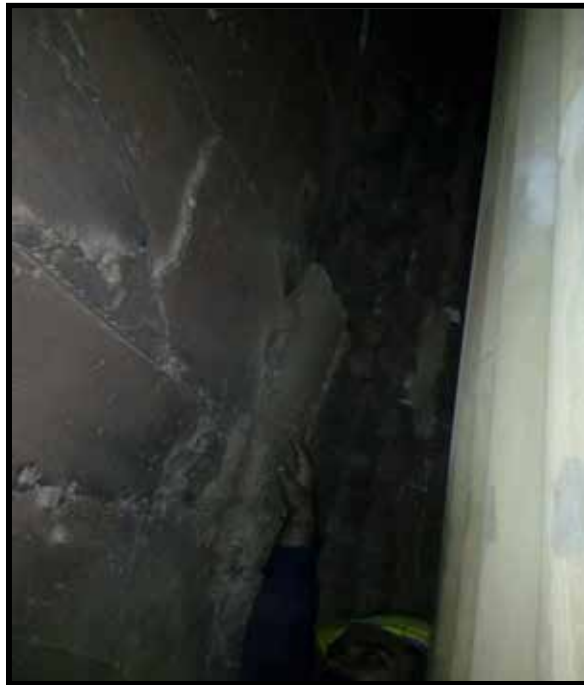
From North Wall Access Door

- Refractory found damaged on roof just above the access door.
- Minor rust and scaling was observed on boiler bank tubes.
- Condition of Secondary super heater coils was found satisfactory.
- Refractory matter was found slightly detached from baffle wall.

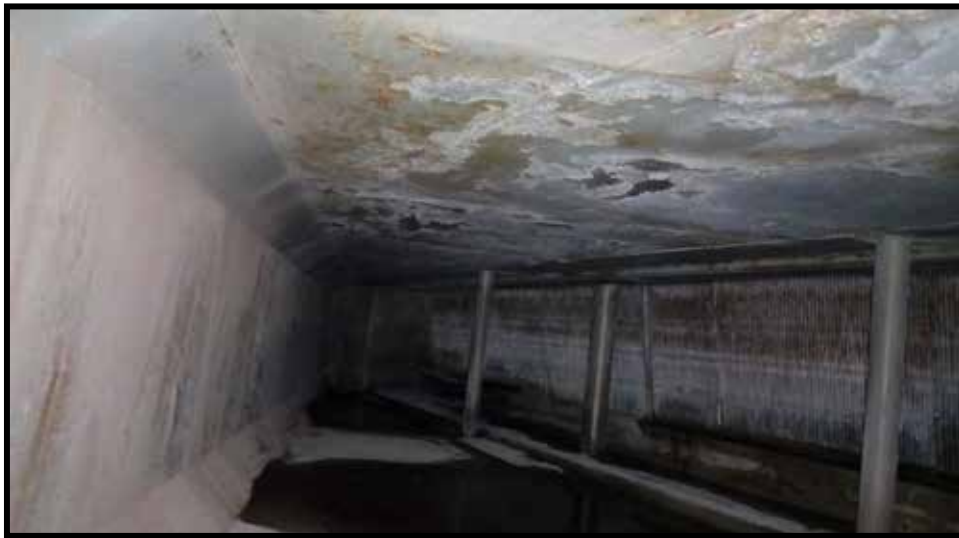
- Painting/ coating of middle compartment roof area was found peeled off.

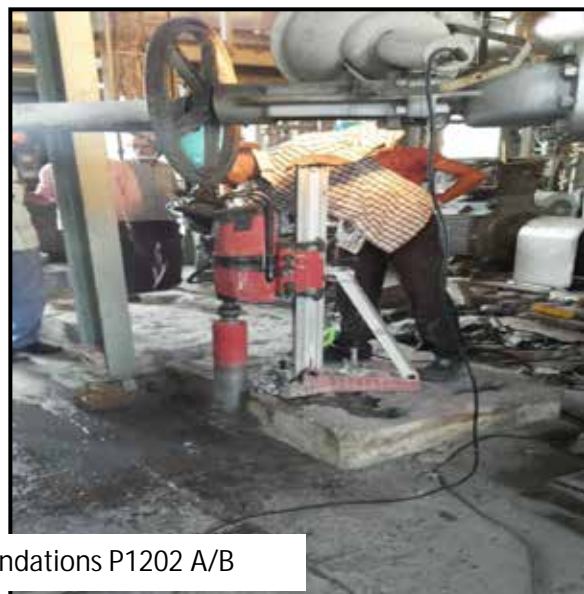
Newly constructed foundations P1202 A/B

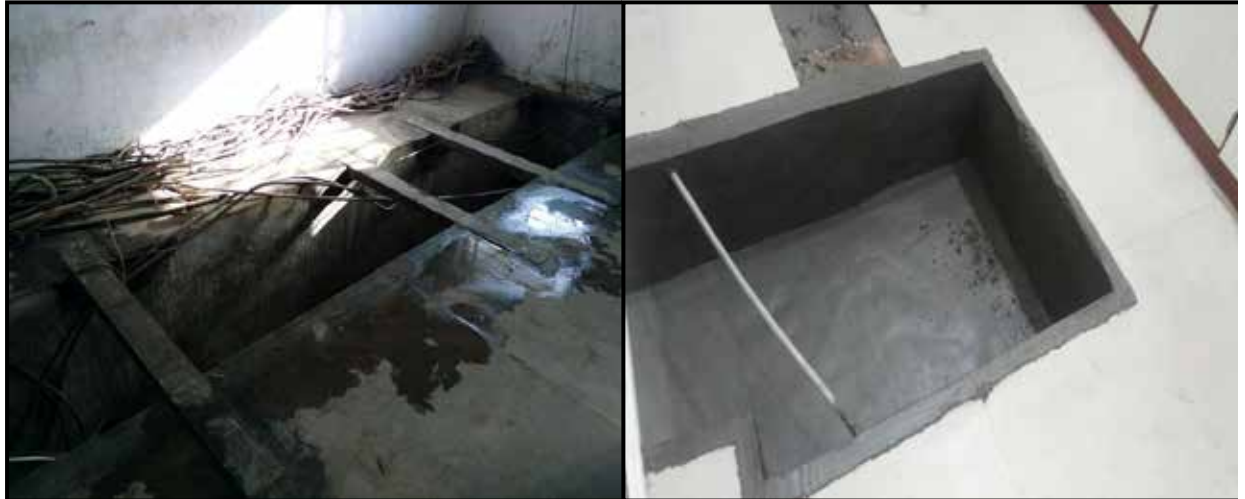
Retrofitting of the damaged surface of the cooling tower sump basin.
