KALOL UNIT

PLANT TURNAROUND REPORT
(MARCH – APRIL – 2017)

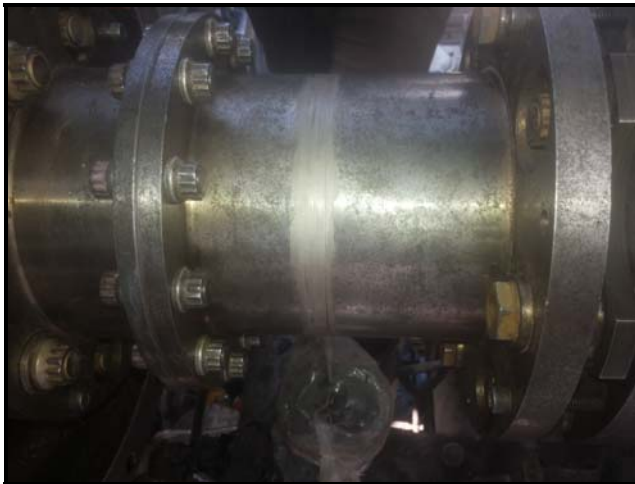
Replaced the Oil Guard (Governor end) as edges found damaged and worn out. Earthing brush was damaged and the holder of brush was touching the spacer, due to which marks were found on spacer.

Marks on 101-JT to JLP spacer

Earthing brush found completely worn out

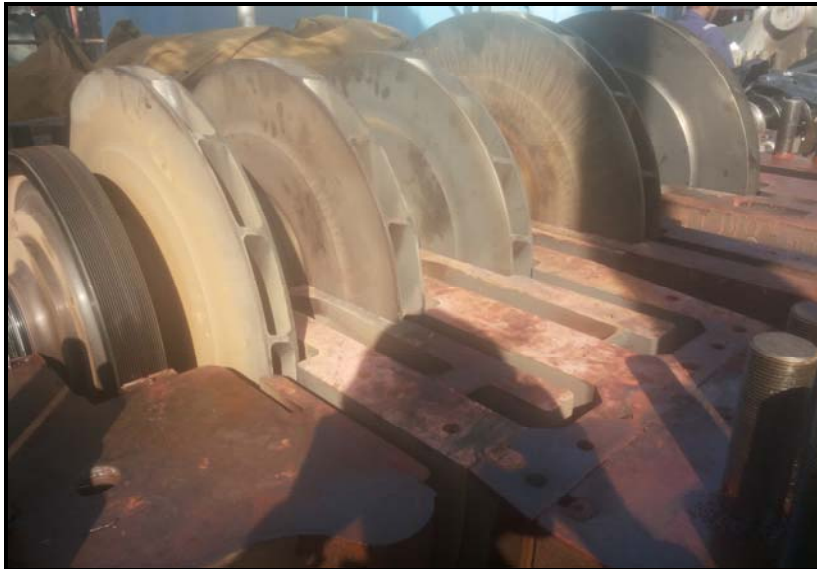
101-JLP was decoupled from both ends. Casing bolts were opened & compressor casing top half lifted by using crane. After opening, it was observed that the condition of rotor, diaphragm and flow path is good and there was no major dust/corrosion in these areas.

Rotor after removal of top casing

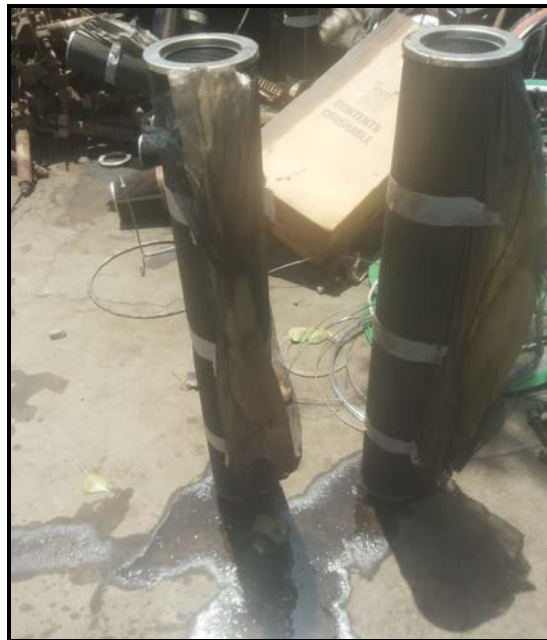
Damaged Filter cartridge of 101-J LO Console

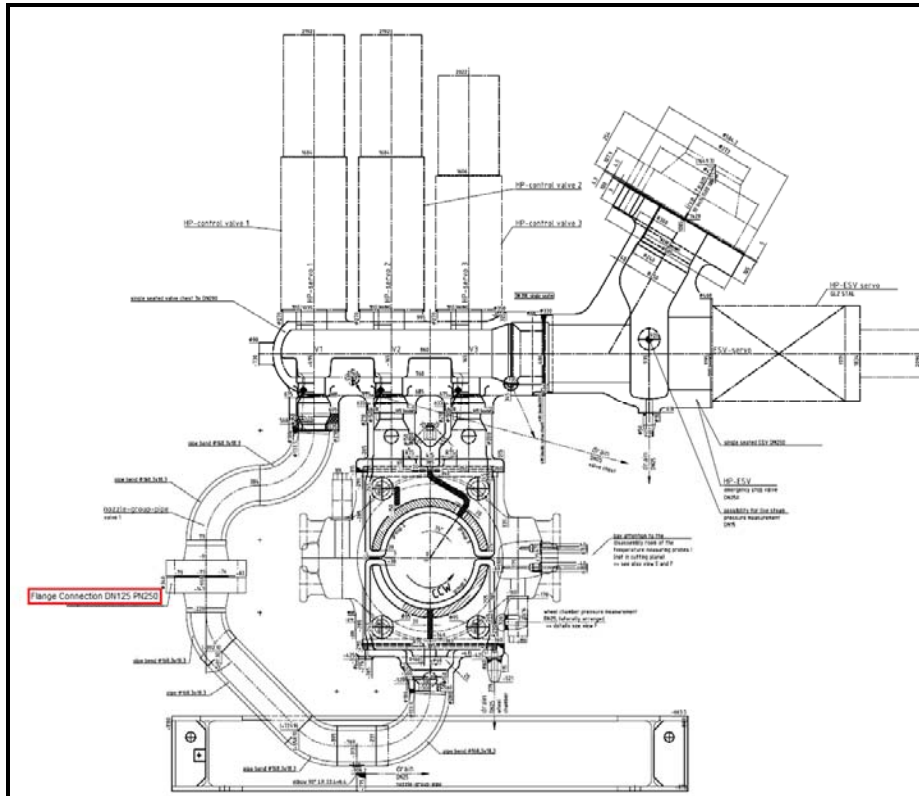
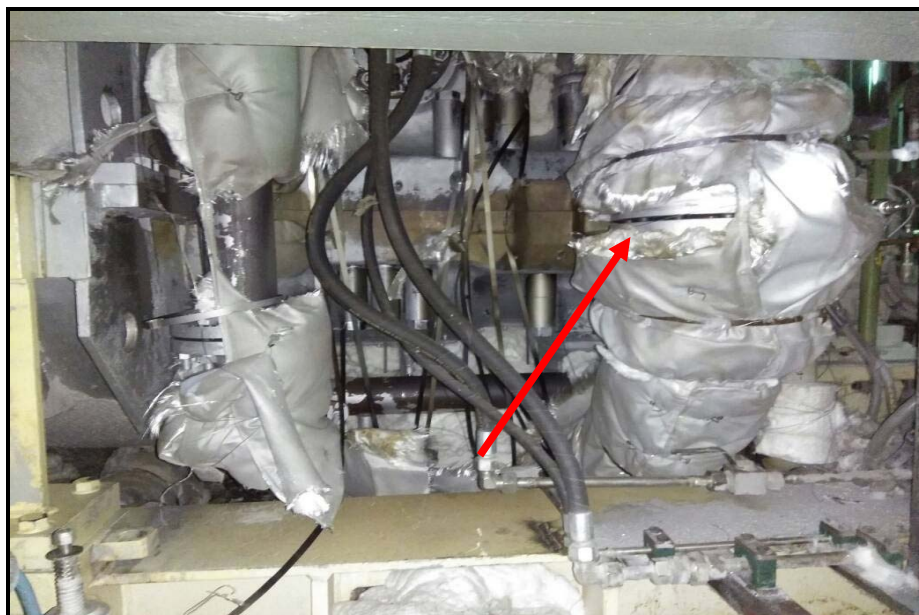
- On 11/05/2017 when turbine was started after attending cooling water leakage problem, the gasket of pipe joint from steam chest to turbine (CV1 valve downstream) got burst. Damaged gasket (Serrated Gasket, Size: DN125 PN250, MOC: SS316) was replaced.

Flange marked in red color leaked during startup

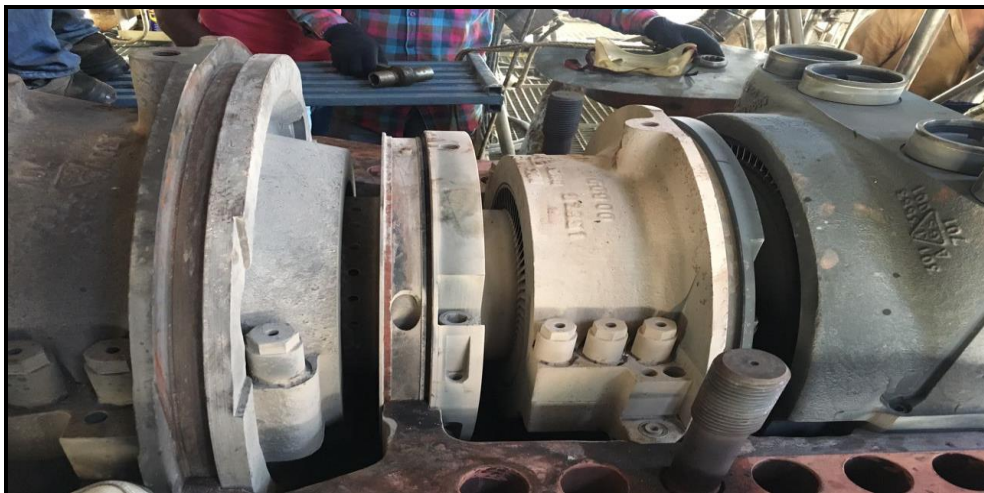
- Removed bottom halves of all three Guide blade carrier, steam chamber and inner gland one by one front side to rear side.
- Scaling was observed on fin area of rotor specially at area of 23 ata extraction steam.

Scaling observed in above picture

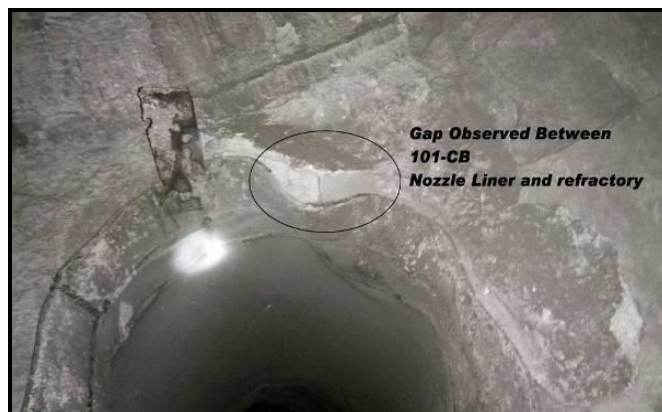
- The liner inside the 101-CB gas inlet nozzle was slightly buckled /distorted. Condition of the thermo well was found satisfactory. Same was observed during previous inspection also.
- The liners inside the 101-CA gas inlet nozzle were found slightly buckled /distorted. Insert liner condition was found satisfactory. Thermowell found detached / missing.

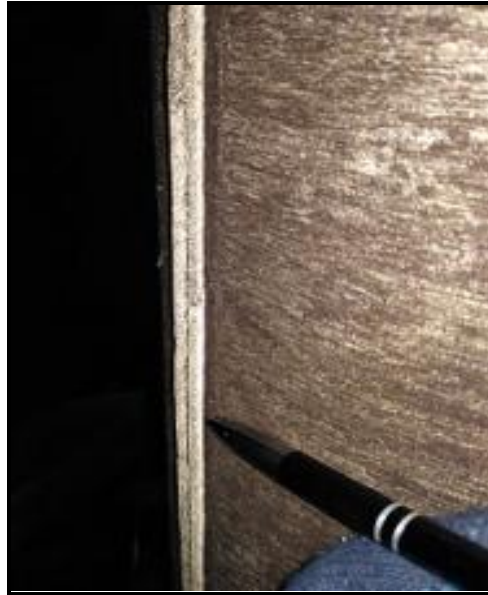
- Previously repaired defects found satisfactory.
- “C” Seam and “L” seam welding found satisfactory

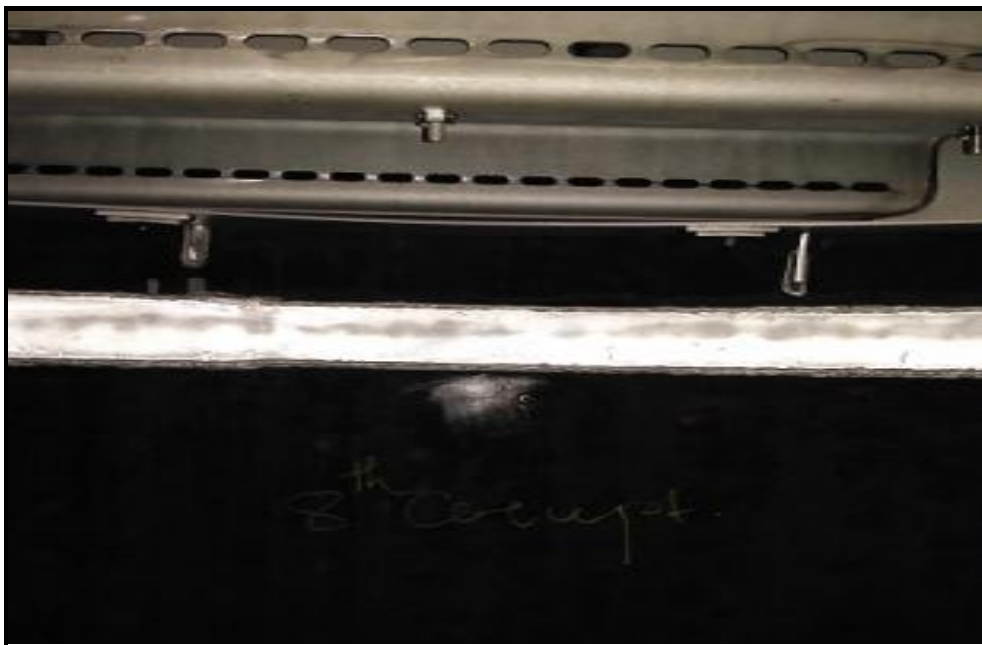
- 04 old cleats (out of 10) having minor corrosion whereas 10 new cleats and its welding observed satisfactory.
- Down comer was observed brown in colour with corrosion in its welding.

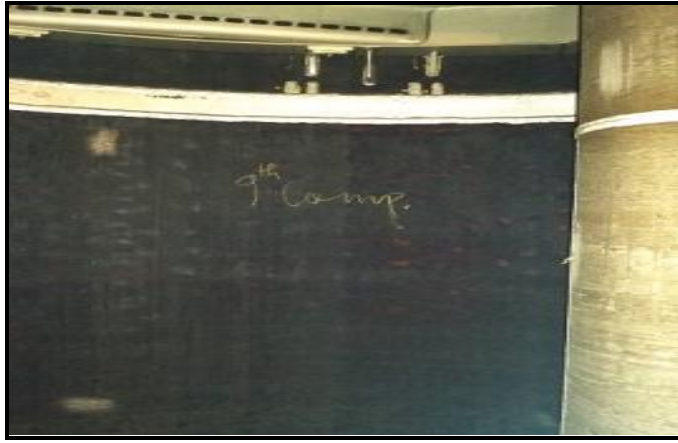
- 10 New and 11 Old cleats and its welding observed satisfactory.
- Down comer was observed brown in colour with corrosion in its welding.

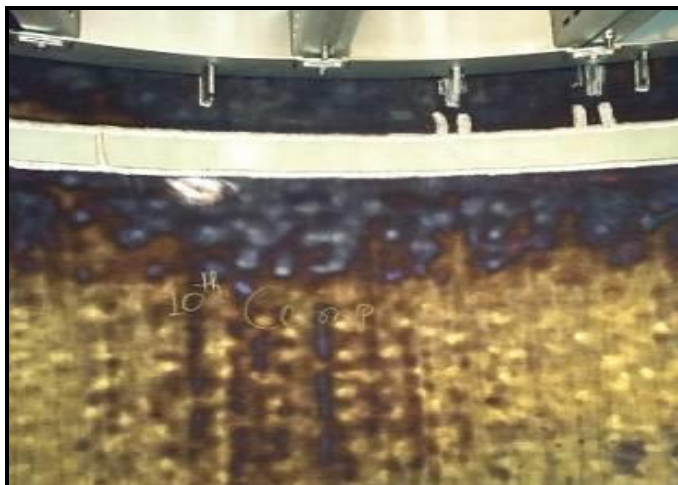
- Shell liner observed brownish in colour
- Previously repaired defects were observed satisfactory.
- 10 New and 11 Old cleats and its welding observed satisfactory.
- Down comer was observed brown in colour with corrosion in its welding.

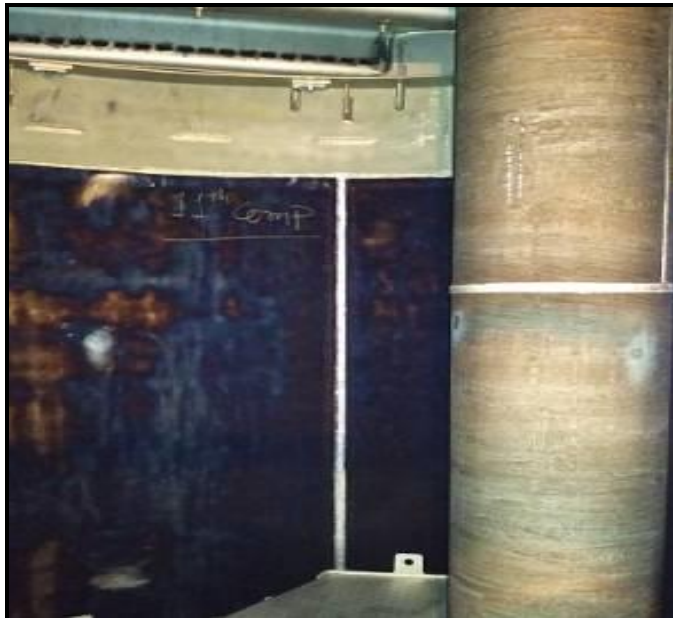
- Shell liner observed brownish black in colour.
- 11 New and 11 Old cleats and its welding observed satisfactory.
- Down comer was observed brown in colour with corrosion in its welding.

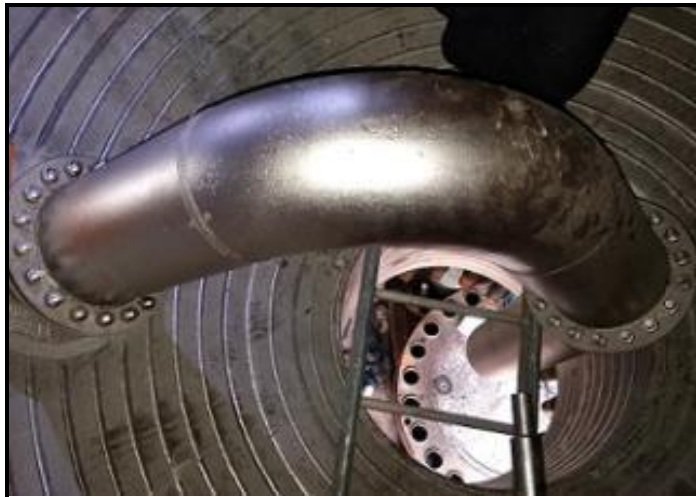
- 01 no. Impingement plate bolt found loose of CO2 Inlet line.

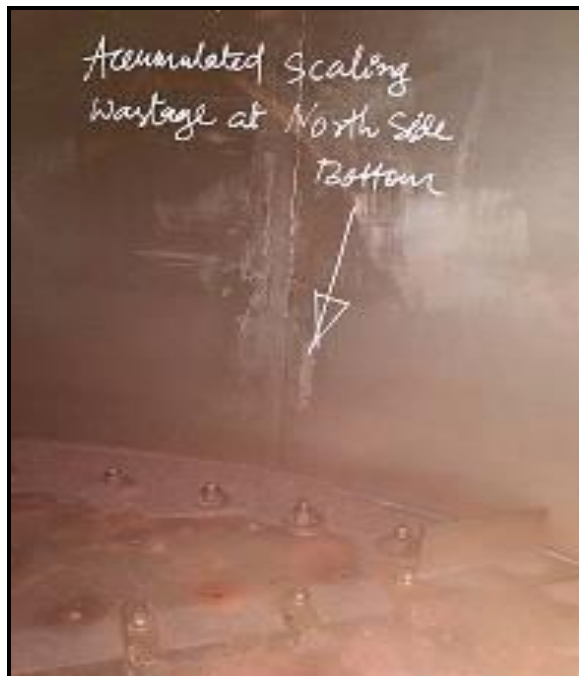
- Brownish coloration was observed.
- Fasteners of sieve tray were found intact in position.
- Trays and its supporting ring observed satisfactory in condition.

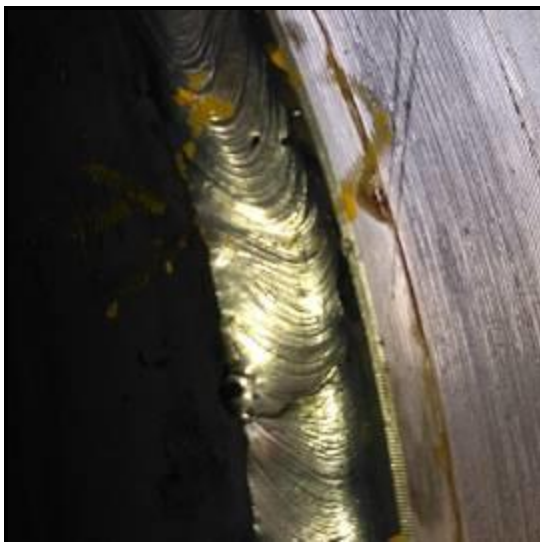
- Overall condition of the vessel was found satisfactory.

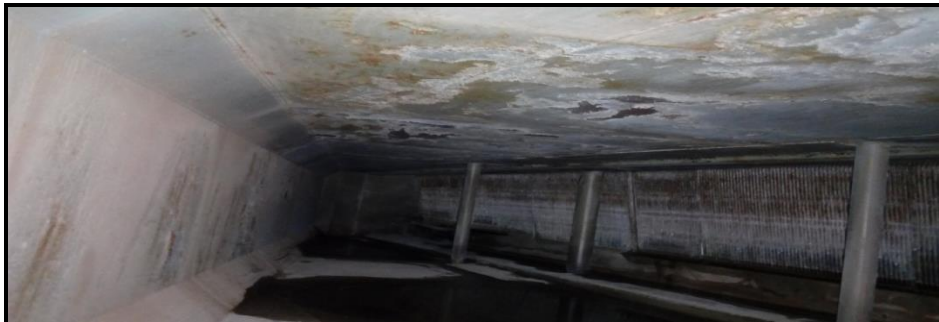
- Minor Peeling off of paint/ primer was observed in top compartment also.
- At rest of the location the Painting/ coating quality is satisfactory.
- Bottom duct bottom surface paint /primer peeled off at several locations.
