KALOL UNIT

PLANT TURNAROUND REPORT
(SEPTEMBER - OCTOBER – 2018)

Plant Turnaround for the year 2018 was taken from **17th Sep 2018** to **15th October 2018** for carrying out ESP Phase III (Energy Saving Project), Preventive maintenance jobs of Static & Rotary equipment.

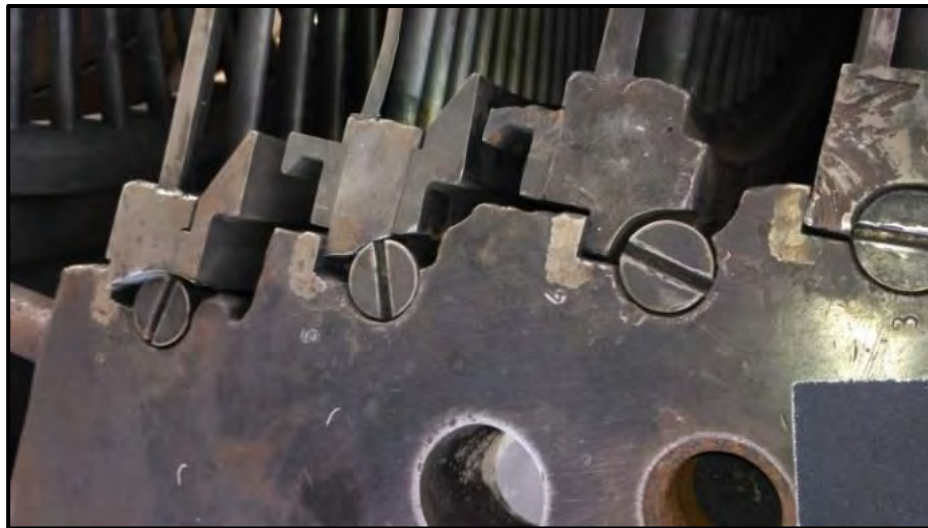
- Moisture rings fixed with the 4th, 5th & 6th diaphragms were found badly eroded.

Replaced 5th & 6th No. Diaphragm by spare

- 5th & 6th no. diaphragms with moisture rings were replaced by spare refurbished diaphragm set. Diaphragm no. 4 couldn't be replaced as it was not seating properly in the groove.

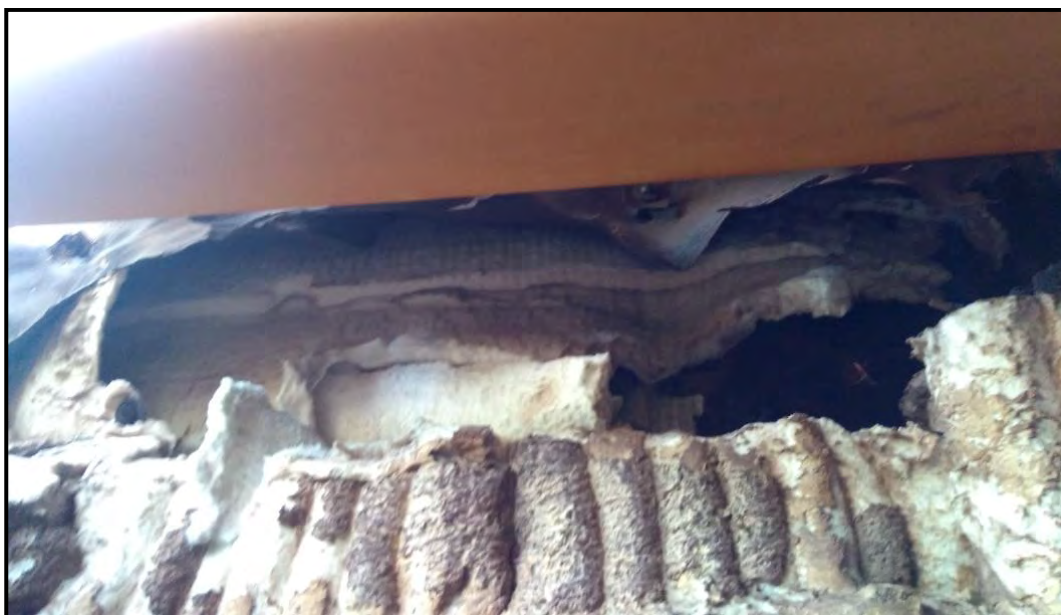
- There was hotspot at South side wall and sparger was provided in this area. It was observed that the insulation of south side wall of MFC was damaged and plate was having hole. The support guide of MFC was removed from position.
- The damaged portion of the plate in this area was replaced and new Ceramic Fibre insulation and incoloy plate was provided. The support guides were also repaired. The castable insulation damaged near Tunnel area was also repaired.

Damaged area of insulation below MFC coil

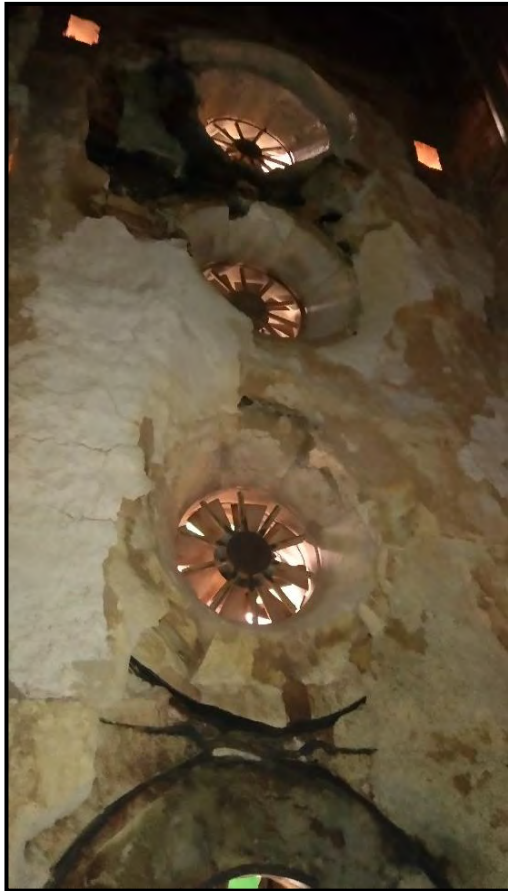
- The arms of Burner # 1, DGN 26 was broken, the lugs was having cracks and burner housing plate was broken at bottom portion.

Damaged Refractory of front wall

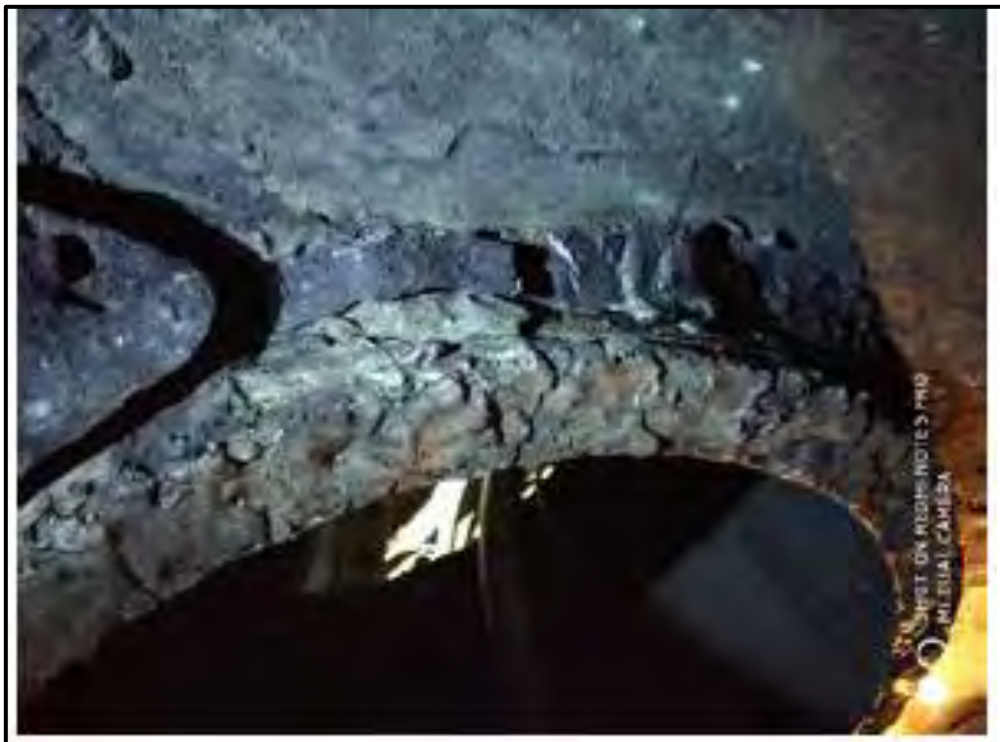
Putty applied on the circumferential weld joint of manhole nozzle with shell from inside was found detached

102-F, Raw Gas Separator: Manhole opened for inspection and then boxed up after applying fresh putty against the detached one on the circumferential weld joint of manhole nozzle with shell from inside. 02 nos. lifted segments of Demister pads from its position in East Side were fixed.

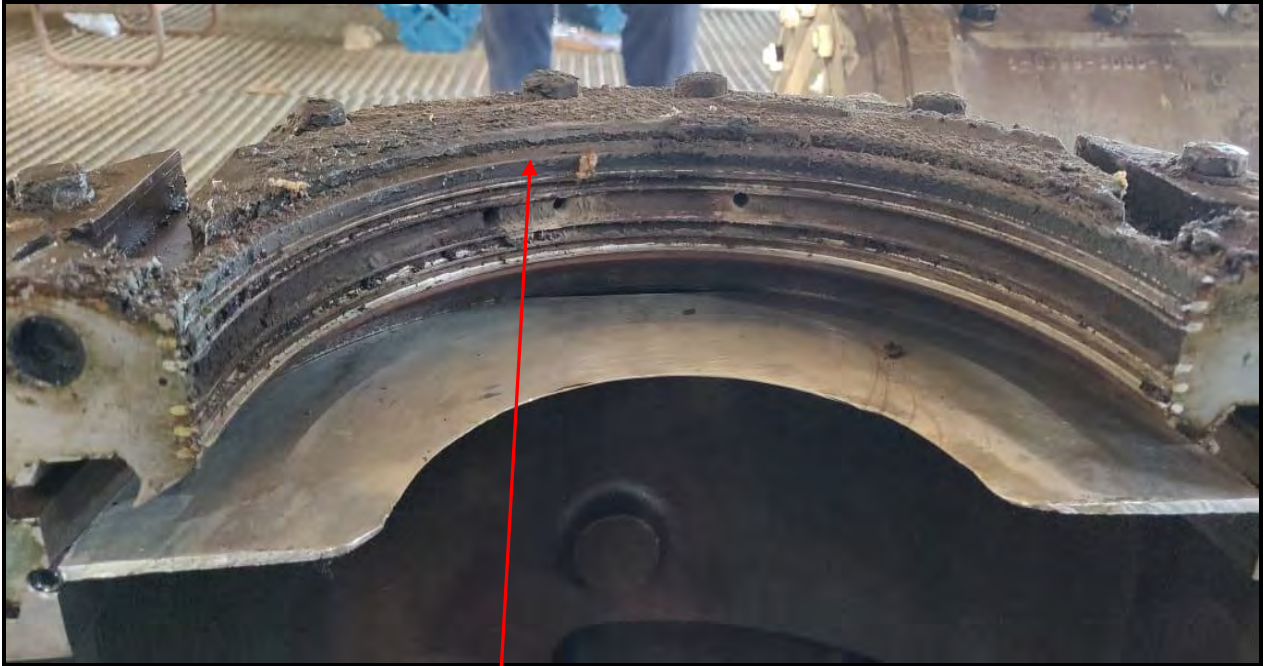
In running plant, frequent spikes were observed in all the four radial probes. The amplitude of these spikes were in the range of 20-30 micron. On analysis, the Baker Hughes/GE team concluded that there was gradual increase in 1X component indication temporary bow of rotor shaft. Temporary bow of shaft may occur due to oil cocking/carburization in oil labyrinth. If due to any reason, steam leaks out from the steam gland & enters the oil seal labyrinth, oil cocking or carburization occurs. With gradual deposition of oil coke, the clearance between shaft & this hard layer of oil coke decreases and at one point shaft rubs the oil coke. On rubbing, a local thermal gradient occurs on shaft creating the bow of rotor.

OIL COKING IN THE OUTSIDE LABYRINTH OF BEARING HOUSING OIL SEAL.

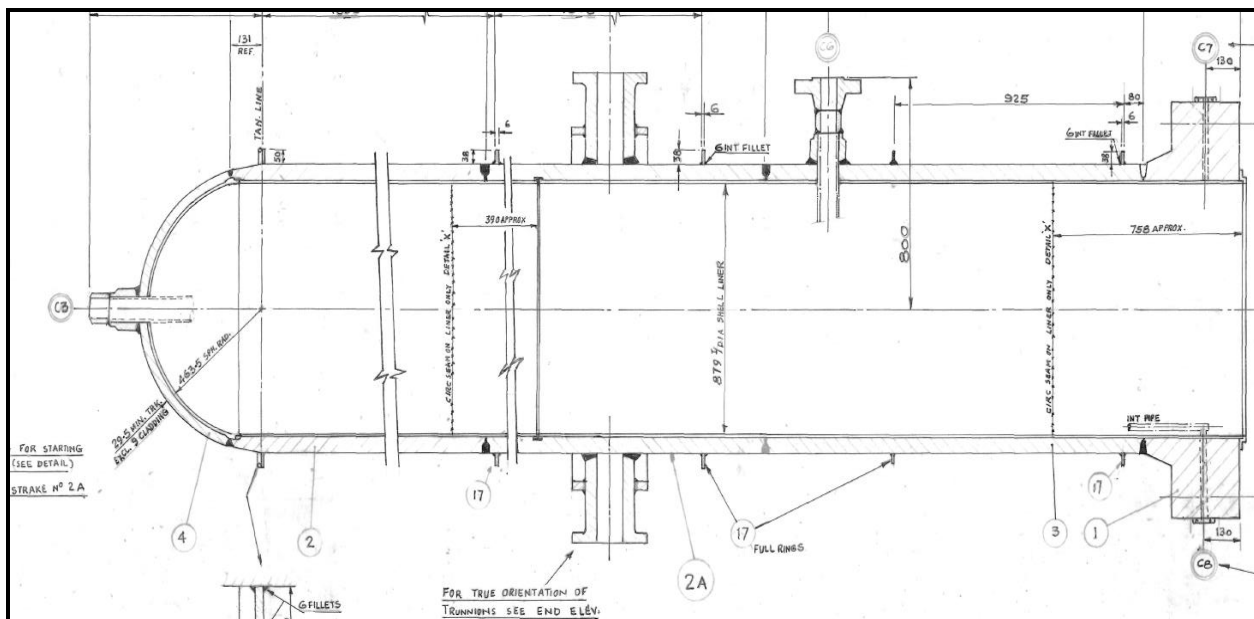
LEAK THROUGH BLIND ON C7 NOZZLE

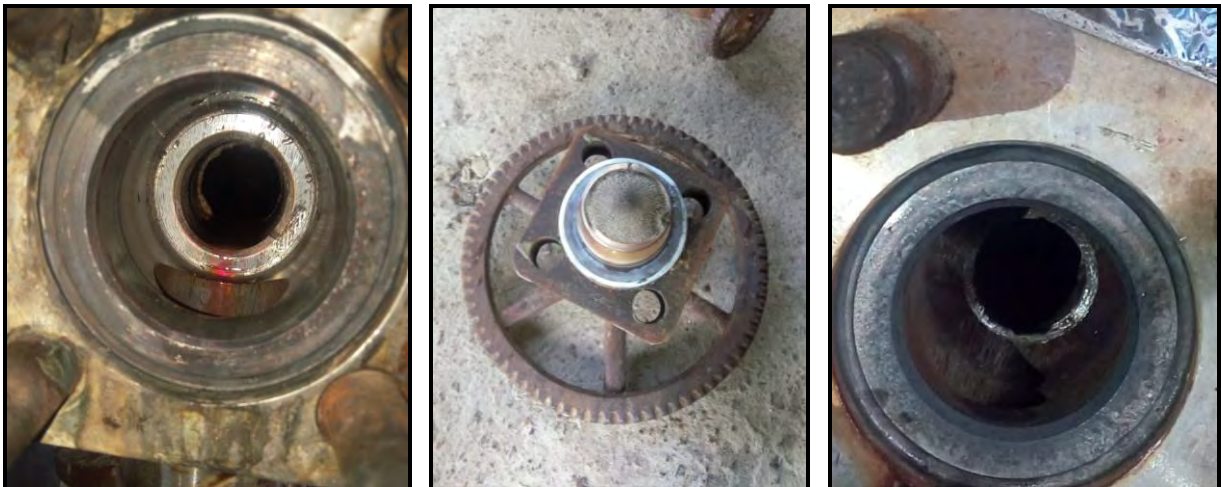
DAMAGE OF AUTOCLAVE UNLOADING VALVE SEAT & VALVE

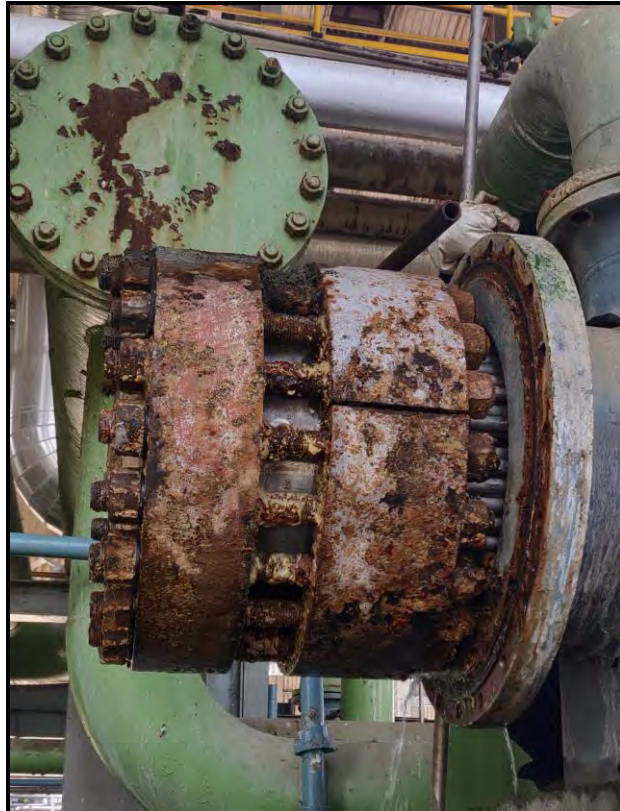
FLOATING HEAD COVER JOINT LEAK

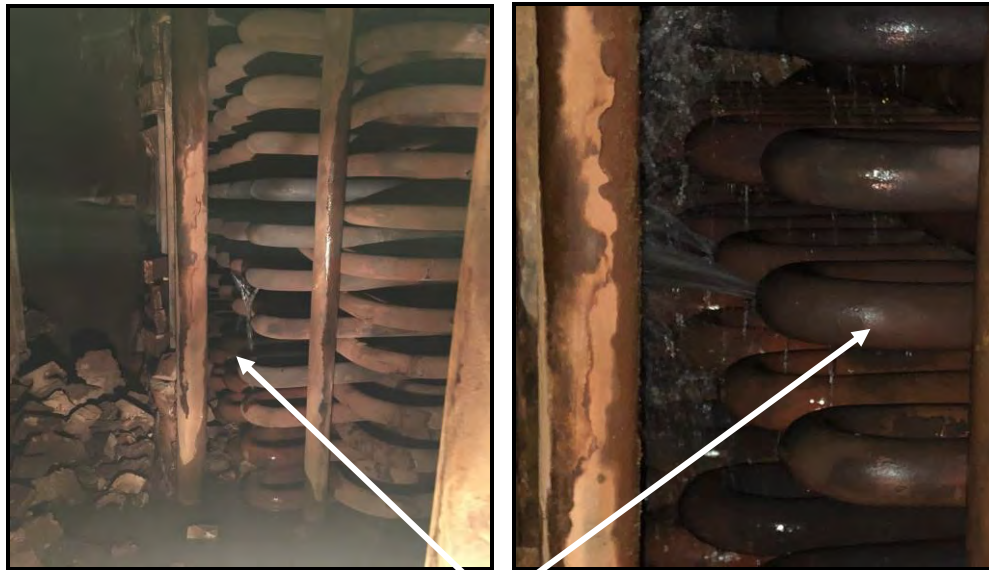
- Inspection of BHEL Boiler (GT 2068)
- 03 nos. U bend of Secondary super heater coils observed having leakage during Hydro-test.

Secondary Super heater coil Leakage

These U bends were replaced by spare ones. Radiography & DP test carried out on weld joints of replaced tubes.
- Inspection of 52" NB CW Inter connection line between New CT and P-4401 C/D sumps.
- Inspection of Cold Insulation lines connected with Ammonia Storage area. 02 nos. of lines having cold insulation were removed to assess the condition & extent of corrosion under supports.

It was decided to replace the all bends by new one. The job was handed over to M/s Shri Ganesh Engineering, Ahmedabad against W.O. 201004190955. Site inspection was done and found that there was no approach from cutting and welding of tube bends. So, it was decided to cutting the front 05 Nos. bank tubes for easy approach to do the cutting, welding work.

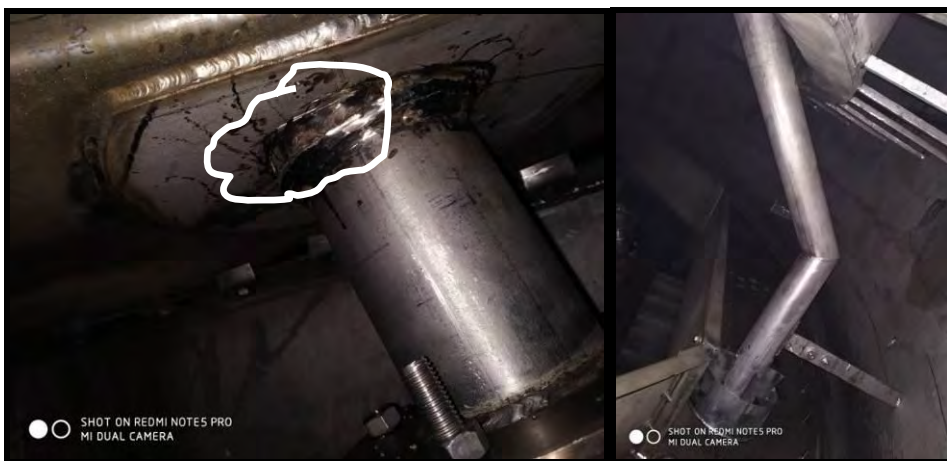
- The other Bubble cap drain line was also observed dislocated and about to get sheared from the top weld.

- 01 nos. plate segment having approx. size of 1.5"x3" found lying on the riser box holding plate. All the damaged parts of the drain pipe support, strips etc. need to be removed from the compartment.

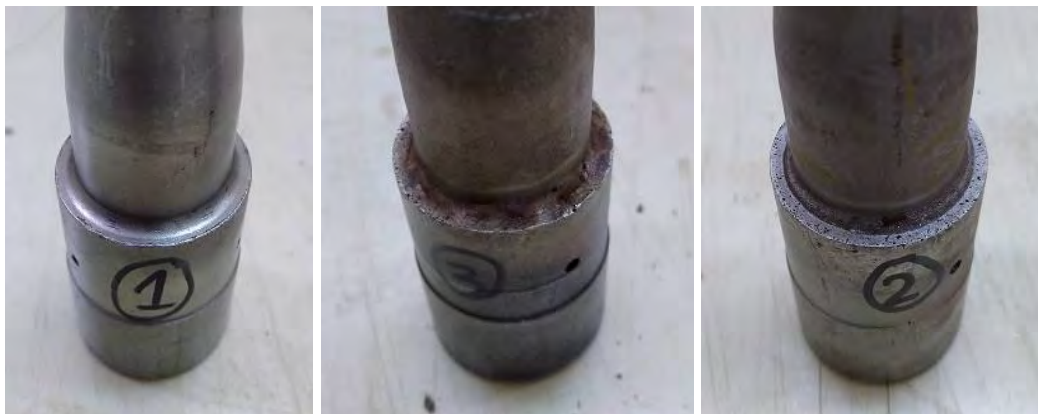
- Gradual thinning of tube ends of Old ferrules observed, viewed from I.D.
- (Images attached)
