IFFCO
KALOL UNIT

P & S SECTION
MAINTENANCE DEPTT.
REPORT NO. 7/1984

ANNUAL TURNAROUND 1984

1.1.1984 - 25.1.1984

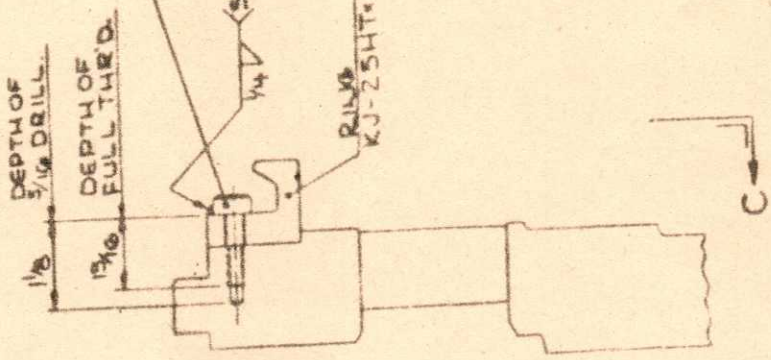
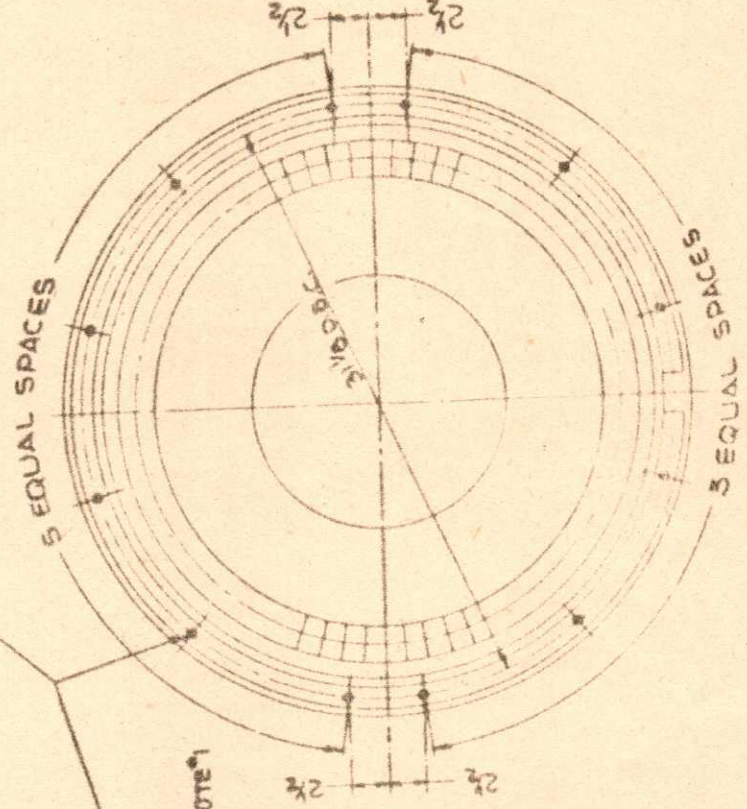
VIEW C-C

Normally moisture rings are plug welded with the diaphragms ; On long run plug welds get deteriorated in several instances, and thereby permitting the moisture rings to loosen. In case the moisture rings come out completely from the diaphragms, severe damage can occur to the rotor. To prevent this, extra fastening of the moisture rings was suggested by M/s. De Laval. We have carried out the extra fastening of the moisture rings to the diaphragms (5th, 6th & 7th) as per the procedure given by the representative of M/s. De Laval. (Refer Drawing attached herewith)

In our turbine, the plug welds of diaphragms were found in good condition, but to have extra precaution, the above modification was done.

DRILLING (TAPPING NOTE IS WITH MOISTURE RING IN PLACE ON DIAPHRAGM.
 $\frac{5}{16}$ DRILL TO DEPTH SHOWN, $\frac{13}{32}$ C-BORE, $\frac{17}{32}$ DEEP, $\frac{3}{8}$ -16 TAP TO DEPTH SHOWN. 6-HOLES IN EACH HALF SPACED AS SHOWN ON $\frac{31}{8}$ D.B.C. TOTAL 12-HOLES.
 12-CAPSCREWS $\frac{3}{8}$ -16 \times $\frac{7}{8}$ LG MATL ASTM A574 (DELAVAL HARDWARE # 003030, MATL. 0404)

NOTES:
 1. TACK WELD EACH CAPSCREW IN PLACE USE $\frac{3}{32}$ DIA. ROD, INCO WELD A.

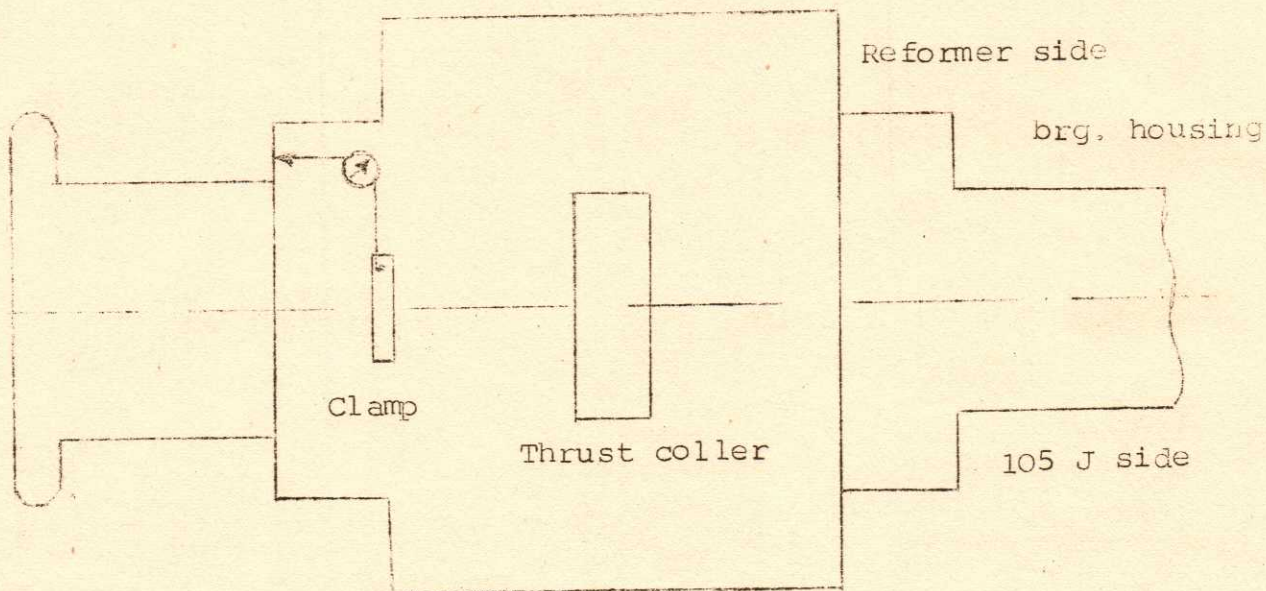
The crack at key portion of bearing pedestal was repaired by metal locking as per following procedure.

The repaired bearing pedestal was then brought to site and put in position and properly aligned by putting necessary shims as per sketch shown below.

Finally alignment readings were taken which are mentioned below.

- a) Welding was removed by grinding
- b) The cracked piece was knocked off
- c) Faces of cracked portions were ground and thoroughly matched by blue impressions.
- d) Cracked portions were properly clamped with bearing block
- e) Metal locking was then carried out
- f) Also the welding was carried out on the left over portion of metal locking for extra strengthening. The welding was carried out with 680 welding electrodes.
