IFFCO
Kalol Unit

P & S Section
Maintenance Deptt.
Report No.9/1987

ANNUAL TURNAROUND - 1987
(12th April 1987 - 3rd May 1987)

INDIAN FARMERS FERTILISER CO-OPERATIVE LIMITED

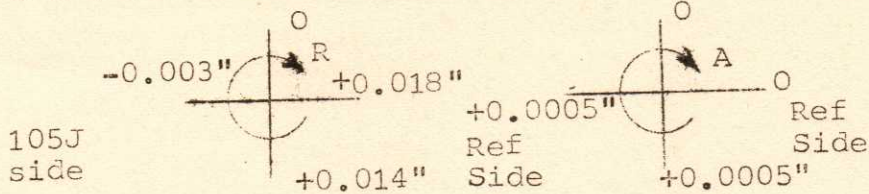
Also, checked the alignment between turbine and L.P. Case rotor after completion of modified exhaust line. The readings are given below.:
