PLANNING SECTION

MAINTENANCE DEPTT.

REPORT NO. 21 / 2001

REPORTONPLANT TURNAROUND( MARCH - APRIL - 2001 )INDIAN FARMERS FERTILISER CO - OPERATIVE LIMITED

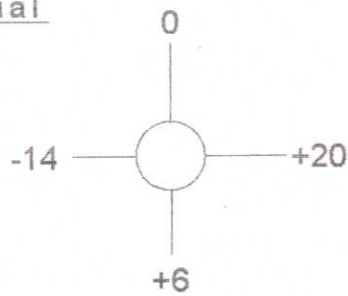
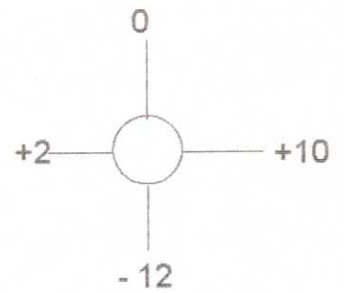
Dial on Gear Box  
1Div = 0.01mm.

Radial

Face

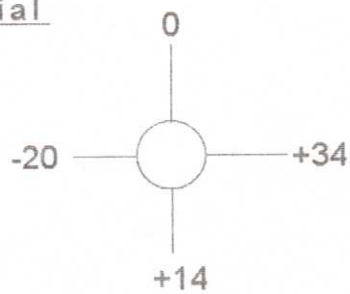
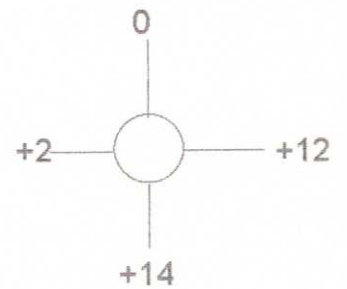
After PM job

Dial on Gear Box  
1Div = 0.01mm.

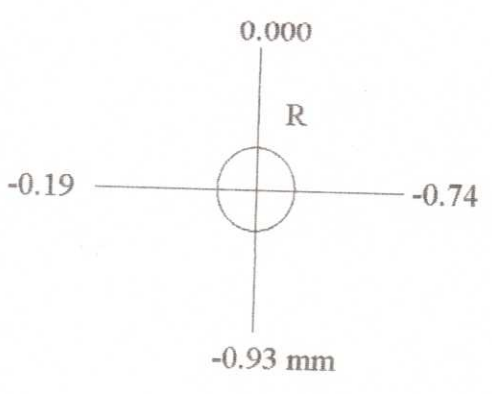
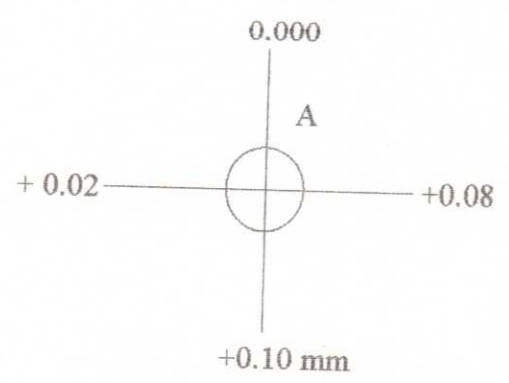
- (d) Governor oil flushed and fresh oil charged.
- (e) Oil console level gauge glass properly screwed to avoid any leakage.
- (f) Oil console was drained, Cleaned & fresh oil charged.
- (g) Turbine to Gear Box alignment was checked  
Following are the readings:  
Dial indicator fixed on gear box (Dial indicator on Turbine Shaft)

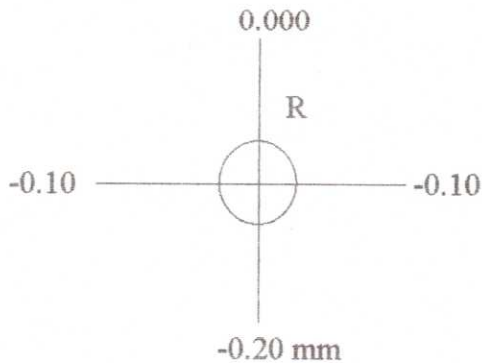
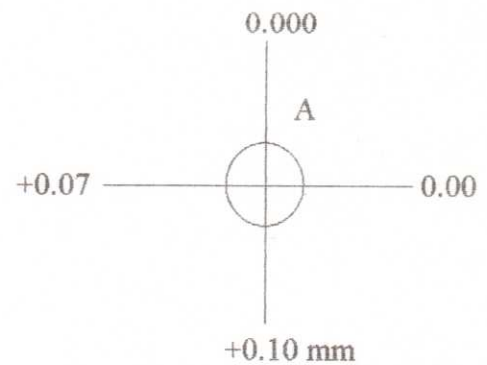
Dial indicator fixed on gear box ( Dial indicator on Turbine Shaft )

Alignment was corrected, Following are the readings:

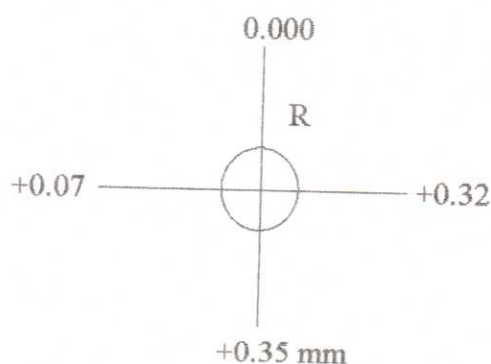
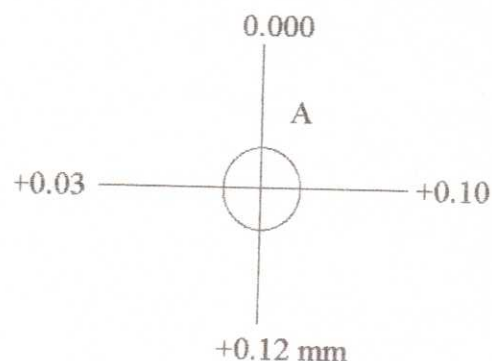
- Both the journal bearings were checked & found okay.
- The clearances were checked & following are the readings.  
Free end side : 0.20 mm                      Coupling side : 0.17 mm
- Decoupled the turbine coupling , cleaned & greasing done.
- Gland packing ( 25 mm) both sides repacked.
- N.R.V. Gland packing repacked.
- Pump & Motor alignment was checked following are the readings.

Dial indicator fixed on motor (Dial indicator on Pump Shaft)

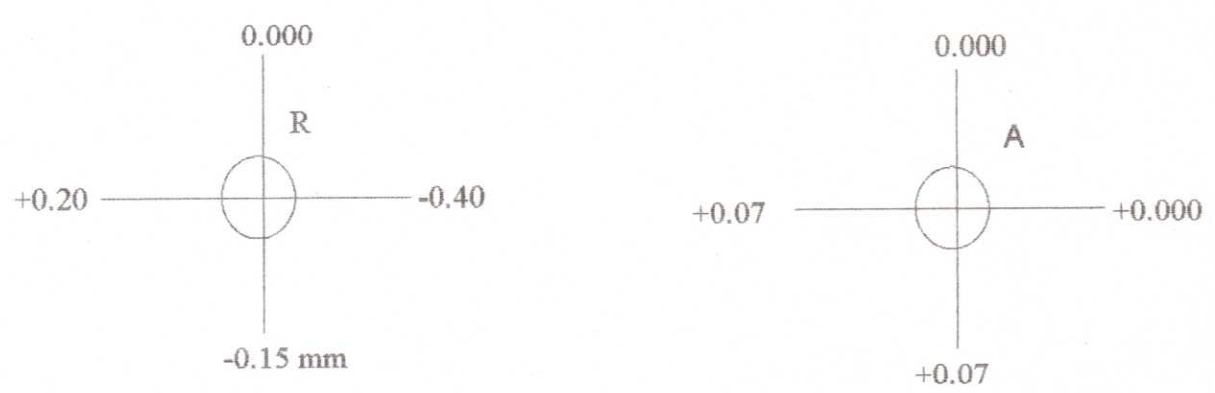
- (a) Both the journal bearings were checked & found okay.
- (b) The clearances were checked & following are the readings.  
Free end side : 0.25 mm                      Coupling side : 0.17 mm
- (c) Decoupled the pump coupling , cleaned & greasing done.
- (d) Gland packing ( 25 mm) both sides repacked.
- (e) N.R.V. Gland packing repacked.
- (f) Pump & Motor alignment was checked following are the readings.

Dial indicator fixed on motor (Dial indicator on Pump Shaft)

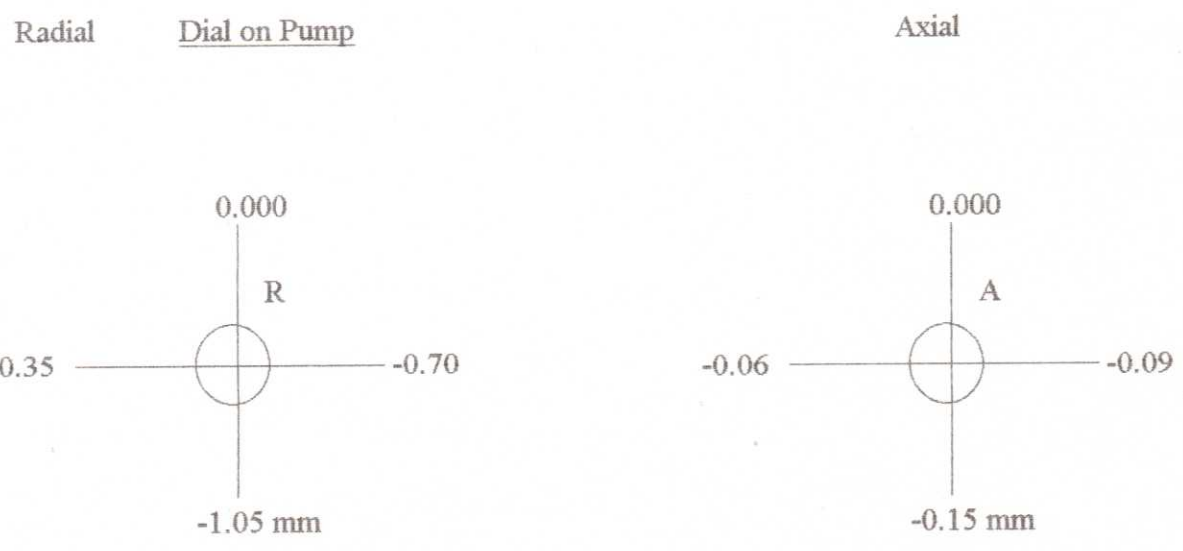
(2) Alignment Readings :

- (a) Type of coupling                      :      Gear                      Float : 9.90 mm
- (b) Gear Box Shaft Hub                :      Good
- (c) Bolt Holes in Hubs                 :      -do-
- (d) Pump shaft Hub                      :      -do-
- (e) Condition of Coupling Bolts      :      -do-

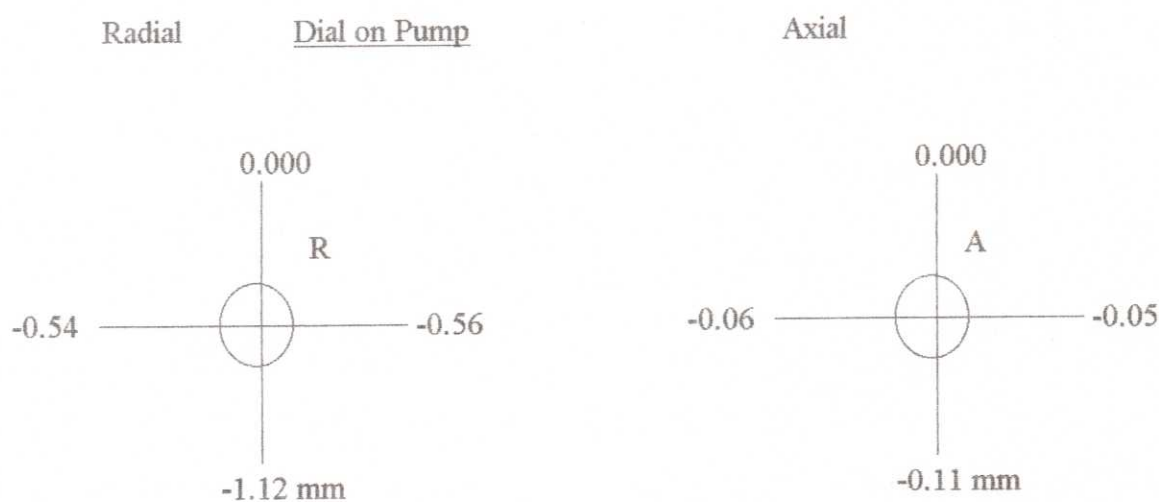
(2) Alignment Readings :

(f) Type of coupling	:	Gear,	Total Float : 9.9 mm
(g) Bolt Holes in Hubs	:	Good	
(h) Turbine Shaft Hub	:	Good	
(i) Condition of Coupling Bolts	:	Re -usable

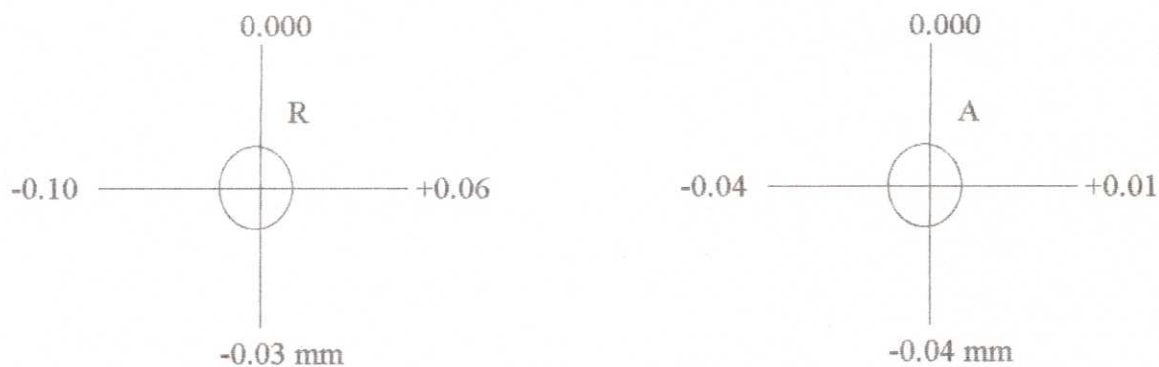
(2) Pump To Gear Box alignment was checked following are the readings.

Dial indicator fixed on Gear Box Shaft (Dial indicator on Pump Shaft)

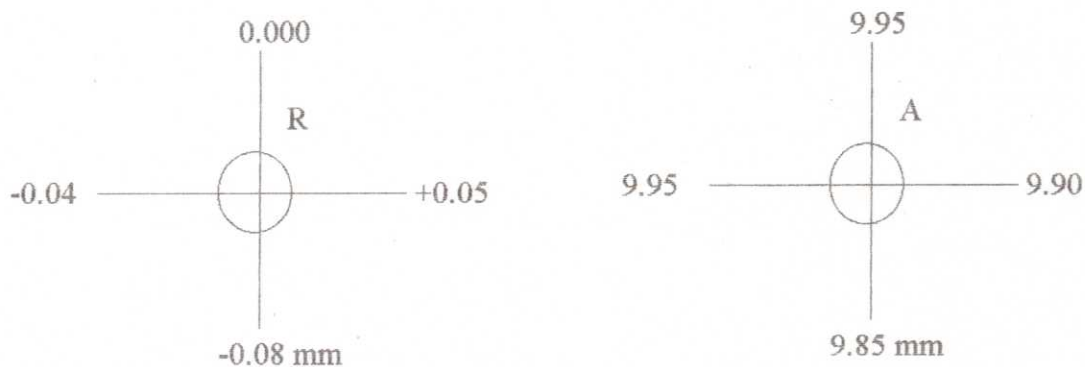
Motor to Gear Box alignment was checked following are the readings.

Dial indicator fixed on Gear Box Shaft (Dial indicator on Motor)

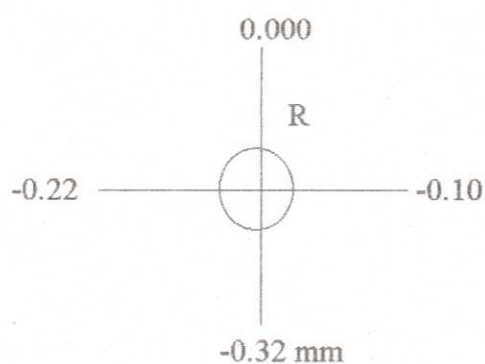
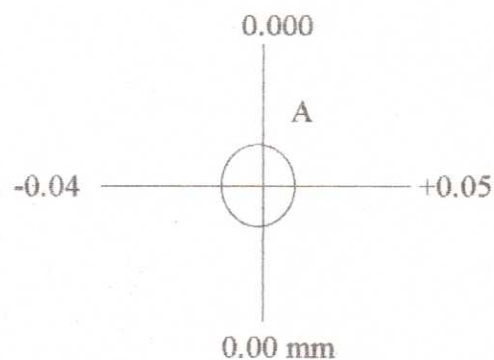
- (6) Bearing Clearance  
 DE : 0.13 - 0.15 mm  
 NDE : 0.13 - 0.14 mm  
 Thrust Bearing: 0.29 mm (provided shim of 0.15 mm )
- (7) Oil Console & filters cleaning : Done
- (8) Renewals : Gaskets
- (9) Final Alignment was checked at the time of doing coupling  
 Following are the readings:

Dial indicator fixed on Gear Box Shaft (Dial indicator on Pump Shaft)

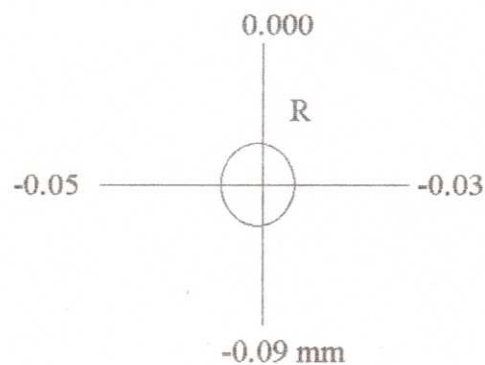
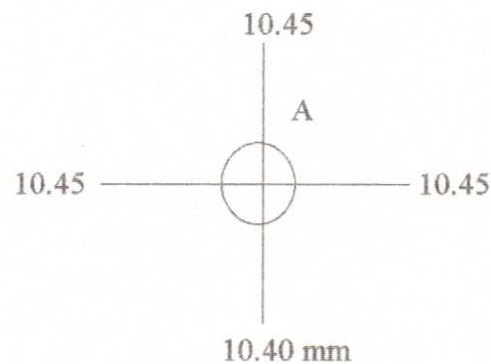
Motor to Gear Box alignment was checked following are the readings.

Dial indicator fixed on Gear Box Shaft (Dial indicator on Motor)

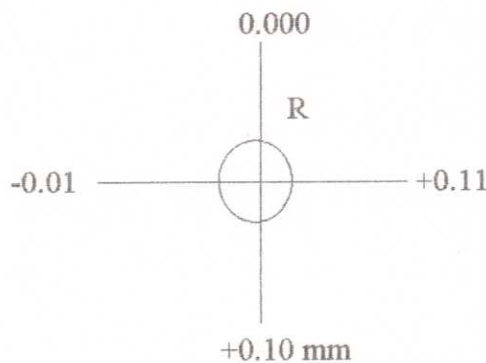
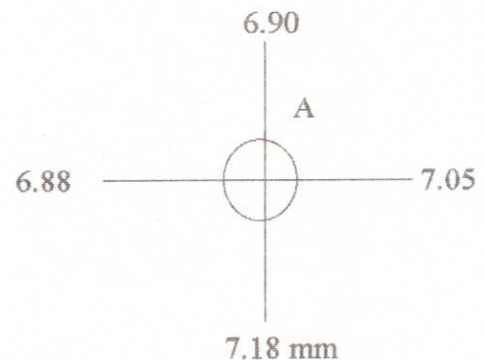
(2) Turbine to fan alignment was checked following are the readings.

Dial indicator on Fan

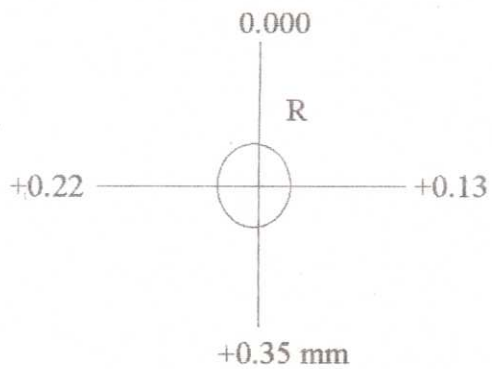
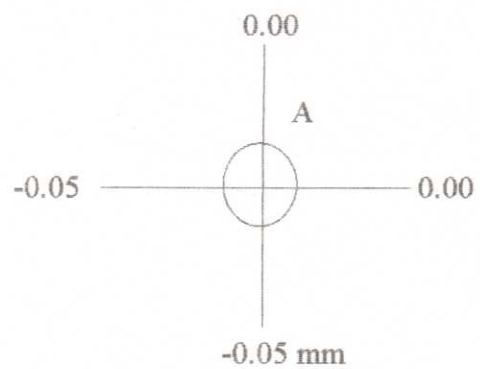
- (3) Clutch to fan alignment was checked following are the readings.  
Dial indicator on Fan

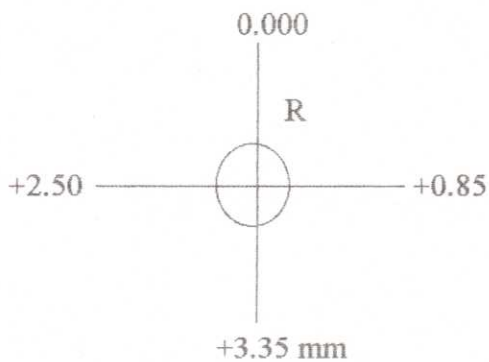
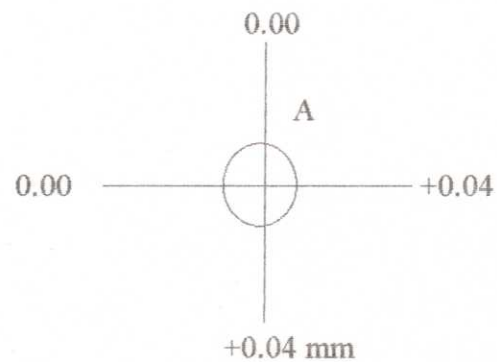
- (4) Motor to Clutch alignment was checked following are the readings.  
Dial indicator on Motor
