MTC / REPORT / 01  
REPORT NO. 27 / 2007

## KALOL UNIT

# PLANT TURNAROUND REPORT (APRIL - MAY - 2007)

INDIAN FARMERS FERTILISER CO - OPERATIVE LIMITED

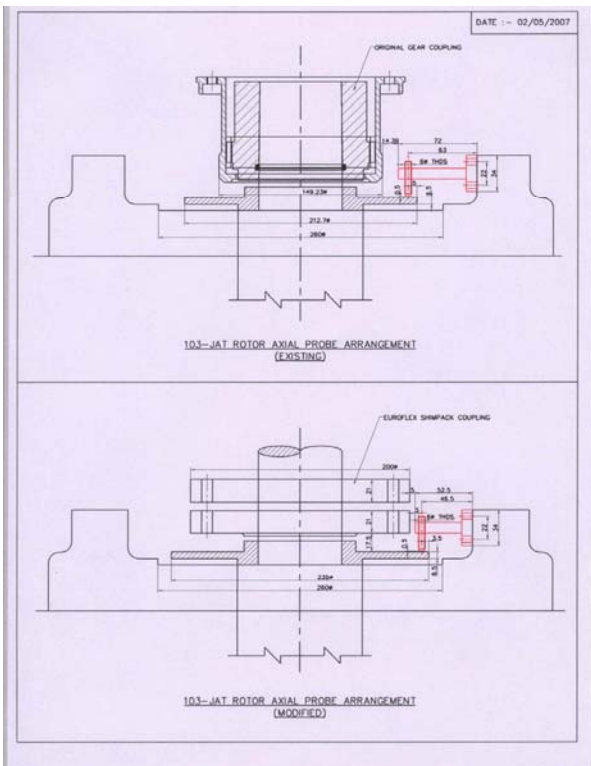
**Arrangement for installing Axial probe for 103-JAT:**

While installing axial probe on the 103-JAT rotor, it was found that, the space for axial probe between the coupling hub rear end and a spacer provided for probe on the rotor, had reduced. This happened because, the new Euroflex coupling hub had flanges at the rear end. After studying it was decided to make a new spacer having OD of around 20-30 mm larger than that of original spacer. Since the spacer is not subjected to steam pressure and temperature material of grade F11 was found to be suitable.

New spacer was made from grade F-11, 6" x 600 # blind flange. The spacer was balanced at 500 RPM. The original Spacer was removed and the new Spacer was installed by heating to around 100<sup>o</sup>C using a gas cutter. Finally it was possible to install axial probe at site.

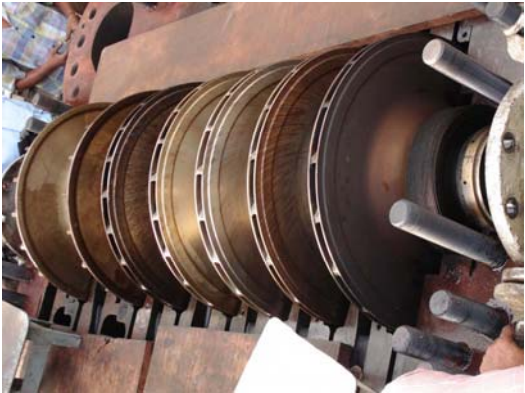
After plant annual turnaround, the Ammonia plant was started on 03-05-2007 and production resumed on 07-05-2007. The plant was running smoothly till 09-05-2007. However, the machine tripped at around 23:50 Hrs on 09-05-2007. After restarting the machine, abnormal vibrations were noticed in Gear Box and HP case of the machine, at around 01:30 Hrs on 10-05-2007. The machine was immediately stopped for inspection. On thorough inspection of the train, it was found that the HP case rotor coupling had slipped from its position and thereby causing extensive damage to both coupling hub &

rotor shaft end. As an immediate measure, HP case rotor & coupling were replaced with available spare ones and the machine train was put back into operation and regular Production was lined up on 14-05-2007 onwards.

System was isolated, clearance for opening of the machine obtained. After removal of top casing, general condition of internals was found good. No oil additives deposit was found. Both the mechanical seals were in good condition. Labyrinth clearances were found in limit. Lining marks were observed on the journal bearing pads; hence the pads were replaced with new one.

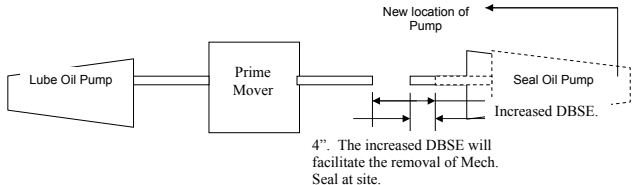
#### The Original & Final Position of 103-J Seal Oil Pump

The 103-J Seal oil pump was so positioned that, after decoupling, the DBSE was not sufficient to remove the mechanical seal of the pump at site. Hence whenever there was a mechanical seal failure the pump had to be completely removed to attend the failure. Hence both the seal oil pumps were shifted by about 4" away from their prime mover to facilitate the removal of mechanical seal at site.

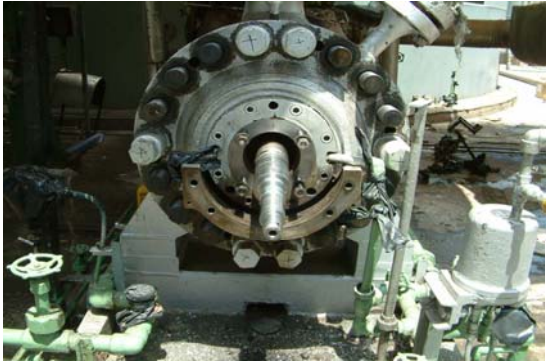
An overview of 104-JA, BFW PUMP during dismantling:

The Boiler Feed Water Pump 104-JA showed high vibrations. Before Shutdown, even after realignment the vibrations did not stop. Further the shims of the coupling flexible element were found broken. Hence it was decided to replace the complete rotor assembly of pump. The turbine was taken for preventive maintenance.

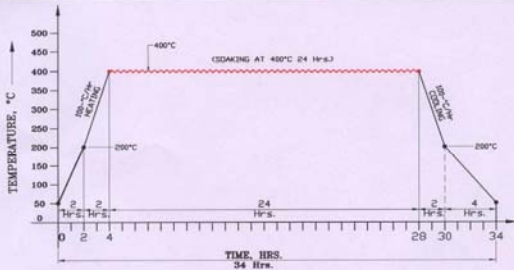
**DEHYDROGENATION OF 105-D C S ELBOW**

As the elbow was in the prolong service of Hydrogen, Dehydrogenation of both the edges was carried out. as per Temperature - time curve below.

Dehydrogenation, Welding and PWHT for Repair of Elbow was done as per attached procedure (Welding and PWHT was done as per QW -201.1 Section IX, ASME BPVC which is attached below):

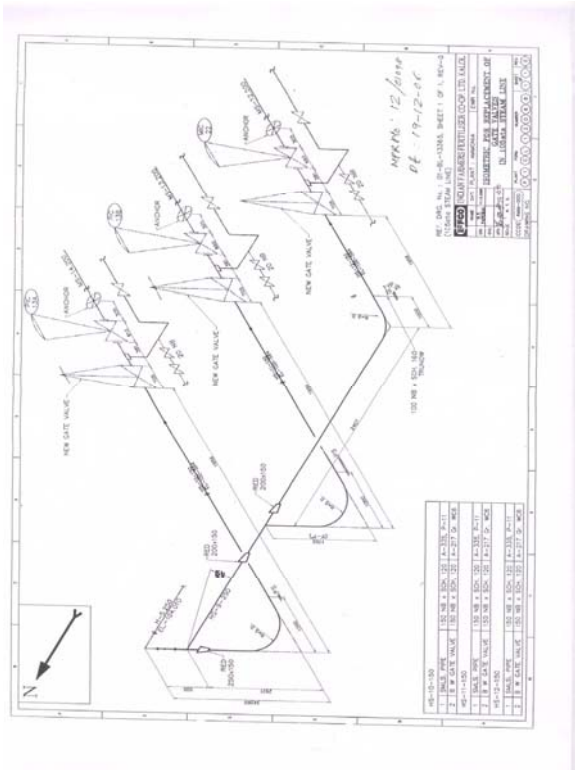
**Sketch for Isometric of Letdown valves**

Entire HP Steam line was replaced with P11 material during KEP. However three CS gate valves were remain to be replaced. There was failure of one valve body during operation. Hence it was decided to replace the three valves with up graded material.

Position of the Valves is as shown below in the attached Isometric:

Hence following major replacement activities were carried out:

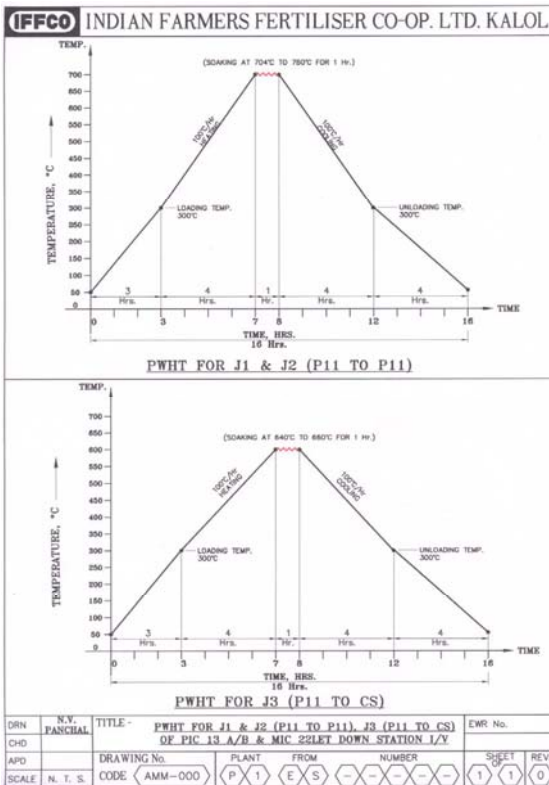
Temperature - time curve for PWHT

After welding, PWHT was carried out as per attached time- temp. curve;

Welding and PWHT was done as per QW - 201.1 Section IX, ASME BPVC procedure which is given below:

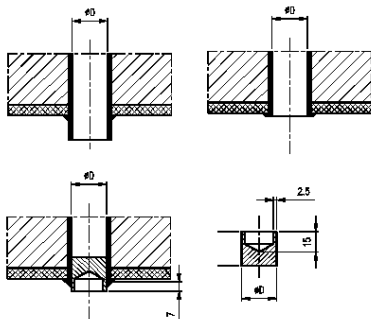
**TUBE PLUGGING SKETCH OF HP VESSELS SUGGESTED BY**  
**M/S STAMICARBON**

Examine this plug by macro examination of two cross sections, perpendicular.

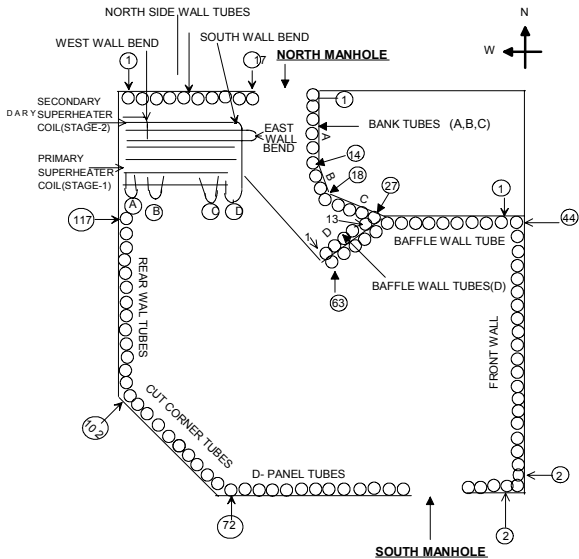
**BHEL BOILER FURNACE LAYOUT  
(GT-2068)**

2. Refer annexure-7 showing tube layout & numbers identifying the individual tubes.
3. Design thickness of tubes : 5.6 mm
