MTC / REPORT / 01
REPORT NO. 30 / 2010

KALOL UNIT

PLANT TURNAROUND REPORT

INDIAN FARMERS FERTILISER CO - OPERATIVE LIMITED

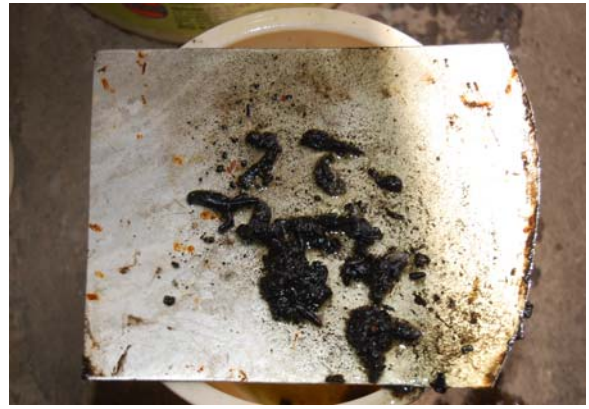
Scattered Black deposits were observed on the side and partition walls of console and at console bottom. There were removed and console was cleaned. Please refer Fig 5 and Fig 6.

FIG 5, Deposits on side wall of LO Console

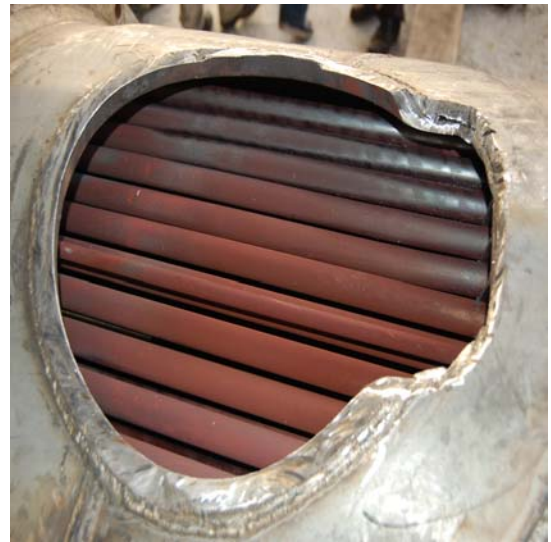
- Grills of both platforms of H-1421 were cut and removed.
 - It was initially tried to remove the tube bundle of exchanger with the help of crane. After lifting by about 1 mtr. , it was observed that the 1st baffle of bundle was getting obstructed with the shell due to the inward bulging of shell near 14" NB gas inlet nozzle.

FIG 10, Tube bundle with old shell lifted by Kobelco Crane

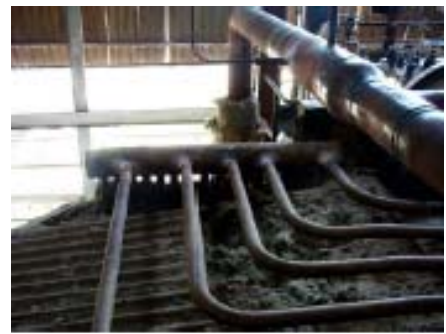
Top Rear Header & Riser Tubes

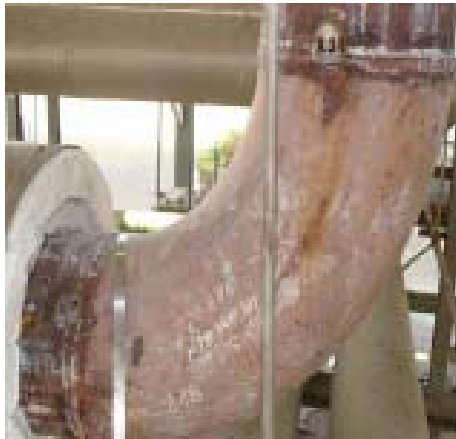
Replica location in Main Steam line

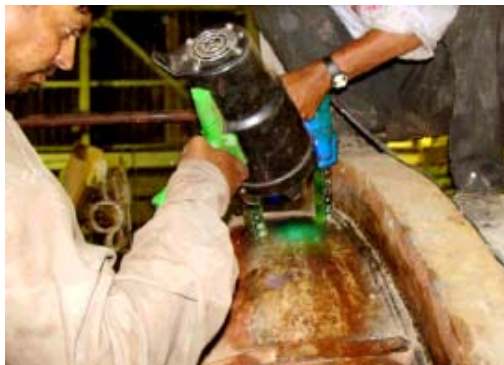
MPI in Steam Drum Dish End
Circumferential seam

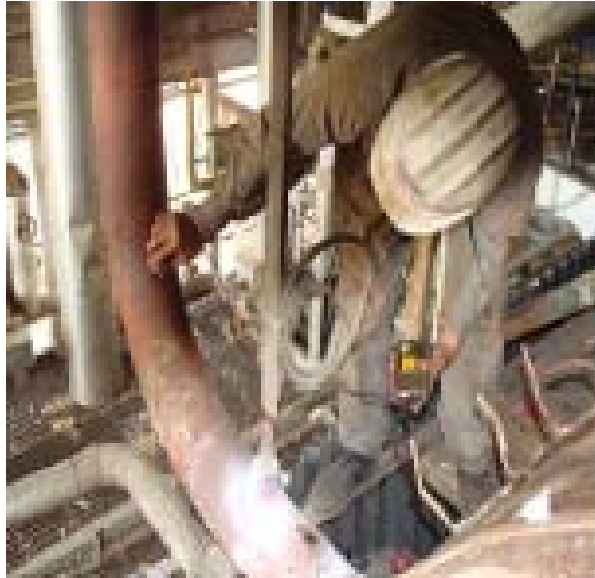
DPT of Feed water line attachment welds

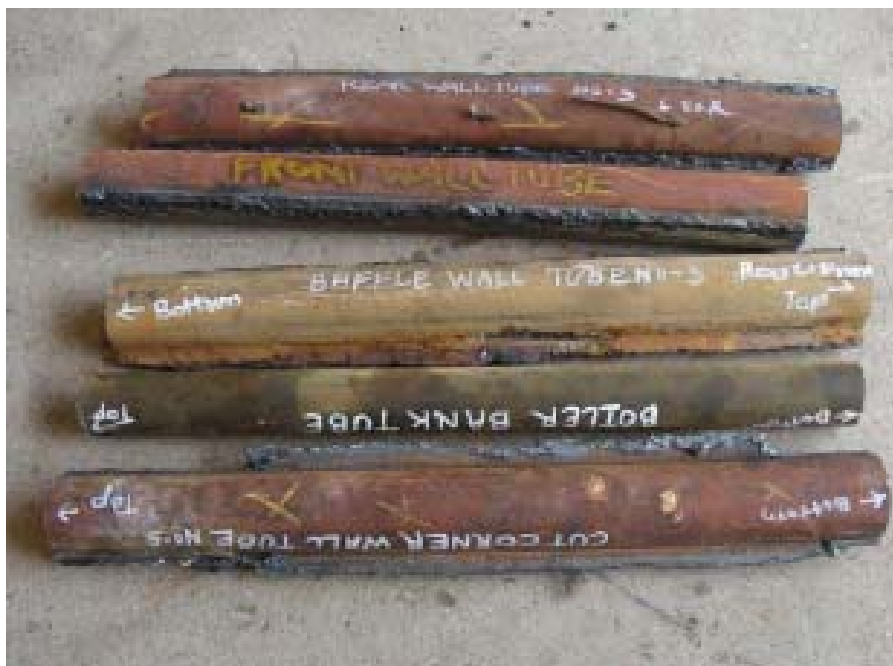
Tube samples cut from various locations for destructive testing
