KALOL UNIT

PLANT TURNAROUND REPORT

(MARCH - APRIL - 2011)

INDIAN FARMERS FERTILISER CO - OPERATIVE LIMITED

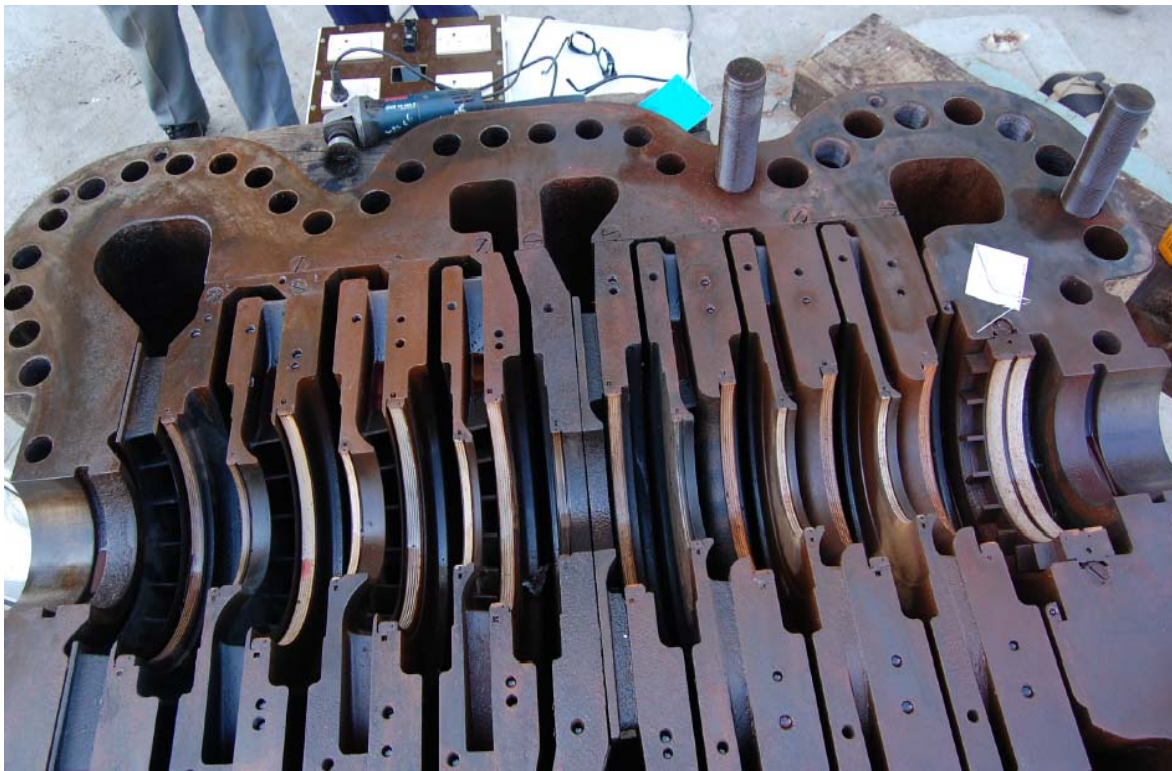
101-JHP TOP CASING CLEANING UNDER PROGRESS

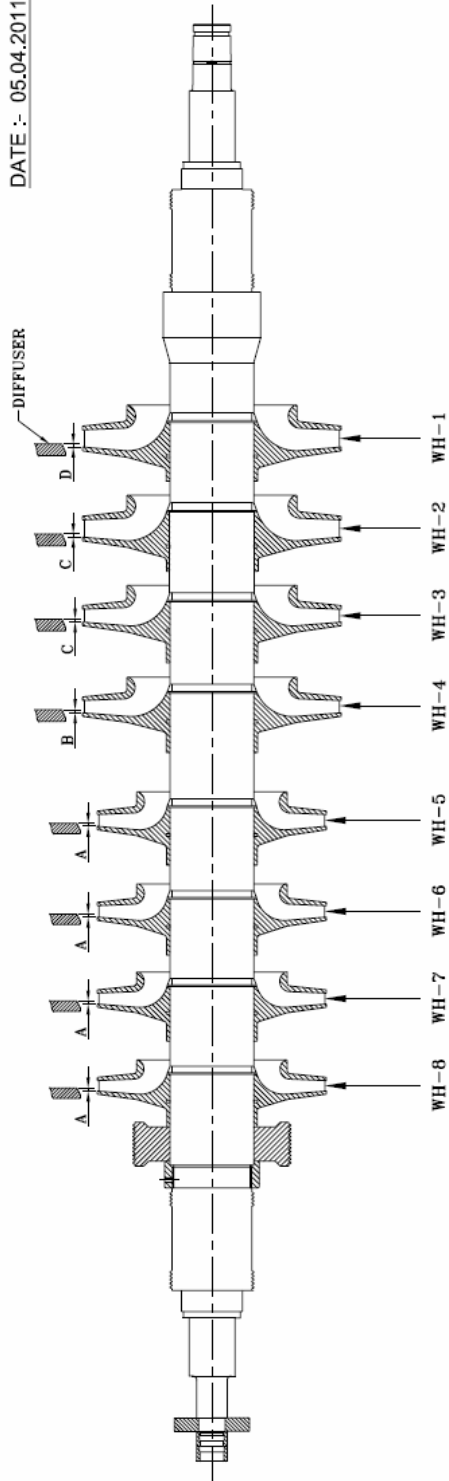
RUNOUT - 101-JHP ROTOR

DESCRIPTION	ROTOR NO.	A	B	C	D	E	F	G	H	I	J	K	L	M	N
EXISTING ROTOR		0.0019		0.0019	0.011	0.0015	0.0023	0.0019	0.0019	0.0019	0.011	0.0023	0.0019	0.002	0.00
IF NEW ROTOR IS INSTALLED		NA		NA	NA	NA	NA	NA	NA	NA	NA	NA	NA	NA	NA

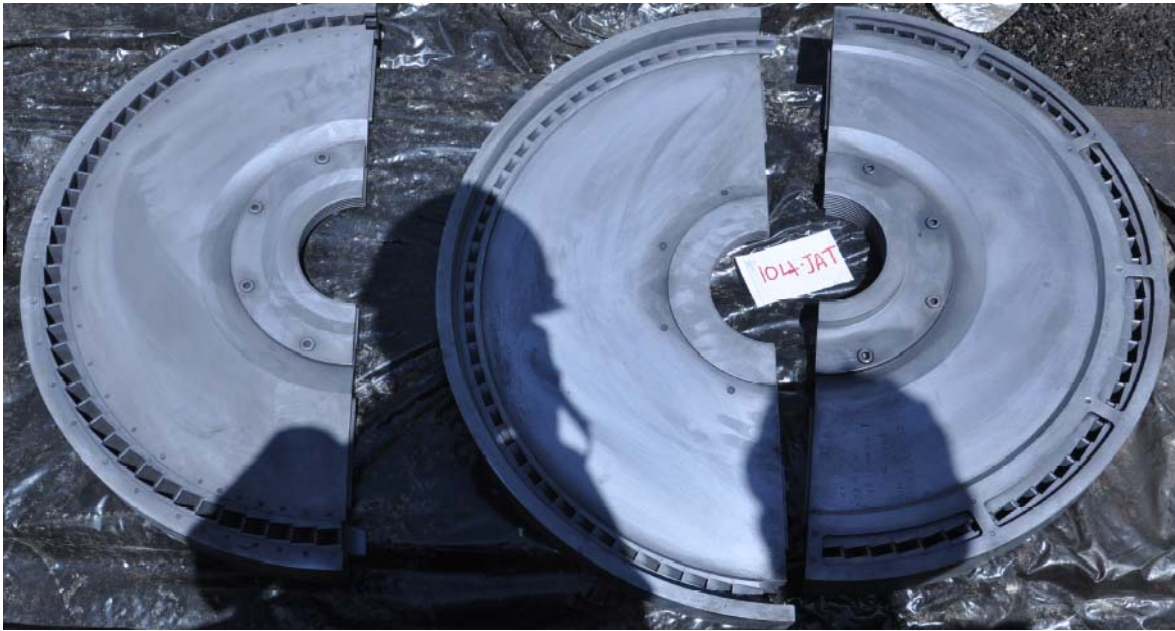
104-JAT DIAPHRAGMS CLEANING & INSPECTION UNDER PROGRESS

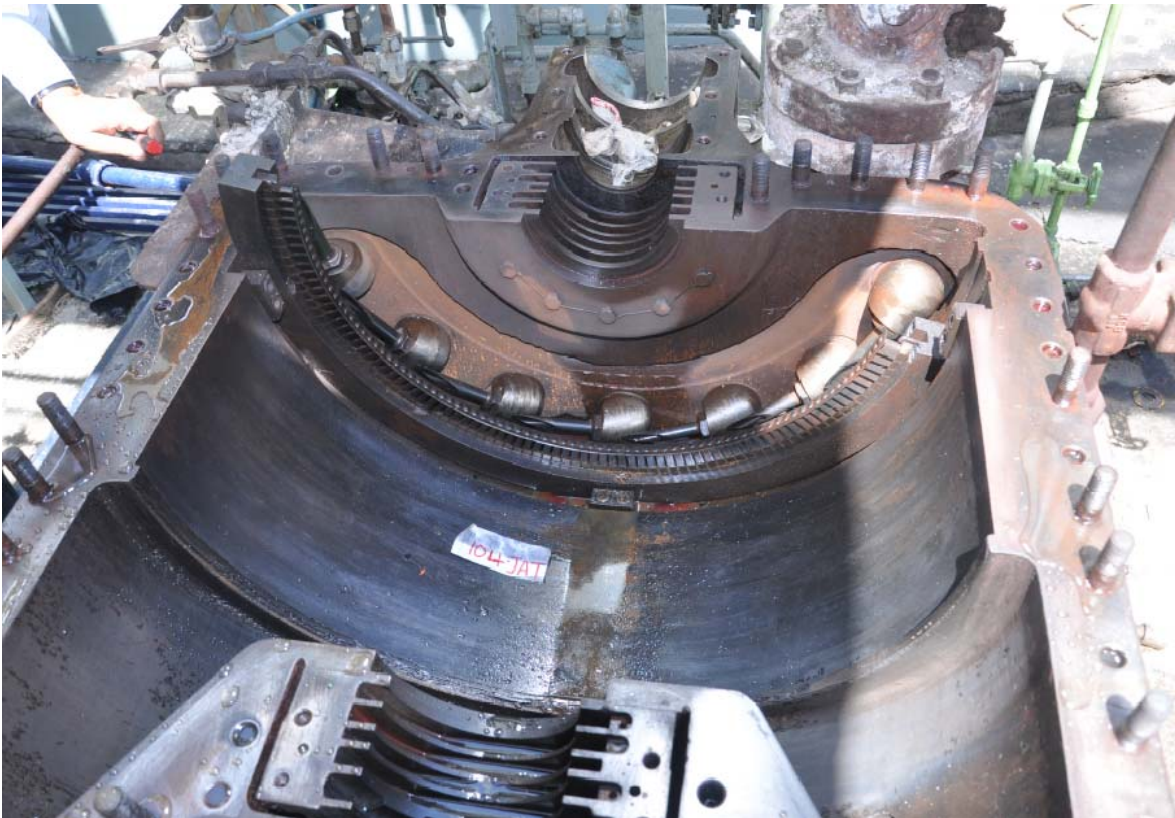
104-JAT BOTTOM CASING CLEANING & INSPECTION UNDER PROGRESS

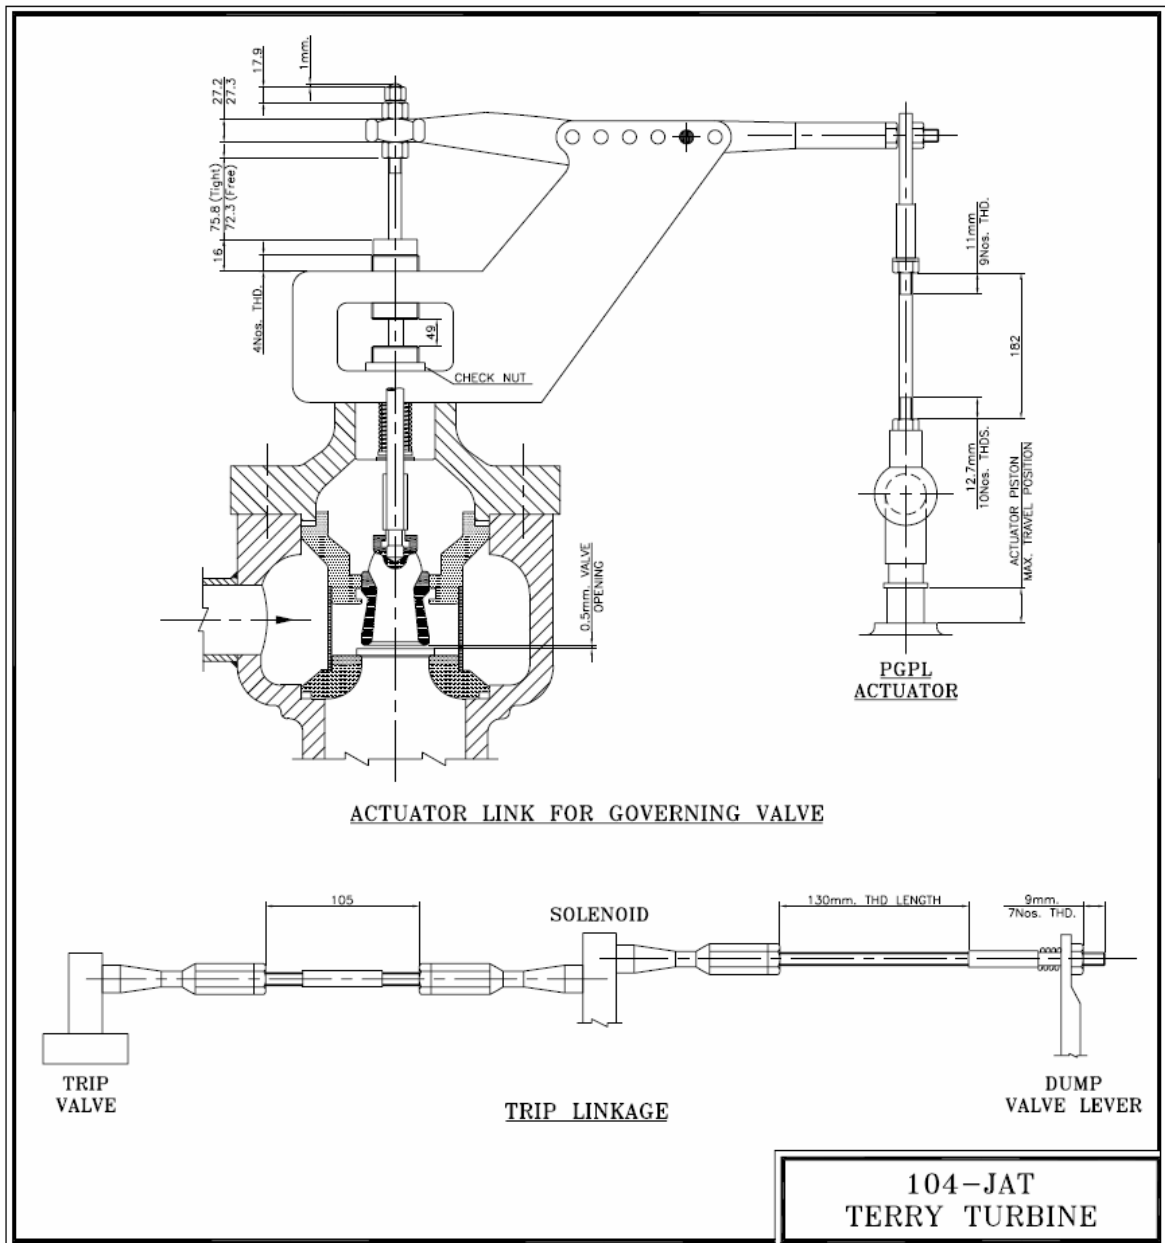
104-JAT GOVERNING VALVE & TRIP VALVE LINKAGES SETTINGS

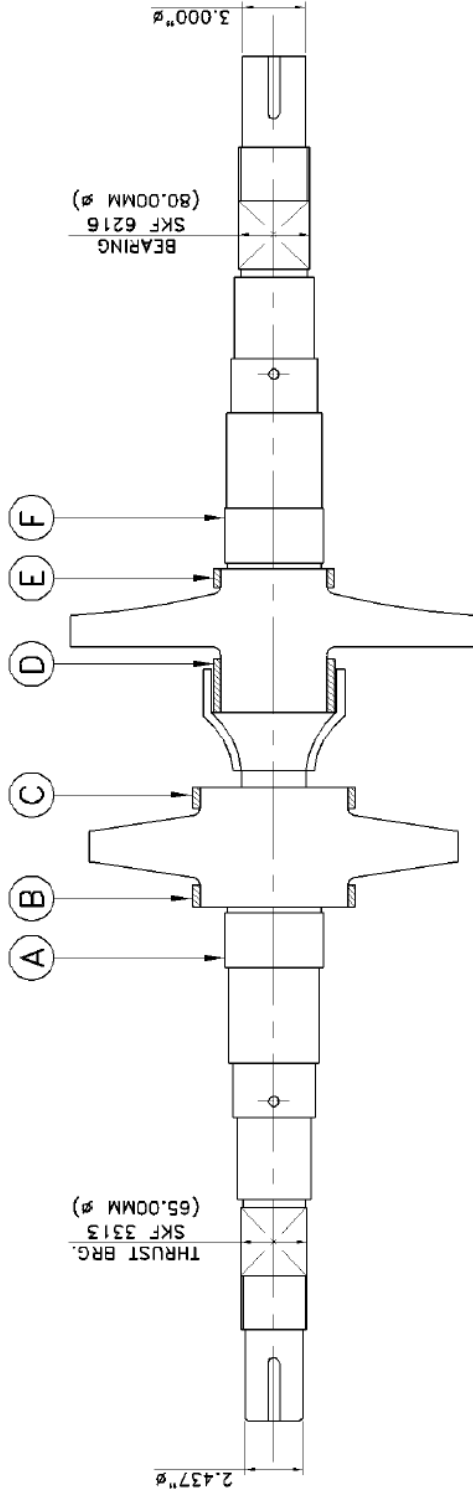
The pump was taken for complete overhauling and to attend the casing parting plane leakage around the seal. The casing was removed after removing both ends bearings and seals. Heavy erosion of carbon steel parts like casing, wear rings etc were observed. New rotor assembly was installed. The mechanical seals were replaced by new one. The end bearings were replaced by new ones. The seal was tested using DM water and no leakages were observed.

CASE RING (I.D.)	NECK RING (O.D.)	CLEARANCE
B	8.020"	7.981"	0.039"
C	8.020"	7.981"	0.039"
D	6.393"	6.359"	0.034"
E	8.388"	8.356"	0.032"

BUSH (I.D.)	SLEEVE (O.D.)	CLEARANCE
A	4.024"	3.999"	0.025"
F	4.024"	3.999"	0.025"

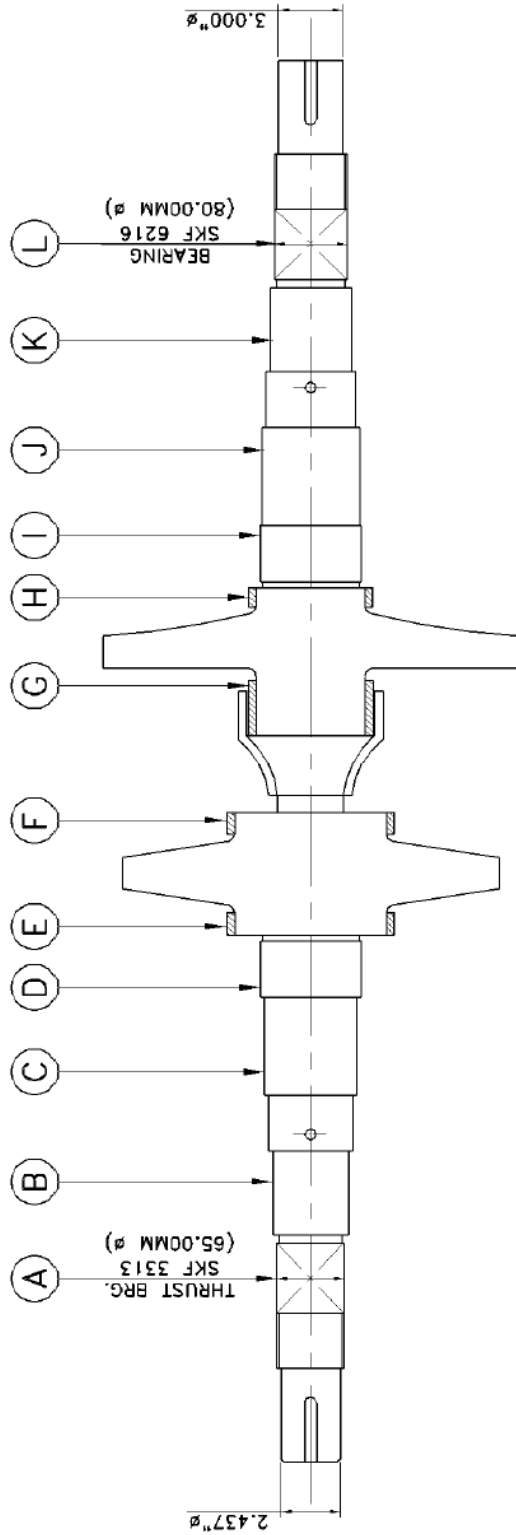
CLEARANCE CHART: 107-J

LOCATION	A	B	C	D	E	F	G	H	I	J	K	L
BEFORE	NA	NA	NA	NA	NA	NA	NA	NA	NA	NA	NA	NA
AFTER	0.005"	0.005"	0.005"	0.005"	0.005"	0.005"	0.005"	0.005"	0.005"	0.005"	0.005"	0.005"

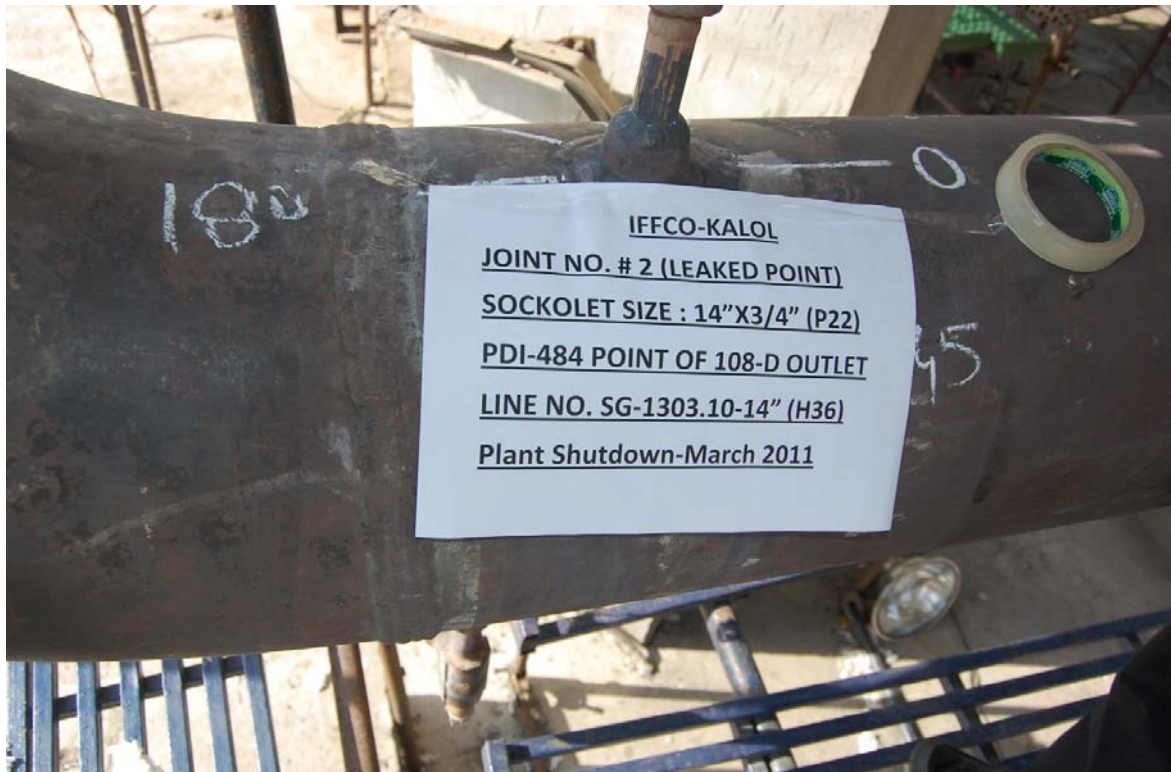
During plant operations, New Synthesis Gas Convertor (108D) outlet to Synthesis gas waste heat MP boiler **PDI-484 Sockolet Point** had a developed crack in the parent metal. The crack was immediately attended by welding with a pad support after arresting gas leak. However all seven sockolets in the New Synthesis Gas Convertor (108D) & Old Synthesis Gas Convertor (105 D) loop were decided for replacement in the shutdown. The contract was awarded to M/S. Skywin Erectors vide W.O. NO. 20101145 dated 02/02/2011. The following major activities were carried out:

- **Total 5 Nos. sockolets & one No. 1-½" drain valve was replaced as follows:**
 - ❖ Joint No. # 1A (Converter Loop) Sockolet Size: 14"X3/4" Drain Point OF 107-C Inlet Line No. SG-1303.10-14" (H36)

- ❖ Joint No. # 1B (Converter Loop) DRAIN VALVE: 3/4" X1500# (P22) Drain Point of 107-C Inlet Line No. SG-1303.10-14" (H36)
 - ❖ Joint No # 2 (LEAKED POINT) SOCKOLET SIZE: 14"X3/4" (P22) PDI-484 Point of 108-D Outlet Line No. SG-1303.10-14" (H36)

- ❖ Joint No # 3 (Converter Loop) Sockolet Size: 14"X1" (P22) Drain point of 108-D Outlet Line No. SG-1303.10-14" (H36)
 - ❖ Joint No (Converter Loop) Sockolet Size: 10"X1-1/2" (P22) Drain point of 108-D Inlet Line No.. SG-1303.09-10" (H36)

- ❖ Joint No # 5 (Converter Loop) Sockolet Size: 14"X3/4" (P22)PDI-484 Point of 108-D Inlet Line No. SG-1303.08-14" (H36)
 - ❖ Joint No # 6 (Converter Loop) Sockolet Size: 14"X3/4" (P22) PI (AP-987) Point of 105 D TO 108-D Inlet Line No. SG-1303.08-14" (H36)

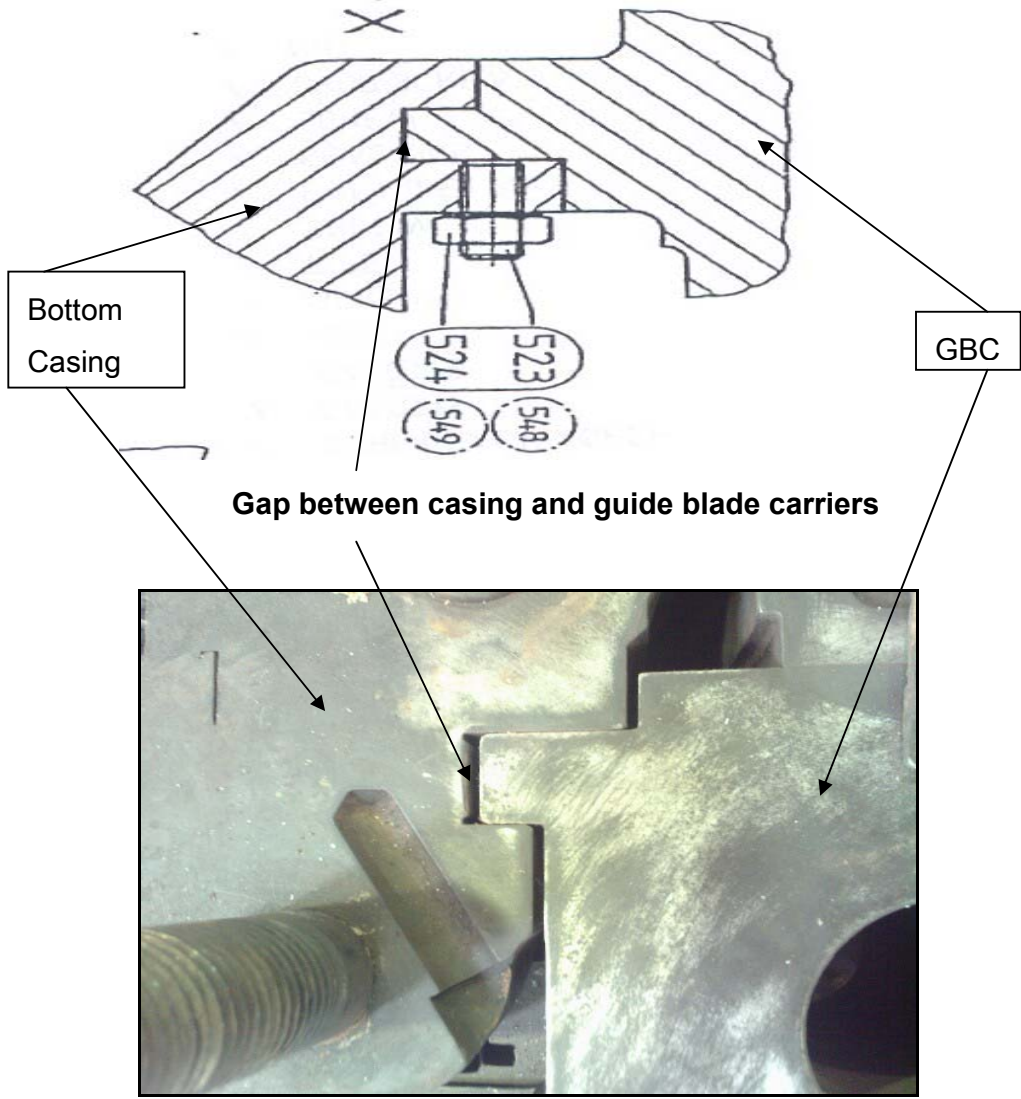
Figure-5

- Gap between casing and guide blade carriers are measured with help of filler gauge as shown in figure -5 and recorded in table -2.

Sr. No.	Description	Left side	Right side
1	Nozzle	1.85mm	1.85mm
2	1 st guide blade carrier	1.45mm	1.50mm
3	2 nd guide blade carrier	1.95mm	1.90mm
4	3 rd guide blade carrier	1.95mm	1.85mm
5	Inner gland	1.45mm	2.25mm

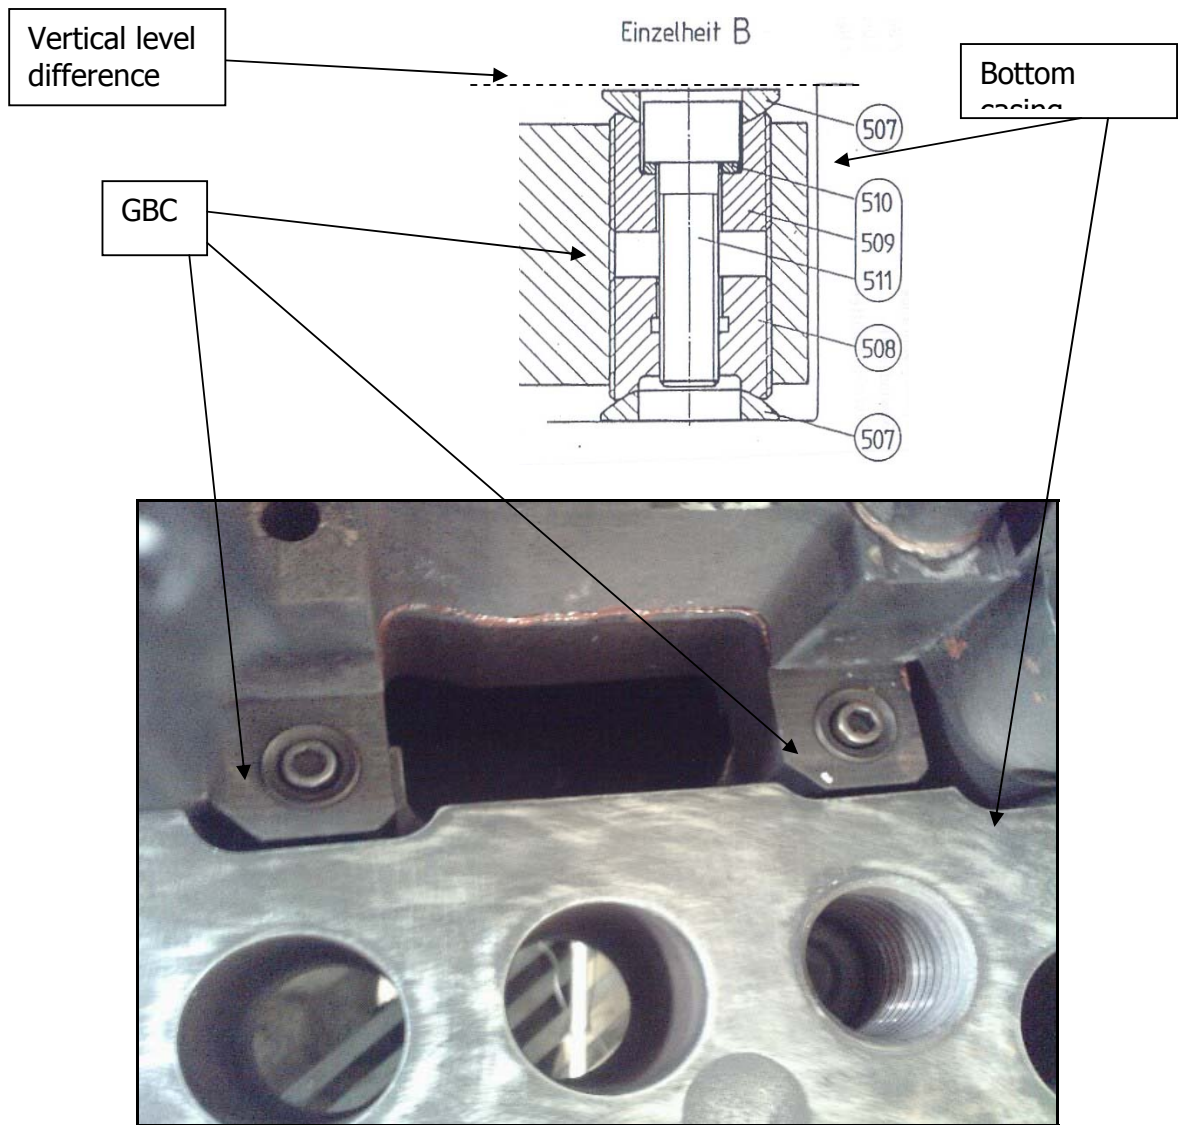
Figure -6

- Vertical level difference between casing and guide blade carrier (gap between spherical washer level and casing facing level as shown in figure -6) was measured and recorded. (Ref. 24+)

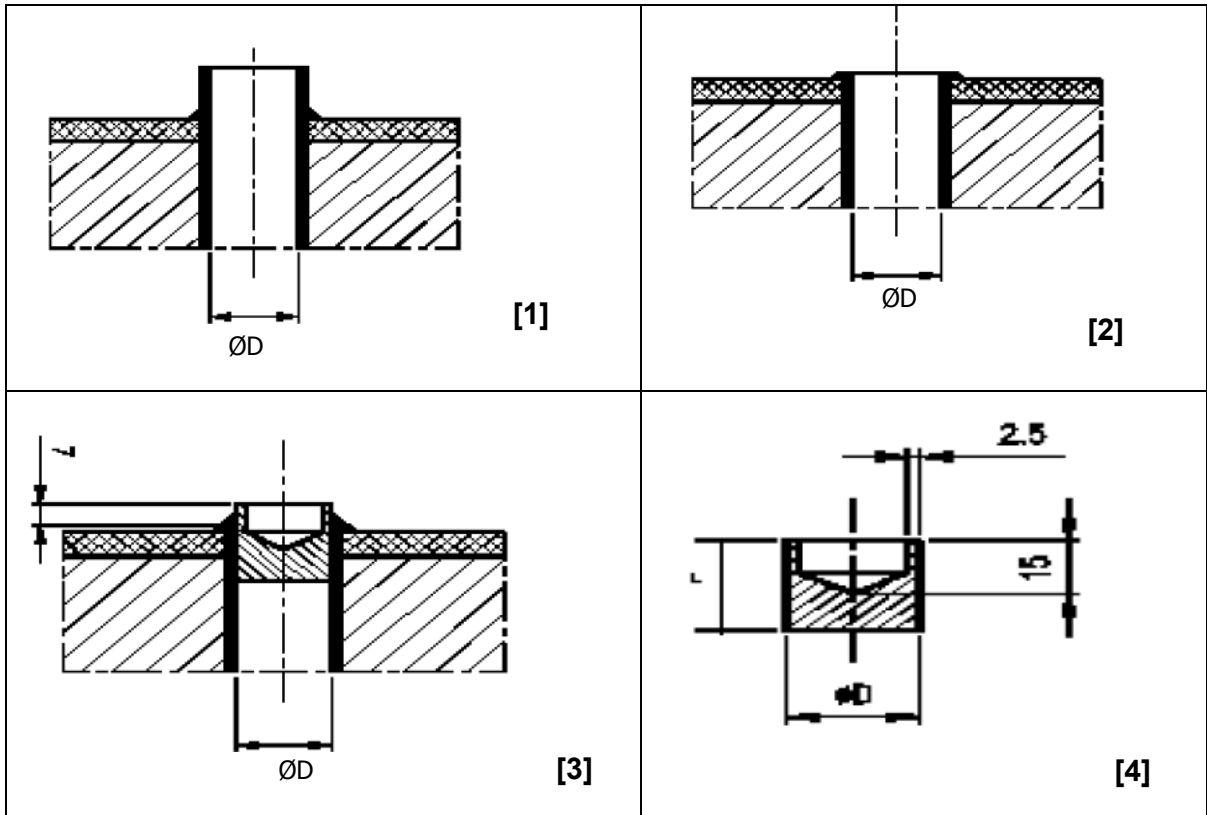
Figure – 19

Tube Plugging Sketch of HP Condenser

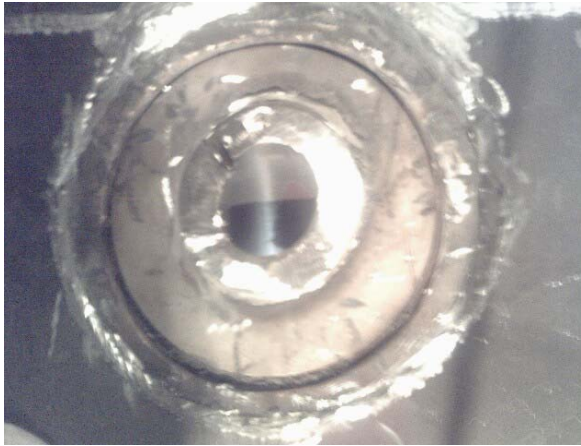
Figure – 20 : After removal of big pad plate

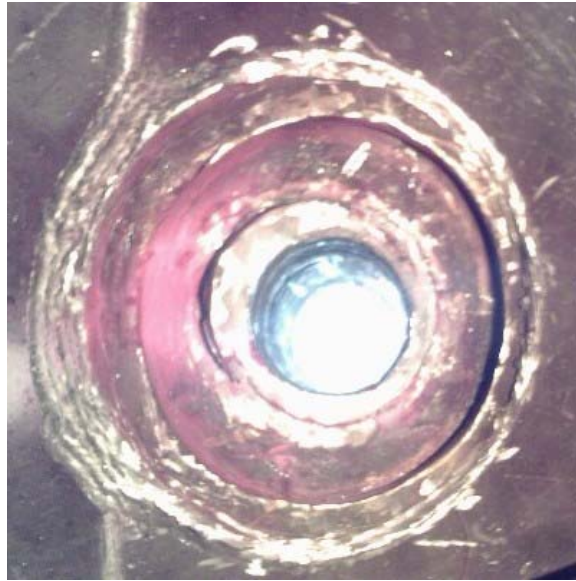
Figure – 21 : After removal of big and small pad plate

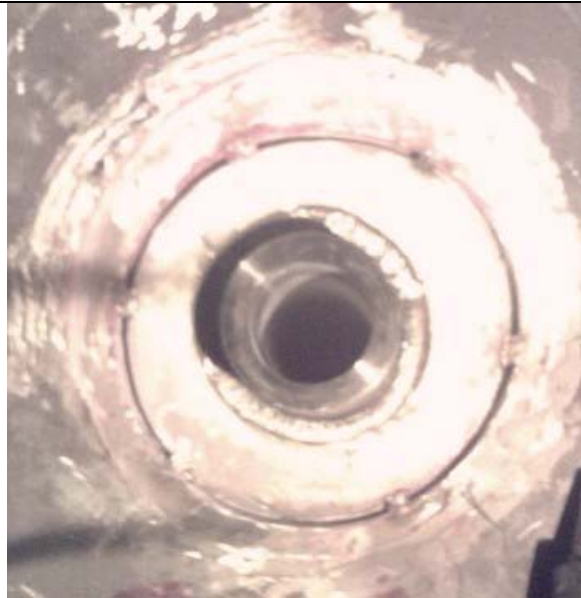
Figure – 21 : Welding of small pad plate

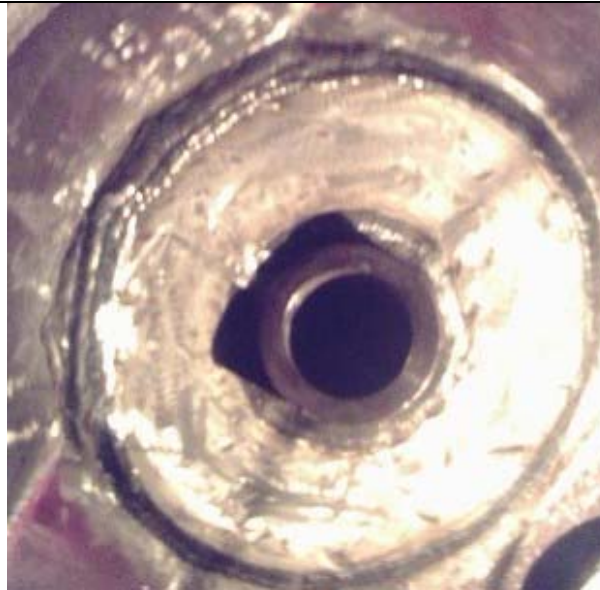
Figure – 22 : After Final Welding

- DP check was carried out after root run and final weld and found OK.
- Radiography of the above joint was carried out after root run & final weld and found OK.

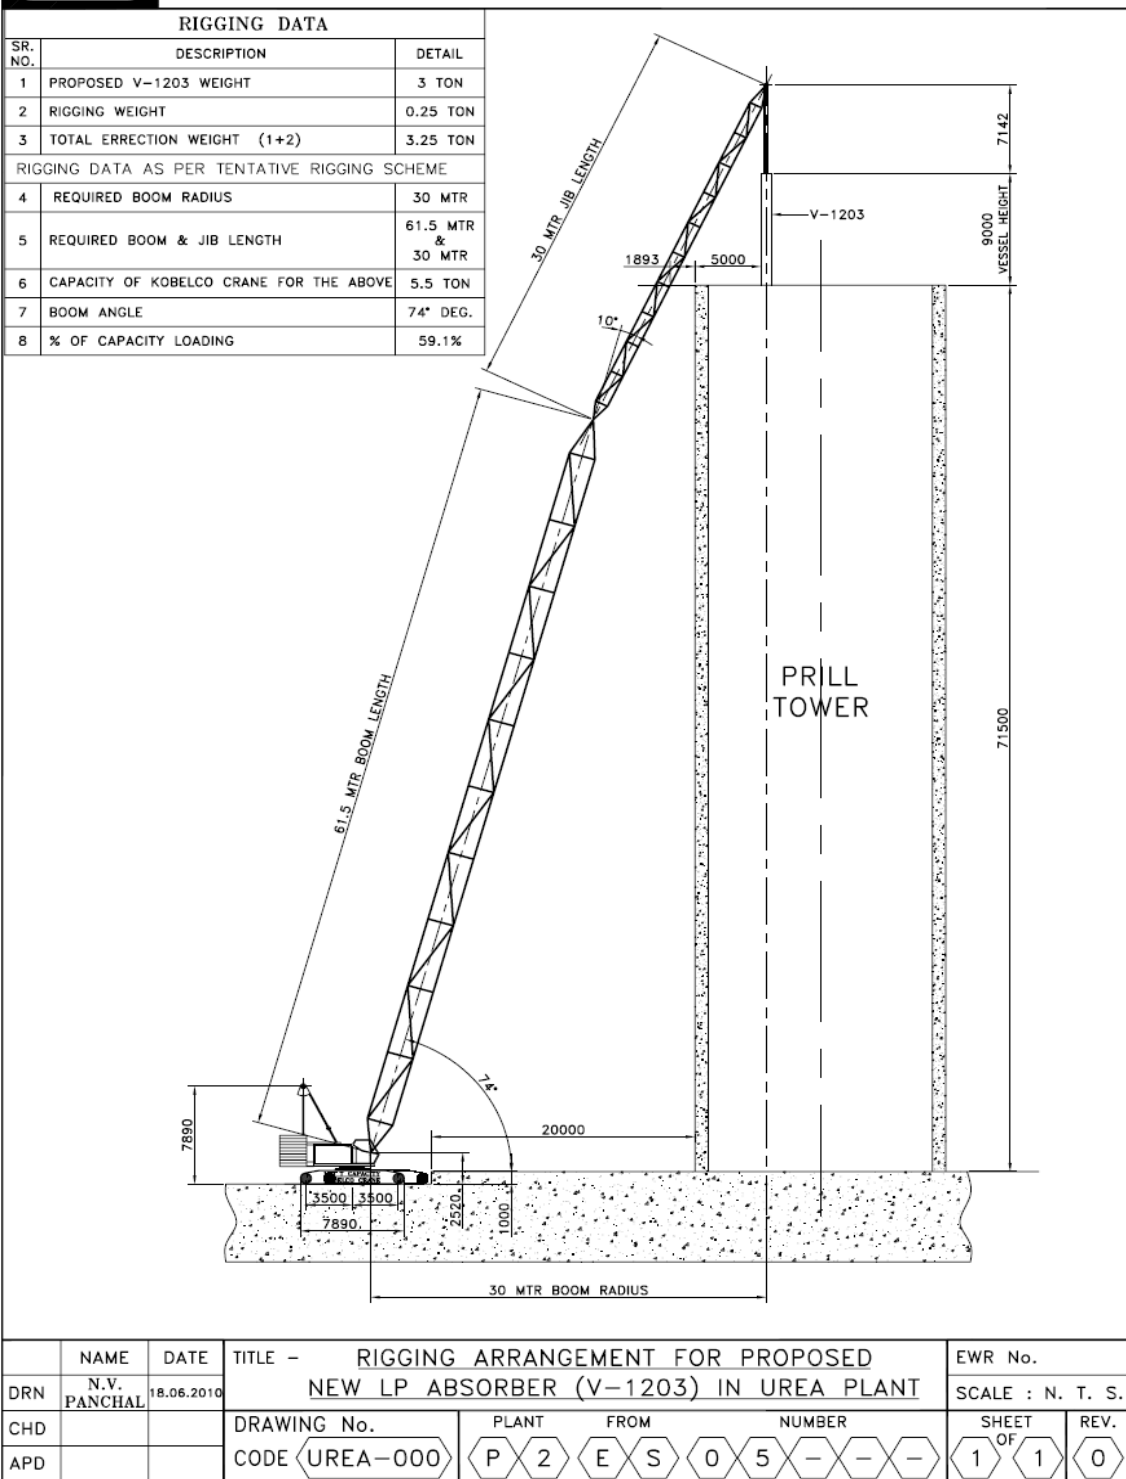
Figure - 26

Also during Annual Shutdown-2010, bulging of appx. 30-35 mm deep was observed just opposite to gas inlet nozzle on in west side of shell above Cir. Seam near nozzle of LIC-1203.

- Lifting of top shell as shown in figure – 27 and figure – 28. The platform grills were removed. However structure was not removed. The top shell was kept at PT top by Kobelco Crane (Weight- approx 1.0 T). (Ref Fig -)
 - The details of crane is given below :
 - Make - Kobelco, Japan
 - Model - CKE-1350
 - Capacity – 135 MT
 - Boom length – 61 m (200') + Jib assembly of 30 m (100')
 - Rigging arrangement is shown in figure – 26.

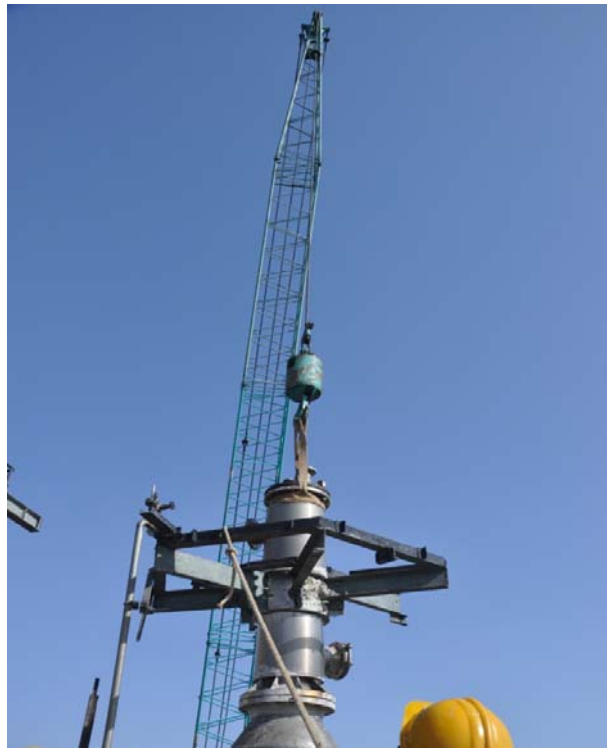
Figure - 27 : Kobelco Crane positioned for lifting top shell

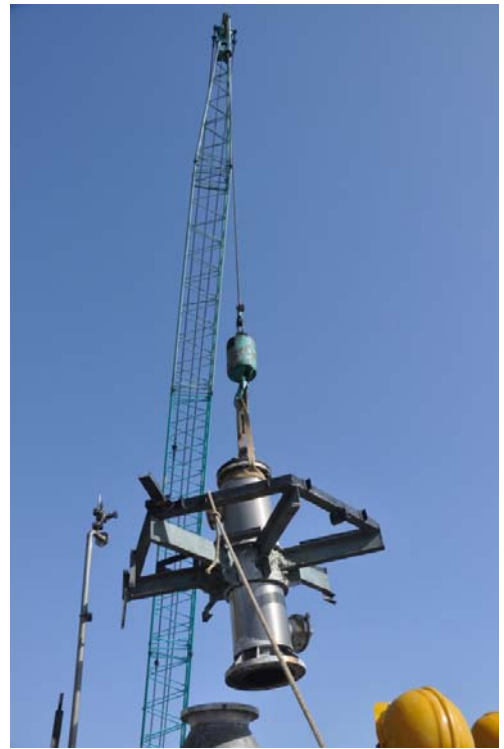
Figure – 28 : Top shell lifted by Kobelco Crane

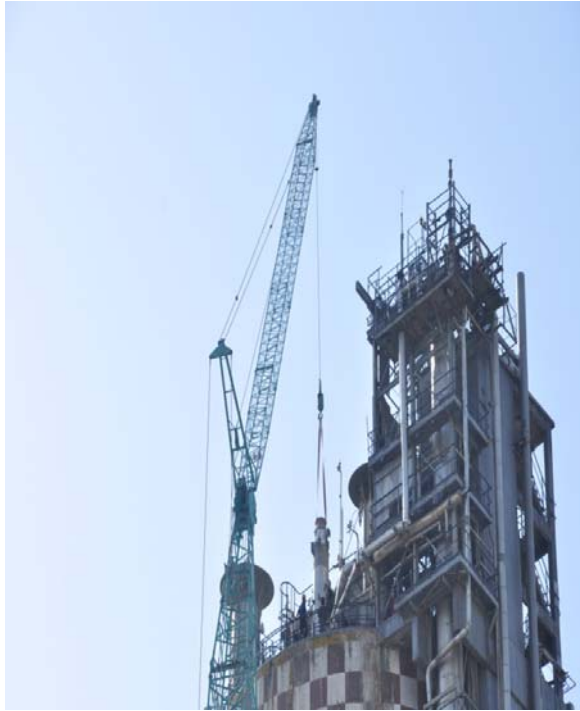
Figure – 29 : Kobelco Crane positioned for lifting bottom shell

- Removal of bottom shell from support after removing the nuts of foundation bolts (Weight- 2.0 T approximately) as shown in figure – 29. Platform and structures were completely removed before lifting.
- Lowering the top shell safely on the ground. The top shell was kept on the side of road near Dry ice plant.
- Removal of packing grids and other internals of bottom shell and fixing in new bottom shell.
- Checking and comparing the dimensions of new and old bottom shell

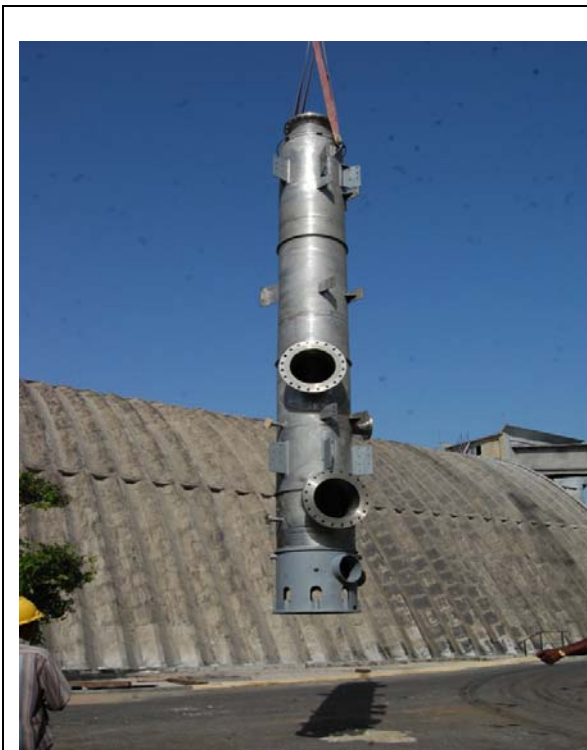
Figure – 30 : New bottom shell lifted by Kobelco Crane

- Cleaning of foundation.
- Lifting of new bottom shell and placing the same on foundation as shown in figure – 30 & figure – 31.
- Lifting of top shell and placing it on bottom shell and tightening after providing the new gaskets and bolts.(Nozzle A3/A4).
- Gas outlet line (Nozzle-C2) was lifted by crane and kept ready for installing.
- Leveling of vessel by water level and by keeping master level on top face of vessel.
- Grouting of foundation.
- Final tightening after grouting.
- Fixing of packing grids and other internals of bottom shell.
- Fixing of packing grids and other internals of top shell.
- For additional clamping of the grid was provided by welding plate at bottom of existing packing support plate and providing clamping arrangement.

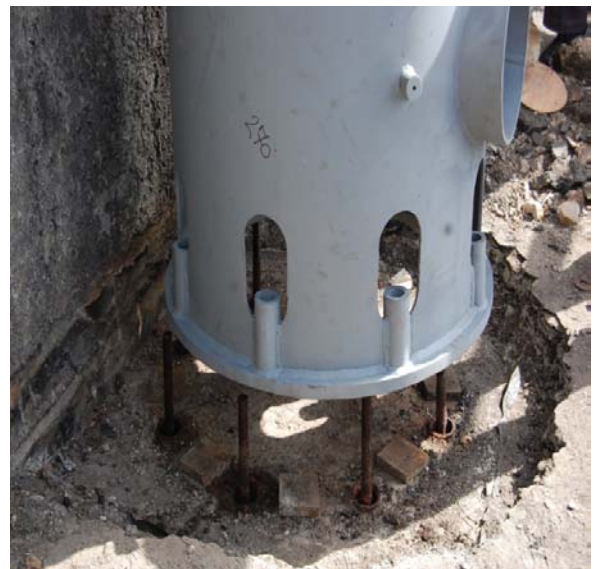
Figure – 31 : New bottom shell being kept on foundation

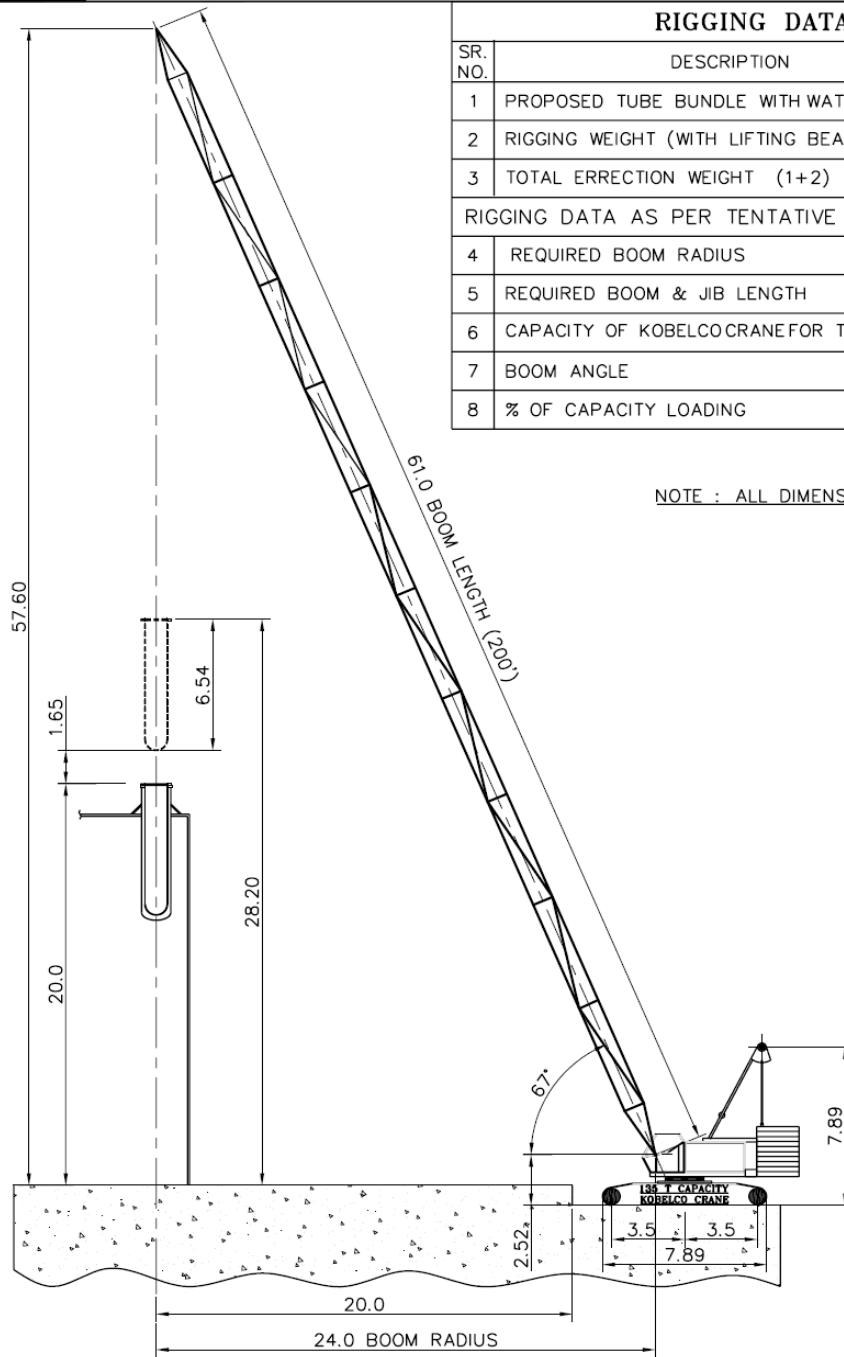
Short Shutdown of Urea Plant was taken at 07-01-2011 to attend leakage of ammonia in CCS-I loop. Even after plugging tube,(1 No U tube) leakage of Ammonia was reported after start up. Ammonia percentage was maintained around 5% by continuous condensate make up & draining of CCS-I loop.

Before Shutdown, preparation was done for lifting of tube bundle, if required. Lifting beam of H-1205 was tested at 15 Ton at Crane Yard and DP test of weld joints were done. Weight of tube bundle as per Drg no.: AP 122 207 - 10.5 Ton. Weight of water was calculated – 2 Ton max. Hence total weight of tube bundle – 12.5 Tone. Drawing for rigging arrangement was made as shown in figure – 32.

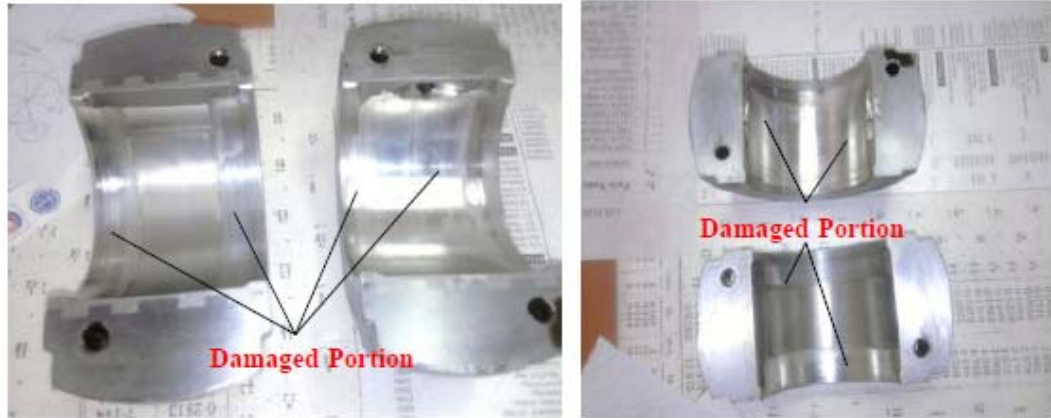
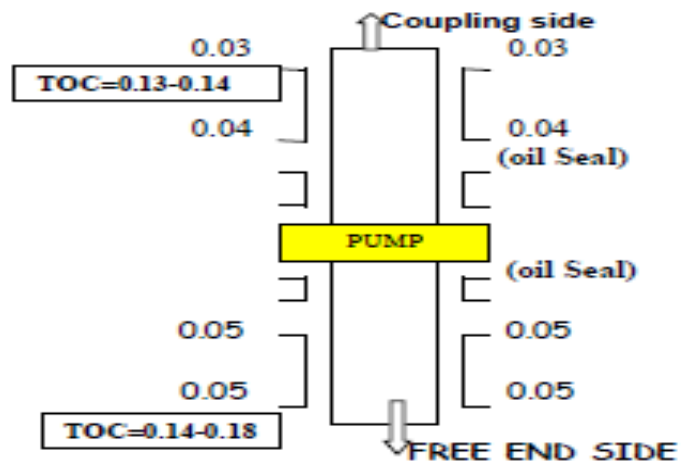
- Coupling float of Turbine to pump was measured and recorded.
- Alignment between turbine to pump was checked and recorded:
- Both Bearings of pump was opened, cleaned, checked.
- Pump inboard bearing was found in good condition.
- Pump outboard bearing was found in damaged condition having rubbing marks. So it was replaced with new bearing.

- After re assembling the bearings, clearances were measured.

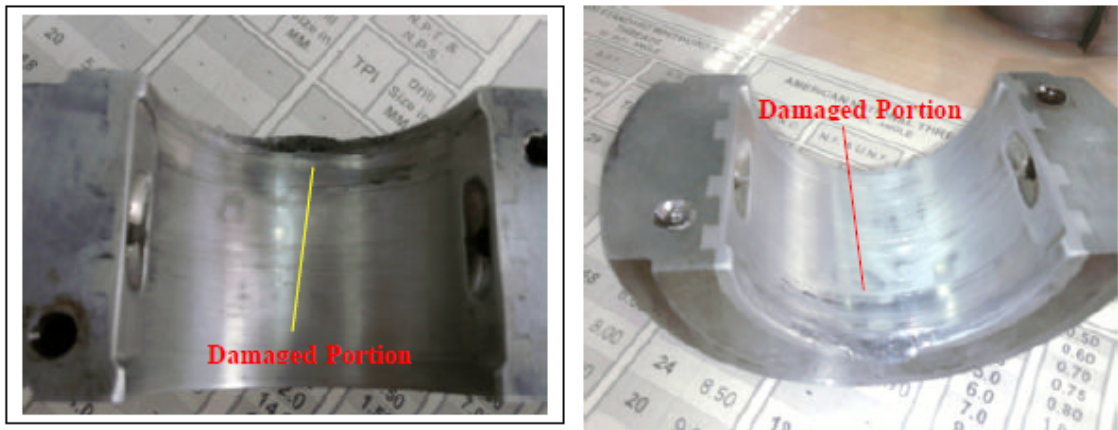
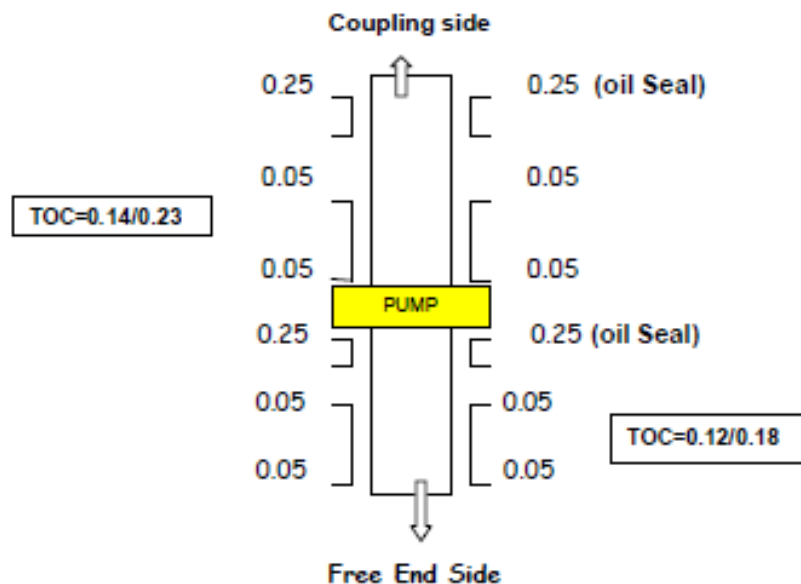
- Coupling float of motor to gear box coupling was measured and recorded as 4.50mm
- Coupling float of Pump to gear box coupling was measured & recorded as 8.30 mm.
- Motor and Pump was decoupled.
- Pump bearings were opened, cleaned & checked.
- Pump inboard was found in good condition whereas pump out board bearing was found in damaged condition.

- Pump outboard bearing was replaced with new bearing
- After re-assembly, Bearing clearances of Pump was measured and readings are as under:

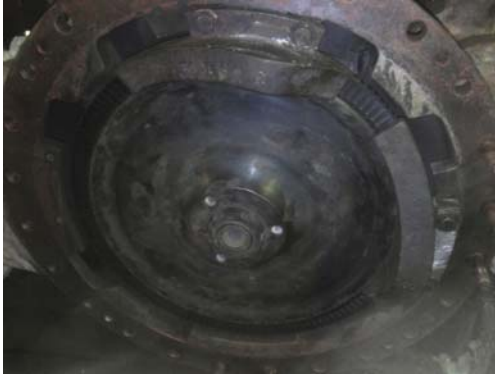
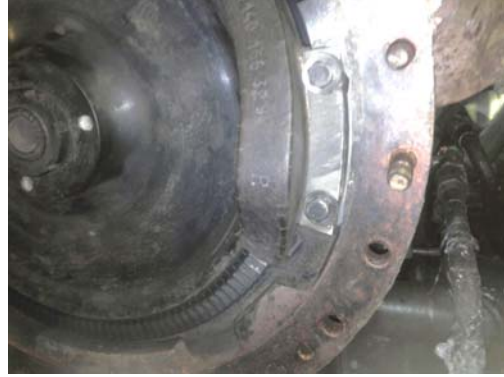
- During opening of Turbine front side reversing chamber, it's one end at bolting hole area gets broken which was initially in cracked condition.
- For proper holding of reversing chamber SS plate of 5 mm thick was placed on it and tightened.

- Following clearances were maintained during reassembly
 Front top Reversing chamber & Wheel clearance = 0.90 mm
 Front top Reversing chamber nozzle clearance = 1.55 mm
 Front side Reversing chamber & Wheel clearance = 0.80 mm
 Front side Reversing chamber nozzle clearance = 1.80 mm
- Regulating and Emergence valve spindle travel was also checked and recorded as 21 mm
- Final Clearance chart is as under:

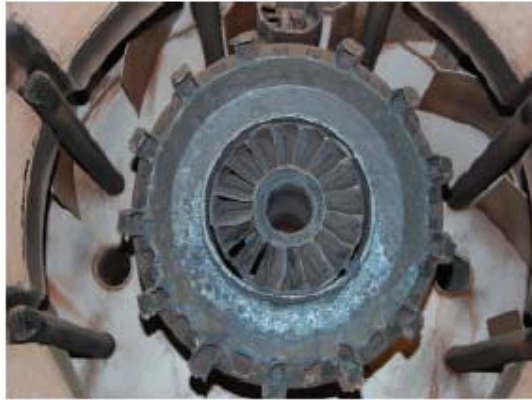
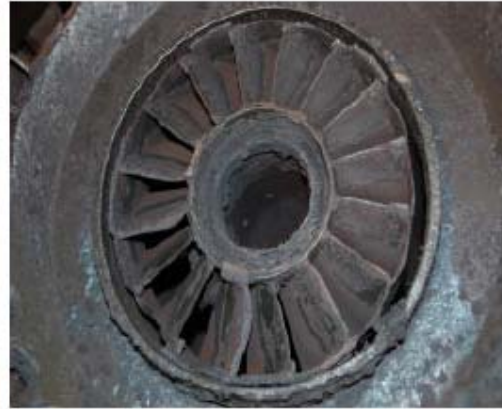
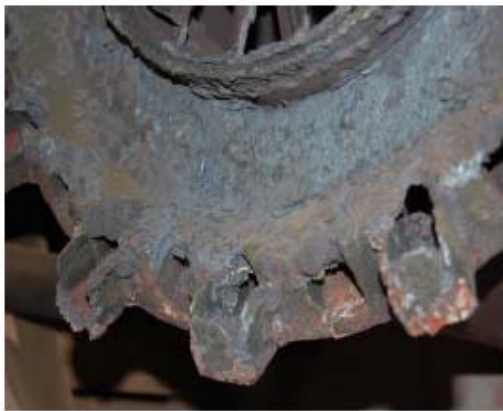
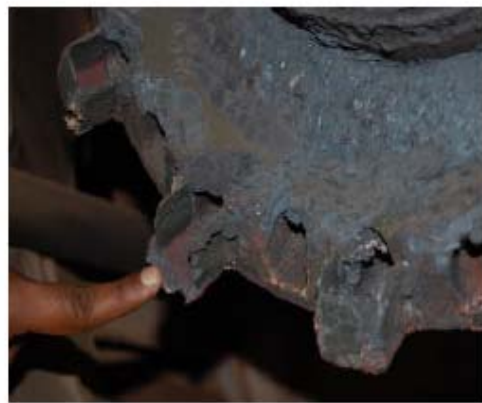
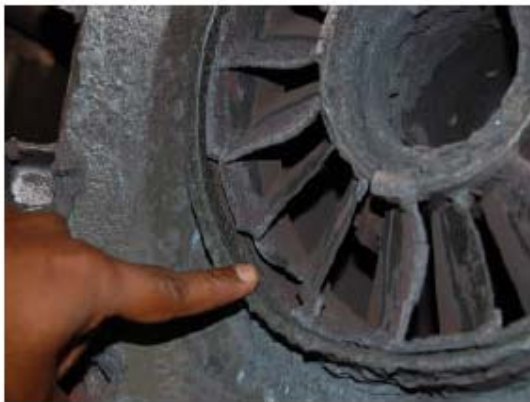
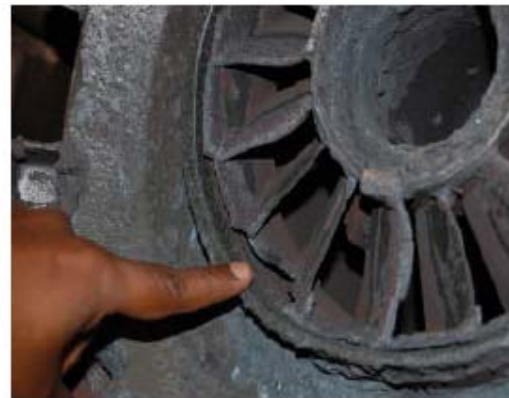
- Steam drum connected all first and second isolation valves gland packing were repacked. M/s Amrutha Engineering was engaged for valve gland repacking job. (Ref: WO No 20090923 dated 05/12/2009 & Amendment dated 24/011/2010).
- All 4 nos. inspection window glasses were checked & cleaned. Two Nos of broken window glasses were replaced. Gaskets of all window glasses were also replaced.
- All dampers of air duct (FD Fan Inlet & Outlet damper, RAH Inlet, Outlet & Bypass damper) were checked and made free by greasing for smooth operation.
- Boiler furnace burners were visually inspected and burner impeller and nozzle tips of both top and bottom syn gas burners were found in burnout condition and the same was shown in the attached photographs

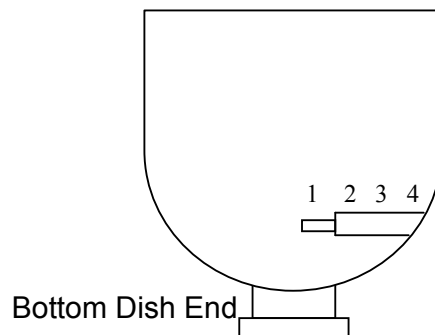
RADIOACTIVE SOURCE WELL

POINT NO.	DESIGN THK.	MEASURED THICKNESS			
		EAST	WEST	TOP	BOTTOM
1	7.5	8.46	8.23	8.57	8.27
2	19.0	18.52	18.29	18.64	18.58
3	19.0	18.75	18.36	18.89	18.58
4	19.0	18.72	18.38	18.77	18.46
