KALOL UNIT

PLANT TURNAROUND REPORT

(MARCH - APRIL - 2011)

INDIAN FARMERS FERTILISER CO - OPERATIVE LIMITED

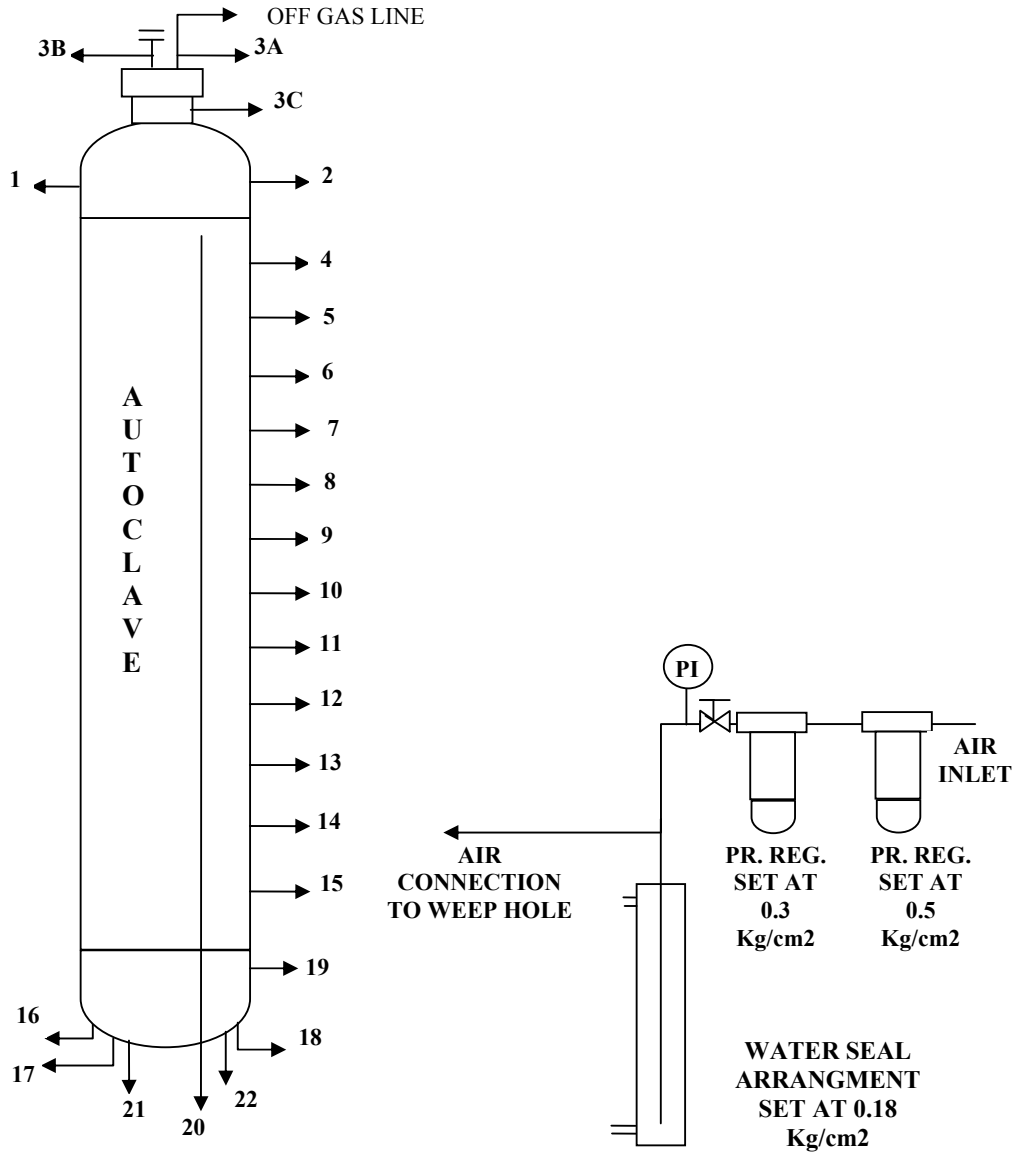
DETAILS OF AIR TEST TO BE CARRIED OUT ON AUTOCLAVE AMMONIA INLET NOZZLE WELD JOINTS

The location of weep holes no. 16, 21 and 22 were air tested. Air test arrangement made is shown below.

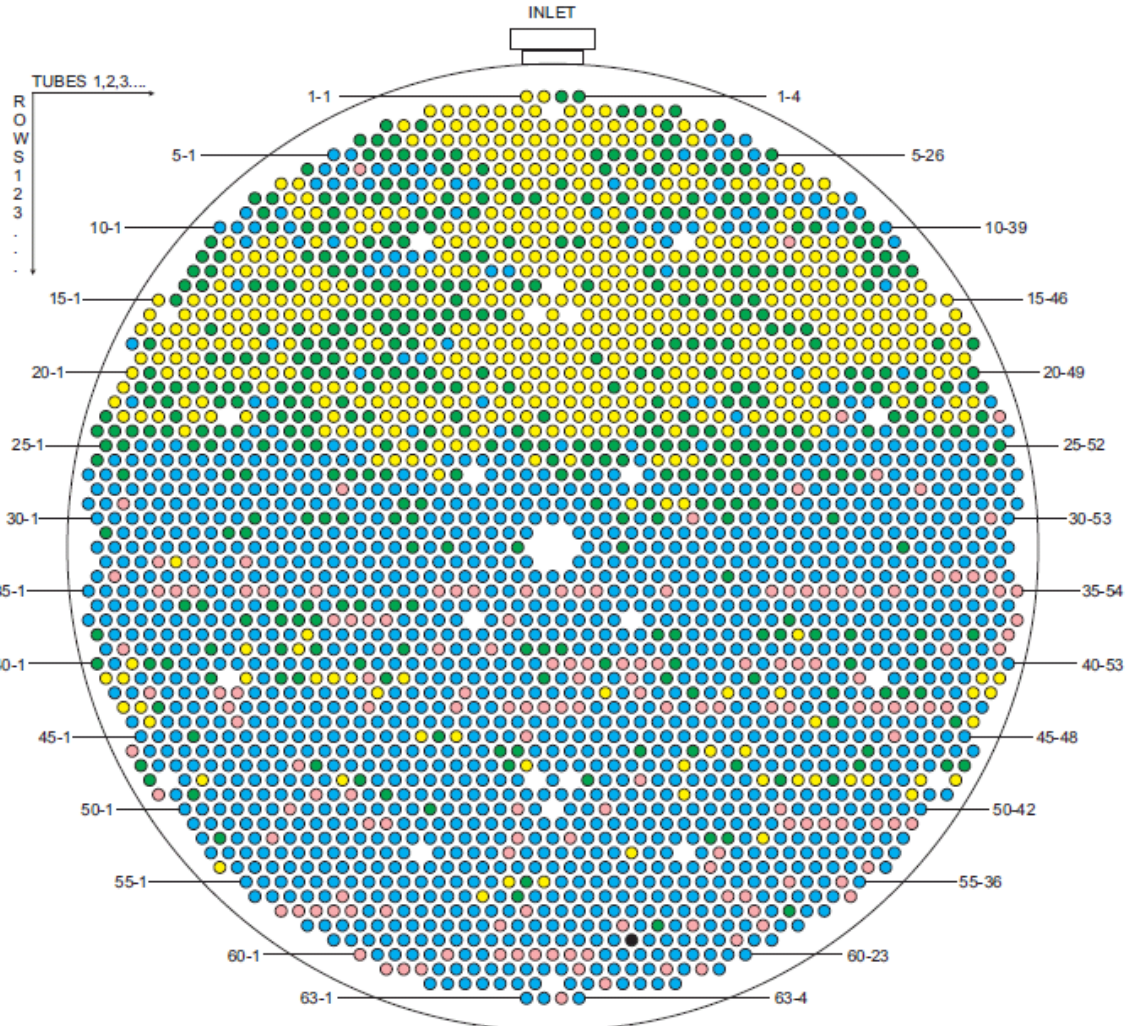
UREA STRIPPER
H-1201/A

Denotes: Wall Loss
