MTC / REPORT / 01
REPORT NO. 33 / 2013

IFFCO

KALOL UNIT

PLAN TURNAROUND REPORT

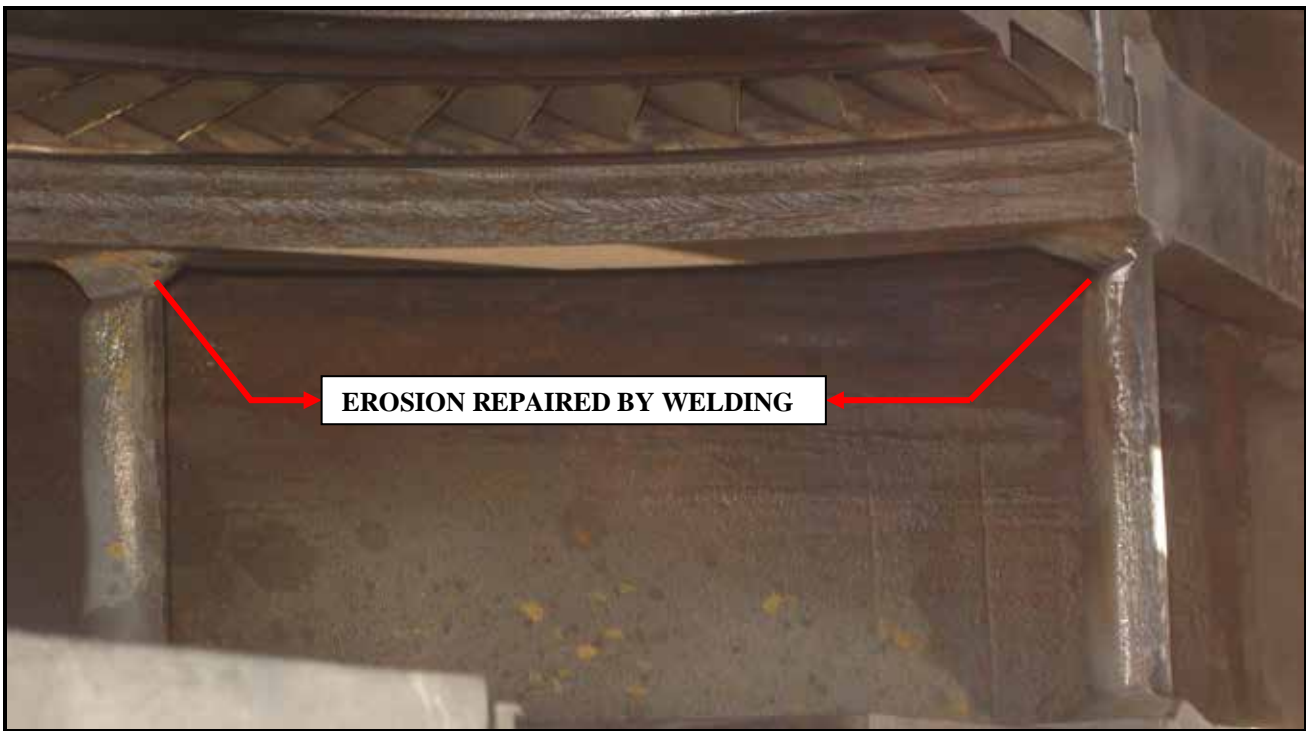
The turbine was taken for complete overhauling after a span of three years to attend heavy gland leak at the steam inlet end. Turbine was decoupled and exhaust pipings were removed. The top casing was removed and all internal radial as well as axial clearances were noted. The bearing clearances were measured and removed for inspection. The rotor was removed and cleaned by sand blasting. The coupling hub rear flange was found to be having a number of bends which may have occurred during rotor float /thrust measurement. These bends were repaired. The top and bottom diaphragms were removed and cleaned by sand blasting. Sand used for cleaning was Kurunda Sand having negligible magnetism level of 0.01 gauss. Heavy erosion was found at the welding joint of one of the reinforcement rods for the diaphragm holders in the bottom casing. This was repaired by welding.

101-JT ROTOR AFTER CLEANING

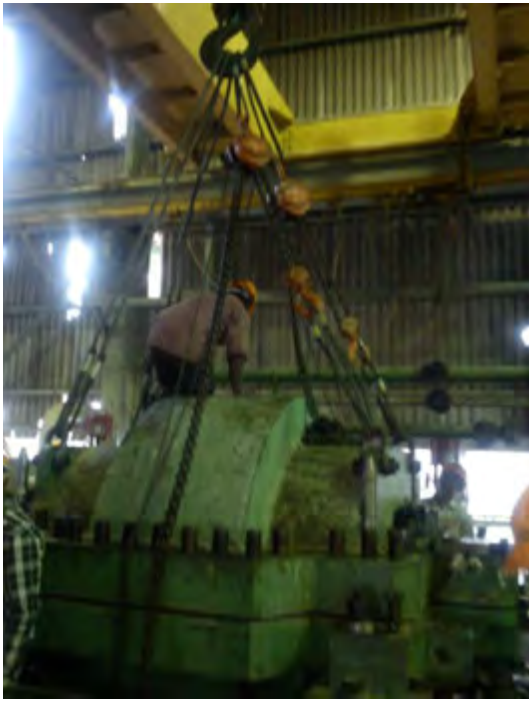
Lifting arrangement of top casing of LP case -1

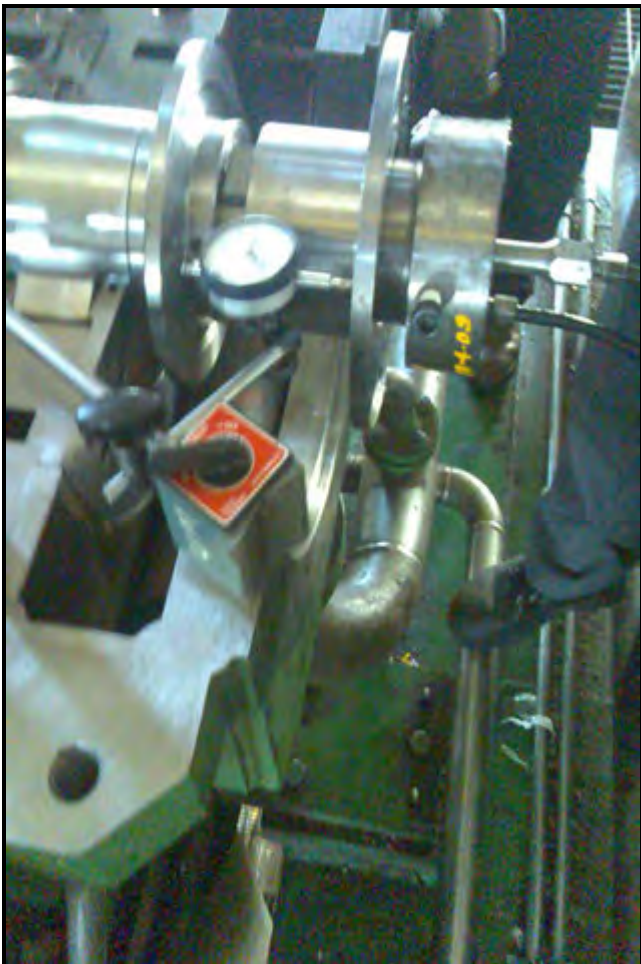
Installation of Coupling Half

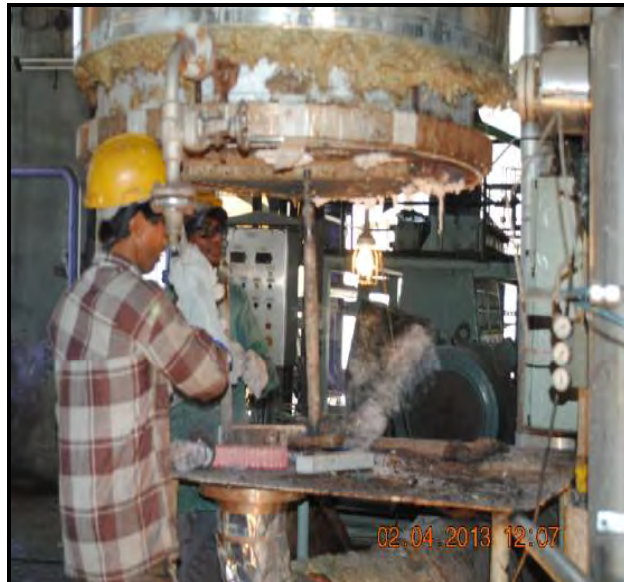
Removal of orifice plugs from bottom tube sheet
