MTC / REPORT / 01
REPORT NO. 35 / 2015

PLANT TURNAROUND REPORT

(MARCH – APRIL – 2015)

INDIAN FARMERS FERTILISER CO – OPERATIVE LIMITED

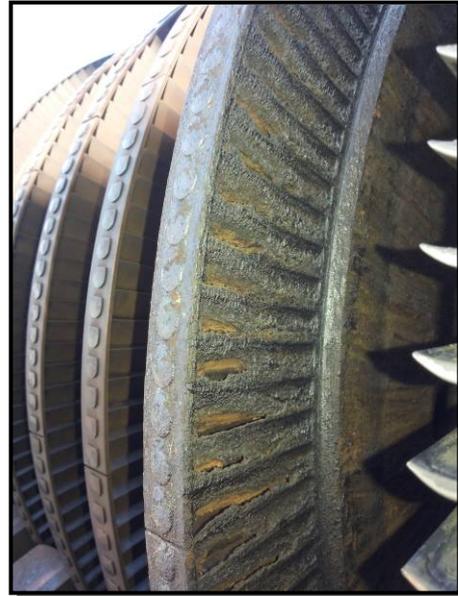
5th stage blades was having deposits and it was choked badly

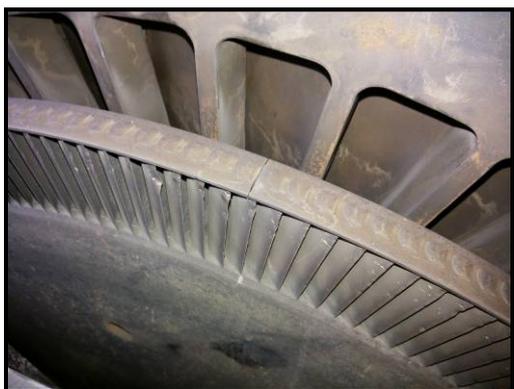
Turbine Casing Parting Plane bolts removed & top casing half lifted from position. The steam inlet strainer was found damaged and some portions of blades was having minor damages. The damages were rectified. Top casing half was cleaned properly by hydrojetting. Diaphragm parting plane bolts removed & top portion lifted out of turbine. Turbine Rotor was lifted from bottom casing after recording all internal clearances. Turbine rotor was thoroughly cleaned by sand blasting. Turbine Rotor was placed in bottom casing & all the readings were recorded.

Some portions of rotor blades was having minor damages

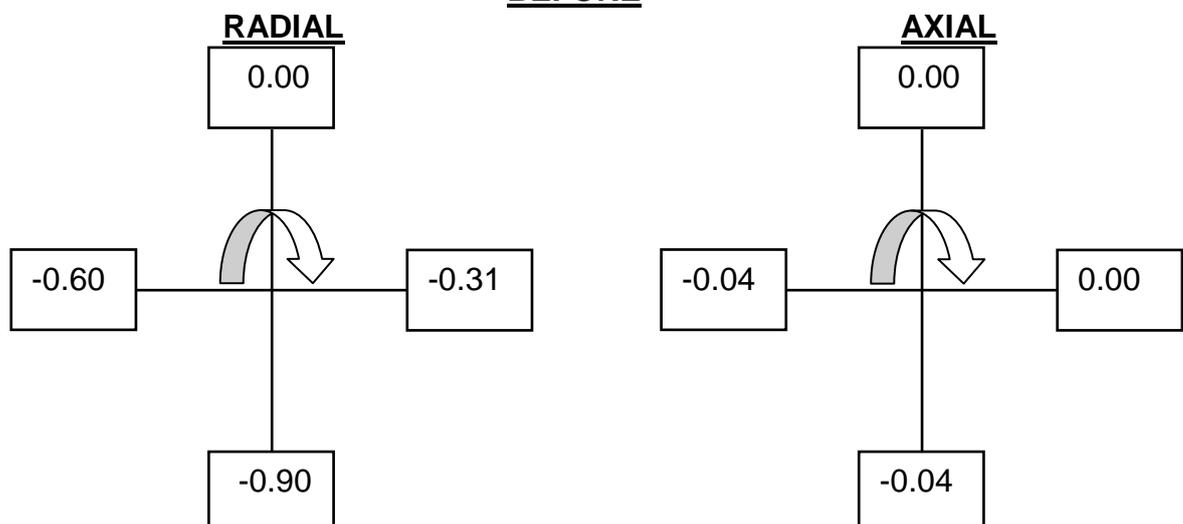
BEFORE

ALIGNMENT READINGS: 107-JT to 107-J

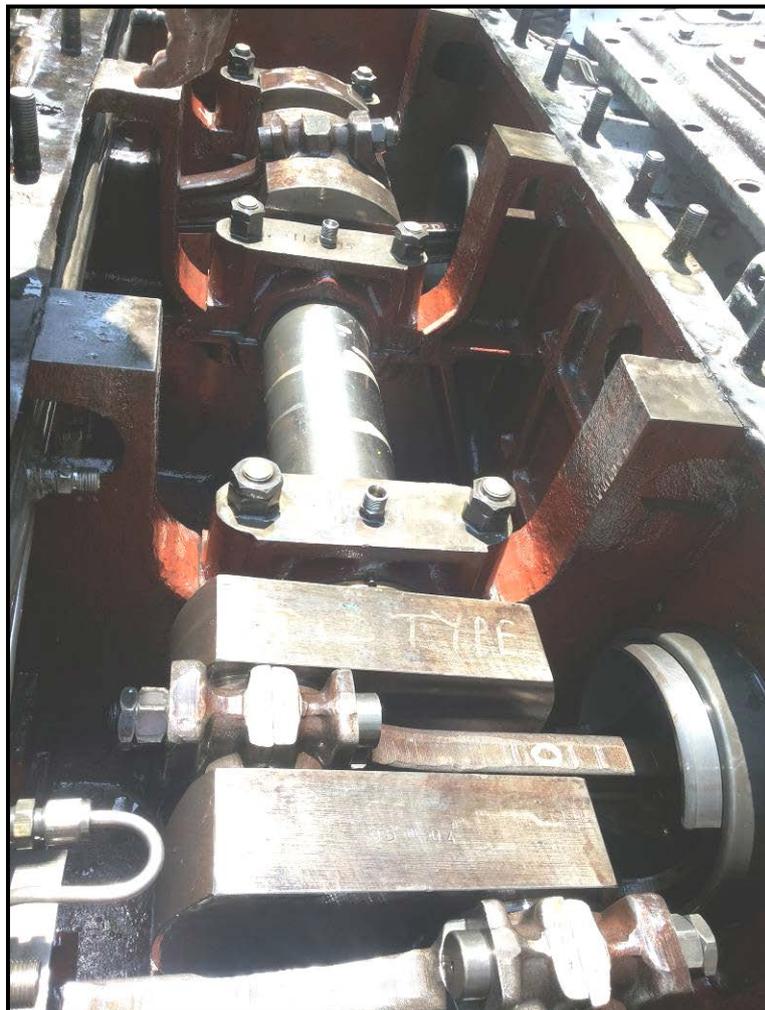
Opened the crank case cover for the inspection of the bearings and other internals. Clearances of all the big end bearings were found on higher side and the white metal lining had worn out. These bearings were replaced by new ones. All other components were visually inspected and found OK. All the clearances were measured and found within limit. All critical nuts were tightened at respective design torque. The AOP was run and oil flow inside the crank case was checked and found OK. The oil scrapper rings were replaced by new one.

Crank case opened

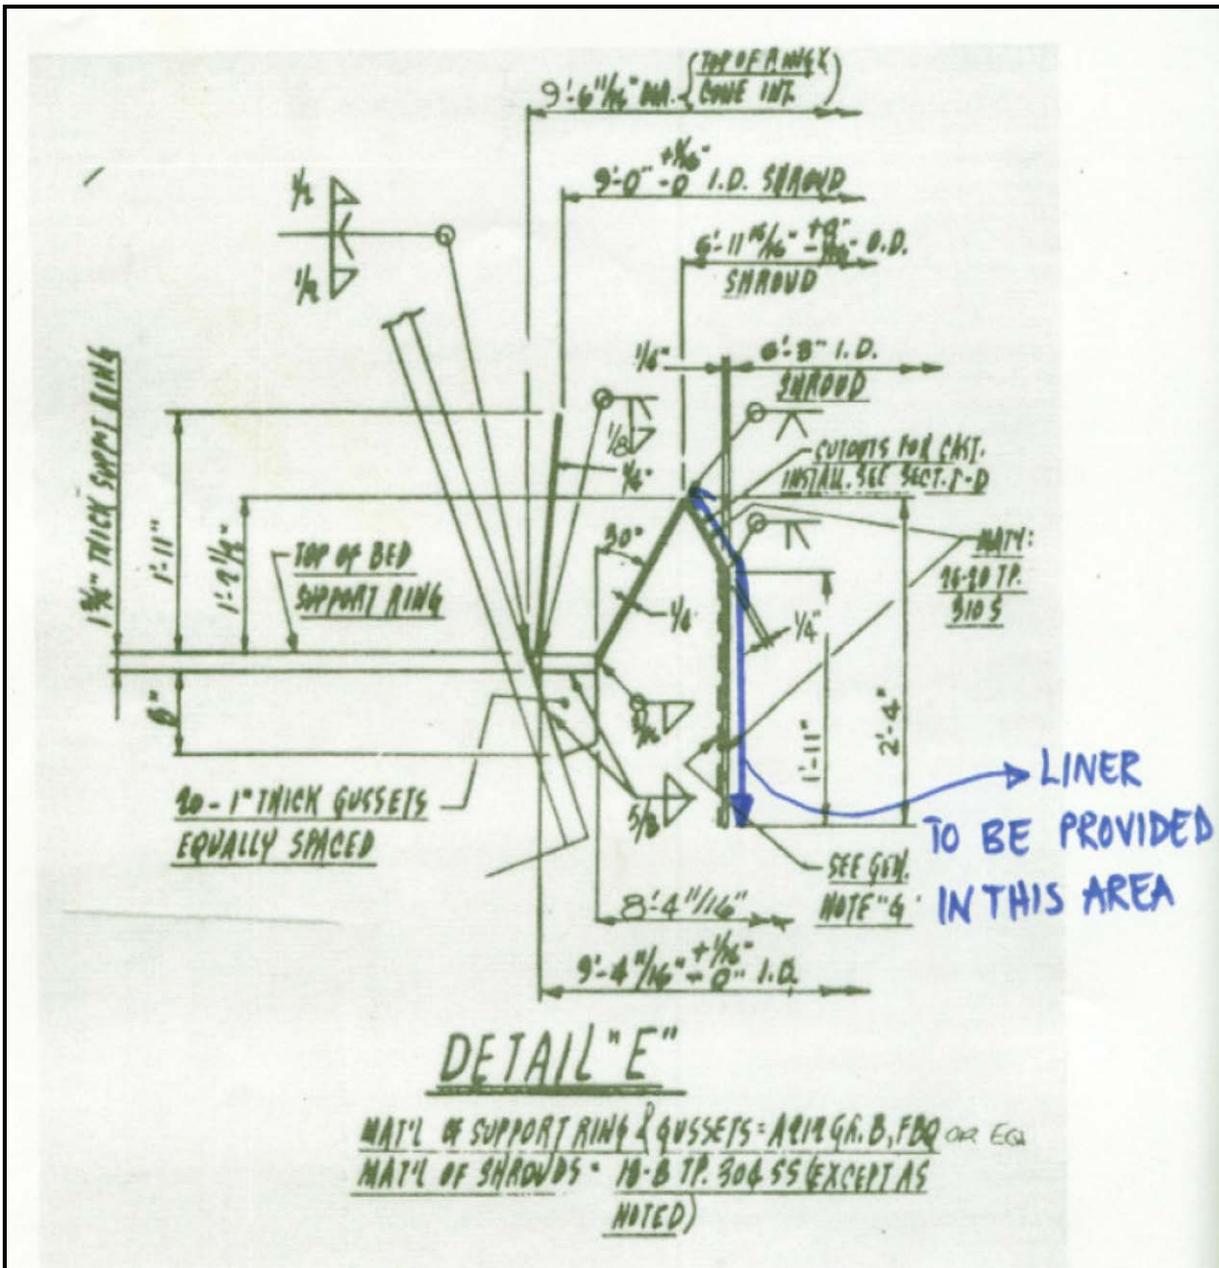
Before Shutdown it was decided to provide a sleeve of 6'3" ID and approx. 2'4" height of Incoloy 800 H material inside the circumference of 103-D below Bed support dome. (Ref IFFCO drawing 01-BN-03003 and attached sketch-Detail E below).

After opening of bottom cover, inspection was done. The refractory was found intact and its condition was good. Hence it was decided not to provide the sleeve.

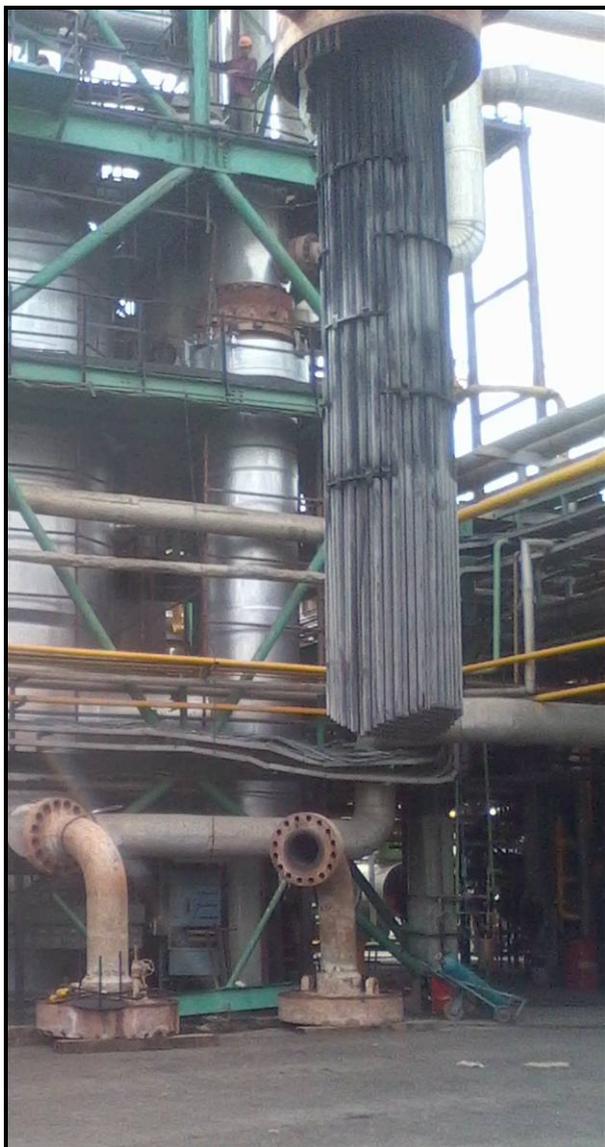
Replacement of Outer & Inner Tube bundle Assembly carried out by the help of KOBELCO Crane. We have replaced the Tube bundle of 101 CA during last shutdown SD-2014 after it was damaged due to failure of chain block. The tube bundle installed in 2014 was in service for over a long period and hence it was decided to replace the Tube bundle during this Shutdown SD-2015.

Tube bundle was lifted and installed by Kobelco crane

Tube bundle Assy. was replaced by KOBELCO (135 T) crane with 95 ft boom length & 16.5 Mtr. Boom Radius with 5' sheave assembly.

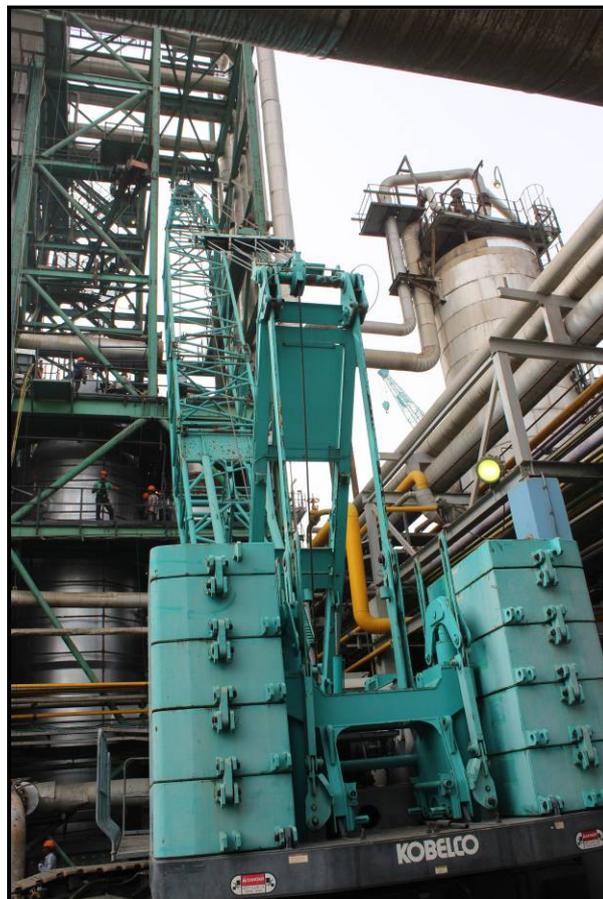
The overhead trolley and beam was removed to remove fouling

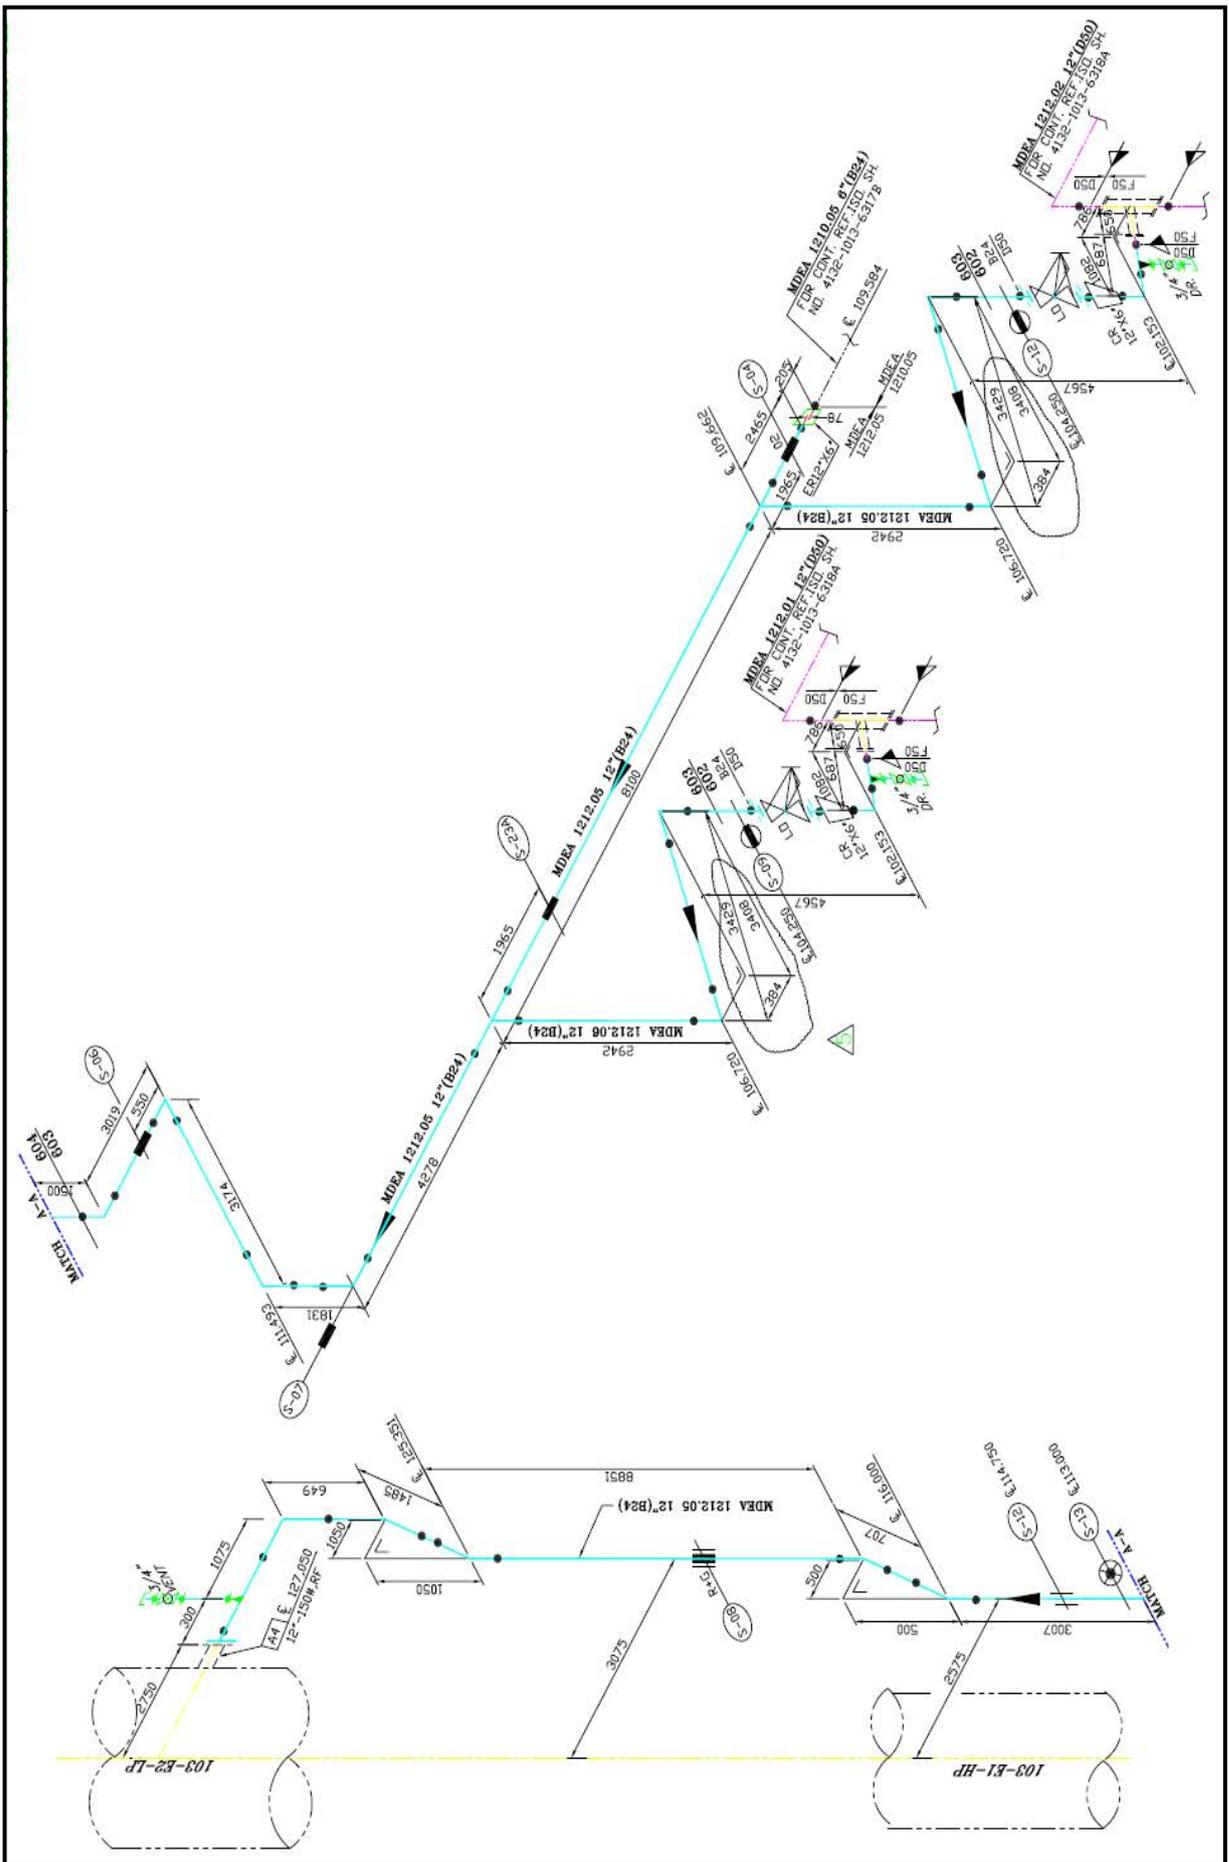
Isometric Drawing of Line No. : MDEA-1212.05-12" (B24) & MDEA-1212.06-12" (B-24)

In recent past, frequent aMDEA leakage problem occurred in common minimum flow line of semi lean solution pumps, 115-JA & 115-JB and split stream solution pumps, 116-J & 116-JA where patch plates were welded to arrest the leakage but leakage still persist. Therefore, it was decided to replace the complete line i.e. Line Nos. MDEA 1210.05 6", MDEA 1210.06 6", MDEA 1212.05 12" & MDEA 1212.06 12" by SS304 material.

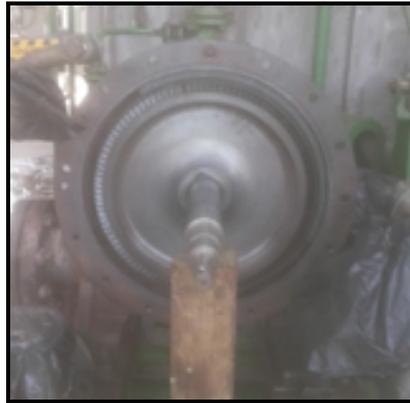
View of rotor of turbine

- Removed the rotor and sector and found good in condition.
- Cleaning of old rotor was carried out with emery paper and Corium Z-97.

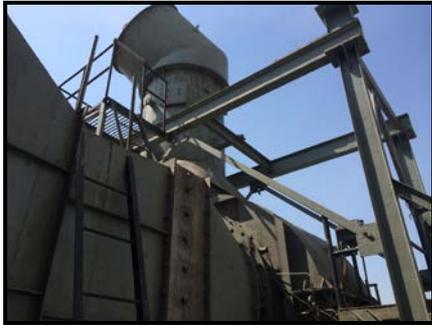
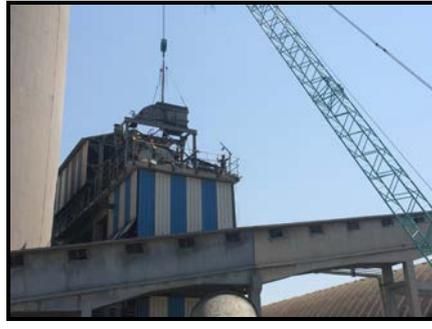
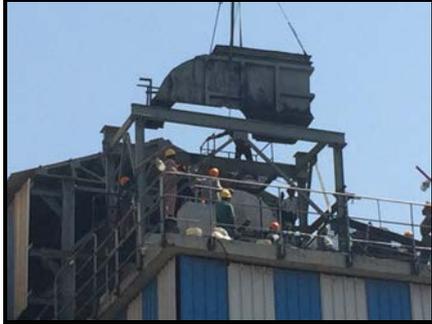
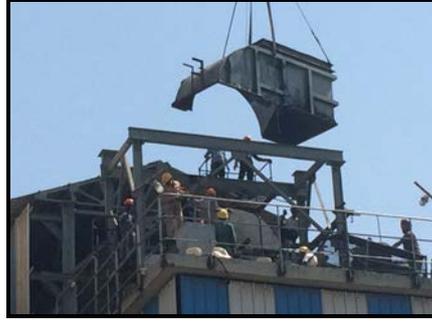
Frequent failures of Fan Drive End bearing were occurred in the month of Feb & March-2015 and all these failures are mainly due to looseness of Bearing adapter sleeve on the fan shaft. OD of shaft at the bearing portion is damaged and became undersize due to scoring on the shaft surface. (See pictures below)

For the removal of fan shaft, first it was tried to remove the fan shaft by jacking it towards the derive end side, and for that pulley and drive end side bearing was removed and fan impeller was locked in the casing. Even after heating the fan hub by gas cutting and hydraulic jacking the shaft, it could not moved. So finally it was decided, to lift the complete rotor by removing the fan top casing half and exhaust hood.

So fan exhaust hood and top casing half was removed by lifting with the kobelco crane.

So it was decided to replace the fan shaft in the shutdown.

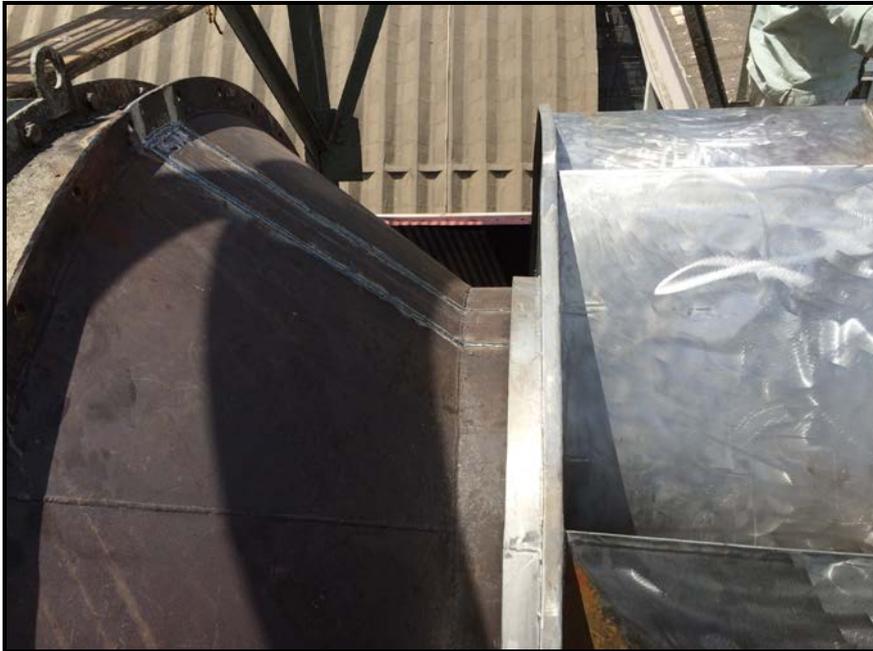
For the easy lifting/removal of Fan rotor, a top segment of suction cone was also cut which was re-welded after positioning of fan rotor which is shown in attached photograph.

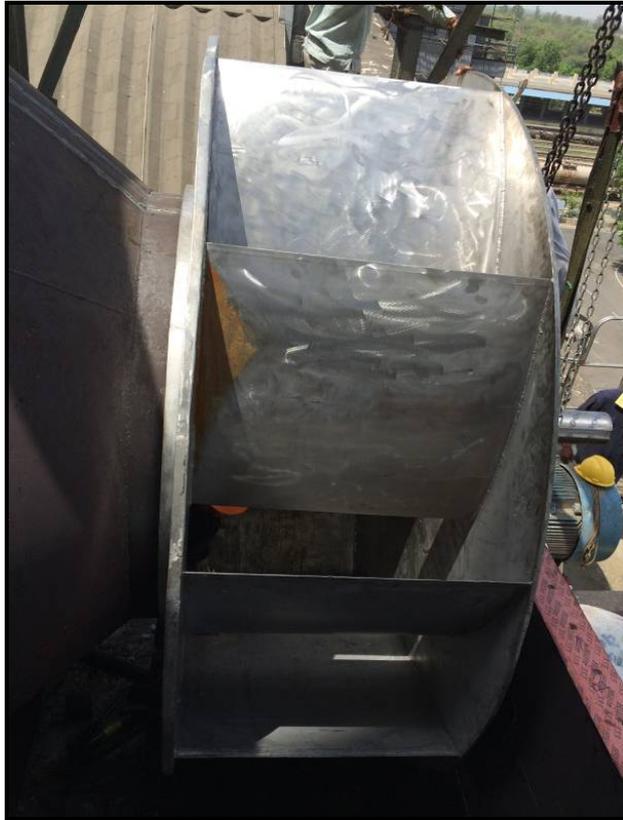
Refurbished rotor of fan was again positioned in the bottom casing and then top casing half and exhaust fan hood was again bolted in the position. Painting of exhaust hood and top casing was done before reinstallation.

During final assembly of Fan rotor drive end side bearing housing, both ends Bearings SKF 22328 CCK C3 W33 along with its adapter sleeve H2328 were replaced.

After assembly of bearings, final clearance was maintained as 0.10-.012 MM.

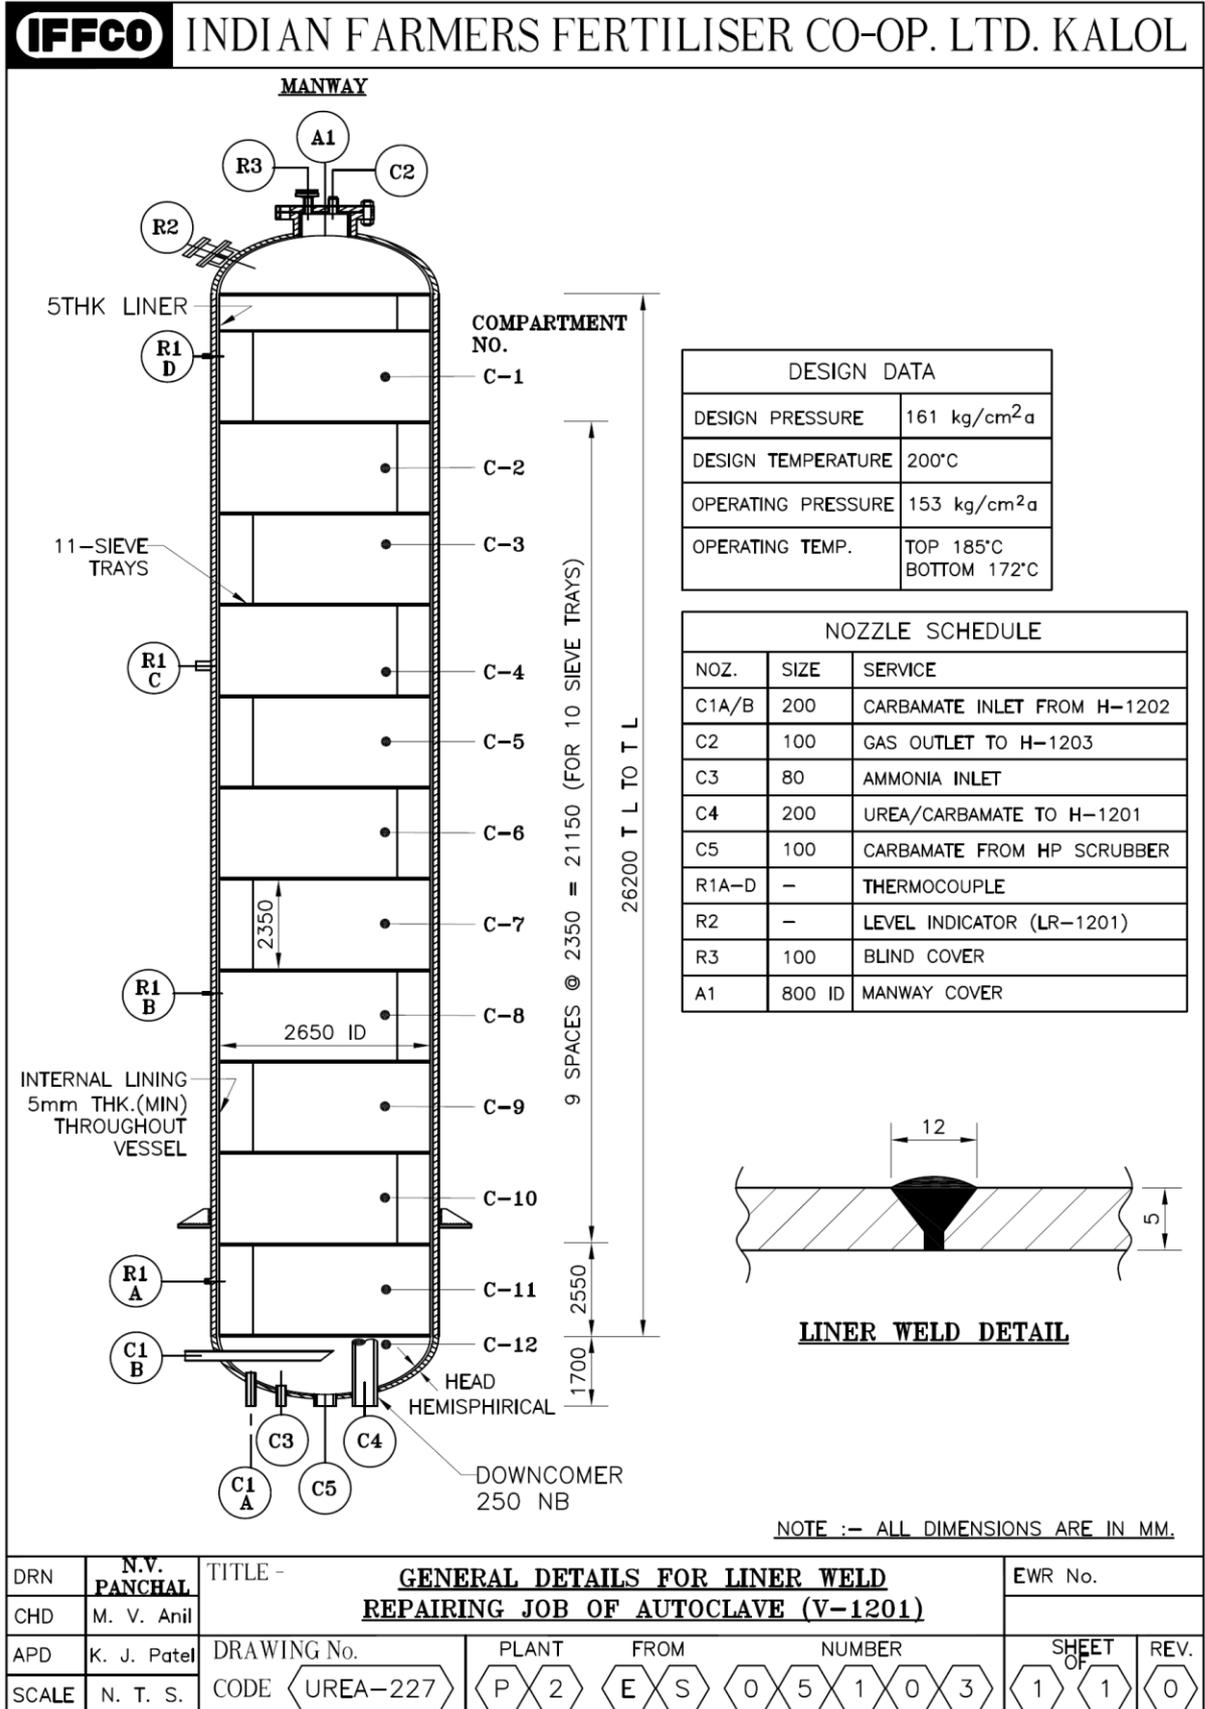
Liner welds of each compartment of V-1201 were most affected by corrosion. It was decided to repair liner weld one by one during shutdown.

During shutdown 2015, repairing of liner weld of 9th & 10th compartment was carried out. M/s Shree Ganesh Engineering, Ahmedabad (CPA 201004151419) was engaged along with our own fabrication and inspection group for above job.

The following repair procedure was followed:

- Weld area was cleaned by SS wire brush.
- Welding joint was ground and flushed. Visible pitting / pores were removed with Grinder and surface was made smooth. It was ensured that grinding was not done deeper than 2 mm below the surface of liner.

- Corroded area of Heat Affected Zone of joints was also grinded and removed.
- DP of grinded portion was carried out. Porosity observed was removed. However if the porosity extends deeper than 2 mm below the surface of liner, it was fused while performing welding.

- Welding was done by TIG using 25-22-2LMn filler wire size -2.4 mm dia with low heat input.
- Inter pass temperature kept below 150 deg. C.
- Minimum three layer of weld was required. At some portions where the width was increased due to removal of corroded portion, an additional layer of welding was applied.

- It was ensured that no area was left ground without welding
- Final DP was carried out.
- Ferrite content was checked. It was found within acceptable limit (Max 0.6 %)

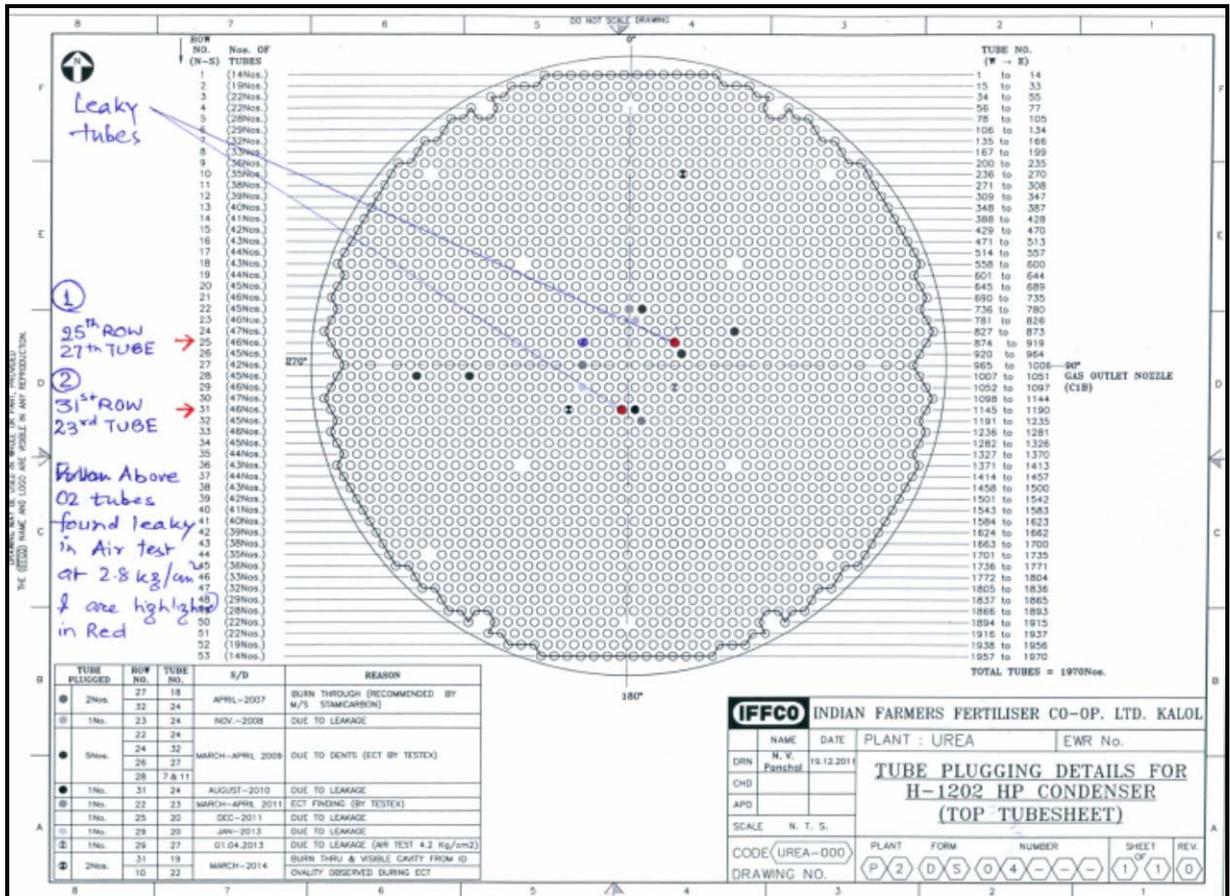
- Leakage was suspected in HPCC before shutdown, so air test was carried out after removing the internals 2.8 kg/cm² and in air test following O₂ tubes was found leaky.

- Row No. 25, tube No. 27
- Row No. 31, tube No. 23

- After that Eddy current testing of tubes was carried out and based on its finding Tube No.31 of Row No. 35 was plugged. In ECT wall loss of 31-40% was observed and internal pitting was also confirmed in boroscopic inspection.
- Based on visual inspection following repairs were also carried out.

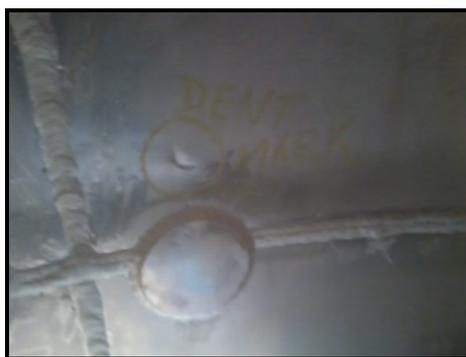
- 06 Nos of Marked crevice cavity in top channel head.
- Approx 1.5mm deep dent was observed on shell liner just above the dome to shell liner weld joint in North-West direction in bottom channel head, marked with Yellow chalk, which is shown in below Photograph.

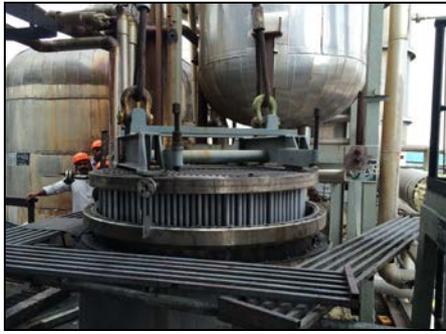
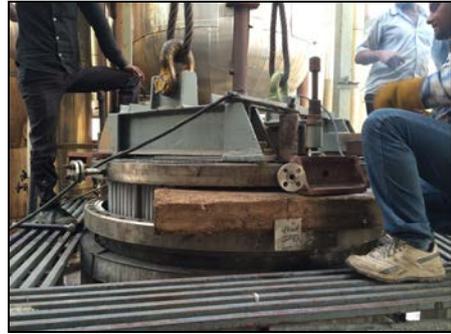
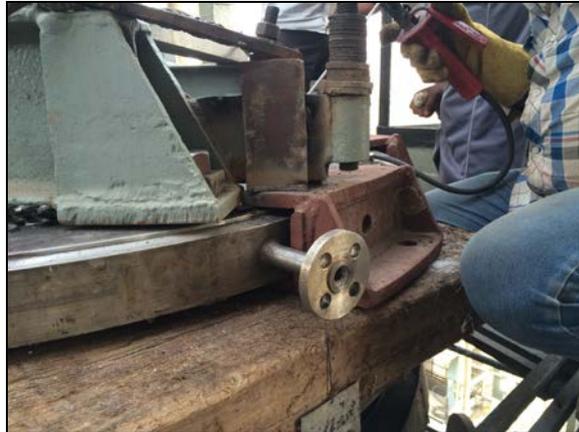
- To remove the tube bundle assembly, all connected pipe lines and steam tracing lines were removed and cut from suitable locations.
- Top dish end removed from position.
- Platform above LPCC was also removed.
- Specially lifting fixture was fixed in the eye bolt hole of tube bundle to lift it upto the height of 1 feet and the tube bundle was then wooden sleepers was placed under the tube sheet to enable to weld the special lugs to lifting fixture to transfer the load from eyebolt hole threads to fixtures for safe lifting of tube bundle. (See attached photograp)

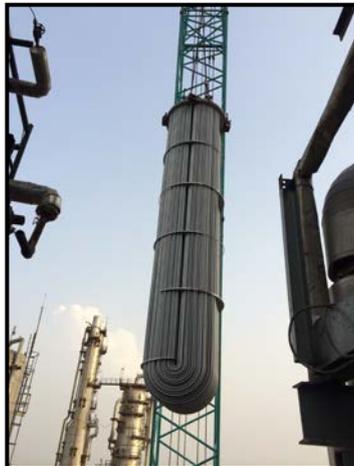
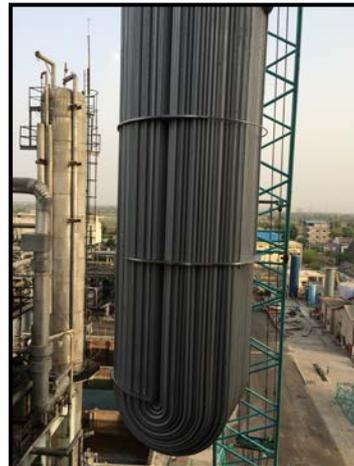
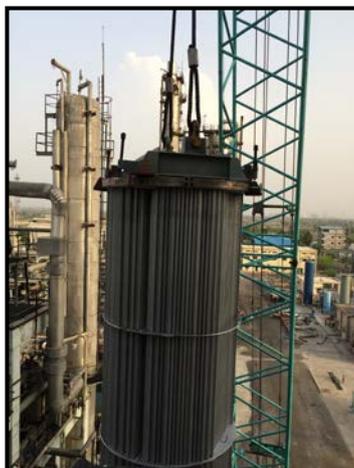
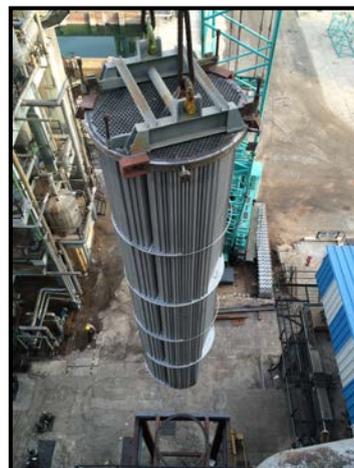
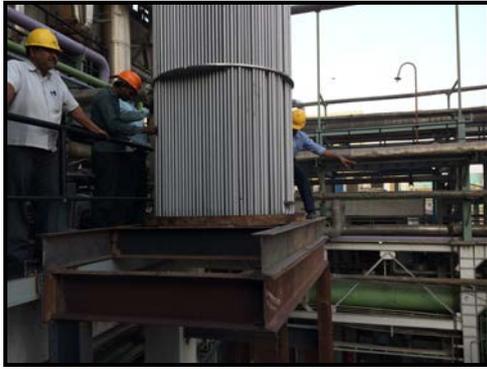
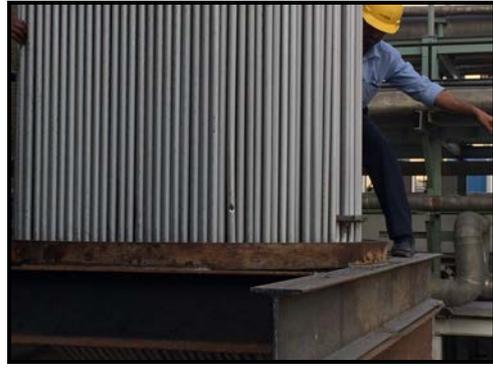
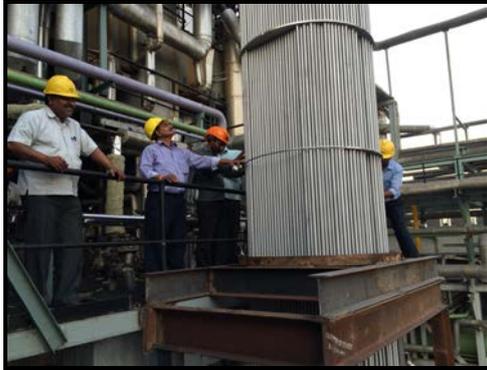
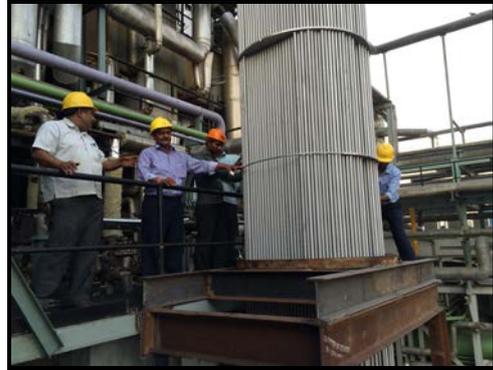
- The approx weight of tube bundle was 18 Tonnes.
- Finally tube bundle was lifted and placed on prefabricated stand as shown in attached photographs.

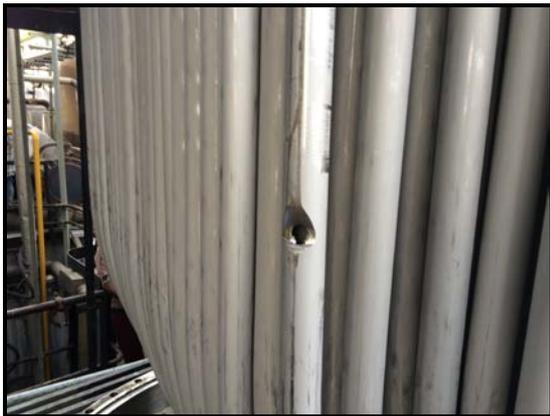
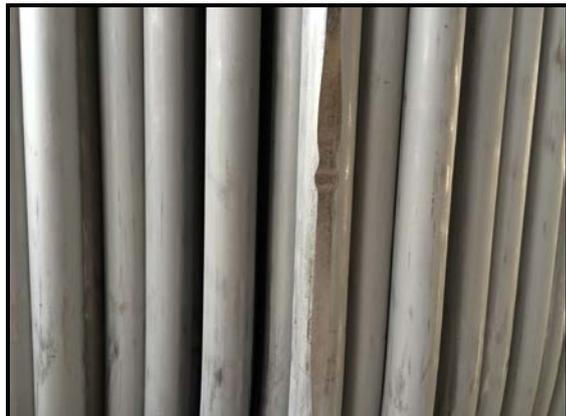
During removal of tube bundle it was observed that 12 mm dia ring welded with baffle plate was found rubbed with the tubes and one of the ring attached to bottom most baffle was found broken also.

Due to rubbing of this ring and tubes severe thinning on some tubes were observed and this was the prominent reason for the failure on one U-tube during Oct-2014. See the below attached photographs.

To arrest the tube bundle vibration and to stop further failure of tubes, following two steps were taken,

- Removed the 12 MM dia ring attached to all baffles, which was the dominant reason for the premature tube failure.

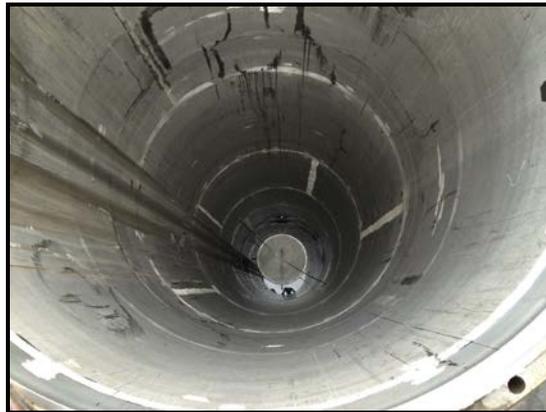
One no. of ring was found broken and lying inside the shell. (See attached photographs below)

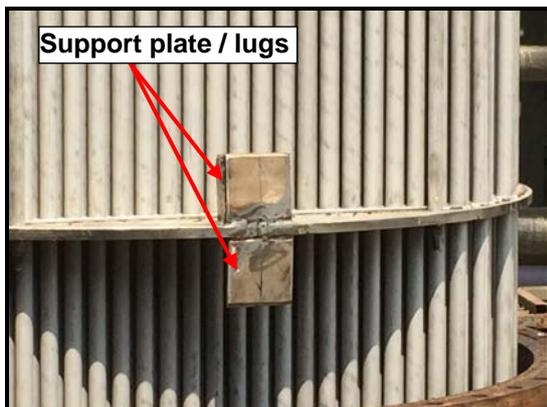
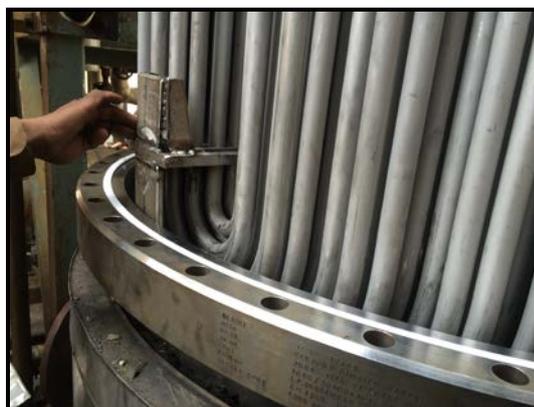
- Tube Baffle locking arrangement was made which restricts the movement of baffle inside the shell.

For this 03 Nos of support plate / lugs were welded on each tube baffle plates and this type of arrangement was done in 03 bottom most tube baffle plates. (See attached photograph)

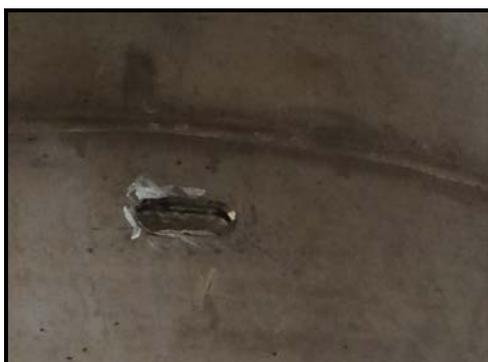
Elliptical hole cut in the shell plate at baffle location

Similarly socket and stud locking arrangement was made in shell by drilling the holes at 9 location at exactly 03 baffle elevations and then a patch plate with hole and threaded socket was welded on shell at cut hole position.. (03 bottom most baffles).

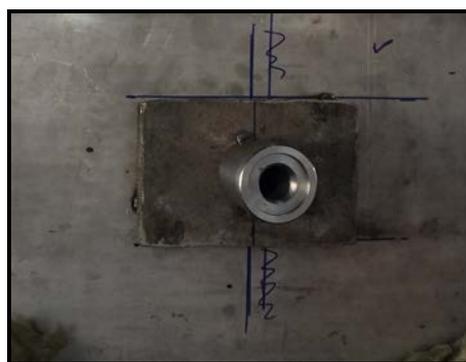
Pad plate with threaded socket tack welded will shell place from out side

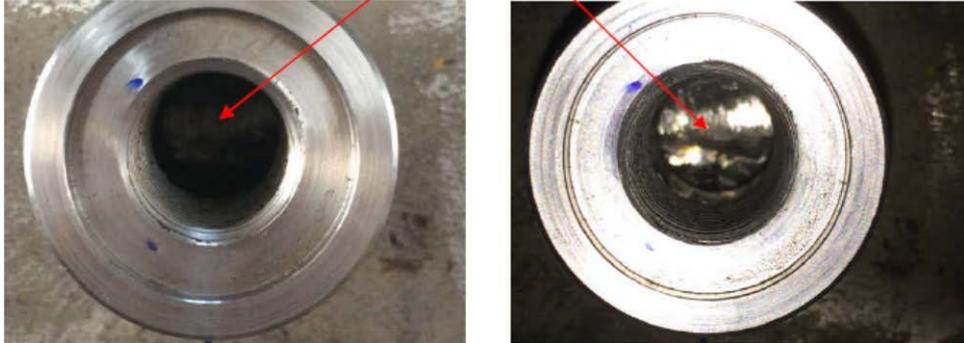
Baffle plate was seen aligned in front of cut hole

Then tube bundle was again inserted in the shell and checked the alignment of hole of shell with that of tube baffle plate that baffle plate was just in front of cut holes in shell.

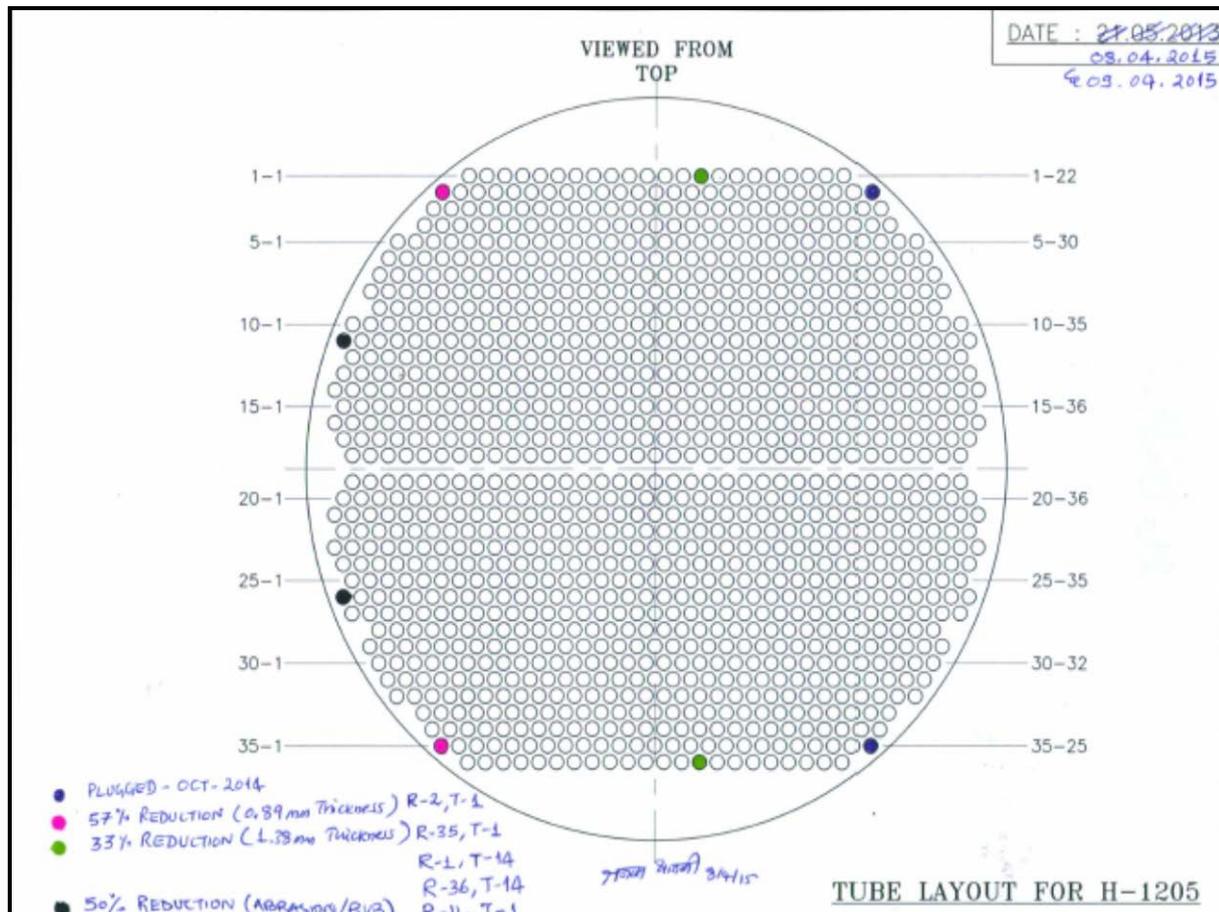
Row-1/Tube-14, Row-36/Tube-14 (33% Reduction)

Row-11/Tube-1, Row-26/Tube-1 (50% reduction due to abraision/rub)

Before taking the hydrotest of tube bundle, following 03 U-tubes were plugged

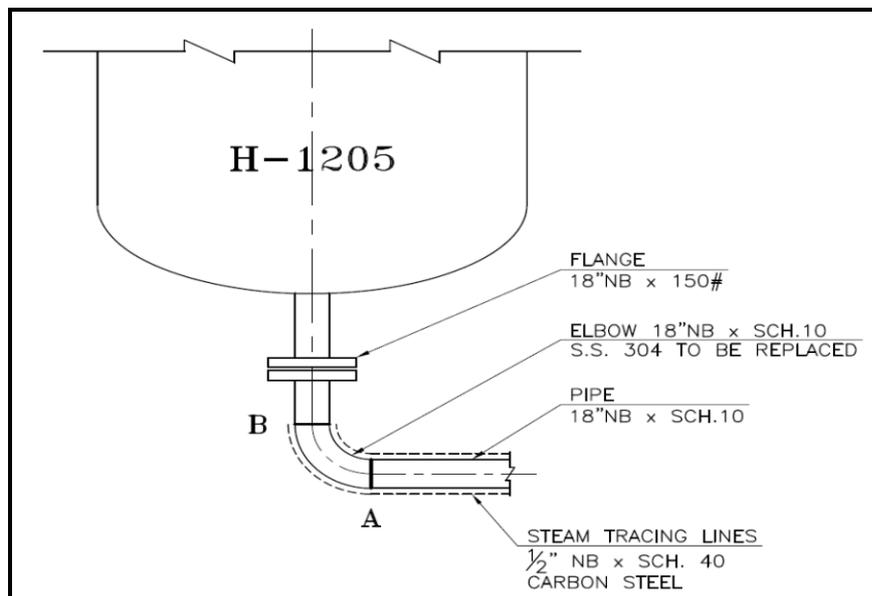
Bottom elbow of H-1205 was leaking due to various pin holes in the elbow area so it was replace in Shutdown-2015.

- Cutting of ½" NB X Sch.40 steam tracing lines.
- Cutting of existing 18" NB X Sch.10 Elbow by grinding at marked locations A & B as shown in above sketch.
- Removal of existing 18" NB X Sch.10 Elbow
- Opening of Bottom flange of H-1205 (18" X 150#)
- Removal of 18" Flange with spool piece.
- Weld edge preparation.
- Fitment of New Flange with Spool Piece and elbow in position.
- Root and final welding by GTAW.
- Inspection including Root weld & final weld DP.
- Welding of Steam tracing lines.
- Final tightening of Bottom flange of H-1205 (18" X 150#) with new gasket.

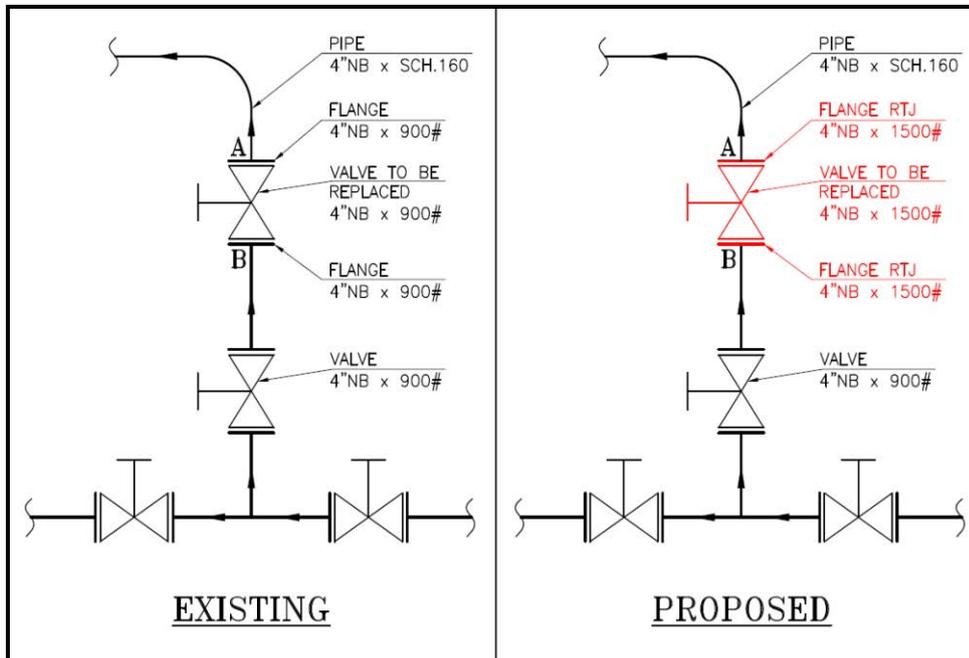
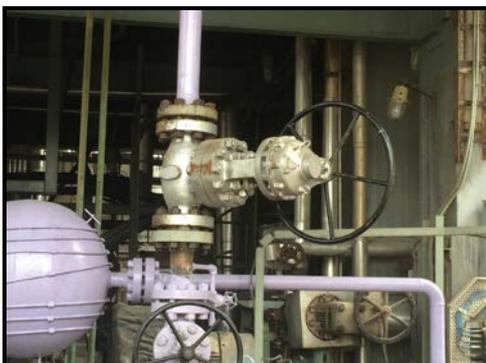
P-1102/C Recycle Line Valve

Two nos of old flanged globe valves of 4" X 900# rating in Ammonia Pump P-1102/B discharge line and P-1102/C recycle line were replaced by new flanged globe valves of 4" X 1500 rating.

- Opening and removal of existing 4" NB X 900# flanged valve.
- Cutting of Existing 4"NB X 900# flanges (A & B as shown in the fig.)
- Weld edge preparation and fitment of New 4" NB X 1500# flanges in position considering flange to flange distance of new valve.
- Root welding of New flanges by TIG Welding followed by Root DP and radiography.
- Fill up and final welding by Tig followed by Root DP and Radiography.

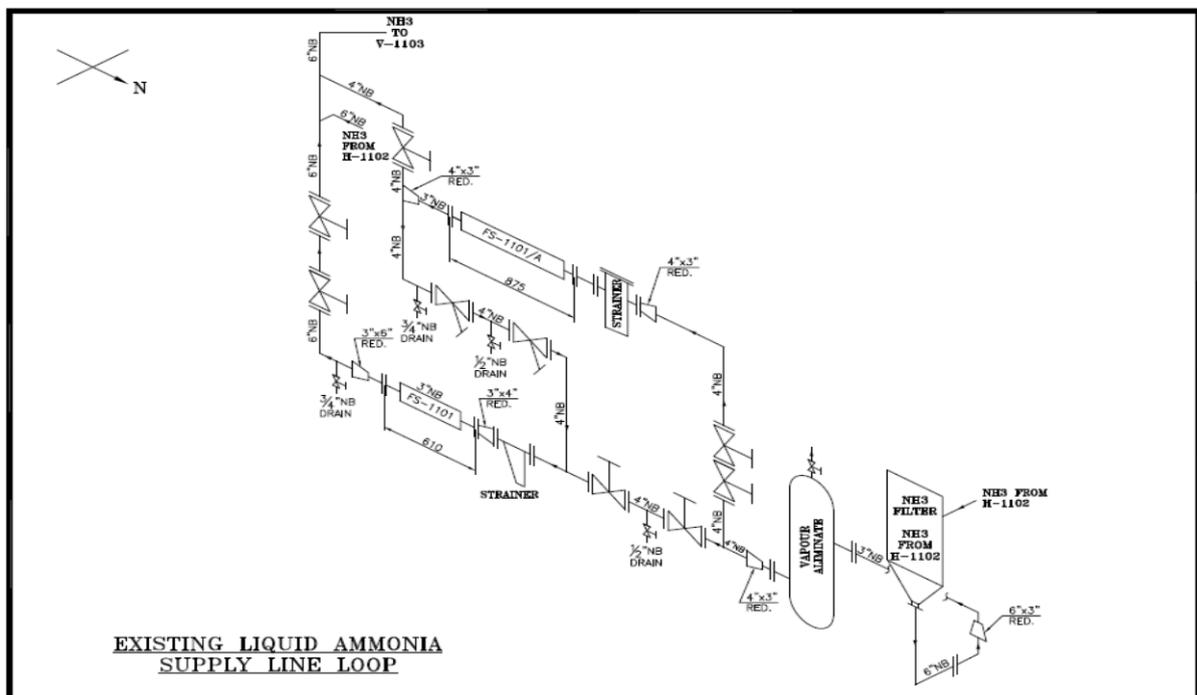
Liquid Ammonia is supplied at a pressure of 14-16 Kg/cm² from Ammonia plant to Urea Plant battery limit. The pressure drop in Ammonia supply system was around 1.5-2.0 kg/cm². Due to this pressure drop vaporization of Liquid ammonia may occur at pump suction which is causing the knocking sound in P-1102/C. So a EWR was raised to study and simplify the Ammonia supply loop at 1st floor. Based on the study following sketch of existing and modified sketch was prepared and the line was modified as per modified sketch.
