MTC / REPORT / 01
REPORT NO. 35 / 2015

PLANT TURNAROUND REPORT

(MARCH – APRIL – 2015)

INDIAN FARMERS FERTILISER CO – OPERATIVE LIMITED

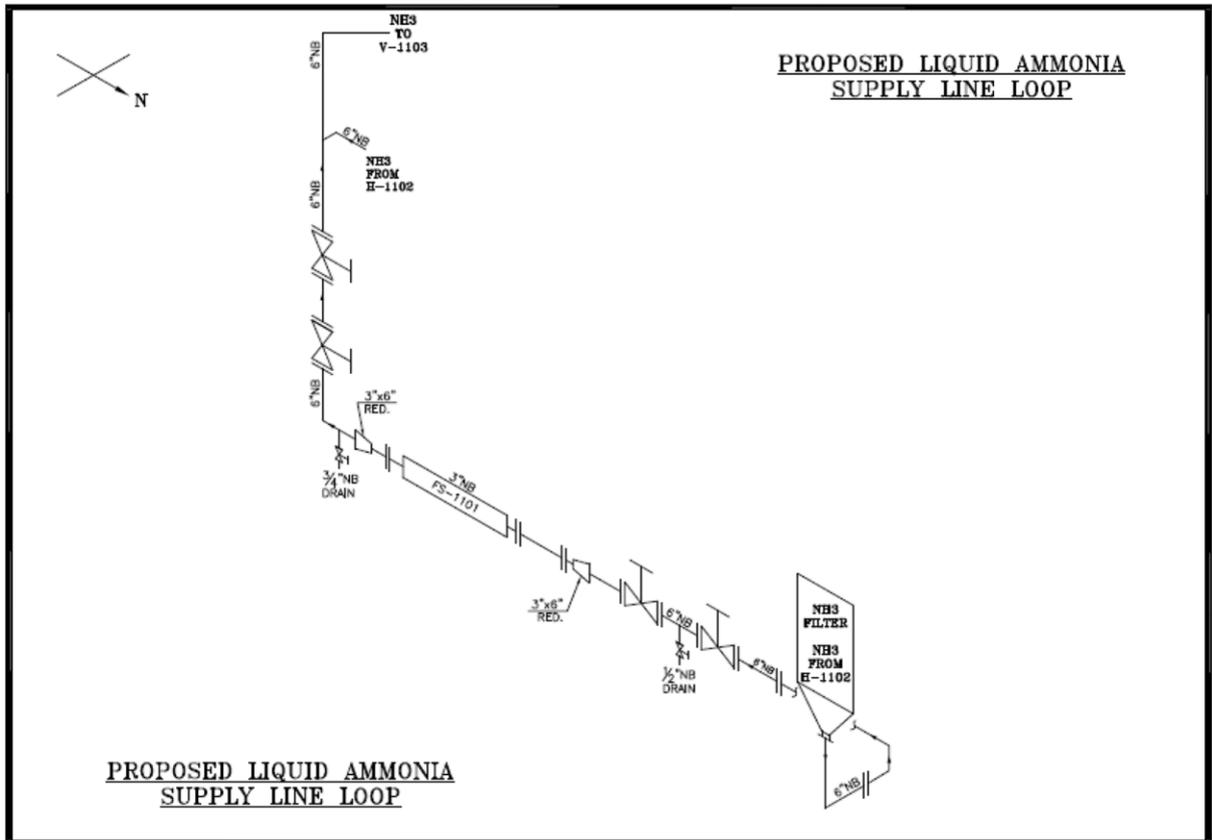
With implementation of above modification, the pressure drop in ammonia supply system in urea plant has reduced by about 0.7 kg/cm2.

In final modification scheme, following components were removed:

- Vapour Eliminator
- Suction strainers provided at upstream of mass flow meters.
- Only one mass flow meter will remain in line.

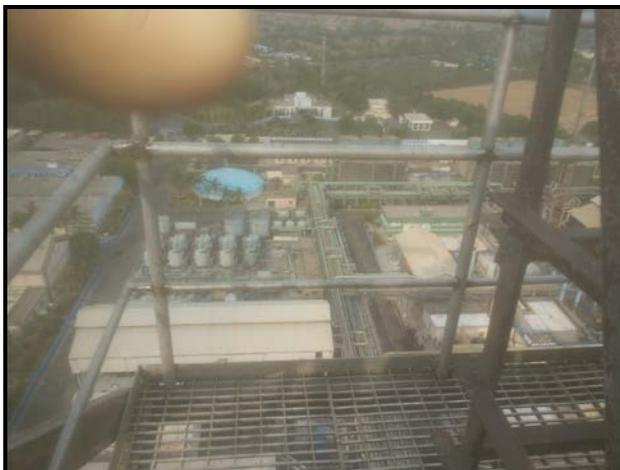
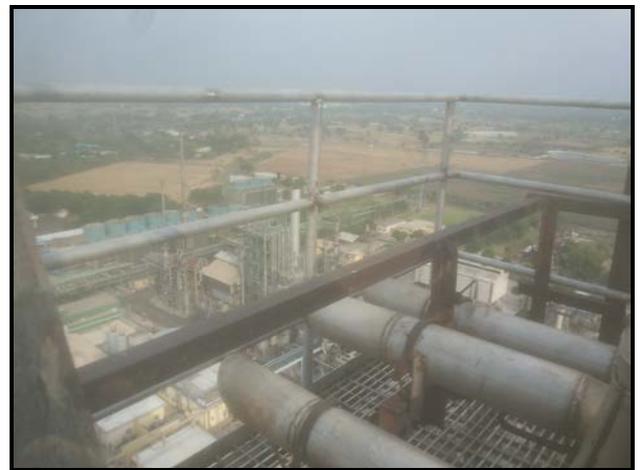
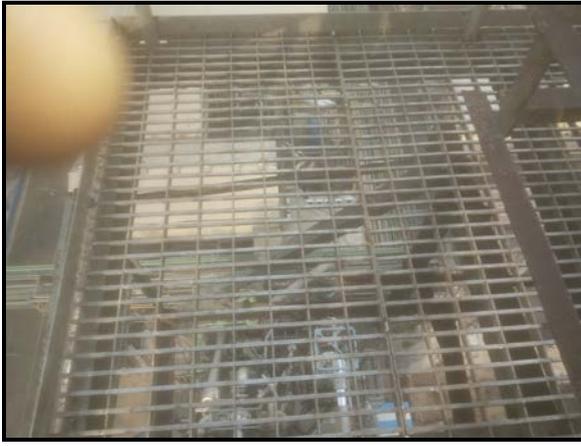
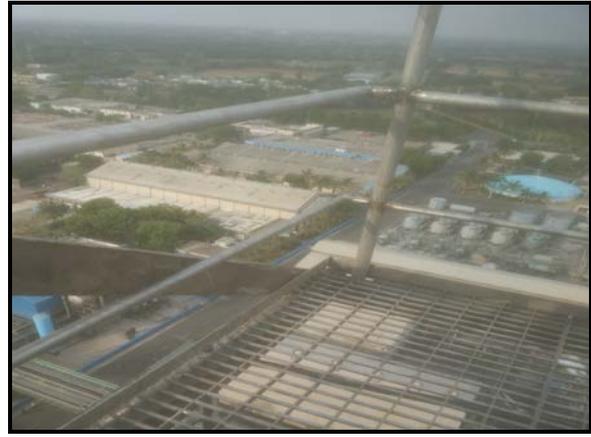
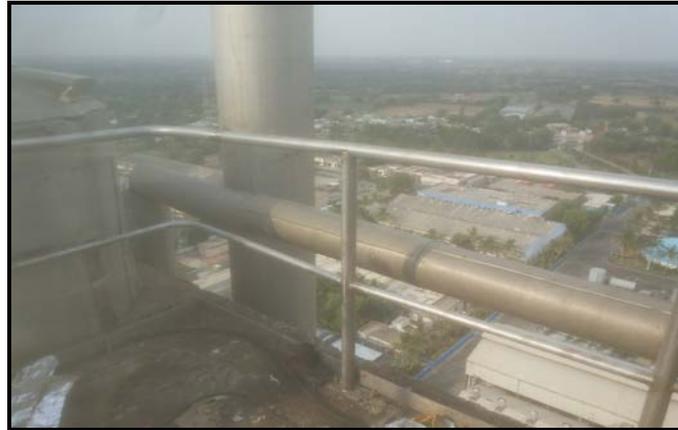
Existing platform at Off gas RV's (RV-1201 A/B/C) was of CS structure and is very congested and was very unsafe also. So this RV platform was modified with SS Material I,e with SS 304 railing pipes and gratings and also size of platform was increased for easy in mechanical jobs at RV station.

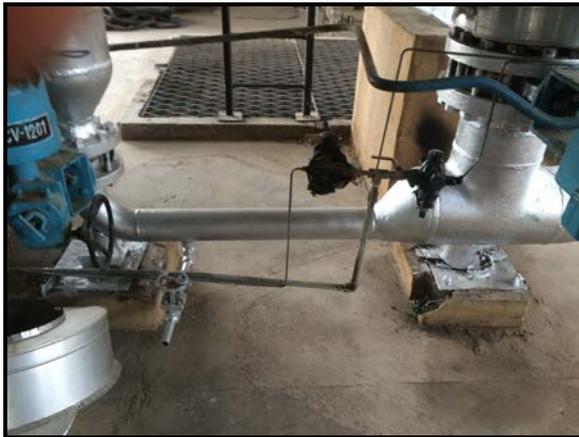
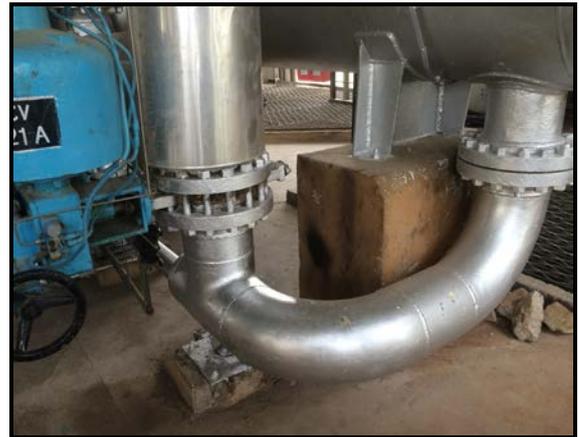
During thickness survey of line no. SC-1212-10"-C2, thickness loss was observed on some locations as marked in the attached sketch.

So the line portion from Equal tee of 10"X10" (Connected to HICV-1221A) to TRCV bottom flange was replaced with new one as shown in attached photograph.

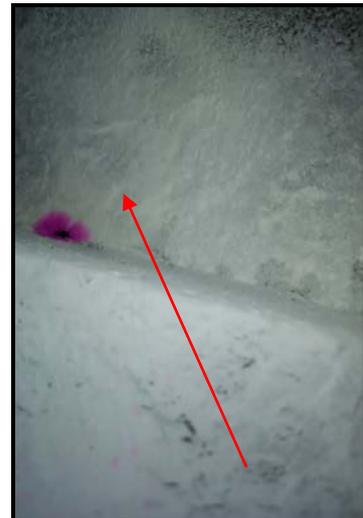
Pinhole in steam chest body

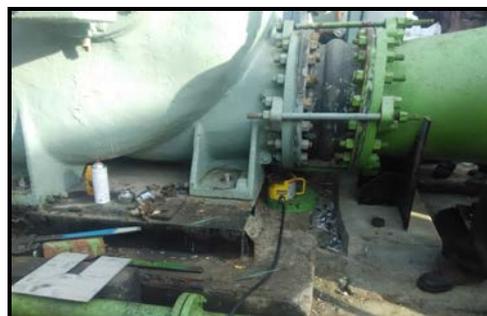
Lifting pump using hydraulic jack

Following activities were carried out during PM

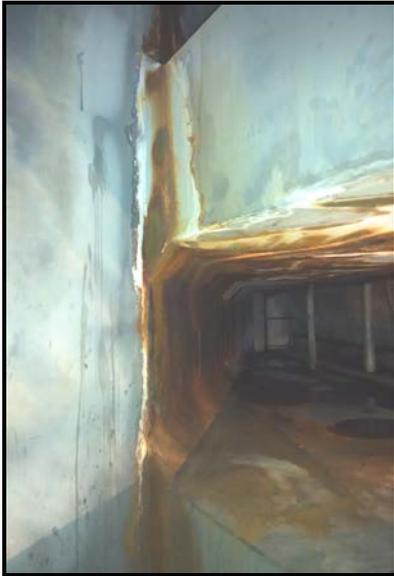
All manway covers of APH were opened. Some portion of Flue gas outlet chamber was found rusted and corroded. Rusting was cleaned by power tools and 2 coat of epoxy coating was applied after primer. Remaining portion of duct of flue gas and air was found satisfactory. Plates were cleaned by water nozzle spray.

Corrosion and rusting area in flue gas outlet chamber

Light leak detection was carried out to check welding. At two portions, pinhole leak was detected. The same was repaired by weld filling. After getting clearance from production department all manway covers were box-up

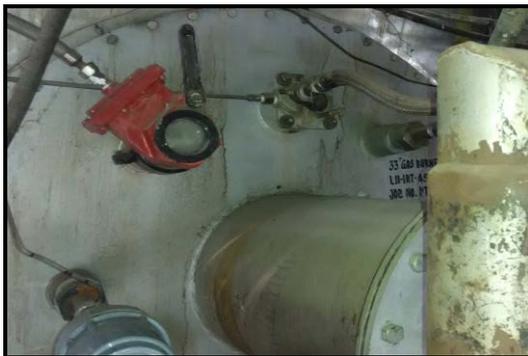
Top burner from outside

During previous shutdown-2014, a fabricated cap with clamp type arrangement was provided on bottom burner tip to prevent the direct impinging of air. After satisfactory performance of this modification, similar cap with clamp type arrangement was fabricated and provided on top burner tip.

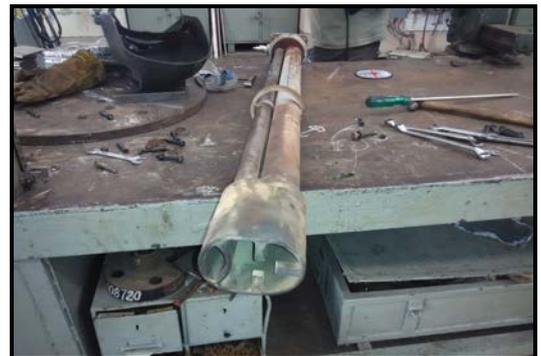
Top burner - After removal from its position

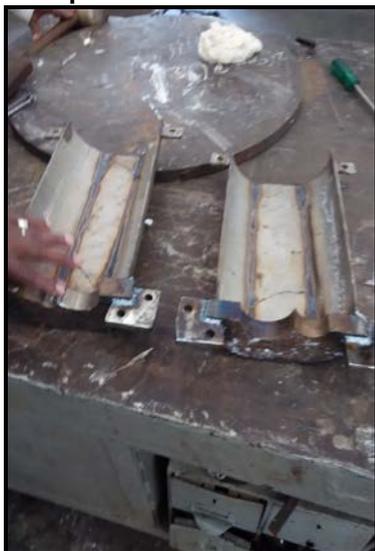
Cap with clamping arrangement

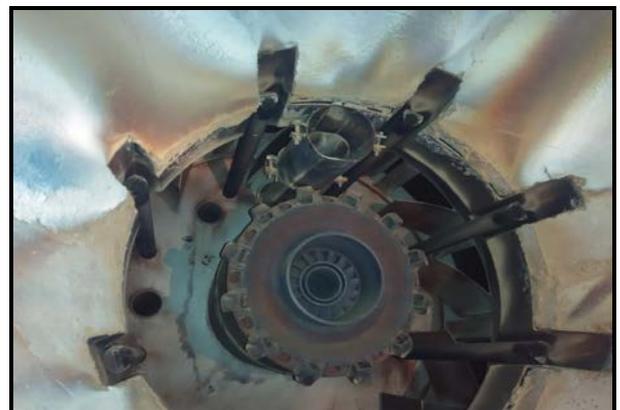
Cap fixed on top burner at its position

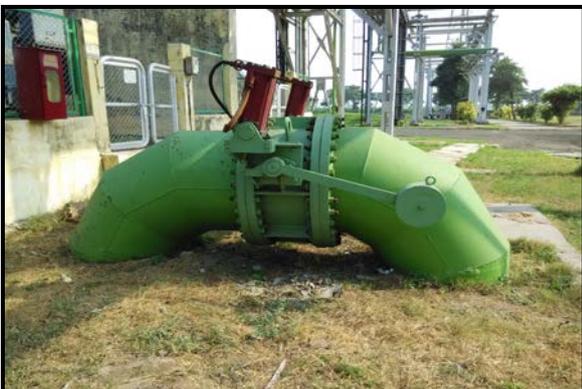
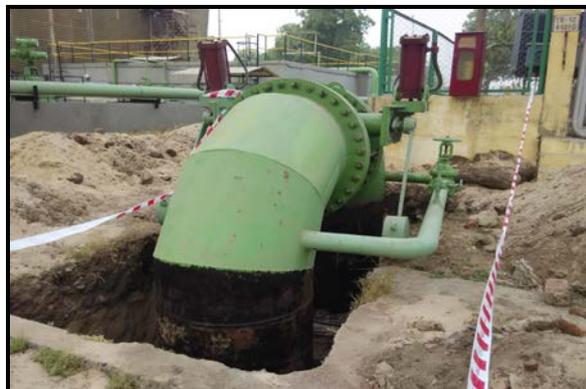
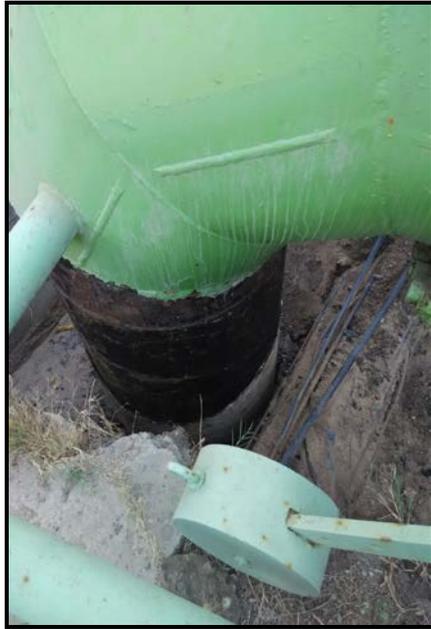
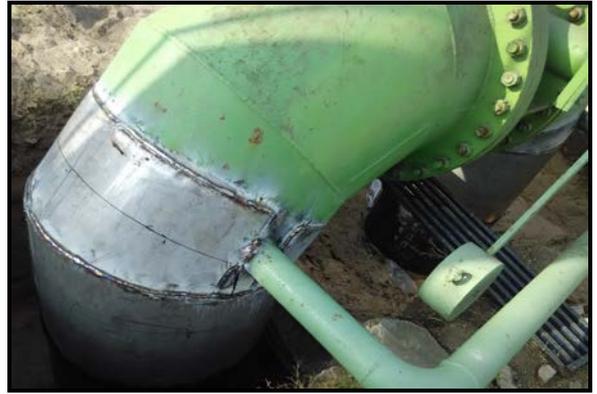
SS 304 Patch plate

- Excavation work in u/s and d/s of NRV was done by civil section
- Removing the wrapping coating with gas burning upto approx 1 mtr depth.
- Cutting of SS-304 patch plate in required quantity and sizes to suit the profile of the pipe.
- Welding of patch plate upto 1 mtr depth on CW headers.
- Inspection including final weld DP.
- Wrapping coating of exposed CS pipe surface of CW header.
- Spark testing of wrapping coating.

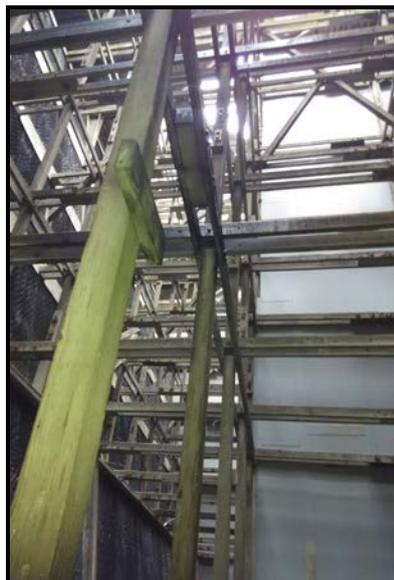
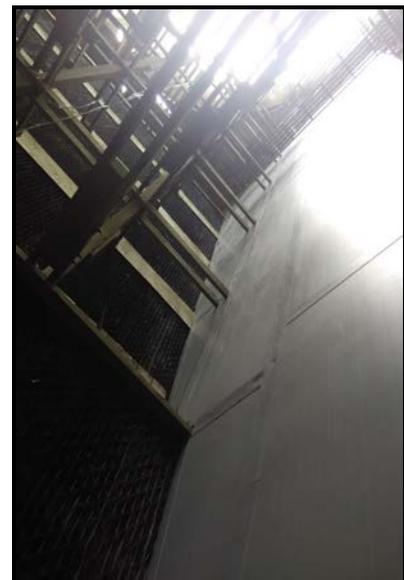
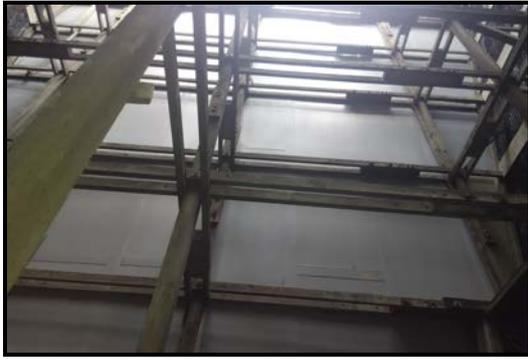
New PVC partition panel installation-1

New PVC partition panel installation-2

New PVC partition panel installation-3

During previous shutdown-2014, old wooden damaged partition panels of old ammonia cooling tower cells A1-A2, A2-A3 and A3-A4 were replaced by new sintex make PVC section partition panels. After finding satisfactory performance of new PVC partition panel, during shutdown 2015, existing wooden partition panels of remaining cooling tower cells A4-A5 & A5-A6 were also replaced with the same.

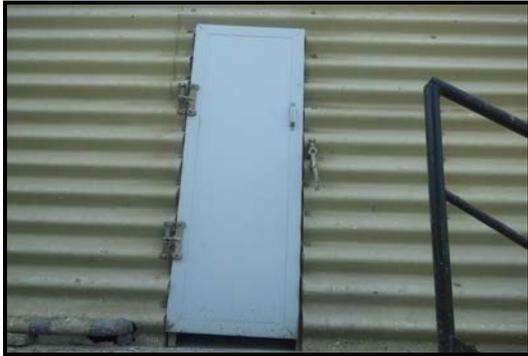
New PVC door

In addition of above job, all wooden doors of old ammonia cooling tower, urea cooling tower and new cooling tower were replaced with PVC panels.

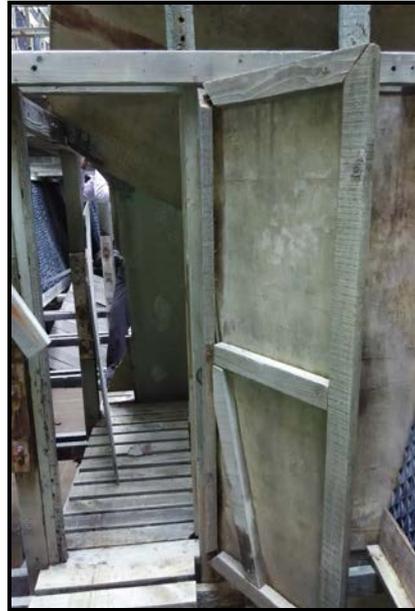
Old wooden door

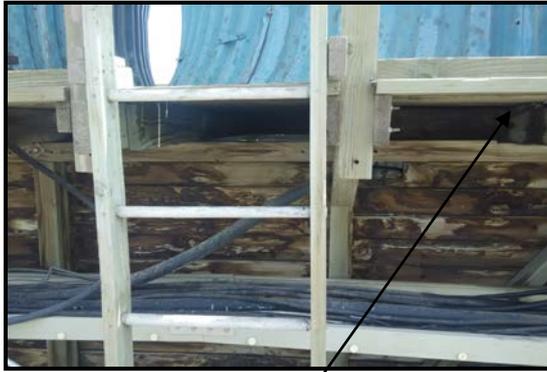
Timber block missing

- Committee comprising members from Mech Maint, Inspection, Civil and Utility Production inspected all the cooling towers and recommended the necessary repairs.
- Based on the committee recommendations, Structural members of the cooling towers were checked and replaced the defective members.
- Corroded fasteners were replaced with new SS304 bolts with SS 304 Square washers.
- Leakages attended from end wall & louvers using mastic (STP make Tarplastic Sealant).
- Repaired stair case
- Replaced on cracked Base casting (Towards admin side) of Old Urea Cooling Tower.
- Fill area of all cooling towers were also inspected for any damage on sampling bases by providing outside scaffolding and removing louver sheet to enter in the fill area. All fill area components and structural members found in good condition, however some PVC V-bars are found dislocated and the same was rectified

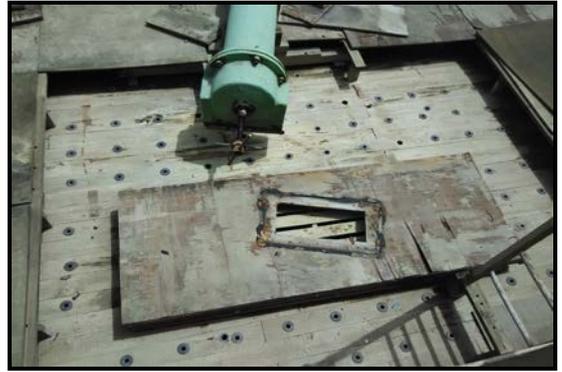
Repairing of water distribution of box-1

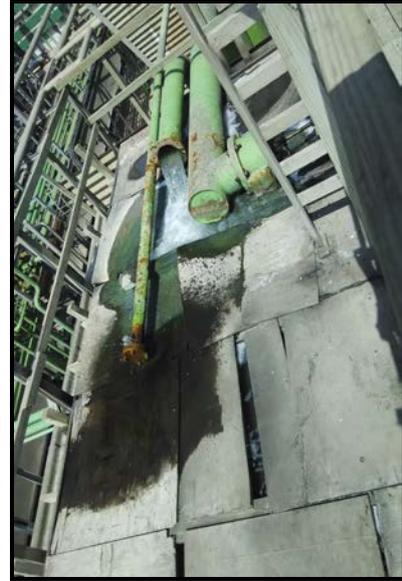
Damaged deck ply

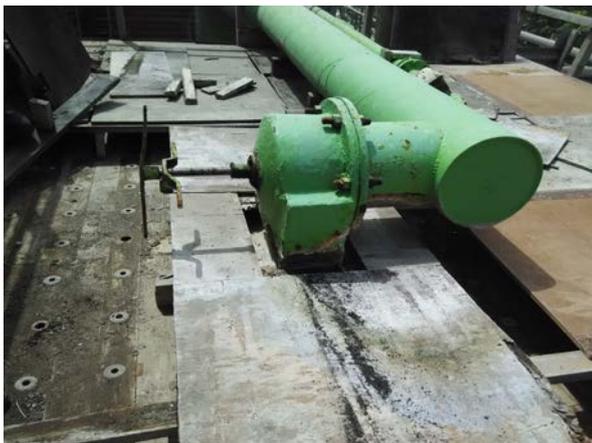
Repairing of water distribution of box-2

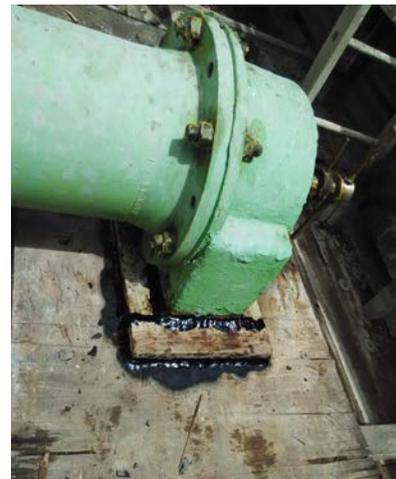
Repairing of water distribution of box-3

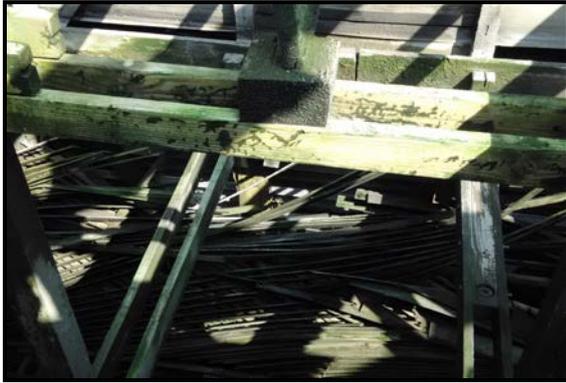
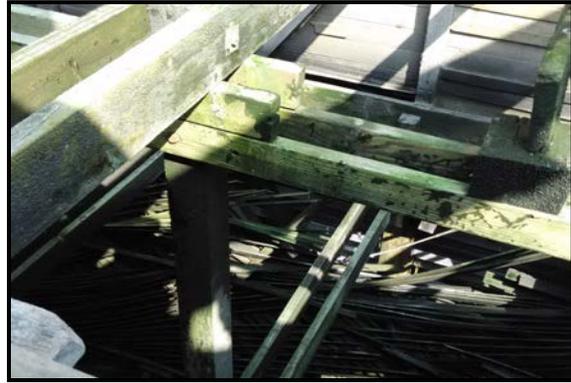
During preventive maintenance of CT fan K-4401-7, both side drift eliminator of CT was found damaged in condition. The same was repaired by M/s Paharpur cooling tower, Vadodara.

Damaged drift Elinimator

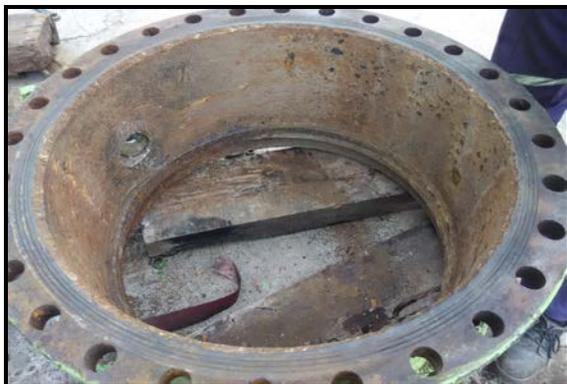
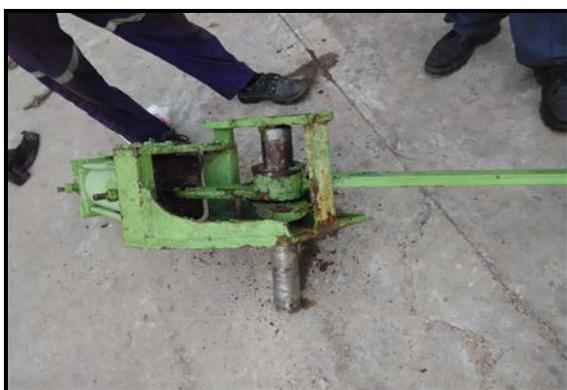
Check valve was dismantled. Corrosion & pitting observed along the disc seat portion, which seems unable to refurbishing. Body seat of valve is having heavy corrosion & pitting. Finally check valve was boxed up after using new gland packing and it is decided to procure new valve to replace existing one during next shutdown-2016.

Check valve parts after dismantling

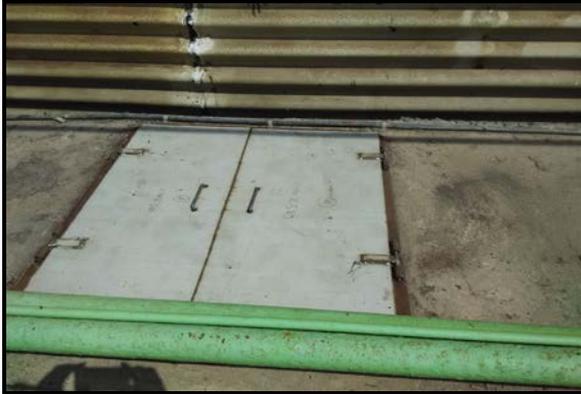
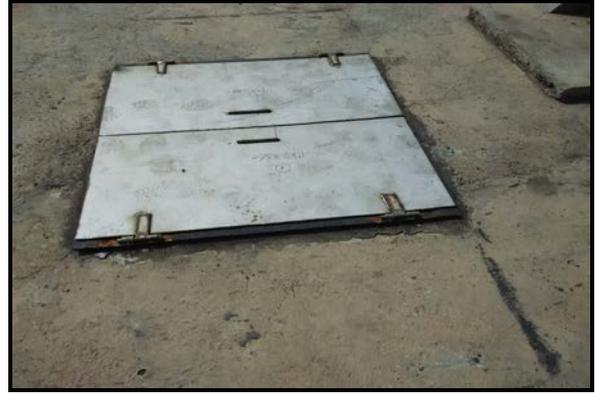
CS covers (6 nos.) of cooling water sump basin were found corroded condition. All new SS304 covers were fabricated and provided on its position.

SS304 Cover

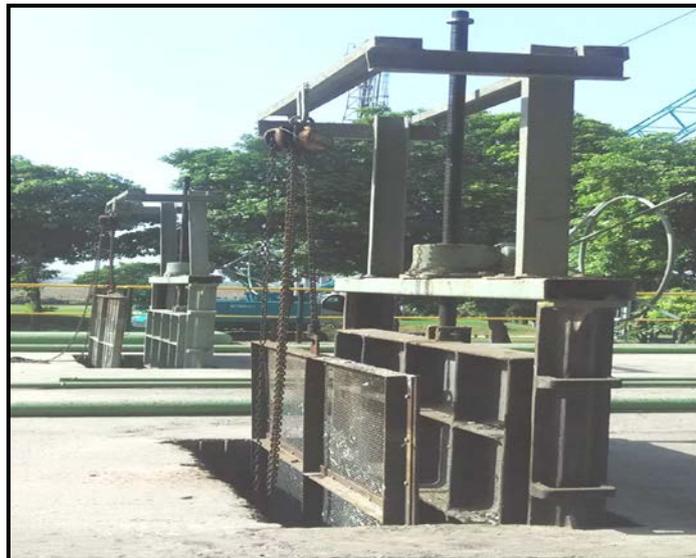
- Stem : cleaning & greasing
- Shutler Seat / Frame seat facing : cleaning & greasing
- Gate no.1: Gear box was opened. Bearing was found in satisfactory condition. Small wear marks observed in gear teeth. Gear box operation was satisfactory.
- Gate no.3: Bottom wedge block was not found.
- Gate no. 4: Bottom wedge block was found in damaged condition.
- Full operation (open / close) of all gate was checked & found satisfactory.

Jash make Sluice Gate

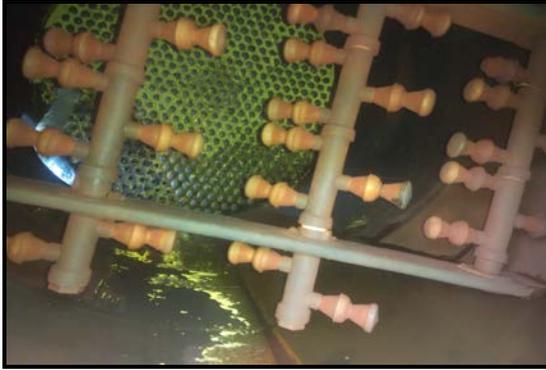
Before rerubber lining

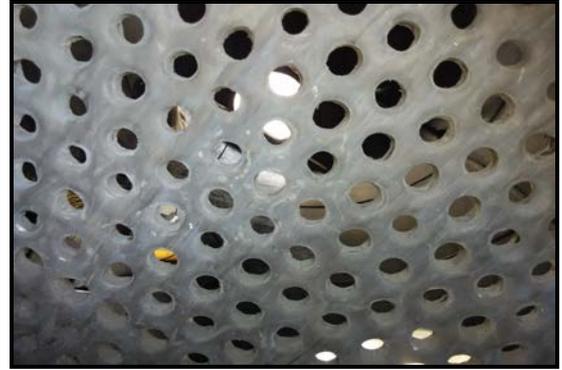
New rubber lining on perforated plate

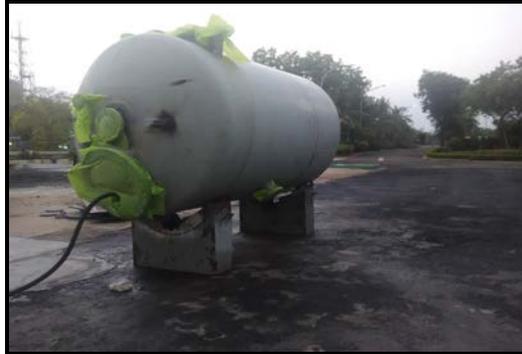
Steam curing after new rubber lining

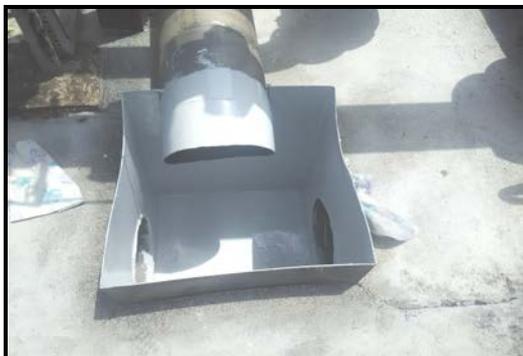
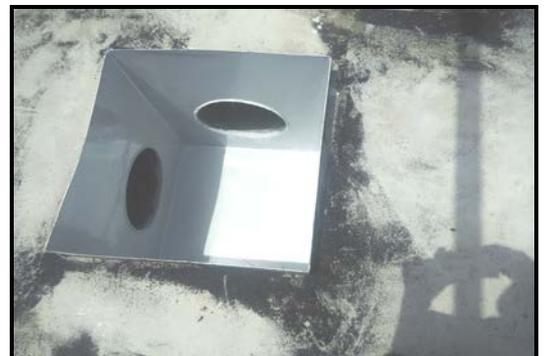
Corrosion Resistance Coating (Valancy 314)

- All existing FRP open channel with drain pit were replaced by fabricated SS304 open channel and drain pit. Job was executed by workshop department. To prevent the chloride corrosion, in three nos. of drain pit a special corrosion resistance coating (Valancy 314) were applied on trial basis.

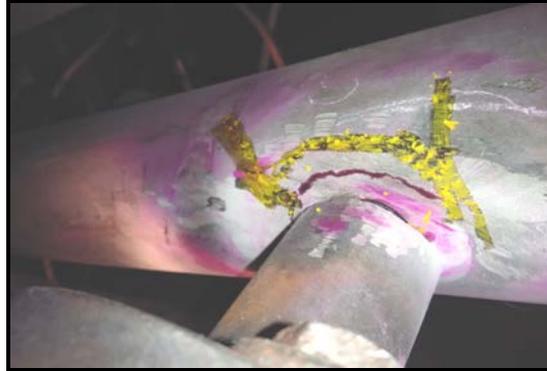
- In new IG cracker, fire observed under the retort no.1 flange joint (from K-5301 towards offsite maint office side). The same was attended by replacing gasket with new one after IG purging. Again fire observed on same joint & DP test was carried out. A crack was observed in weld joint of crack gas inlet line to header (to combustion chamber). The same was repaired after grinding and welding.

Cracked area

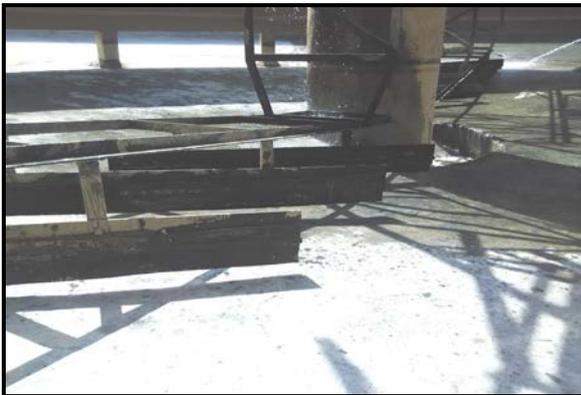
In Clariforculator sump, 8 nos. of bottom rubber scrapper were found in damaged condition. The same were replaced with one. Bottom bush of paddle-B was also found corroded condition. New bush was provided

Bottom rubber scrapper

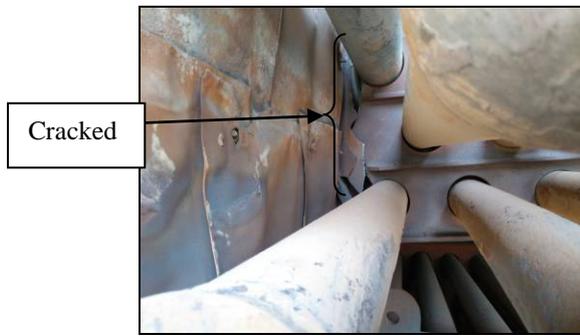
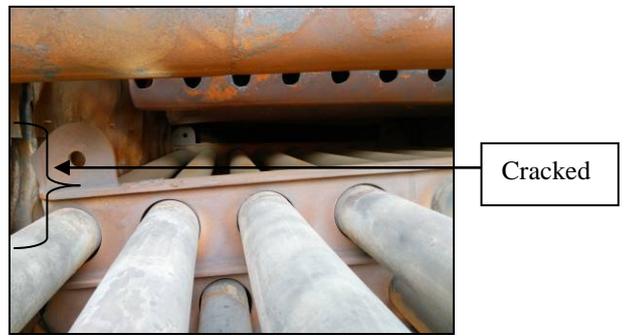
- South side 01no. Support found cracked/damaged. (2nd support from of East side)

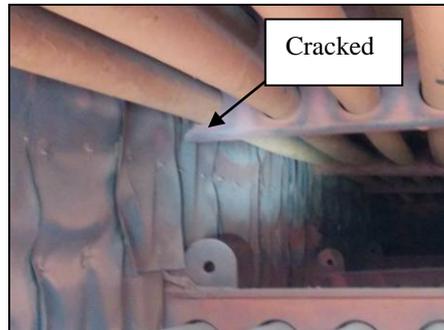
- HT and LT super heater coils were found in satisfactory condition.
- Supports of LT/HT steam super heater coils were found in satisfactory Condition.
- 6" to 8" gap found between insulation protection sheets at East side just above partition wall.
- HT steam super heater top coil tube fins found damaged in approx. 100 mm length for 02 nos. of tube at East end.
- 02 nos. of thermo well near damper of PRC-23 found bent downward.
- Insulation covering sheet found distorted and bounding with wire.

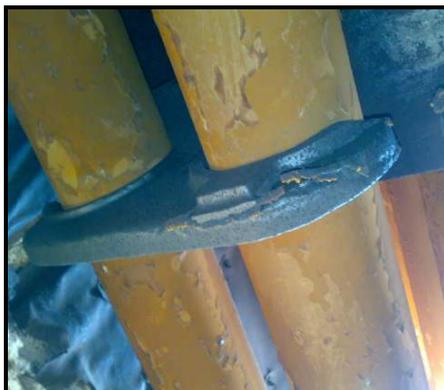
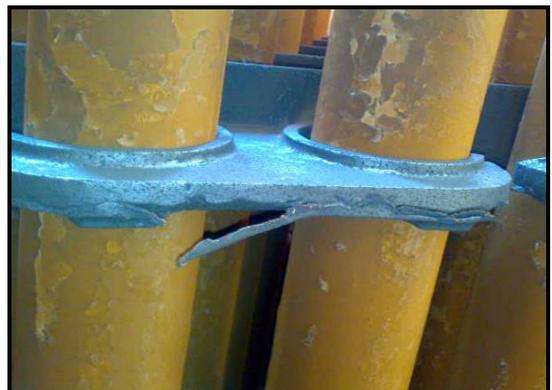
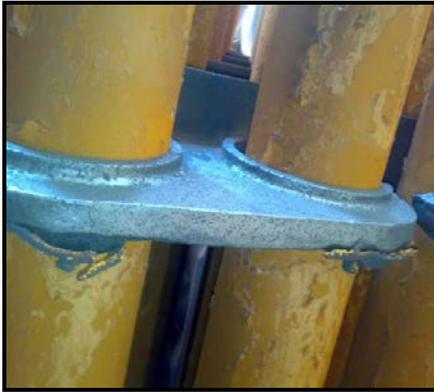
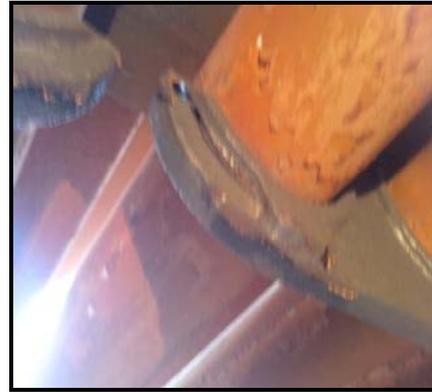
- Hard scaling was observed on all the tubes of Mixed Feed Coil.
- Bottom most part of Insulation covering plate was found burnt off at most of the locations. This was observed in previous inspection also.
- Refractory at the ceiling found superficially cracked at few locations.
- Peeling off of top layer of casting was observed on first two rows of east side anchor supports of mixed feed coils. Refer attached photographs.

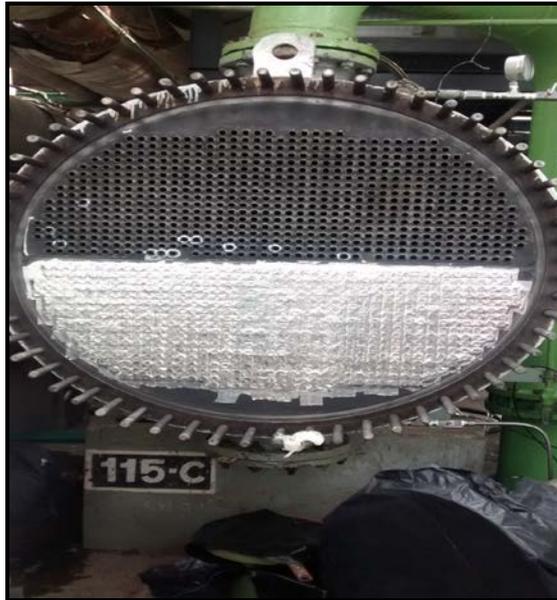
Tube sheet masking by Aluminum tape.

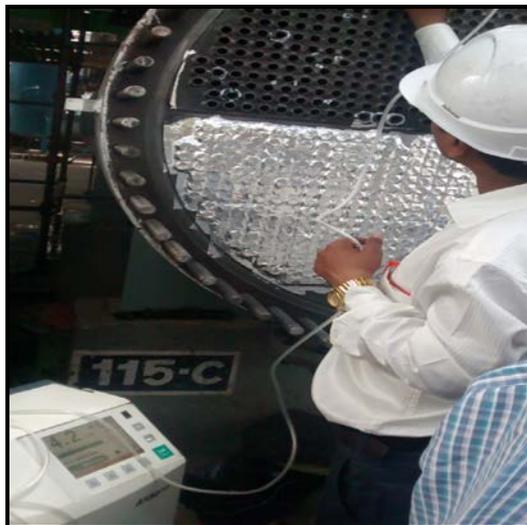
Leak detection in progress.

- Total 88 nos. tube sheet welding were found defective in helium leak testing. The same were repaired by grinding and welding.

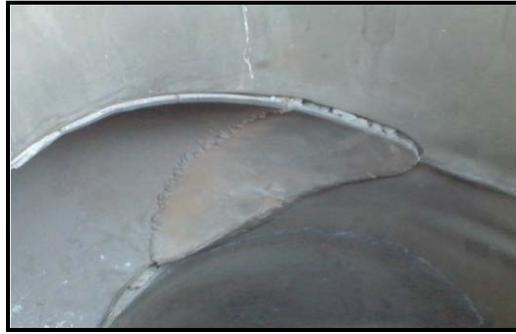
- Appx 1" Gap was observed between shift liners of top shell to transfer line in complete circumference.
- Crack observed on the weld joint of patch liner to transfer line liner in approx. 4" length.

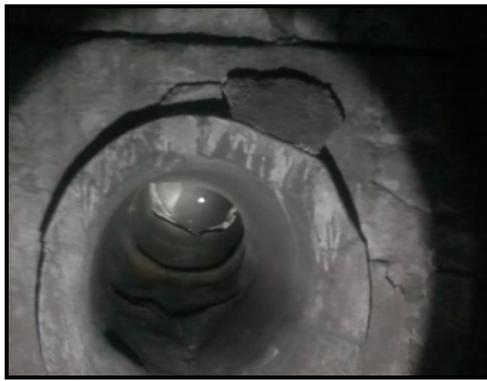
101 CA Nozzle View

- The refractory around the 101-CA/CB gas inlet nozzles (approx half of the top circumference) was found eroded and loosened.

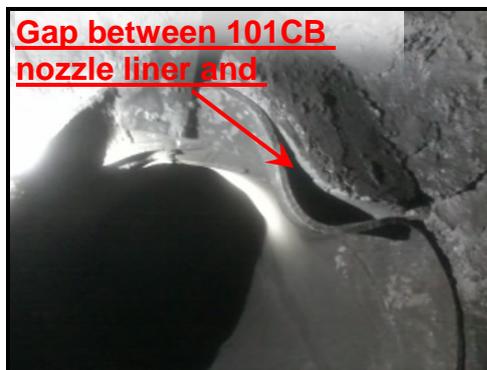
- Gap was observed between the 101-CA/CB gas inlet nozzle liner and the shell refractory joint. Gap of approx 2" was observed towards the 101-CB nozzle.

The same was observed in previous inspection also.

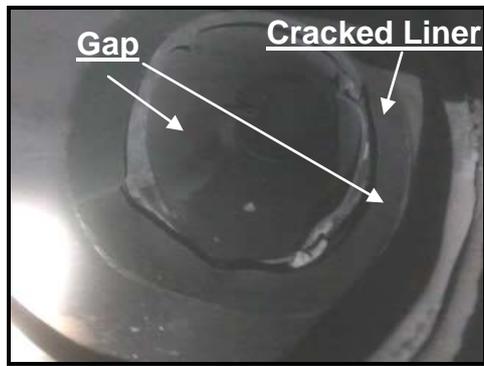
- The liners inside the 101-CB gas inlet nozzle were slightly buckled /distorted. Condition of the thermo-wells was satisfactory. The same was observed in previous inspection also.
- Longitudinal weld of one of the liner pieces of 101 CA gas inlet nozzle was found opened hence exposing the refractory as shown in the attached fig.

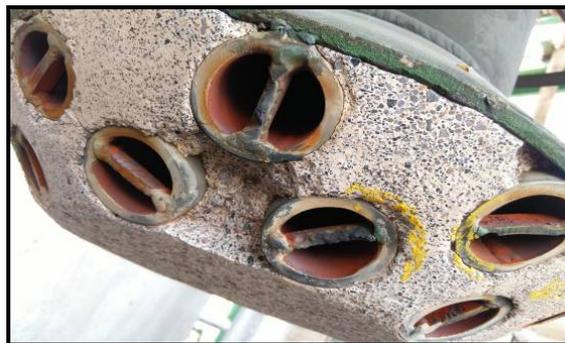
- Scattered cracks were observed at refractory around nozzle holes.
- Straightening vanes and its support ring found slightly distorted.
- Refractory found fallen around the nozzle.

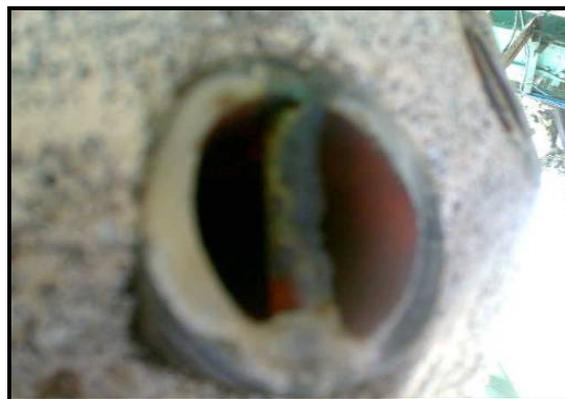
- Some Partition plate of nozzle holes found partially burnt and some found with crack at its centre & end welds.

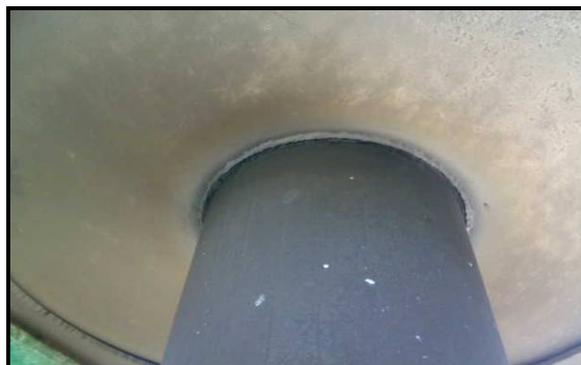
- Insulation cover weld with top cover liner found eroded.

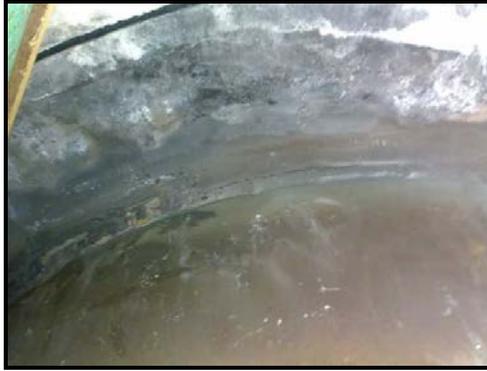
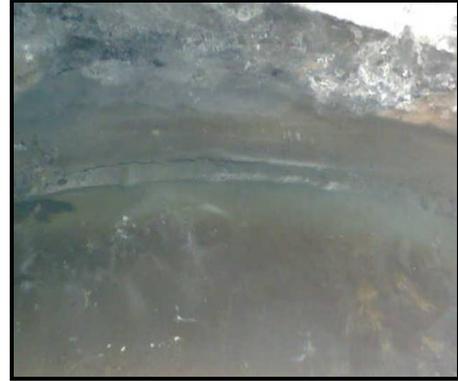
- Circumferential crack was observed at the top cover liner welding.

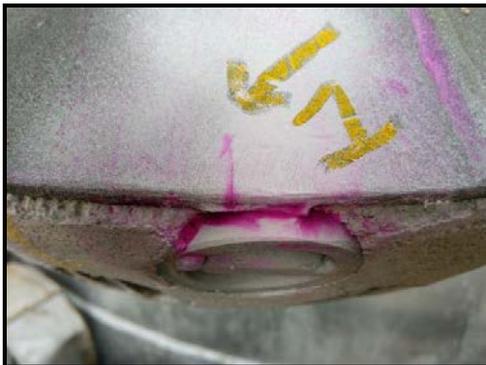
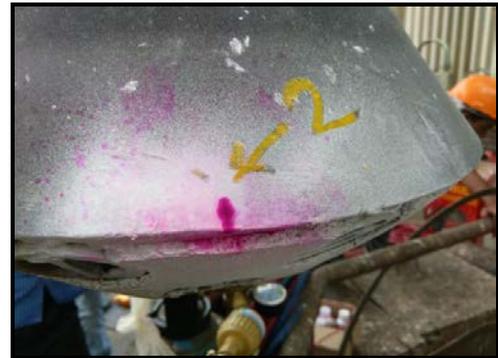
- 02 nos. cracks of approx 15mm length were observed on conical surface as shown below.

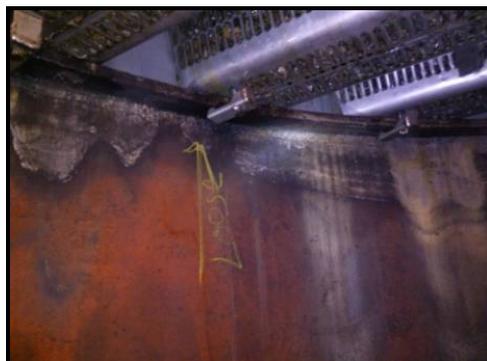
- 01 no. Rasching ring holding clamp was found loose at south side

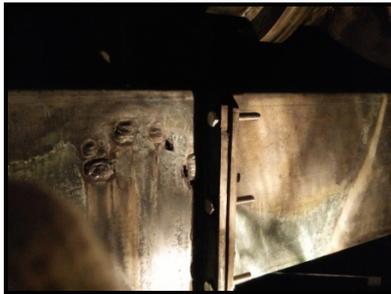
- Excessive gap as compared to others was observed in several rasching ring holder.(between two half of holder)
- 01 no. rasching ring holding clamp was found loose at west side.
- Condition of liquid distributor was found satisfactory.
- Brownish grey coloration was observed on the shell as well as on all the fittings.
- Corrosion cavities and holes were observed on South most liquid distributor collector plate, located just below the liquid distributor. (Visible just from M/H)

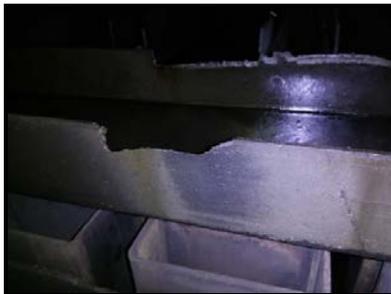
- Gas riser holding plate was found eroded/damaged from top edge at west side.

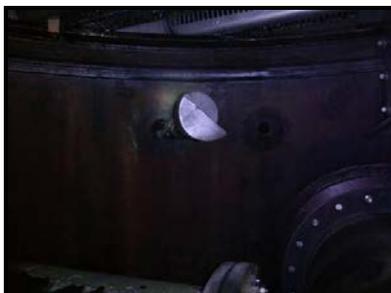
- Sample collector was found twisted.

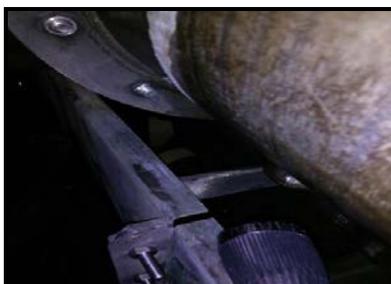
- Debris was found lying on the gas riser holding plate.

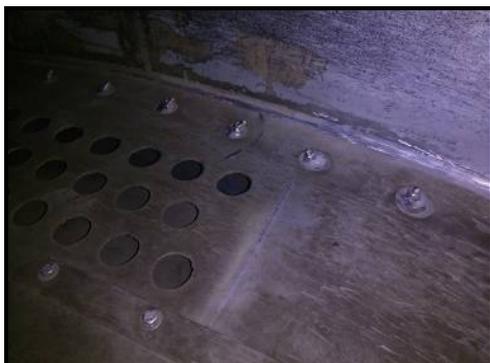
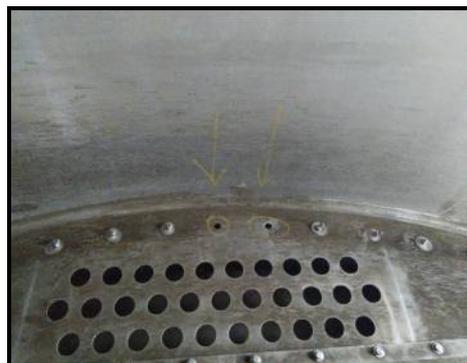
- Rectangular riser box and other fittings found intact in position.
- Holding bolts of bottom tray found loose and bent at many locations. 02 nos. bolts are missing from at north side.

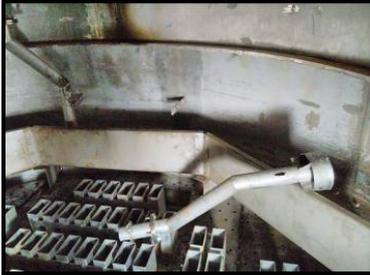
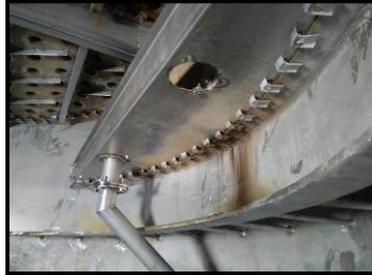
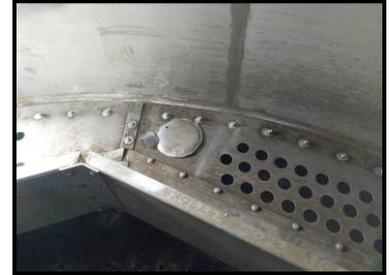
- Silver coloration observed at scattered locations. Weld joints observed as if etching has occurred resulting in slightly differing color in comparison to adjacent shell surface.
- 01. no. 3" bubble cap tray drain line was found broken at North-West side and same was lying on the rectangular riser box. End plate of same 3" line was broken and found lying on the bottom tray.
