MTC / REPORT / 01
REPORT NO. 40 / 2023

PLANT TURNAROUND REPORT
(APRIL – 2023)

INDIAN FARMERS FERTILISER CO.-OP. LIMITED

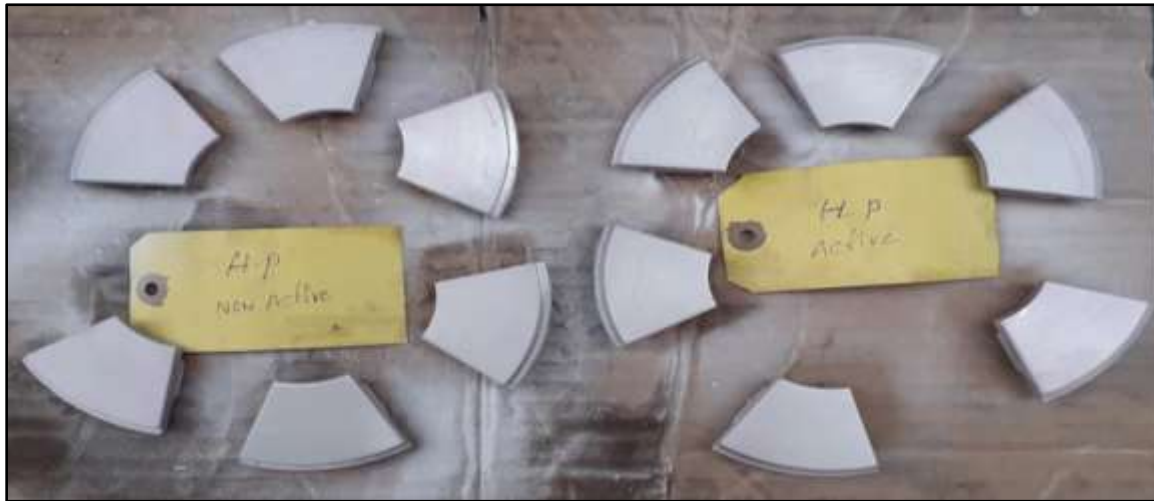
HP Compressor Rear thrust Pads (Active/Non-Active) DP test conducted

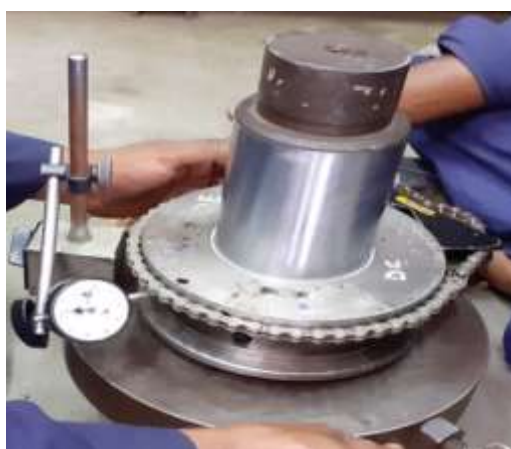
Turbine/LP/HP Compressors DE/NDE Bearings clearances checked by Mandrel Method.

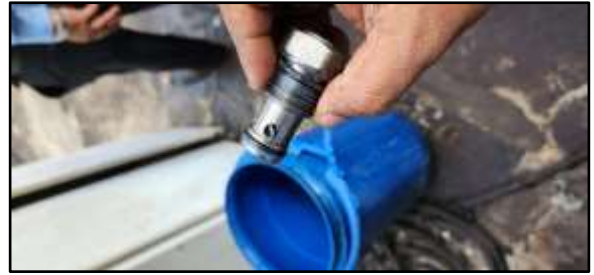
- As per P & ID, checked all the Oil paths and opened the NRV 8511 of COP 8504 and found some particles got jammed between the seats. Removed the particle, re-assembled and installed it in position.

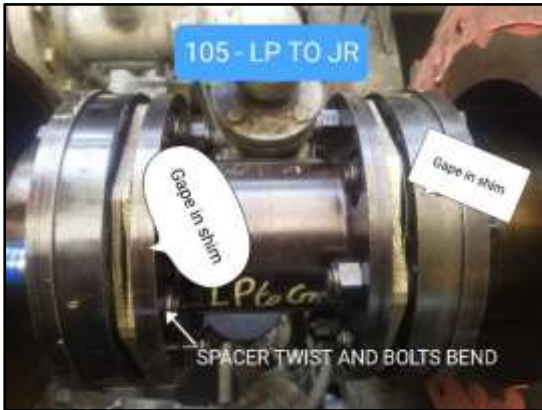
105-JLP, the gear box end was decoupled. The couplings were visually inspected. Damage was found in flexible elements & bolts. So, replaced the complete Transmission unit & bolts with new ones. Axial thrust was measured (0.30 mm) and found within the limit. Journal bearing clearances are checked by rotor lifting.

Damage of coupling shim and bolts between LP to GB.

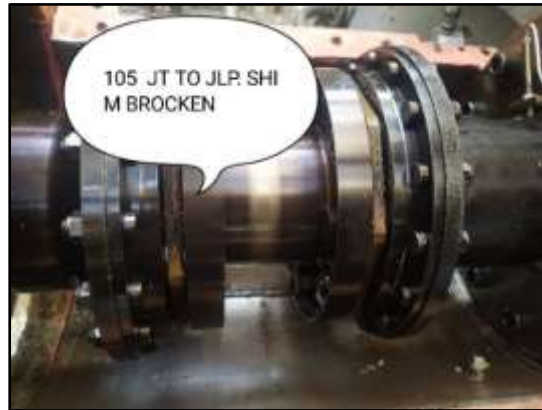
Turbine & LP side was decoupled, and both ends the element assy. shims found damage, replaced the transmission unit with spare one. The Journal bearings and Thrust bearings were taken for inspection. Thickness of NDE Thrust pad were measured and one pad thickness was reduced to 18.86mm remaining were 19.07mm. Replaced all the NDE thrust pads with spare one (old 101-JT). Gauss readings of the bearing pads were measured and found within limits. The pads were visually inspected as well as dye penetration tested and found OK. Bearing clearances were taken and found within the design range.

Damage of coupling Shims between Turbine to LP compressor.

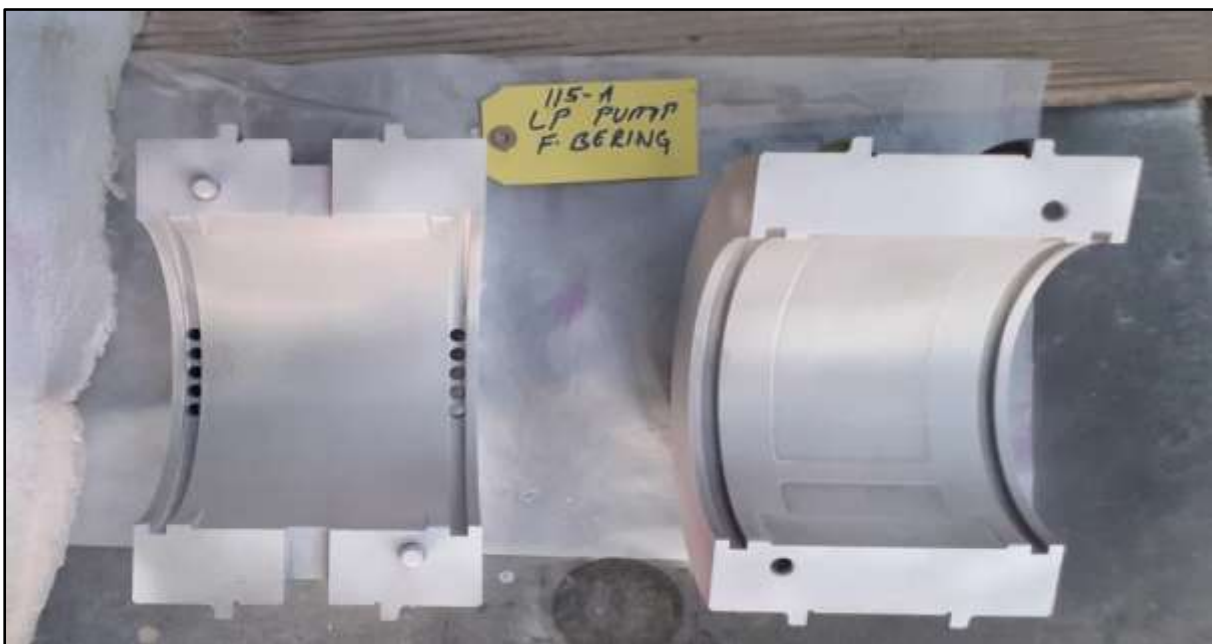
The pump was decoupled and both ends bearing housing opened. The DE side bearing clearance were measured and found in higher side. Replaced the bearing with new one. The thrust bearing and NDE ends radial bearings clearance were measured and found within limit. The bearing pads were visually inspected and DP inspected and found OK. The gauss measurement was taken and found within acceptable limit. The suction strainer was cleaned.

Pump Front bearings DP test conducted.

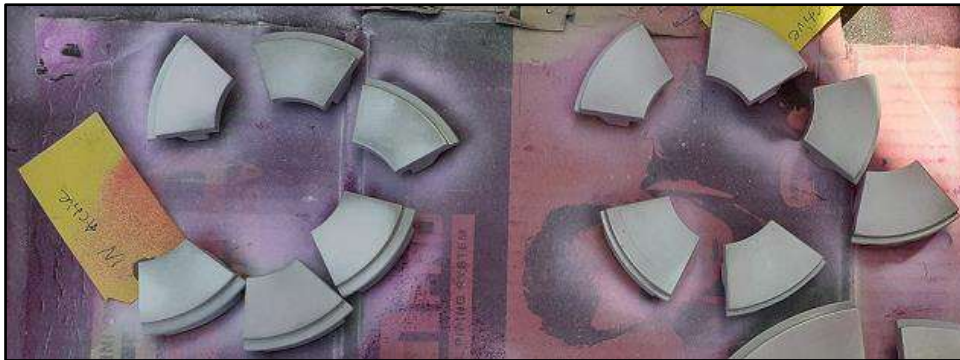
Both ends journal bearing sleeves were visually inspected and dye penetration tested and found OK. The bearing clearance were measured and found within design range. Magnetism level of the bearings was checked and found within desired value. The main oil console and its filters elements were cleaned and installed. The seal flushing fluid coolers and strainers were cleaned. The NDE Bearing housing gasket was replaced with new one.

Turbine thrust pads DP test conducted

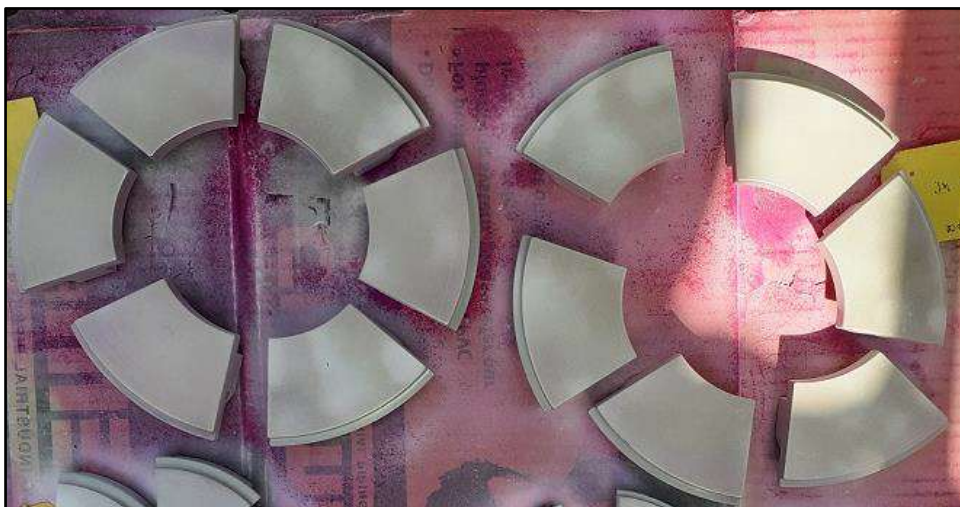
Pump thrust pads DP test conducted

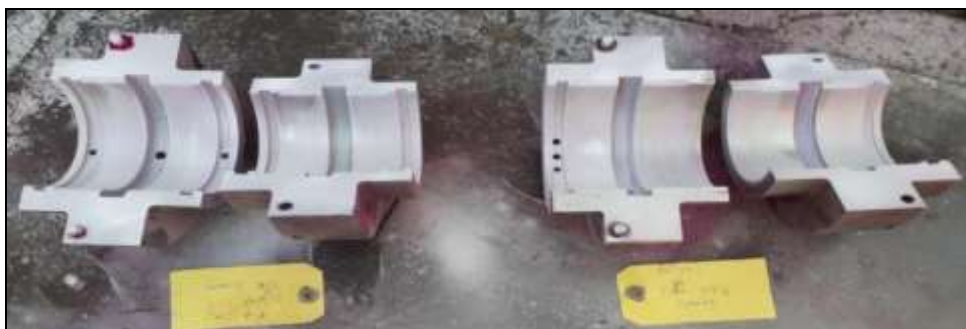
Pump DE/NDE bearings DP test conducted

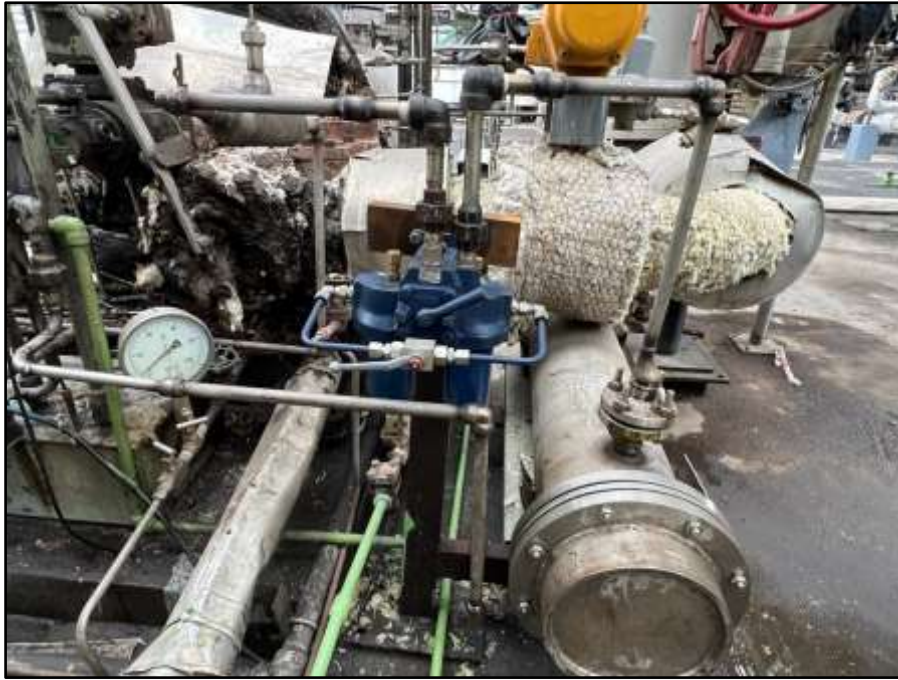
Lube oil Cooler with new Duplex Filter assembly installed in cooler outlet line

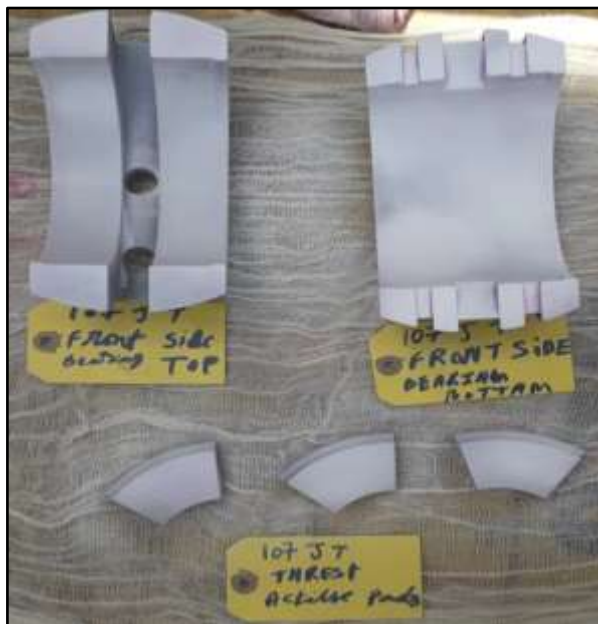
The turbine was decoupled, coupling was inspected and DBSE was noted. Turbine (107-JT) front & rear bearings and thrust pads were thoroughly polished and dimensionally checked and found to be within limits. DP tests were carried out and found to be okay. The magnetism level of all bearings was found to be within limits. Clearances were measured and found to be within the limit.

Turbine Front bearings, Active side thrust pads DP test done.

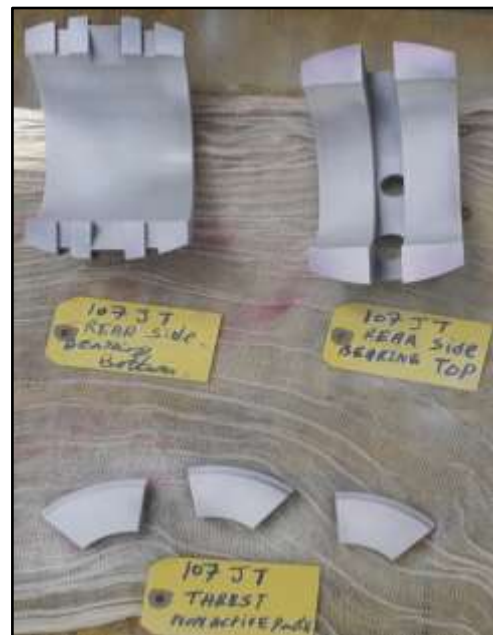
Turbine Rear bearings, Non-active side thrust pads DP test done

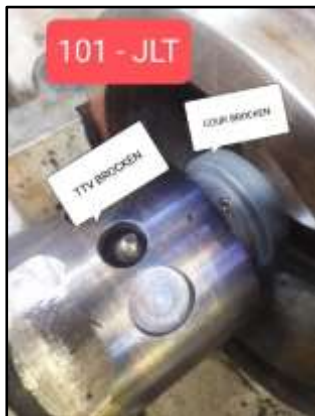
Turbine Trip pin broken

- Preventive Maintenance of Turbine was carried out.
- DE & NDE Bearing Housing's top cover was opened for bearing inspection.
- Both the bearings were checked and found ok.
- Turbine trip pin assembly found damaged, so replaced the trip pin assembly by removed one from spare rotor assembly.
- Actuator to turbine coupling was inspected and found ok.
- Speed sensor ring found loose.
- Axial thrust was found to be 0.28 mm
- Mesh of Strainer of LO pump was found ok.
- All bearings Oil were flushed.
- Actuator was replaced with new one as the drive shaft was having play.

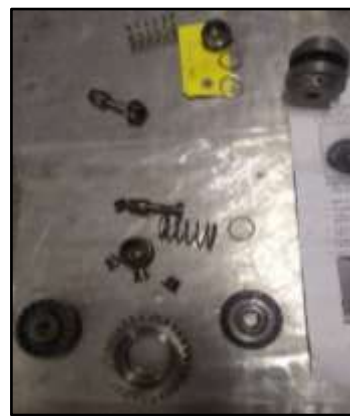
Complete trip assembly replaced

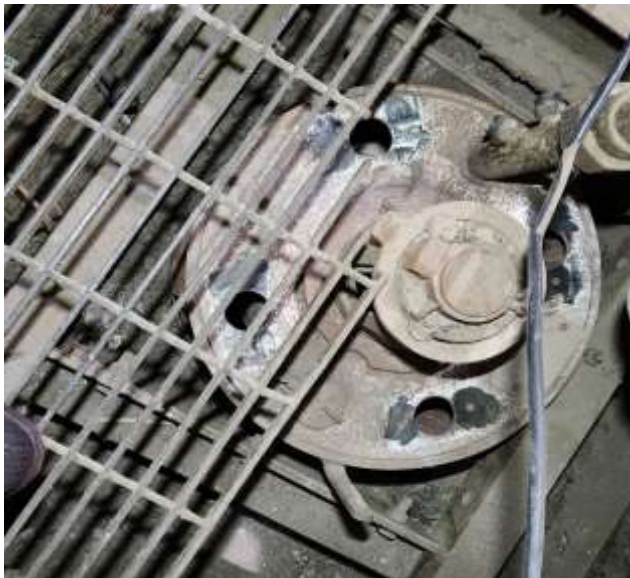
Arch burners damaged studs cut

- The roof insulations were inspected. Damaged / dropped insulation blocks were replaced by new ones and gap was filled.
- All Side wall insulations were found intact & in satisfactory condition.
- Damaged header insulations were replaced / repaired.
- Scaffolding erected & dry ice blast cleaning of all reformer tubes were carried out.
- NDT of reformer tubes were carried out by Inspection section.
- Damaged / broken tunnel slabs were replaced by new ones.
- All spring hangers locked for inspection & unlocked after completion of the job.
- All burners air resistor overhauling done.
- Arch burners damaged clamping studs and ferrules of gas inlet lines were replaced by new ones.

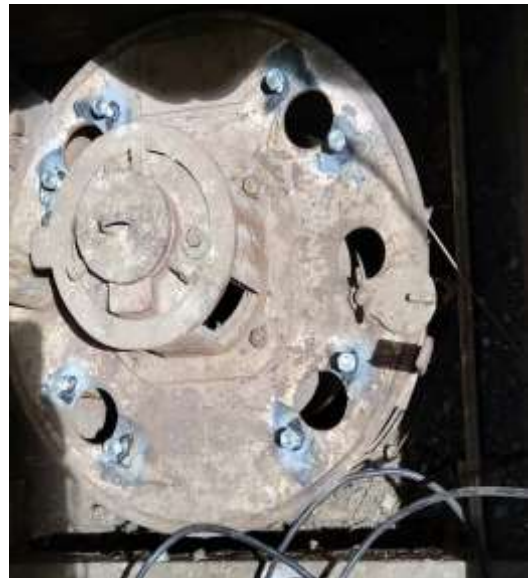
Arch burners new studs welded

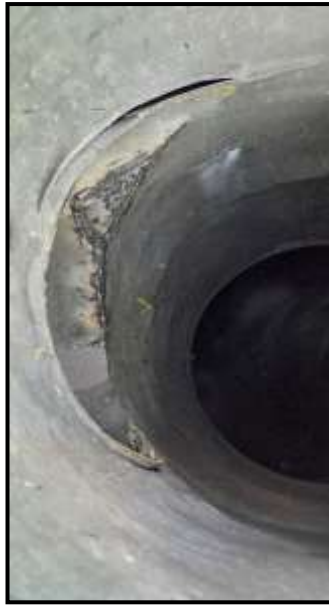
Weld Repaired Liner

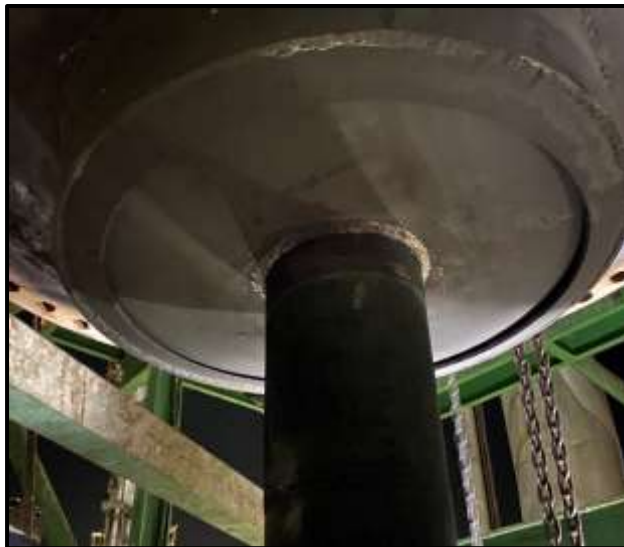
Severely eroded circumferential weld of central pipe with top cover liner was repaired by welding. Weld fill-up done on crevice observed at few locations on both sides of long seam of old pipe. Weld fill-up done on eroded weld of old pipe. (Below perforated trays)

Weld fillup done on eroded welding

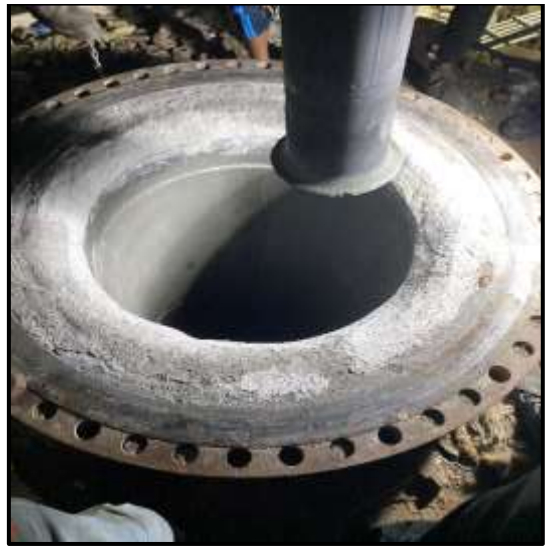
Top Flange Refractory repaired

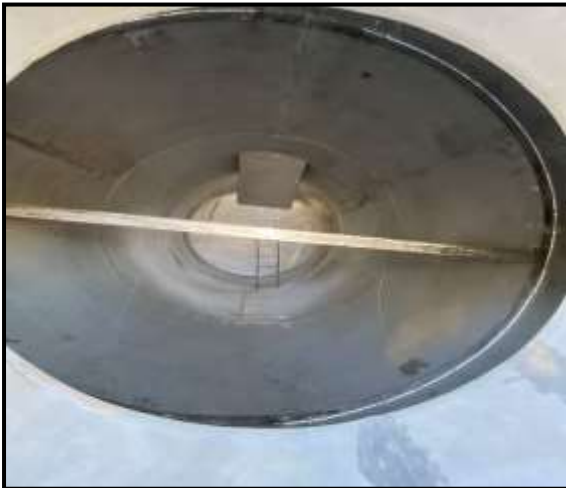
Inside view of new 103-F from top nozzle

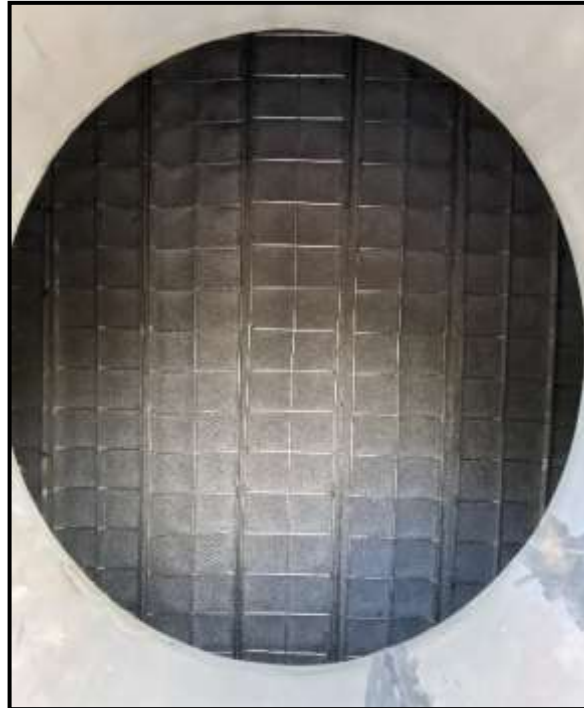
Demister Pads installed

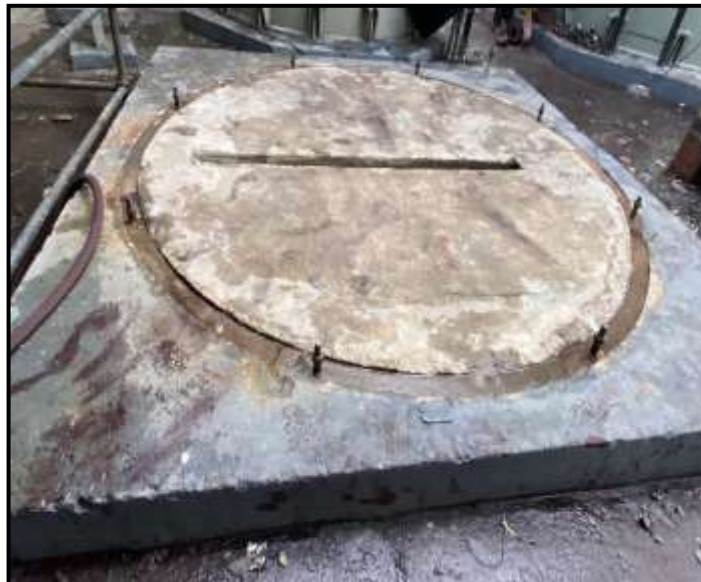
Foundation after removal of 103-F

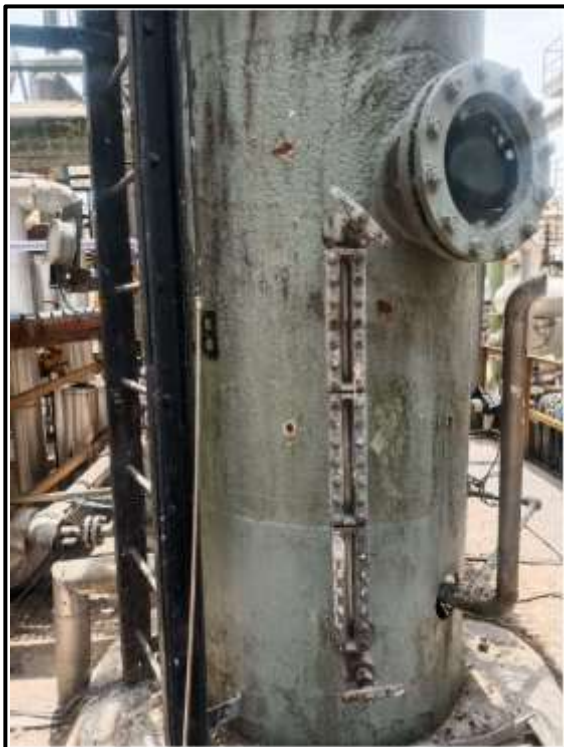
Bottom portion of B3A Vessel in PGR before Coating

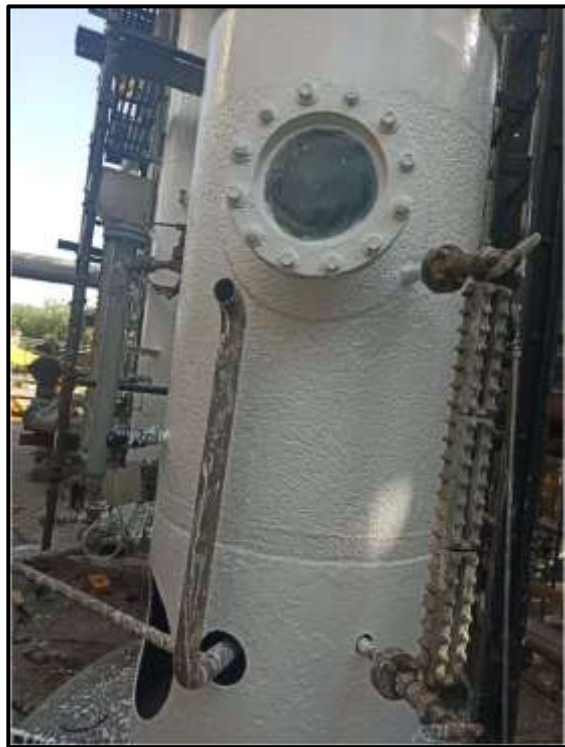
Bottom portion of B3A Vessel in PGR after Coating

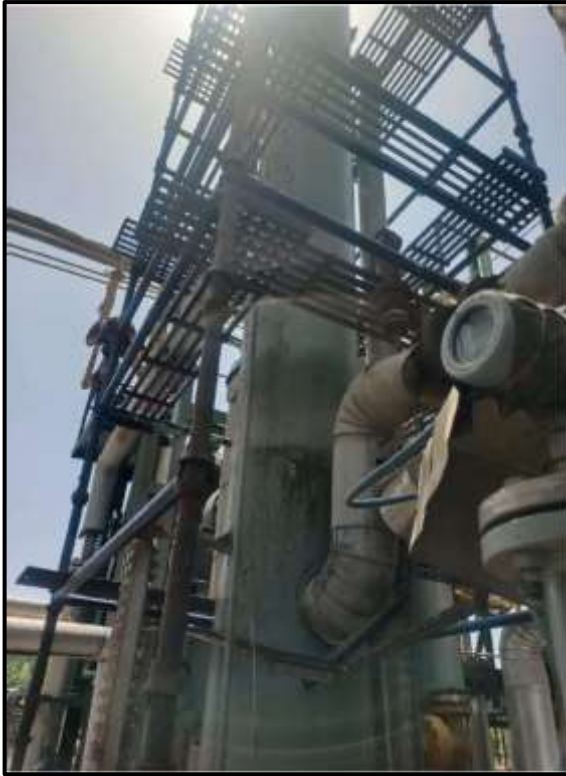
K-1 Vessel in PGR Before coating

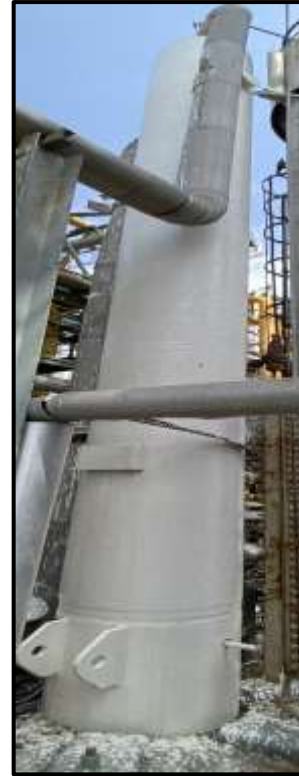
K-1 Vessel in PGR After Coating

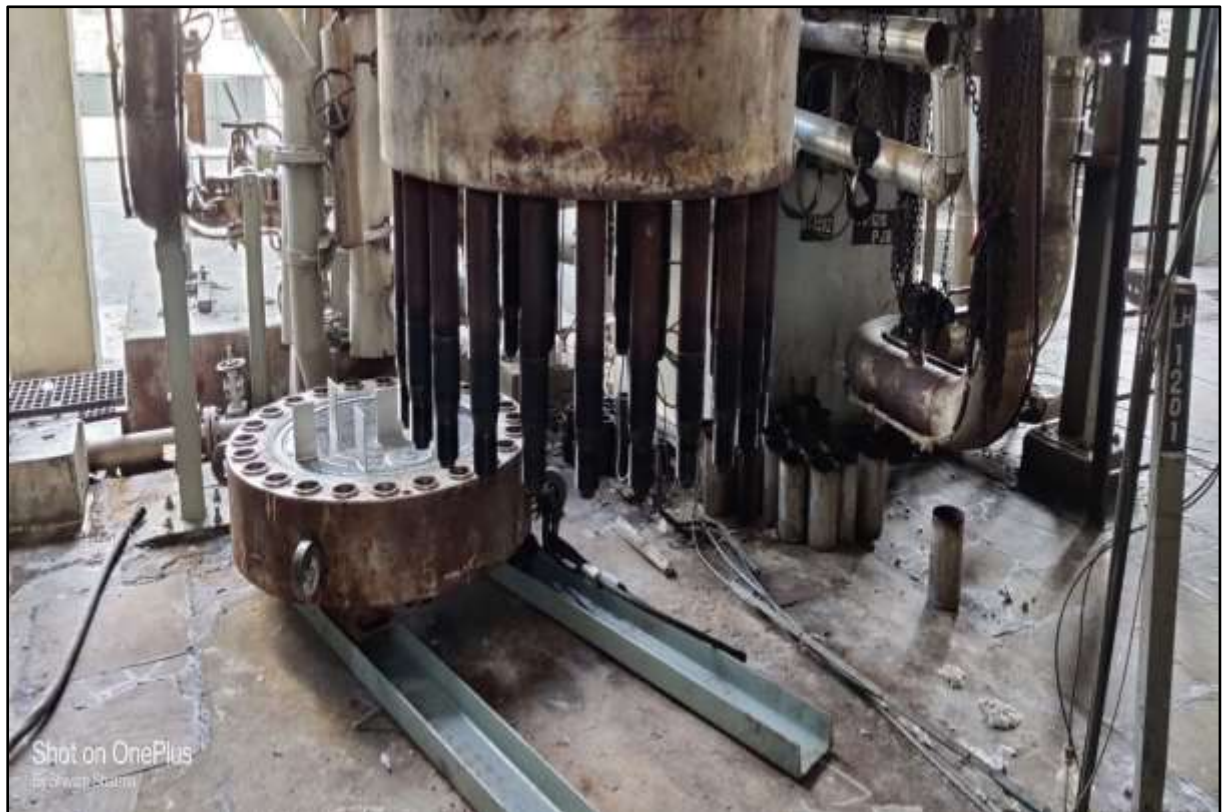
Bottom manhole cover removed and placed on Hillman roller

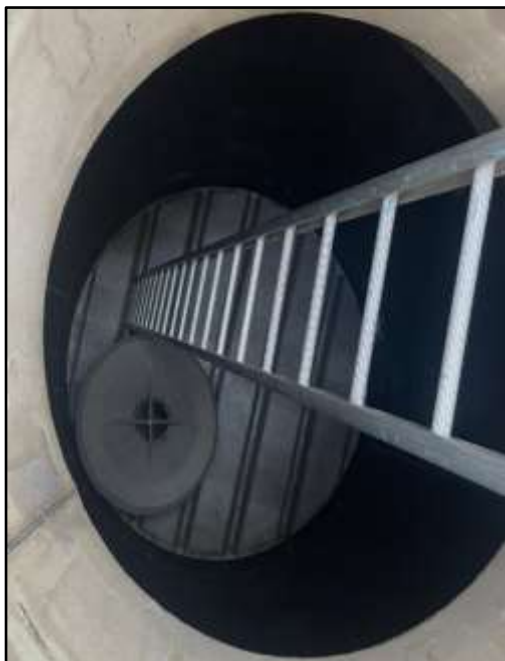
Top manhole removed

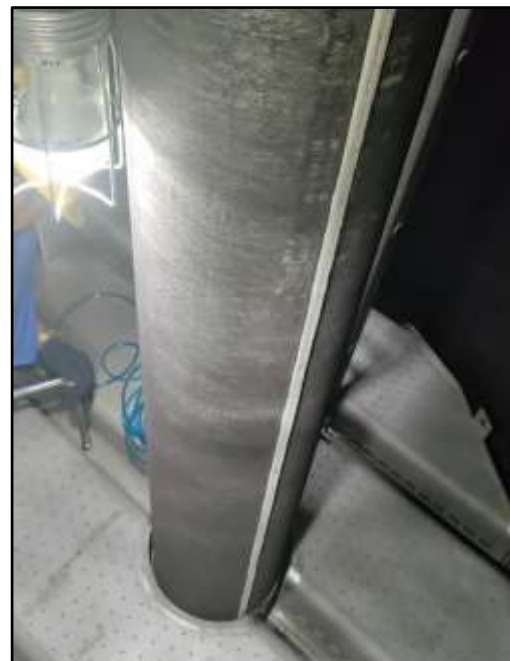
Downcomer line condition

Post welding the downcomer line was filled with DM water to check for any leakage. No leakage was observed hence the condition of welding was found satisfactory.

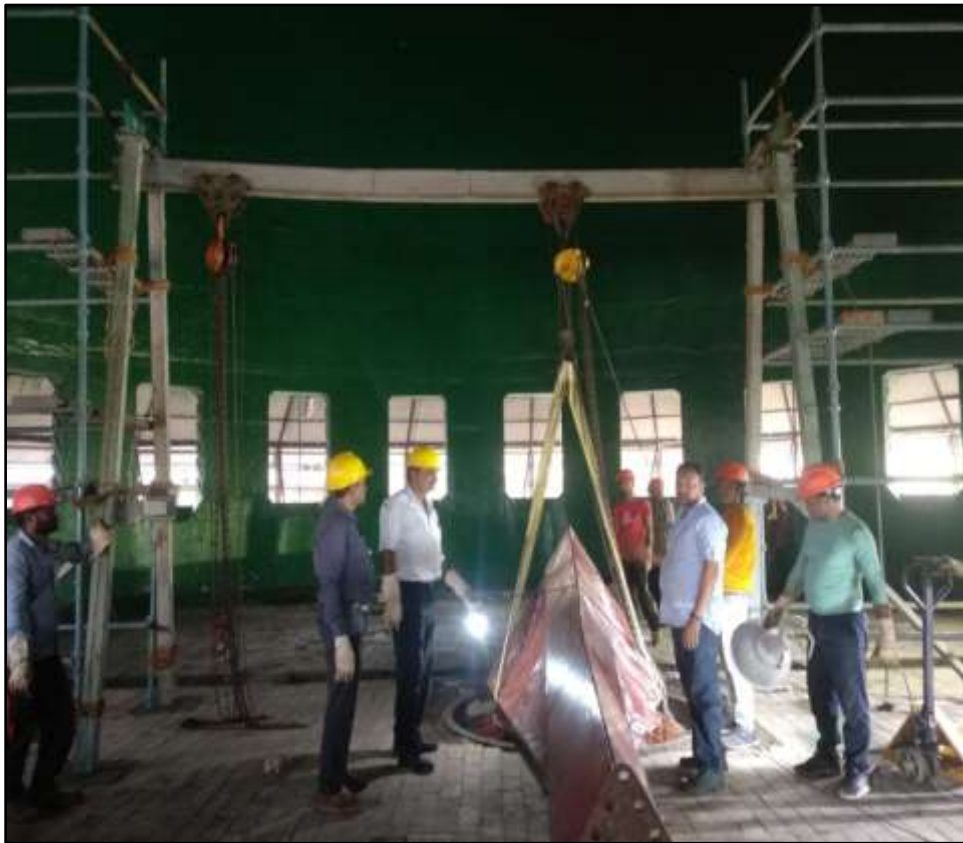
Derrick arrangement for removal of scrapper arm.

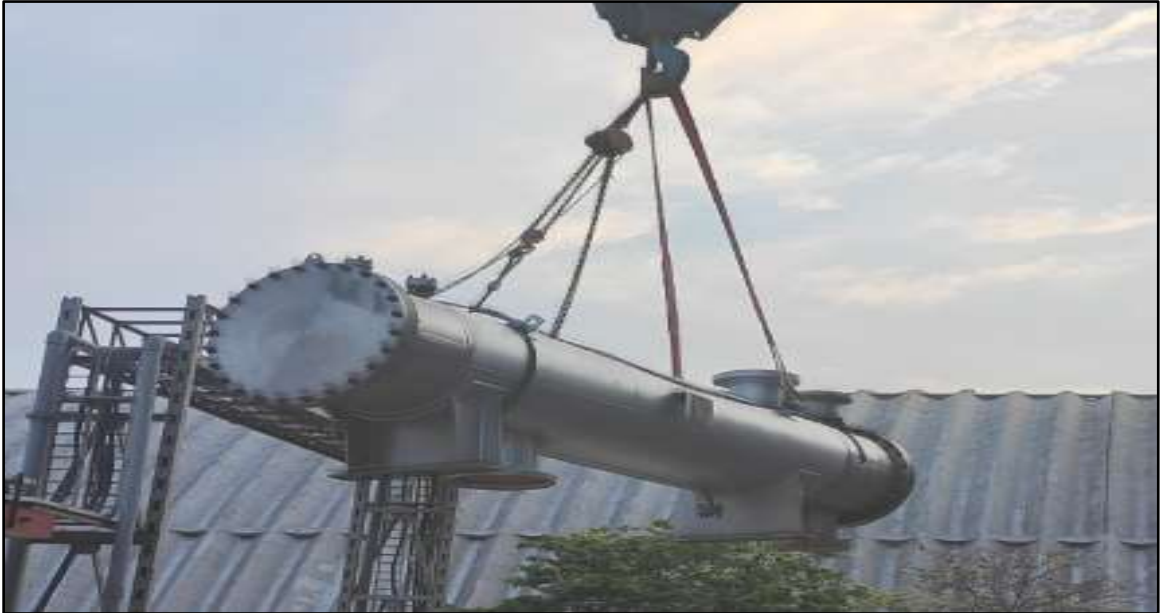
Lifting of new heat exchanger

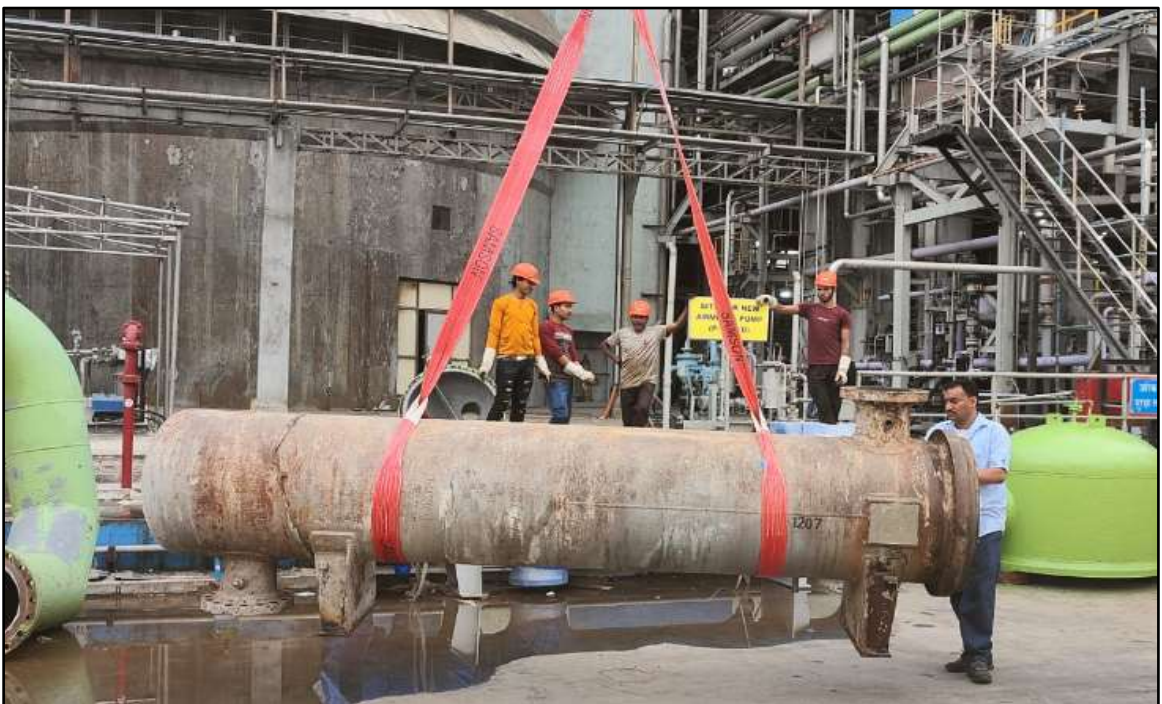
New heat exchanger was procured from M/s Chem process, Ahmedabad via PO No. 201004231161 dated 21-Nov-2022 as old heat exchanger tubes were plugged more than 30%. Hence, same was replaced during shutdown internally. Modification of the existing lines for the new heat exchanger was done by M/s A. M. Erectors.

Old heat exchanger being removed.

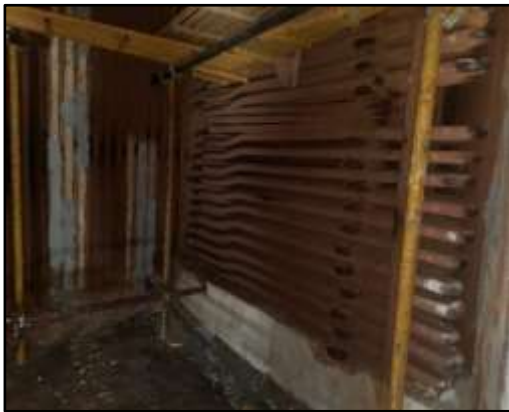
Refractory inside boiler furnace

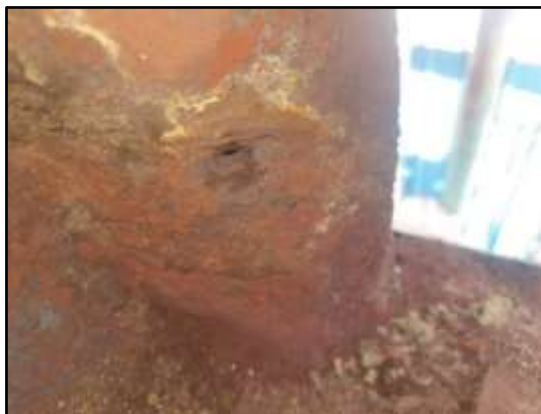
- Pinhole was found at deaerator down comer 6" line and was repaired.
- 5th number Tray segment was found displaced from its original location and repaired

Pinhole at deaerator downcomer line

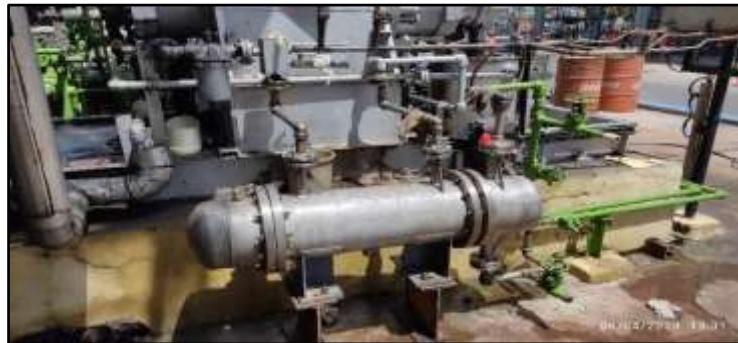
Replacement of damaged part of duct and Lube oil cooler of P-5111 is replaced

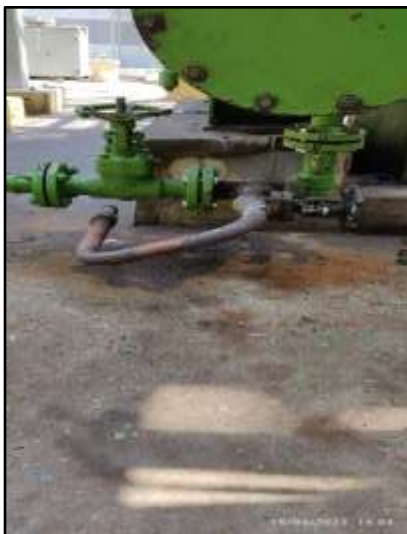
Cooling water drain line extension work

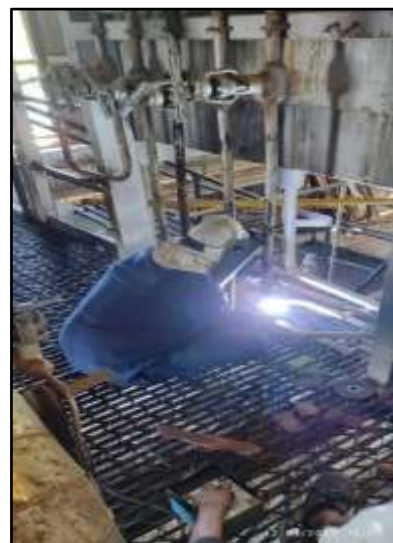
Vent lines repairing

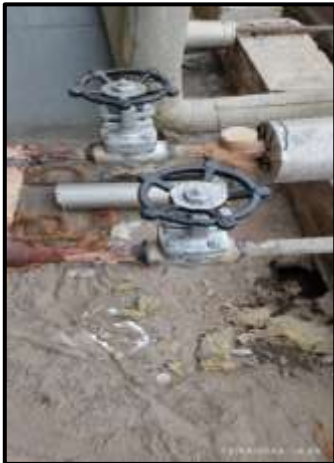
Gate valves replaced

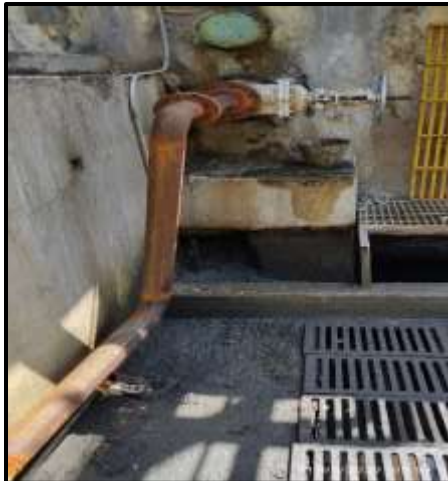
Old urea basin drain line replacement

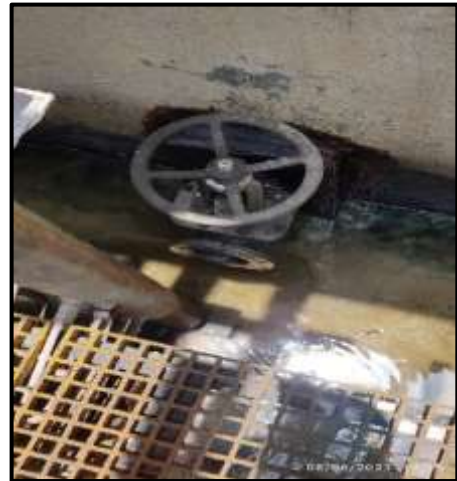
Basin drain line valve replacement

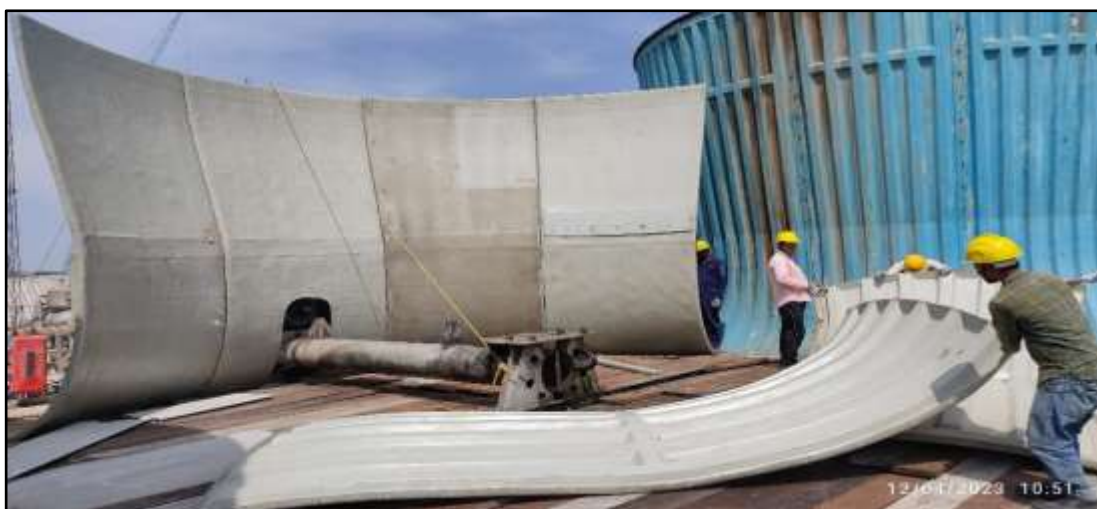
Cooling Tower Cylinder, Fan Blade and Hub assembly replacement

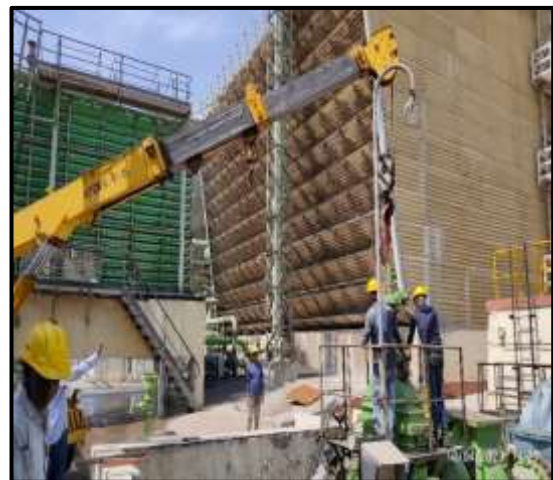
NRV and Gate valves repairing

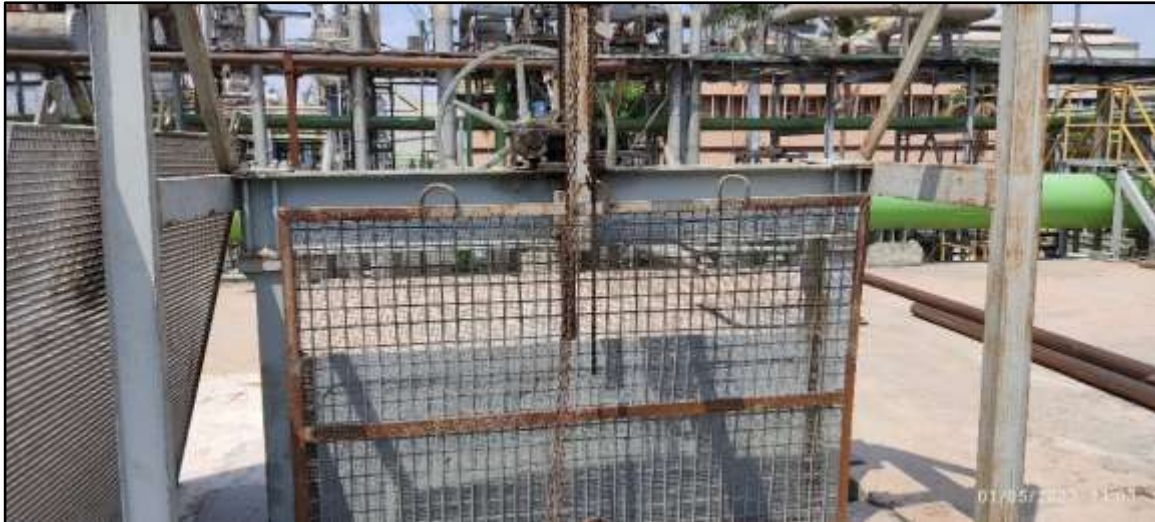
Jash make Sluice Gates preventive maintenance

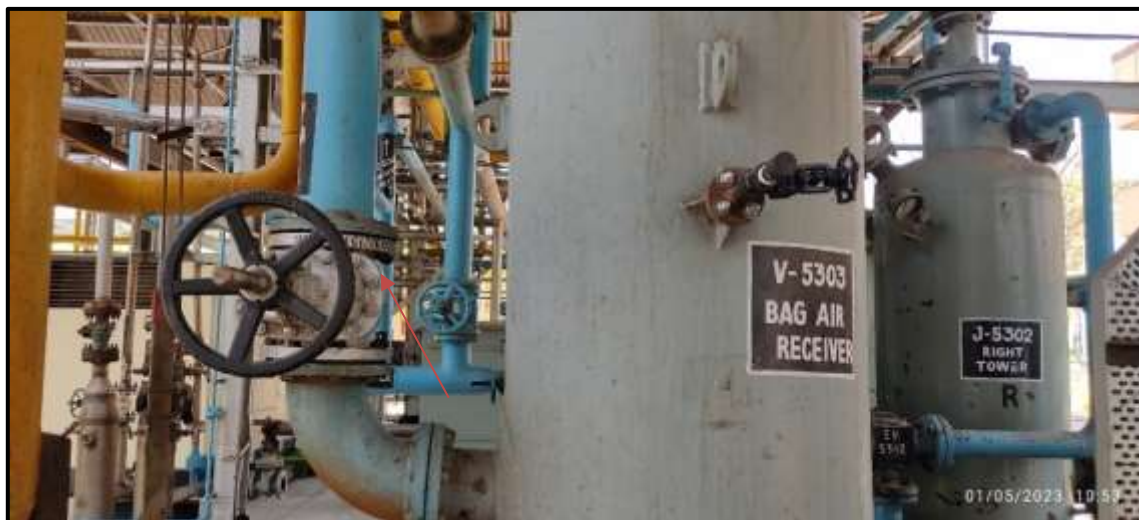
6" X 150# Gate valve replaced

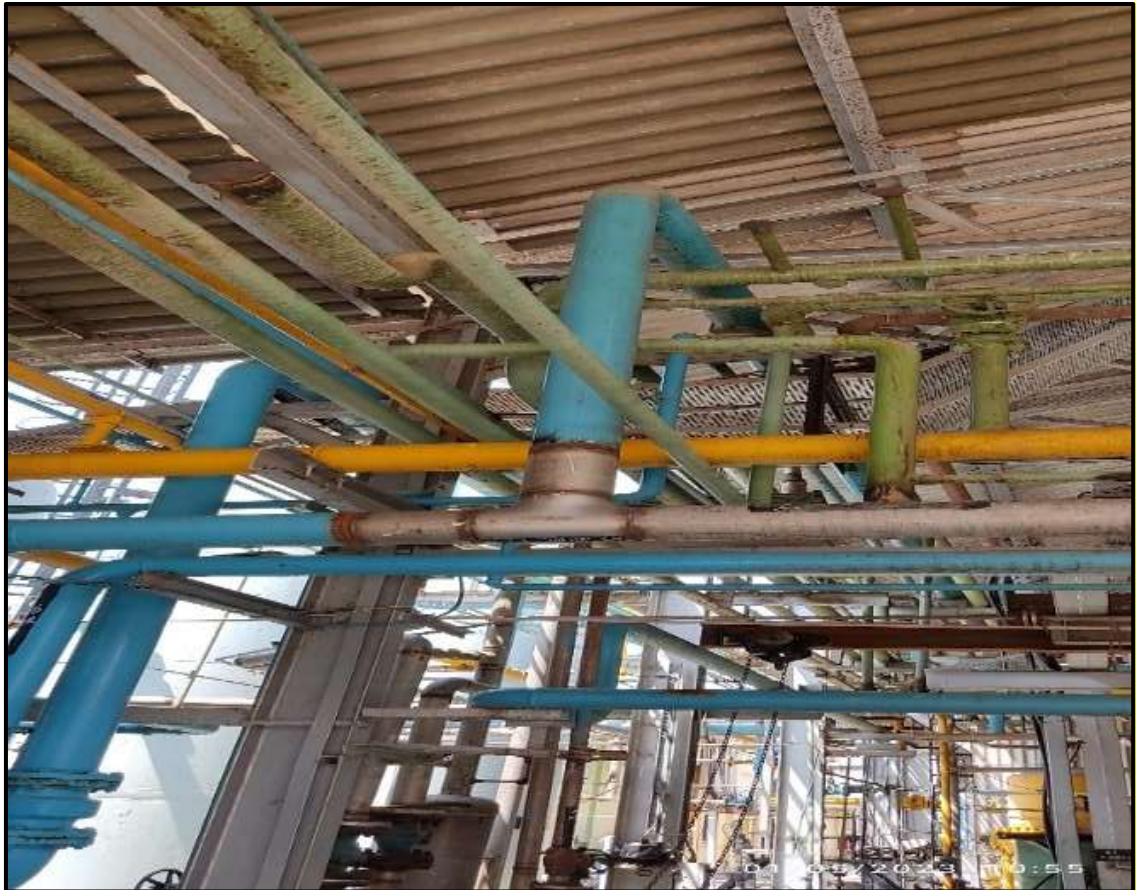
Redundant Cooling water lines removal

- Gate Valve ASTM A 216 GRADE WCB 6" NB x 150# HP airline inlet to bagging air receiver (V-5303) is replaced
- Old Bagging Air Receiver (V-5303) Loose Instrument Air Line (Redundant) Near New IR Compressor is removed and isolation valve is provided.
- Old reciprocating compressors redundant cooling water lines were removed.

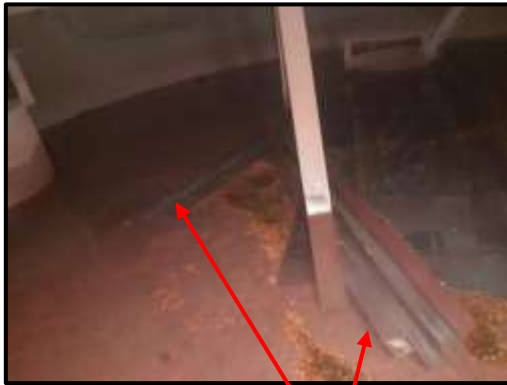
- Reddish coloration was observed inside the shell.
- Water found accumulated at bottom of the dish end.
- Resin found accumulated at bottom of the dish end.
- 02 bolt found missing of the tray enclosure manhole.
- Tray segments were found displaced from its position.
- Few tray supports were lying on bottom dish end. A metallic plate found lying on BDE.

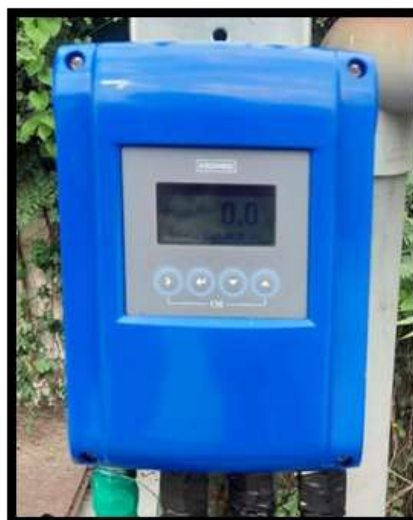
FI-6200 Transmitter / Flow indicator

FI-6200: The old flow meter was showing faulty reading. During its calibration it was found that one of its flow element coils was opened, so the meter cannot be repaired in installed condition and action was taken to for its replacement to latest model.

Flow element was installed 2.5 meters below ground level in a 24" pipeline carrying raw water from Jaspur plant to Narmada WTP plant.

Required Welding, cutting and mounting work performed with the help of M/M.

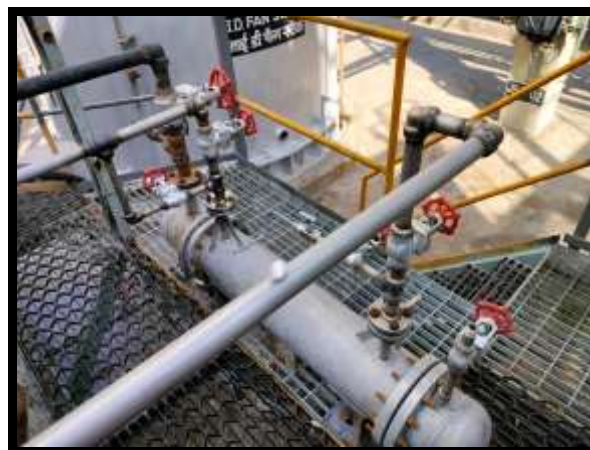
Additional lube oil cooler

Previously, it was observed that existing LO cooler of 101BJT was insufficient and unable to maintain lube oil temperature within operating range, specially during summer season.

Therefore, additional lube oil cooler is provided for 101-BJT in parallel to existing cooler, with complete isolation for oil & CW side, to ensure lube oil temperature is kept within the operating range.

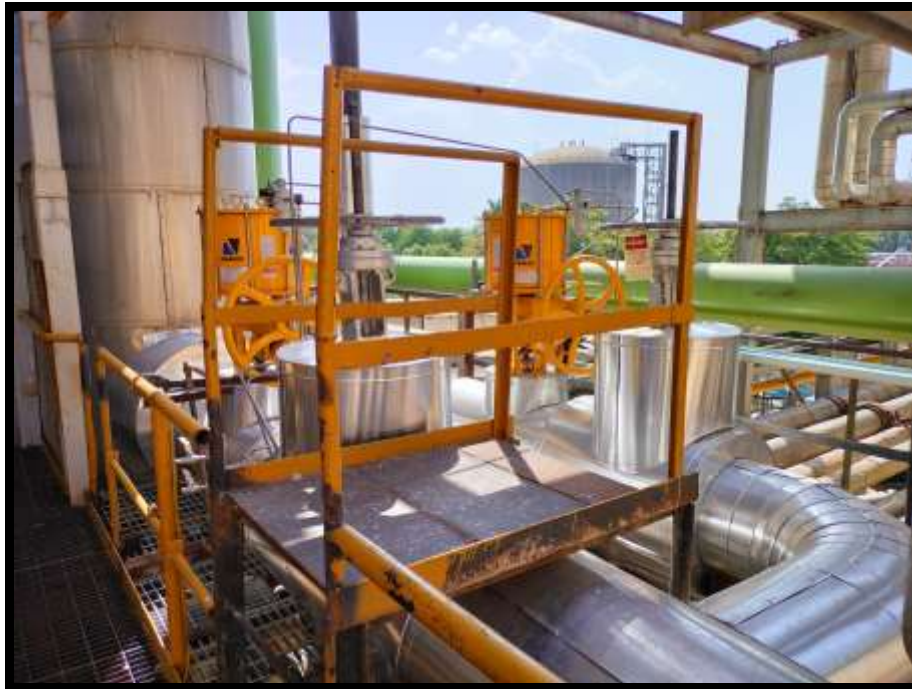
Split pressure control valves

PICV-1130 (20") control valve was provided to vent 4 ata steam to atmosphere via silencer, to maintain 4 ata steam header pressure in case of any abnormal condition. The problem of frequent passing of PICV-1130 was observed and was also difficult to maintain.

Accordingly, suitable line modifications were carried out to provide new 8" PICV-1130 A & B for split range operation. PICV -1130A will operate from 0 to 50% range and PICV-1130B will operate 50 to 100% range

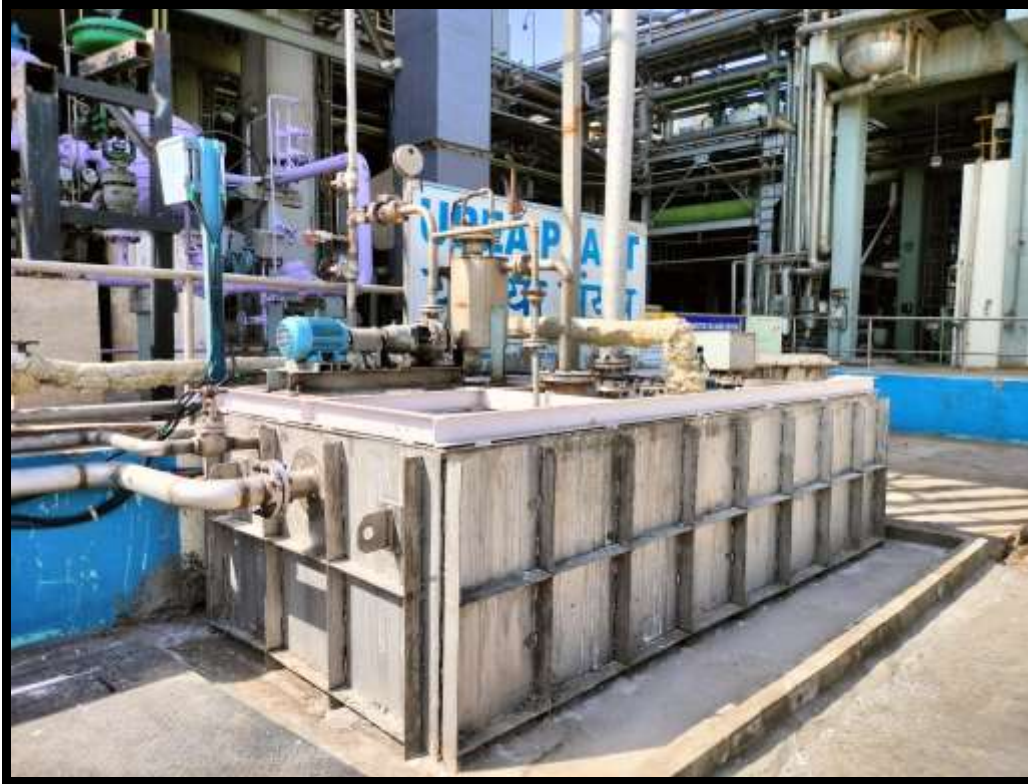
New underground ammoniacal water tank

Underground ammonical water tank (T-1302), capacity – 9.8 m³ was installed to collect ammonical water from closed draining system, and collected water can be recycled to Process water tank (T-1301) for further processing in Hydrolyser stripper system. This tank was located at the site of proposed new centrifugal pump, therefore, a new tank with bigger capacity – 13.6 m³ was constructed and installed at different location, along with associated pump and piping.

Fabrication & installation of new underground ammonical water tank (T-1303) and associated Piping jobs (Ref: EWR U 399).

Job was carried out by M/s J&J Engineers.
