IFFCO
Kalol Unit

P & S Section
Maintenance Deptt
Report No.8/1986

RE V. A M P T U R N A R O U N D - 1986
(19th March 1986 - 3rd May 1986)

INDIAN FARMERS FERTILISER CO-OPERATIVE LIMITED

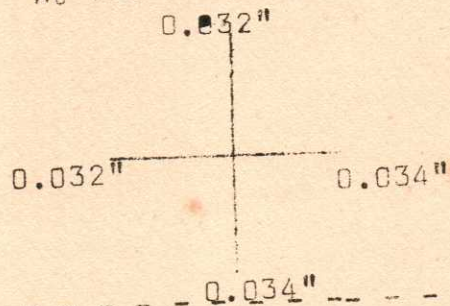
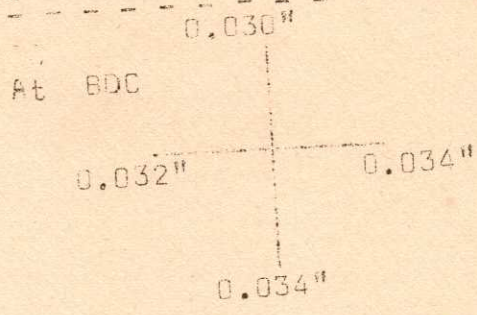
Cylinder bore of existing one was found to have increased by about 1 mm in diameter. Hence it was decided to replace complete cylinder by new a modified one supplied by M/s PD England.

At TDC & Middle
 0.032"

Piston cone clearance
 at TDC - 1.20mm at top
 - 1.15mm at bottom
 at BDC - 1.50mm at top
 1.35mm at bottom

TDC - 4.32 mm
 BDC - 4.60 mm

A new piston with piston rod fitted with wearing pads was assembled with new cylinder. Cylinder was levelled in range of 0.001" in 10" length, at head end side.

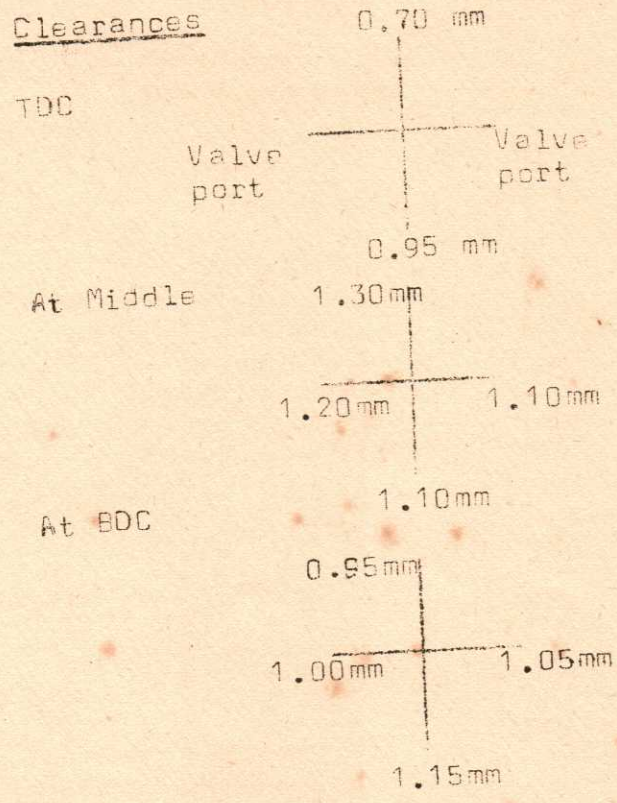
Previous readings of piston rod runout indicated necessity of wear band replacement. New wear bands were assembled with old piston and machined to required size (247.10 mm). Same was assembled with new piston rings and gas packings.

Piston rod runout

Vertical	Horizontal
TDC	0.005"	0.0025"
Middle	0.005"	0.0025"
BDC	0.000"	0.000"
