I F F C O - K A L O L - U N I T

PLANNING SECTION
MAINTENANCE DEPARTMENT
REPORT NO.13/1992

P L A N T T U R N A R O U N D - 1 9 9 2

INDIAN FARMERS FERTILISER CO-OPERATIVE LIMITED

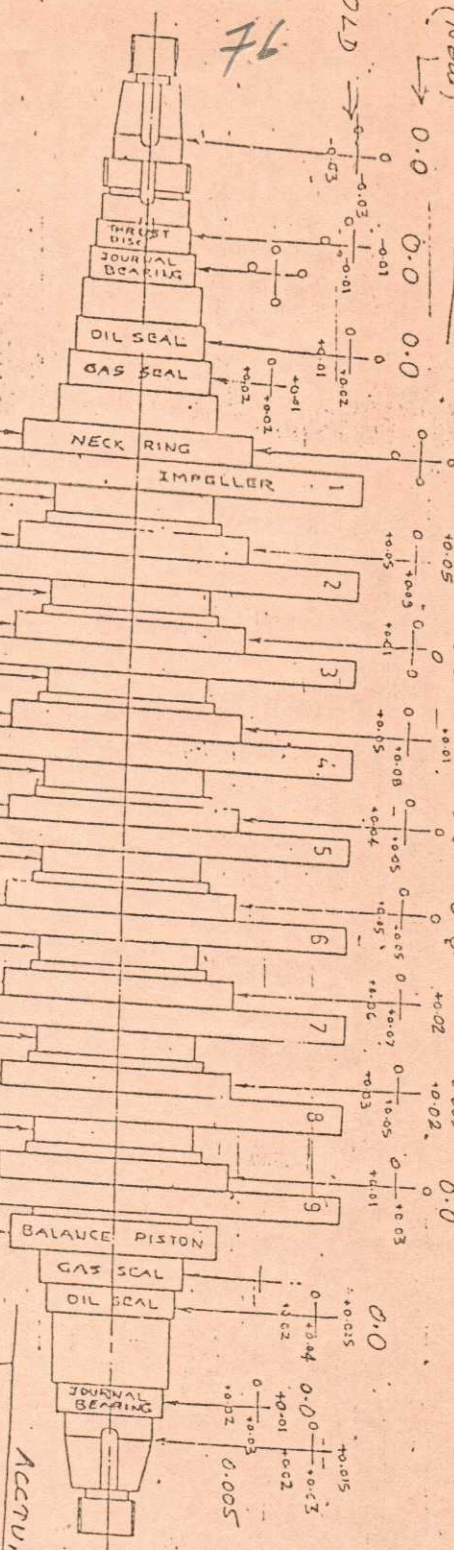
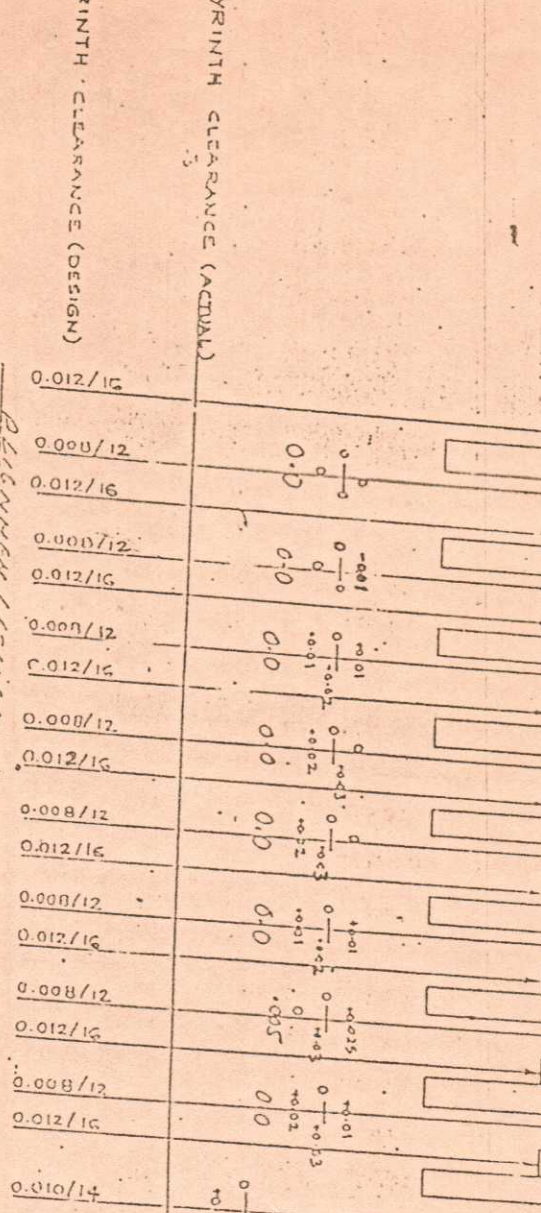
IMPELLER - DIFFUSER PASSAGE OVERLAPS & AXIAL CLEARANCES

JOURNAL BEARING CL.	0.005"
THRUST BEG. (TOTAL NINE)	0.016"
SEAL RING (JOURNAL BEG)	0.019"
SEAL RING (THRUST BEG)	0.007"
LADYRINTH SEALS - SMALL STAGES 1 TO 9	0.006"
BALANCE PISTON LADY.	0.012"
INNER LADYRINTH	0.007"
INNER SEAL RING	0.002"
OUTER SEAL RING	0.0065"
TOTAL AXIAL FLOAT	0.246"
SUCTION SIDE FLOAT	0.119"
DISCHARGE SIDE FLOAT	0.127"
