KALOL UNIT

PLANNING SECTION
 MAINTENANCE DEPARTMENT
 REPORT NO.15/1995

R L A N T - T U R N A R O U N D

J A N U A R Y - 1995

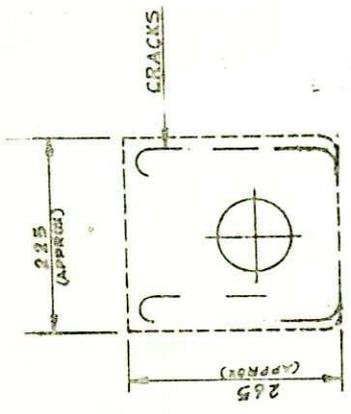
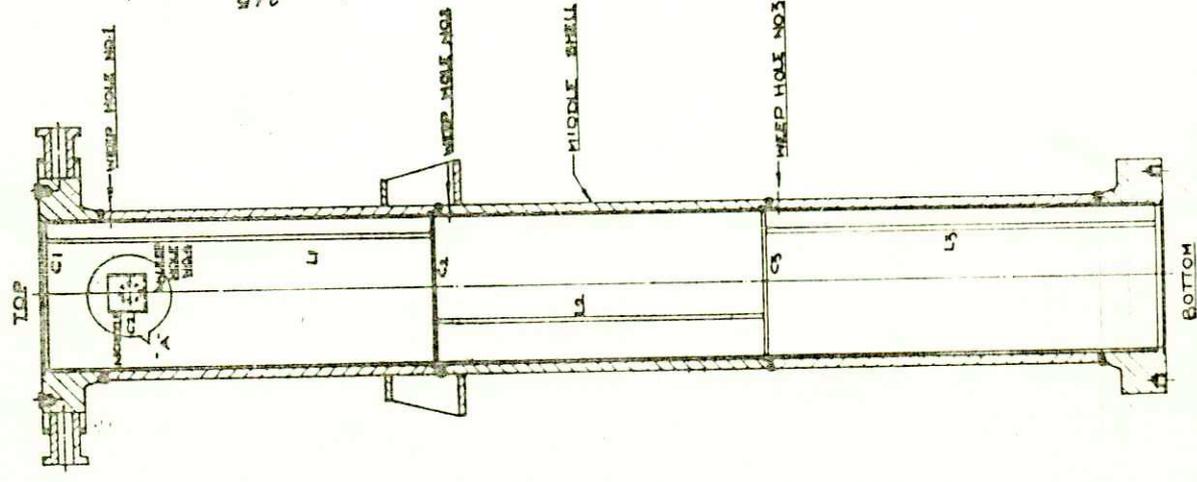
H-1203 SHELL

CRACKS DETECTED ON THIS HAZ AREA AFTER GRINDING THE BASKET FLUSHING WITH THE LINER AND CHEMICAL ETCHING (CRACKS ARE NOT THRU & THRU) (APRIL 1986)

L - LONGITUDINAL WELD SEAM
C - CIRCUMFERENTIAL WELD SEAM

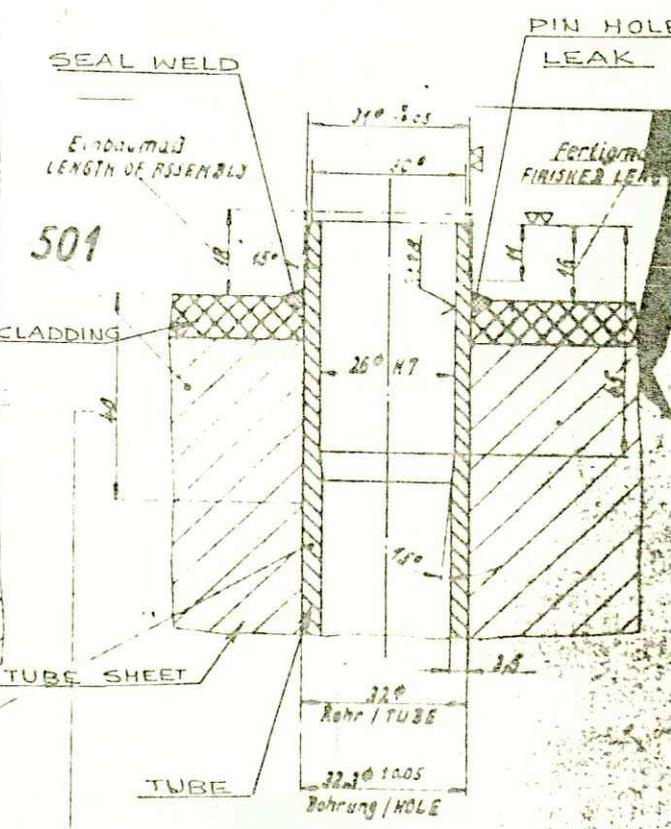
H-120 TUBE REPAIR DETAIL

On visual inspection it was found to be erosion and corrosion of seal welding of tube with overlay in many tubes surroundings of tube No.1712 and require weld deposit. 5 threaded socket weld also eaten away due to erosion and corrosion. D.P.test was carried out in all suspected welds and found to be 6 blind pin holes in seal welds of tube with overlay in top tube sheet.

TUBE NO. 1712
 PIN HOLE WAS NOTICED IN
 THIS OVERLAY WELDING AREA
 THIS PORTION WAS GROUNDED
 AND REPAIRED BY WELDING
 ELECTRODE USED SANDVIK
 25; 22; 2 LWN.

Passivated of weld repair and around the weld by using 5 - 10 % HNO₃ followed by rinsing with DM water. Refer drg. elevation of tubes in drg.No.AO 62769 (H-1201)

Vor dem Einschnitten leicht anwalzen.
 LIGHTLY EXPANDED BEFORE WELDING.
