IFFCO

KALOL UNIT

PLANNING SECTION  
MAINTENANCE DEPT.  
REPORT NO: 17/1997

REPORT  
ON  
PLANT-TURNAROUND

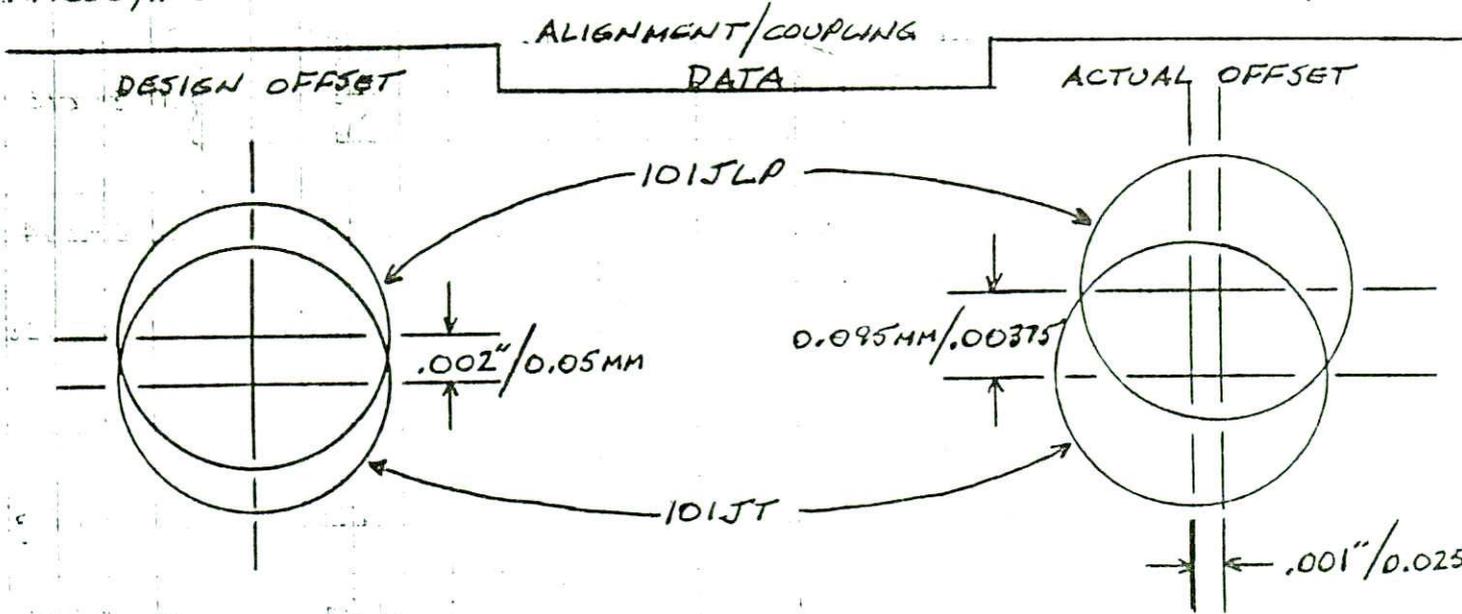
- NOTE :
1. REVERSE INDICATOR METHOD NOT USED. FACE AND RIM ONLY
  2. ALIGNMENT DATA BY GANGOTRI TURBO TECH. ENGG. SERVICES
  3. FACE READINGS (PARALLELISM) SHOW FACES OPEN ON LEFT SIDE AND BOTTOM BY .0016" (0.04 MM).
  4. LOOKING FROM TURBINE TO COMPRESSOR
  5. DIAL INDICATORS READING ON COMPRESSOR HUB.
  6. ALIGNMENT AND METHOD ACCEPTED BY D. HANDAR - IFFCO.

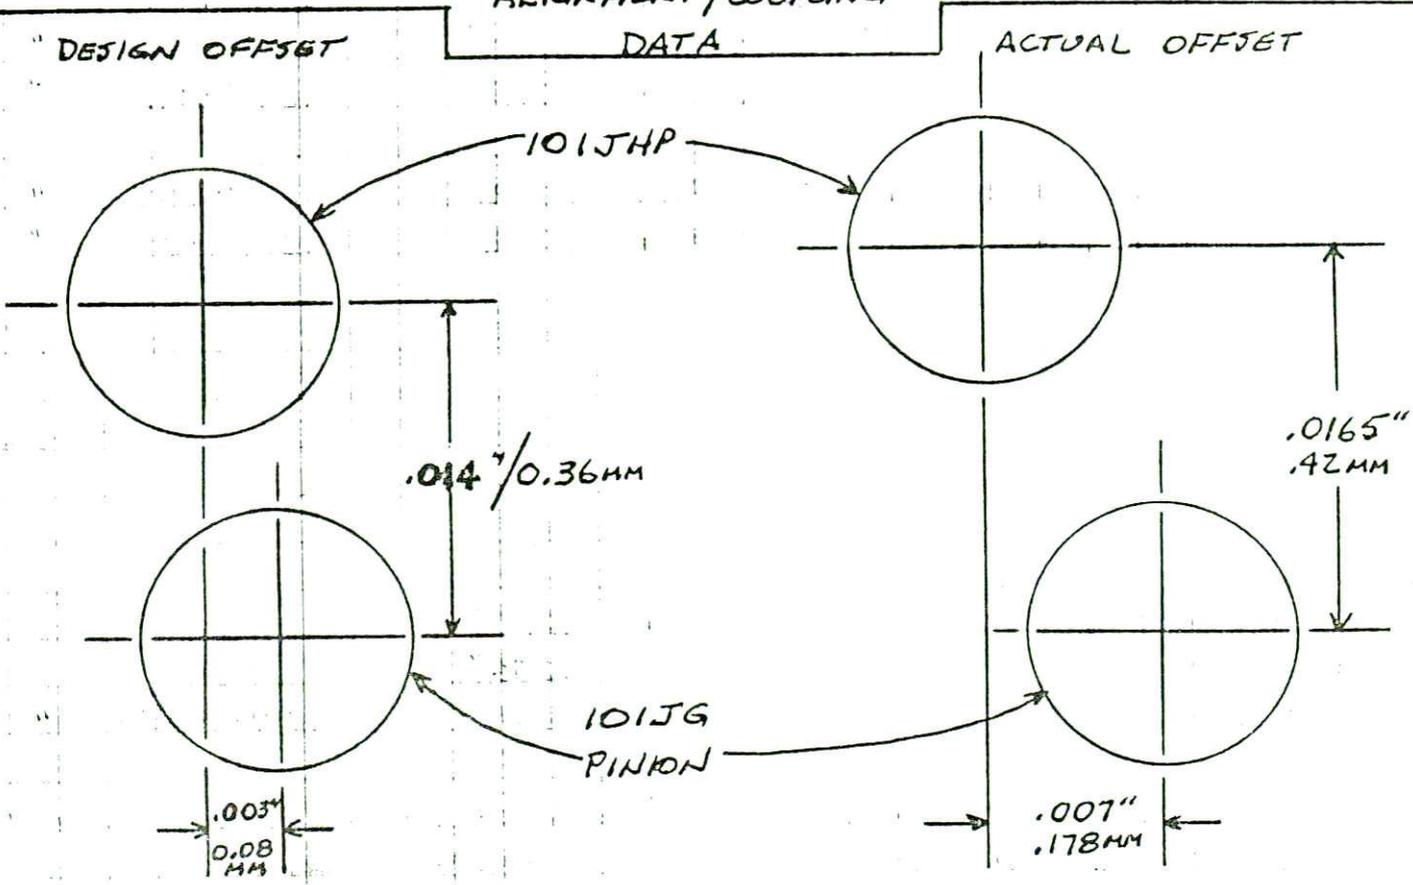
- NOTES: 1. REVERSE INDICATOR METHOD NOT USED. RIM AND FACE ONLY.  
 2. ALIGNMENT DATA BY GANGOTRI TURBO TECH. ENGG. SERVICES.  
 3. FACE READINGS (PARALLELISM) SHOW FACES OPEN ON RIGHT SIDE AND BOTTOM .001" (.025MM).  
 4. LOOKING FROM PINION TO COMPRESSOR  
 5. DIAL INDICATORS READING ON PINION HUB.  
 6. ALIGNMENT AND METHOD ACCEPTED BY D. J. NAHDAR - IFFCO.
