IFFCO
KALOL UNIT

PLANNING SECTION
MAINTENANCE DEPTT.
REPORT NO : 18 / 1998

REPORT
ON
PLANT TURNAROUND

(APRIL - MAY - 1998)

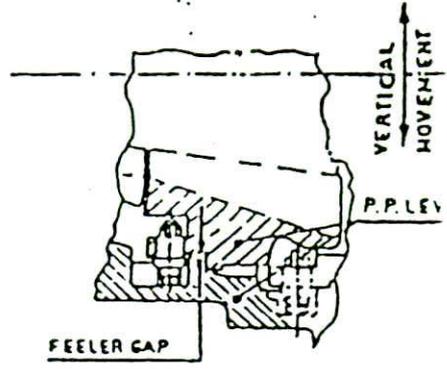
GUIDE BLADE CARRIER

CARRIER NO		1	2	3	4	5	6
FEELER GAP	LEFT	1.15	1.05	1.03	1.37		
	RIGHT	1.15	1.11	1.03	1.37		
PP LEVEL	LEFT	-0.19	-0.15	-0.25	+0.05		
	RIGHT	+0.11	-0.15	-0.25	+0.17		
VERTICAL MOVEMENT	TOP						
	BOTTOM

- CENTERING OF CARRIERS SHALL BE CARRIED OUT AFTER FINAL CENTRATION AND LOCKING OF FIXING/ECCENTRIC BUSHES.
- AFTER COMPLETE CENTERING ENSURE THE LOAD AND SEATING ON SPHERICAL WASHER.

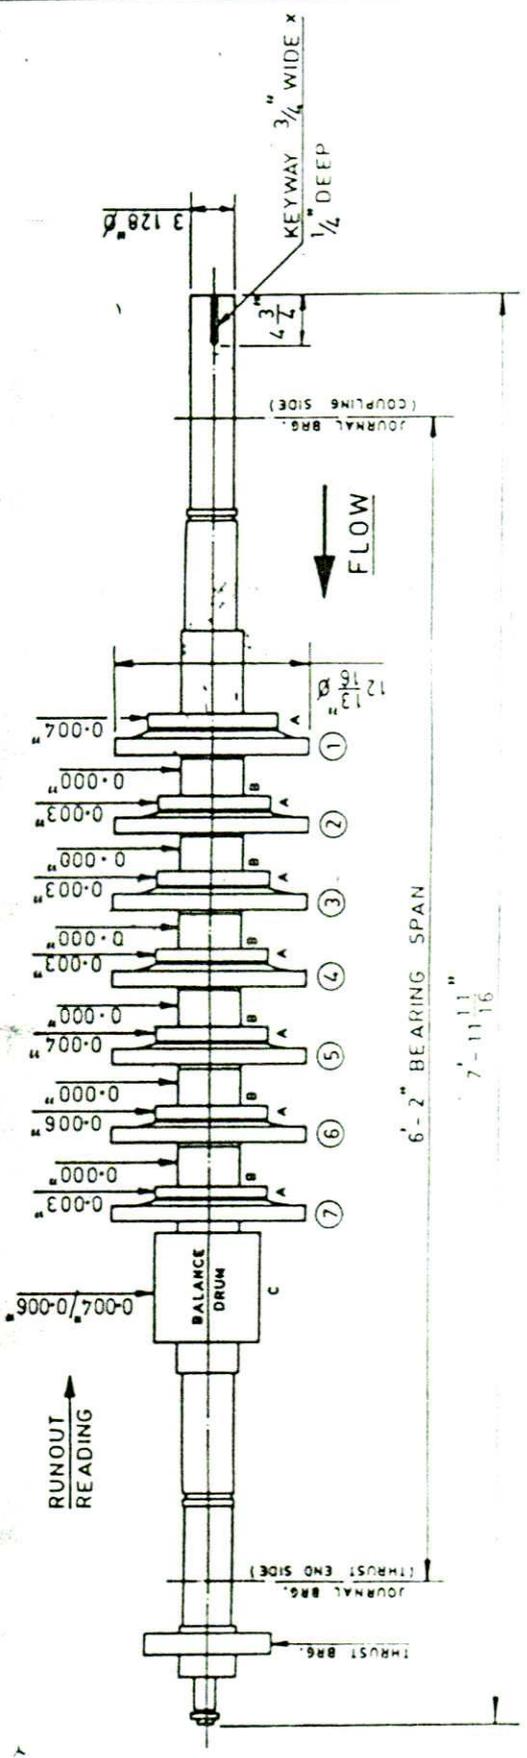
104-J/JA BFW PUMP CLEARANCES DATA

IMPELLER NO.	IMPELLER NECK RING CLEARANCE (A)			INTERSTAGE BUSHING CLEARANCE (B)			BALANCE DRUM CLEARANCE (C)	
	WEAR RING I.D.	NECK RING O.D.	CLEARANCE	BUSH I.D.	SLEEVE O.D.	CLEARANCE	BUSH I.D.	BALANCE DRUM O.D.
1	8.504"	8.480"	0.024"	4.000"	3.988"	0.012"	6.875"	6.868"
2	7.383"	7.360"	0.023"	4.000"	3.988"	0.012"	6.878"	6.868"
3	7.383"	7.360"	0.023"	4.000"	3.988"	0.012"		
4	7.383"	7.360"	0.023"	4.000"	3.988"	0.012"		
5	7.383"	7.360"	0.023"	4.000"	3.988"	0.012"		
6	7.383"	7.360"	0.023"	4.000"	3.988"	0.012"		
7	7.383"	7.358"	0.025"					
BALANCE DRUM							6.878"	6.868"

1. JOURNAL BRG. CLEARANCE + 0.006" (COUPLING SIDE)
2. JOURNAL BRG. CLEARANCE + 0.006" - 0.008" (THRUST END SIDE)
3. THRUST BRG. CLEARANCE + 0.014"
4. TOTAL FLOAT + 11 MM.
5. COUPLING FLOAT + WITH PLATE - 8.45 MM. W/O PLATE - 17.80 MM.

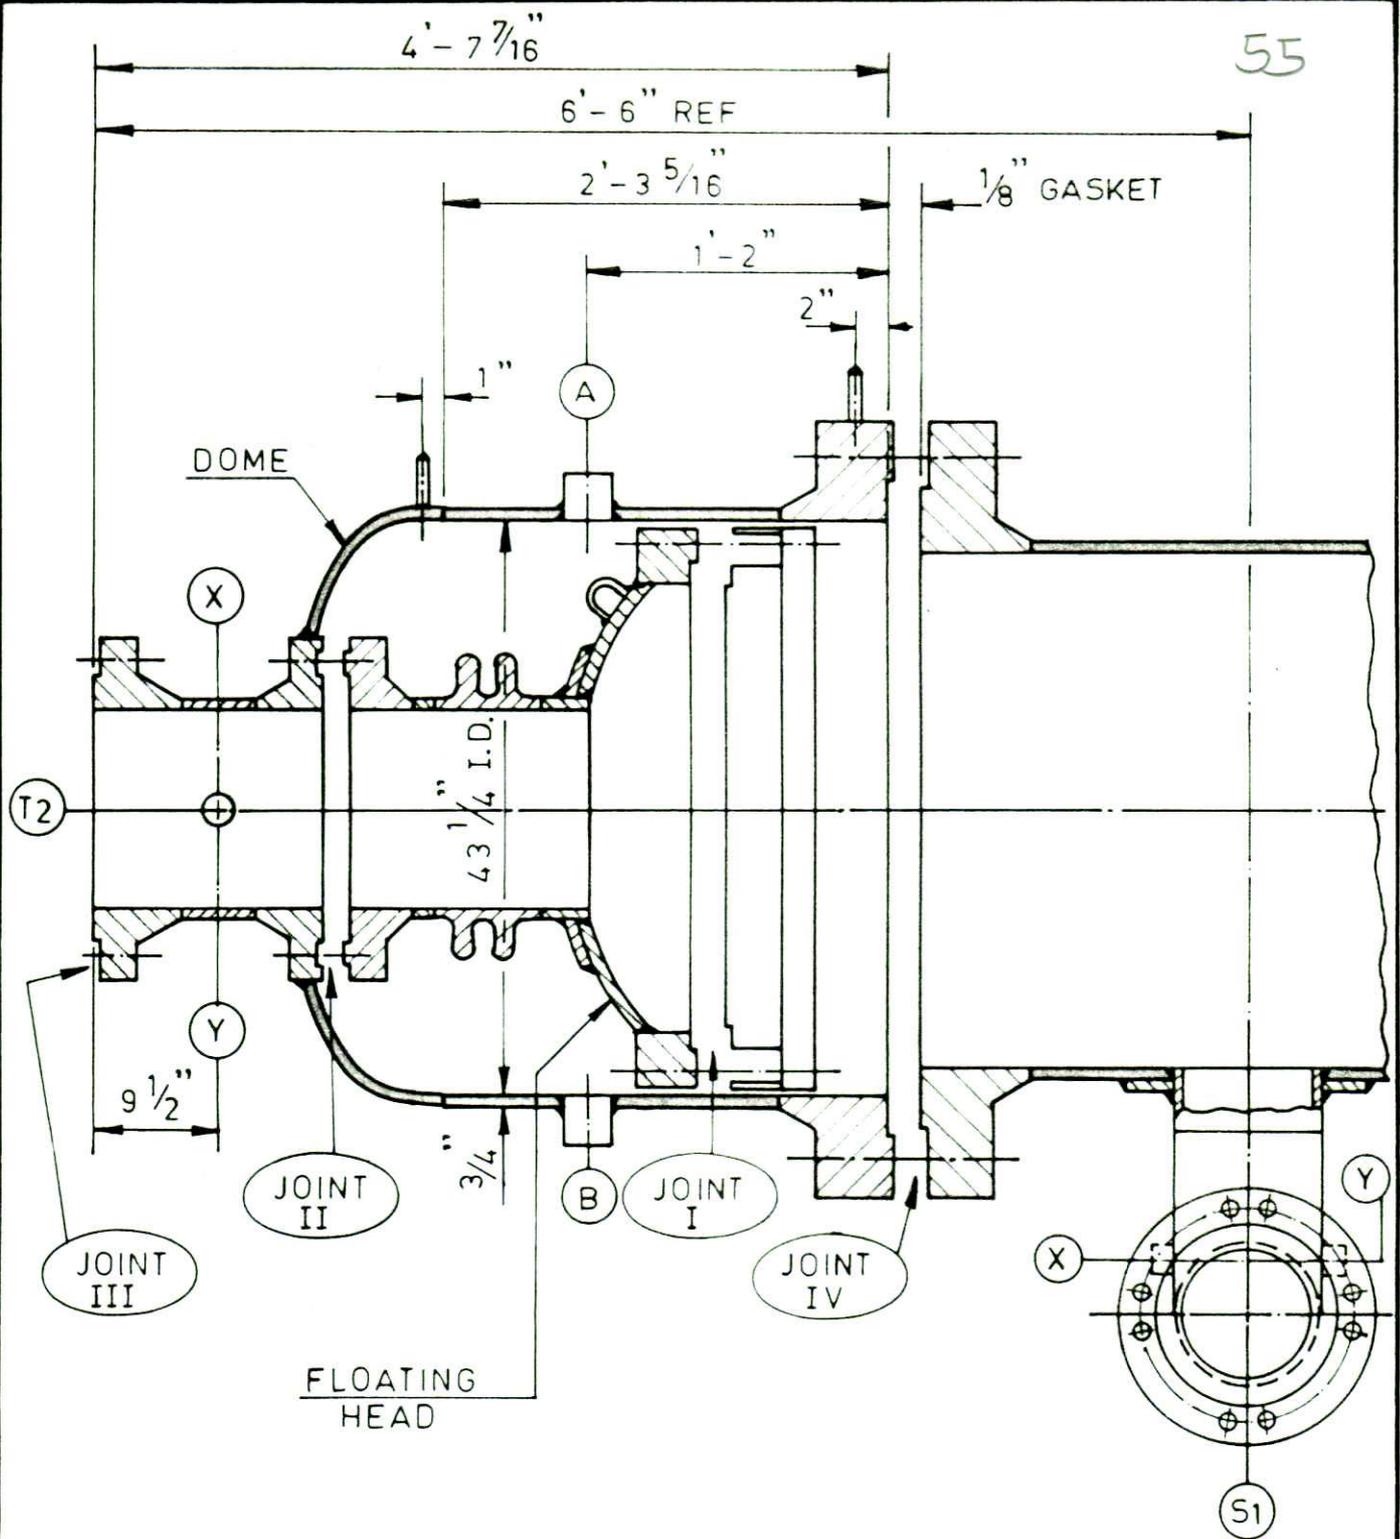
TUBE SIDE INLET END OF 104 - C

ROW NO.	NOS. OF TUBES	NOS. OF TUBES PLUGGED (FROM 90° TO 270°)
15	12	
14	15	
13	18	
12	19	
11	20	6, 13
10	23	15
9	24	7, 12, 16
8	25	9, 10, 11, 21
7	26	7, 10
6	25	16
5	26	8
4	27	22 (OLD ONE)
3	28	12, 16, 18, 26
2	29	
1	28	
1	28	
2	29	
3	28	14, 18
4	27	18
5	26	15
6	25	15
7	26	15, 25
8	25	
9	24	
10	23	
11	20	
12	19	
13	18	
14	15	
15	12

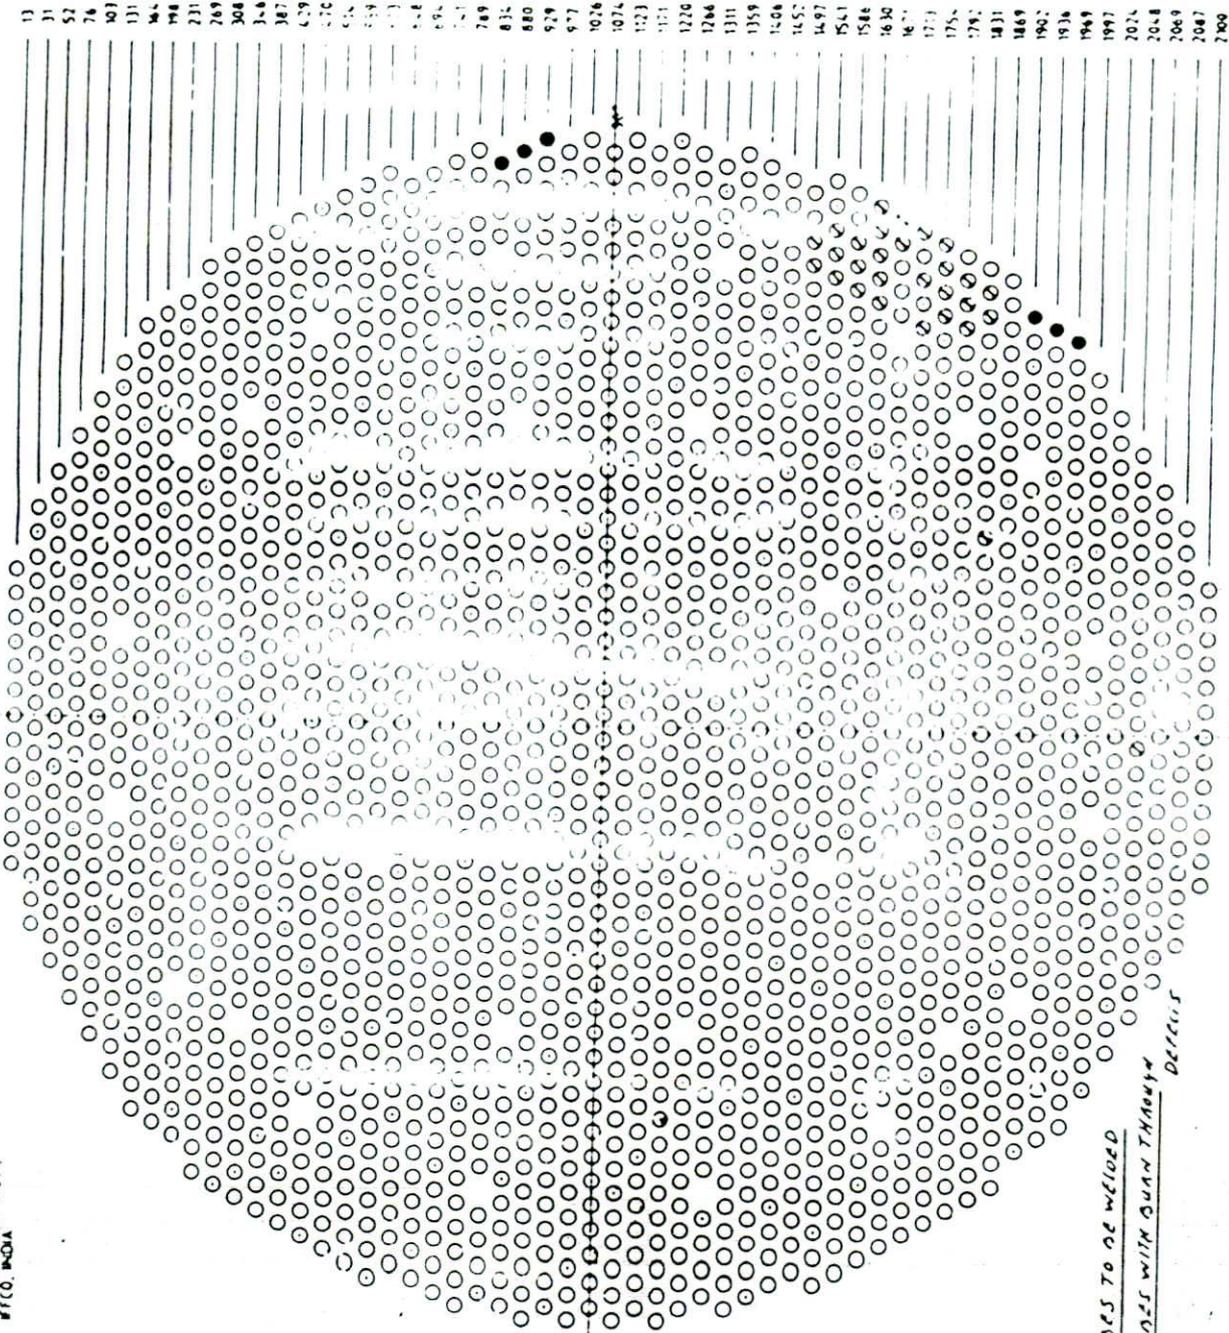
Liquid inlet

TURNS TO BE RELOADED
