MTC / REPORT / 01
REPORT NO. 23 / 2003

IFFCO
KALOL UNIT
REPORT
ON
PLANT TURNAROUND
(MAY - JUNE - 2003)

INDIAN FARMERS FERTILISER CO - OPERATIVE LIMITED

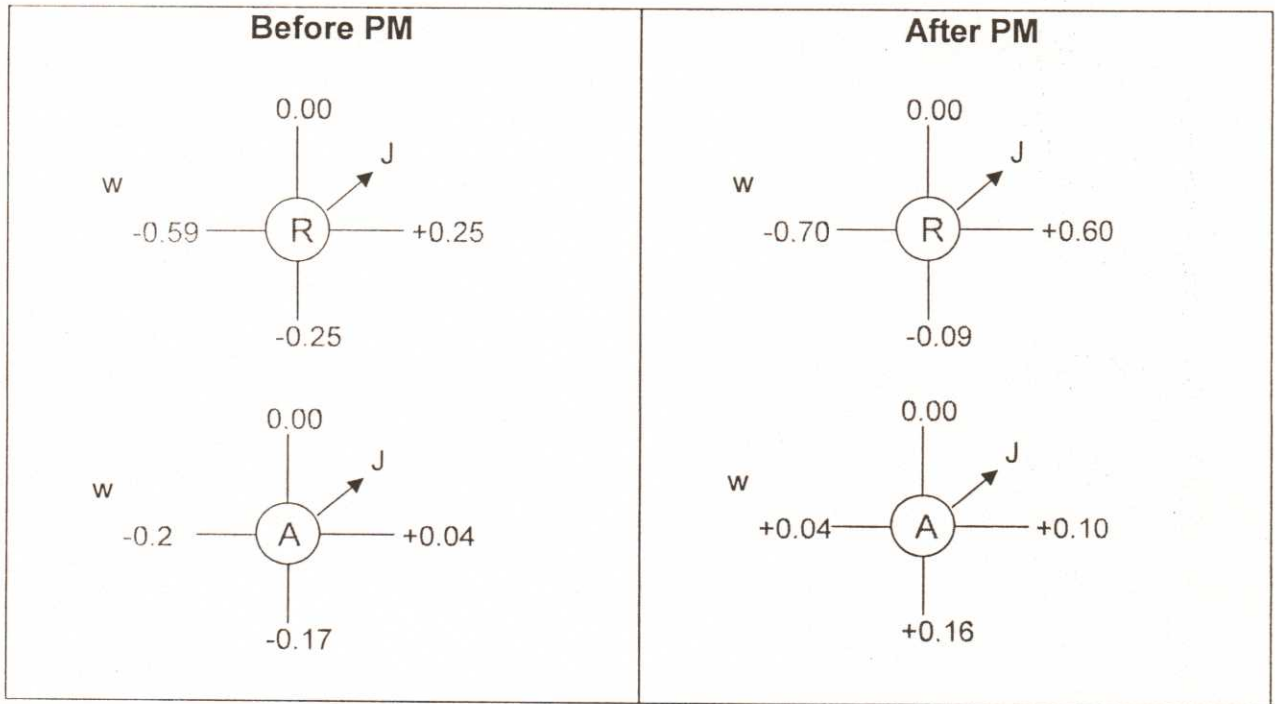
102 JT TO 102 J

Turbine was decoupled and bearings were inspected. Coupling float was below recommendation due to sludge deposit in coupling gear. Coupling end journal bearing found to have crack in white metal lining of both halves, the same was replaced with reconditioned bearing. White metal lining of governor side journal bearing bottom was peeled off . Hence replaced with new one. 3 nos. thrust pads were found having crack and dent. Hence it was also replaced. Labyrinths at both ends were also replaced as it was damaged and clearances were on higher side. Gauss measurement of rotor shaft and bearings carried out. Thrust collar (7.9 gauss) and Opposite thrust end bearing base ring (36 Gauss) was above allowable limit and the same was removed by degaussing.

Journal & thrust bearings were inspected. Coupling side journal bearing clearances were above the design value. Hence it was replaced. Both Journal bearing pads and journal portion of shaft found to have brownish sledge. It was cleaned. Axial thrust was more than required. Hence active side shim thickness was changed to 2.38 mm from 2.28 mm. Gauss measurement of rotor shaft and bearings was carried out. Gauss reading of thrust end journal bearing base ring (33 gauss), thrust collar (13 gauss) & opposite thrust end journal bearing base ring (44 gauss) were found above limit and the same were removed by degaussing.

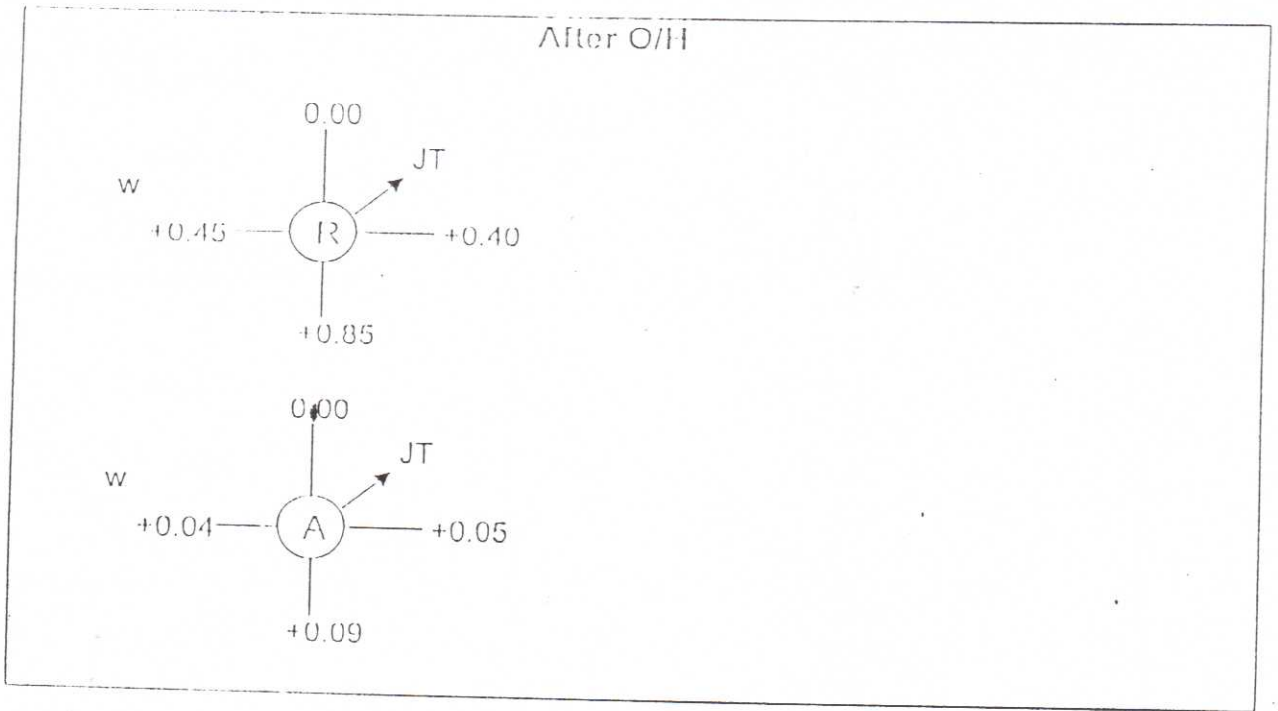
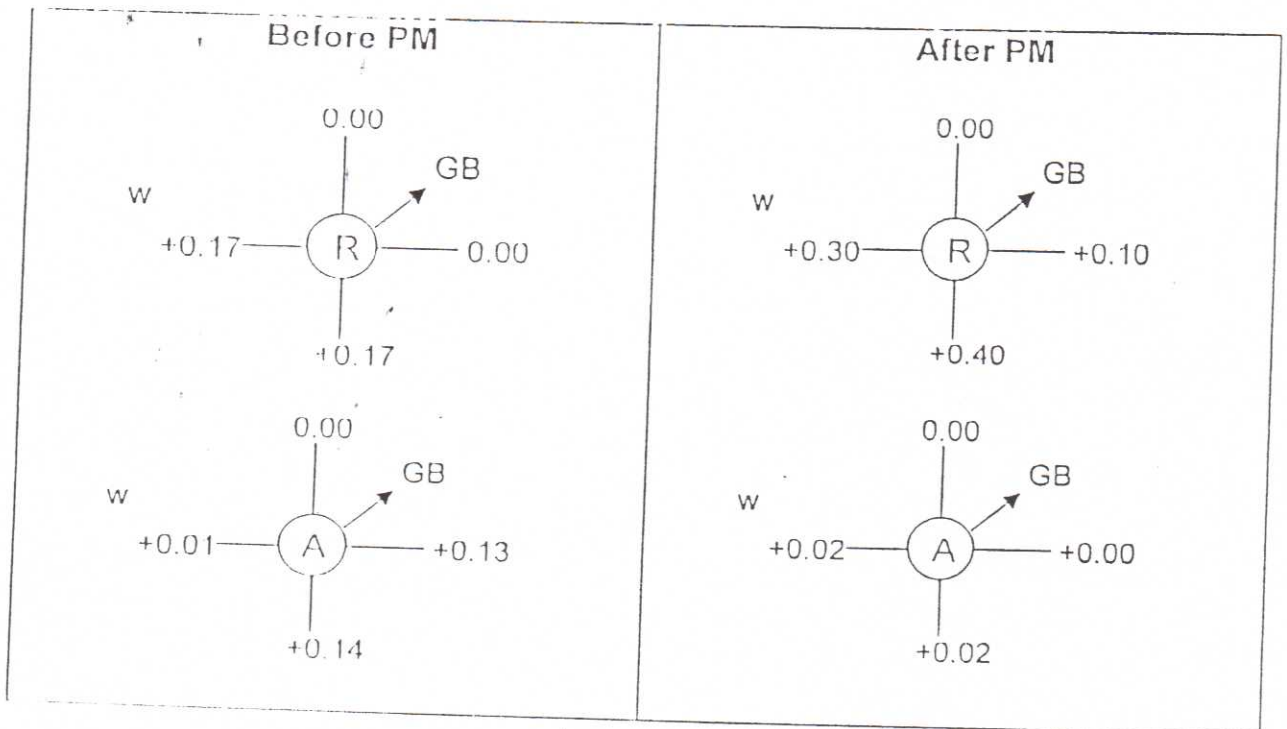
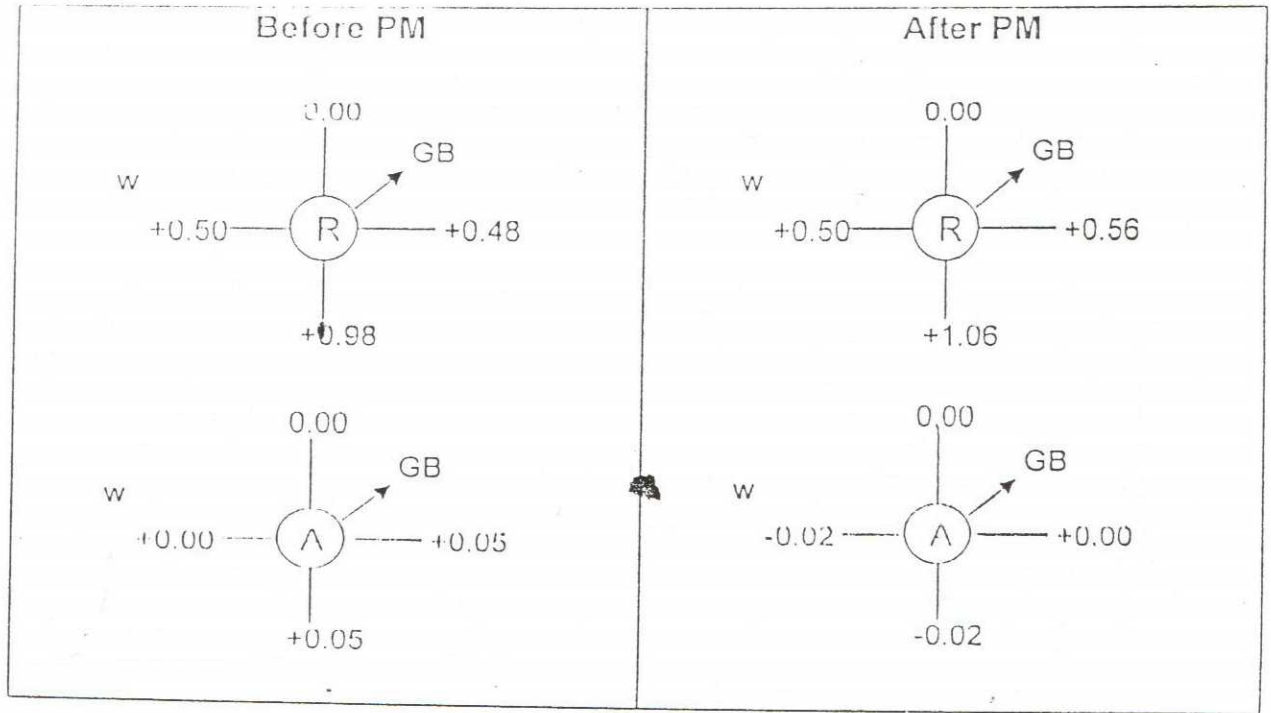
Alignment Readings (Dimms are in mm)

- Pitting was found on rotor shaft portion between partition and 8th stage wheel.
- Pitting found on roots of blades in last two wheel
- Silica deposits were observed on rotor blades.
- The rotor was in good condition and reused the same rotor after cleaning.
- Gauss measurement was carried out. Thrust collar and shaft found to have 8 Gauss and it was removed by degaussing.

- Partition planes of all diaphragm except 2nd and 3rd stage, found corroded.
- Grooves formed on top and bottom ring of diaphragm blades due to erosion. Erosion was severe on 4th, 5th, 6th & 7th stage diaphragms.

- Corrosion observed on casing top and bottom halves on 4th,5th,6th & 7th stage diaphragm seating area.
- SS inserts on 6th and 7th stage diaphragm also found corroded. SS inserts were provided during Annual Turnaround April 1997.
- Following Labyrinths were replaced with new one :
32 - 2 nos, # 30 - 2 nos.,# 64 - 3 nos, # 65 - 3 nos, # 66 - 1 nos.,# 9 - 2 nos

KJ 52 DDH - 5th stage diaphragm ,KJ 52 DDJ - 6th stage diaphragm & KJ 52 BBE - 7th stage diaphragm . These diaphragms were repaired by M/s Alstom Projects India Ltd., against our WO no. : 9912667 dtd. 16/01/2003. After assembling of diaphragms, it was observed that clearances was below recommended value. Hence machining of top and bottom ring of diaphragm blades on steam outlet end was carried out. For 6th stage a cut of 0.008" was taken and for 5th & 7th stage even though a cut of 0.014" & 0.022" was required respectively, maximum possible cut without cutting the edges of blades were taken. Spare for 4th stage diaphragm was not matching with the existing one. It is having part no. KJ BBB instead of KJ 52 BBB.

Nozzle clearance was found to be 0.056 ". Total float after placing top casing was 0.205". Journal bearing clearances were checked & recorded and found within limit. Inactive thrust ring was replaced with new one due to crack in the old one. Gauss measurement of bearings was carried out. Gauss reading of thrust end journal base ring was high. Hence it was removed.

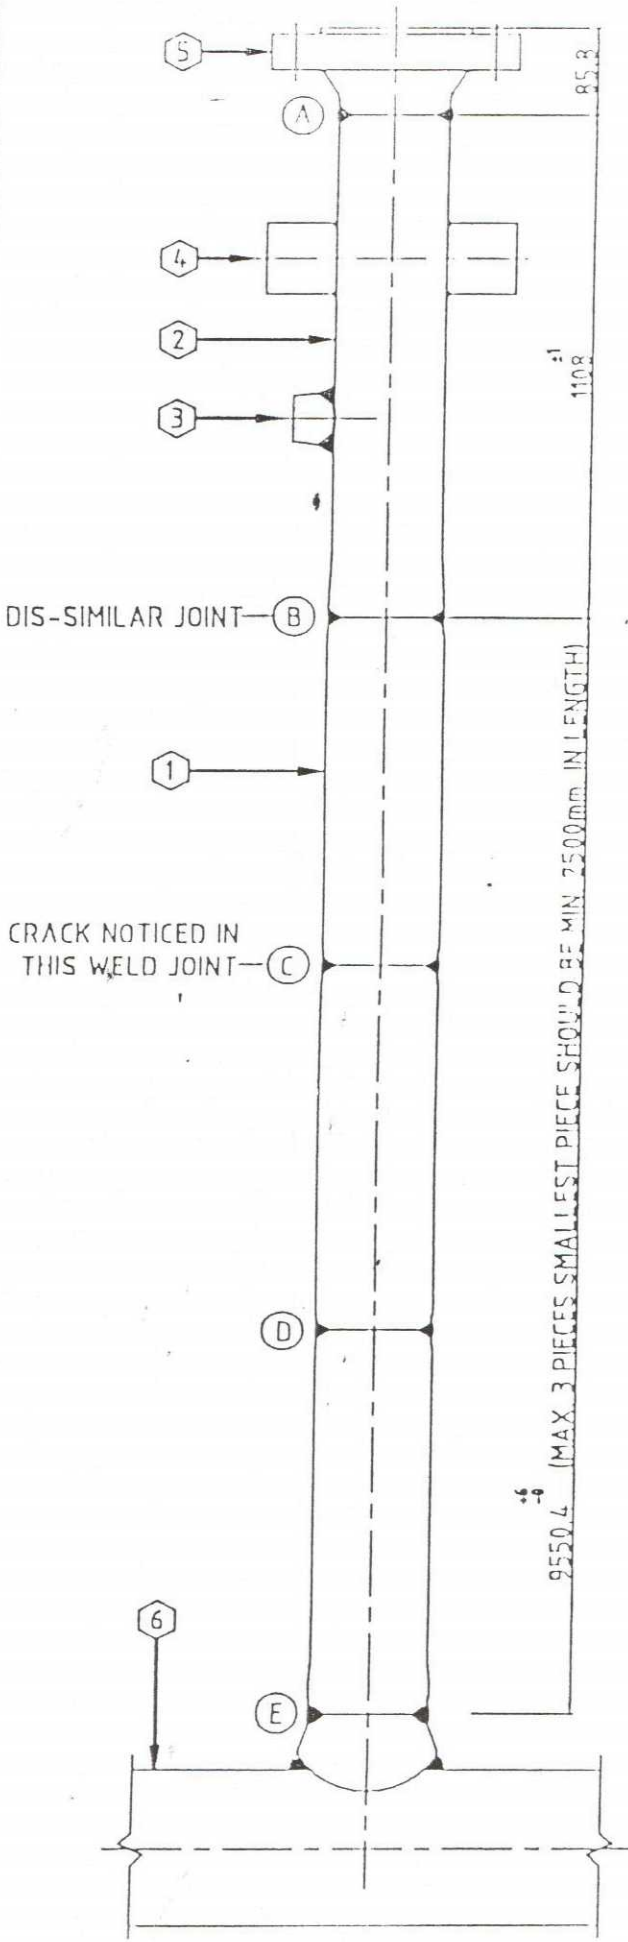
RISER TUBE FOR PRIMARY REFORMER (101-B)

In Ammonia plant, Ultrasonic scanning was carried out of all the reformer tubes by M/s PDIL. During radiographic weld examination of C-Joint of catalyst tube; cracks were found in several catalyst tubes. Total 25 no.s of defective tubes and 1 no. of defective riser were removed. The defective weld joint of all the removed tubes were rewelded after solution annealing. All the 25 no. of tubes and 1 no. of riser tube were replaced with new / repaired tubes.

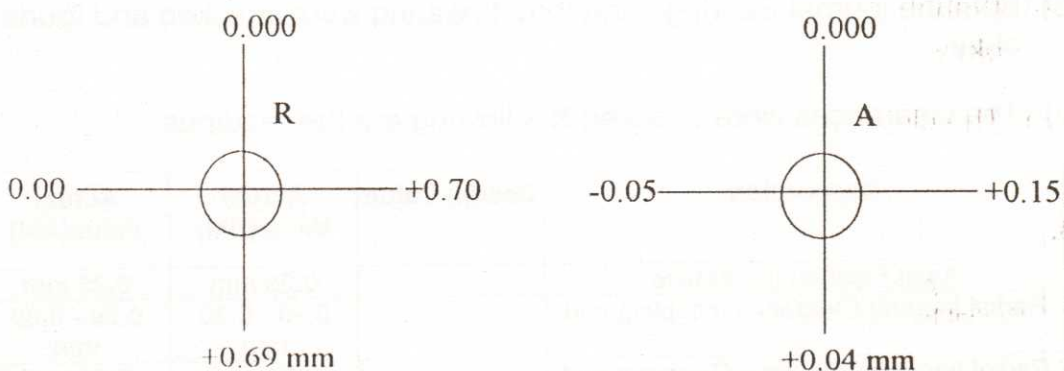
Following are the readings :

Dial on gear box Coupling

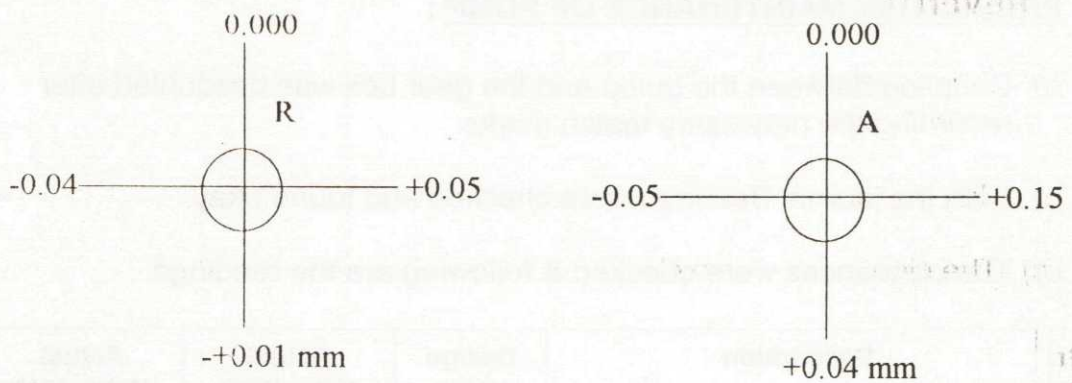
Alignment was corrected,
Following are the readings:
Dial on gear box coupling

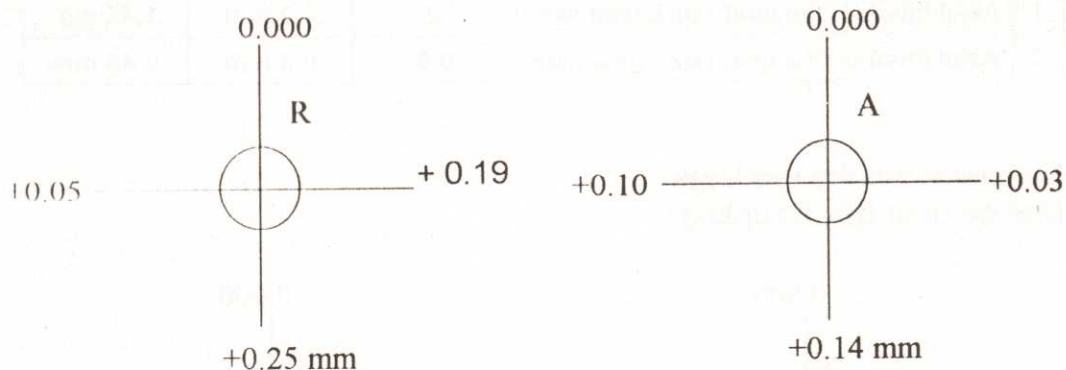
- d) Governor assembly was removed, cleaned, inspected and boxed up.
- e) Governor oil flushed and fresh oil (Servo 32 No.) charged.
- f) Oil console was drained, cleaned and fresh oil charged.
- g) Additional packing assembled in steam control valve.
- h) Main oil pump and Auxiliary oil pump suction strainer were cleaned & boxed up.
- i) Gear box to Turbine alignment was checked.

Following are the readings:

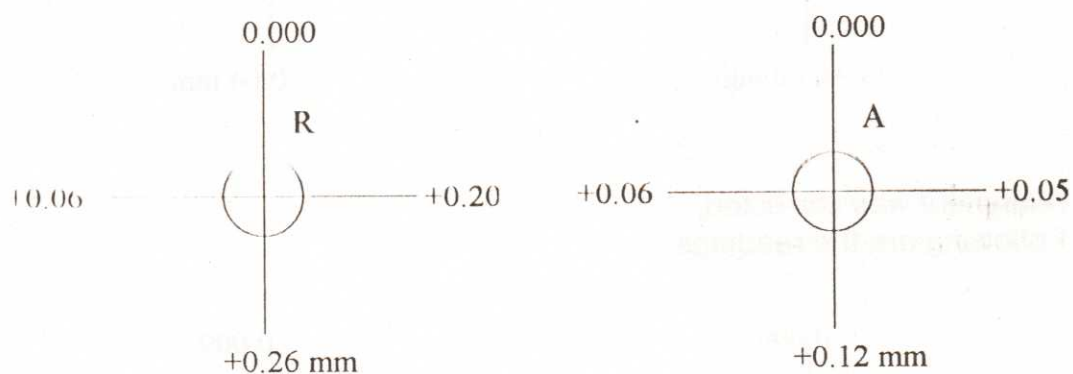
Alignment was corrected, Following are the readings:

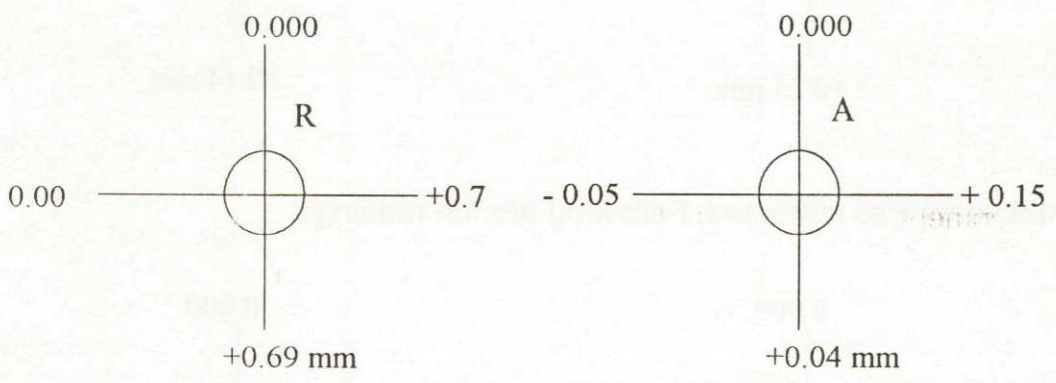
Following are the readings :
Dial on gear box Coupling :

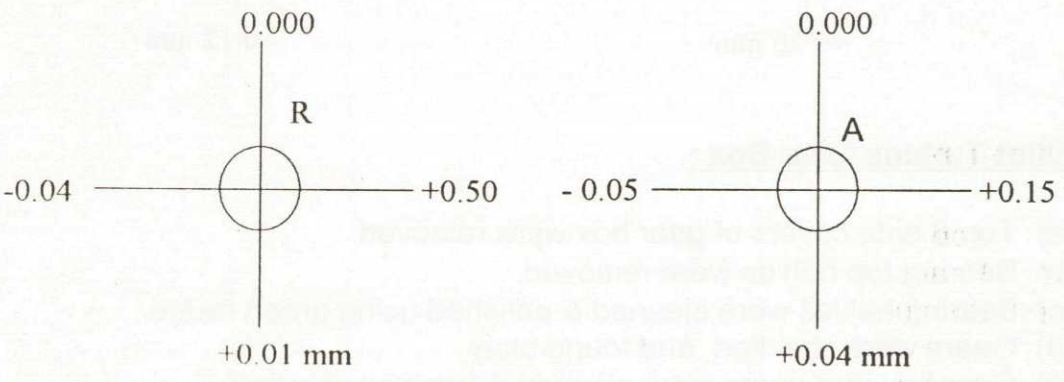
Alignment was corrected,
Following are the readings:

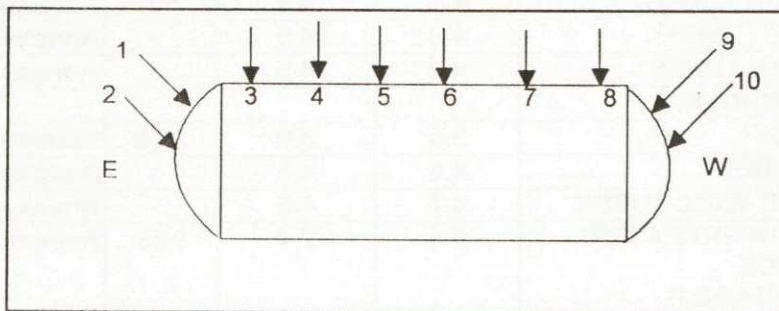
THICKNESS MEASUREMENT REPORT OF STEAM DRUM

<u>SHELL</u>				
POINT NO.	TOP	BOTTOM	NORTH	SOUTH
3	100.9	100.4	102.1	100.8
4	-	-	100.9	101.5
5	-	-	100.9	100.3
6	-	-	101.6	100.2
7	101	100.8	100.3	101.4
8	100.9	101	99.7	100.6
<u>DISH END:</u>				
POINT NO.	TOP	BOTTOM	NORTH	SOUTH
1(E)	78.3	79.6	79.7	79.7
2(E)	82	82.8	82.2	82.5
9(W)	82.1	80.4	82.2	80.2
10(W)	79	79.4	79.6	79.8

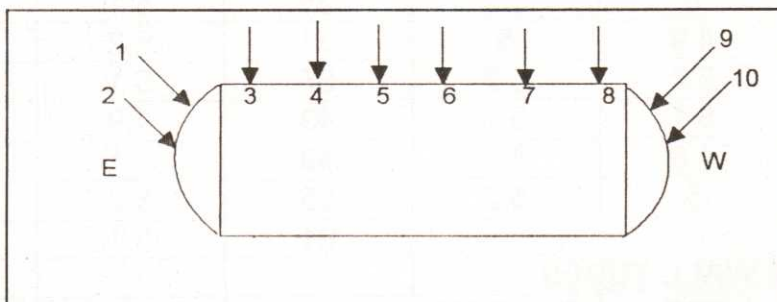
THICKNESS MEASUREMENT REPORT OF MUD DRUM

<u>SHELL :</u>				
POINT NO.	TOP	BOTTOM	NORTH	SOUTH
3	82.3	82.2	82	82.3
4	82.4	82.6	82.1	82.2
5	82.7	82.6	82.1	82.1
6	82.2	82.5	82.6	82.5
7	82.3	82.5	82.7	82.6
<u>DISH END:</u>				
POINT NO.	TOP	BOTTOM	NORTH	SOUTH
1(E)	58.9	58.3	58.4	58.1
2(E)	56	57.2	55.3	58.7
8(W)	56.2	56.4	58.2	56.5
9(W)	57.9	58.2	57	58.7
