# P R E F A C E

Plant Turnaround for the year 2004 was carried out from 20-05-2004 to 09-06-2004 for preventive maintenance of the plant equipment / miscellaneous jobs pending for the plant shutdown, including hooking up or taking tapings for the ambitious energy saving schemes of the Ammonia plant.

#### **AMMONIA PLANT**

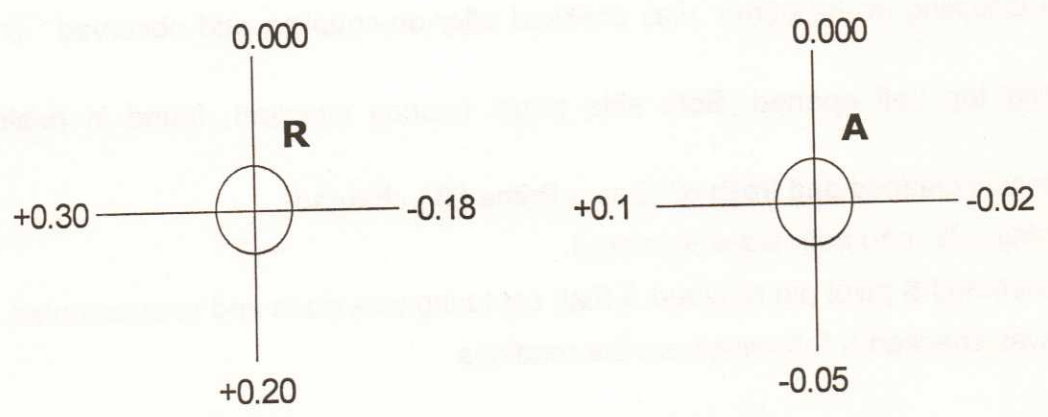
Both the journal Bearings were checked & found okay.  
The clearances were checked & following are the readings.  
Free end side: 0.27 mm  
Coupling side: 0.30 mm  
Both the bearing housing were flushed with oil & fresh oil servo prime 68 charged in the both bearing housing.  
Decoupled the pump coupling, cleaned & greasing done.  
Gland packing (25 mm) both sides repacked.  
Worn-out markings were found on Pump side coupling teeth upto 10 mm length.  
Bearing Housing drain valves replaced. (3/8" N.B. Gun metal valve)  
Alignment was checked & followings are the readings

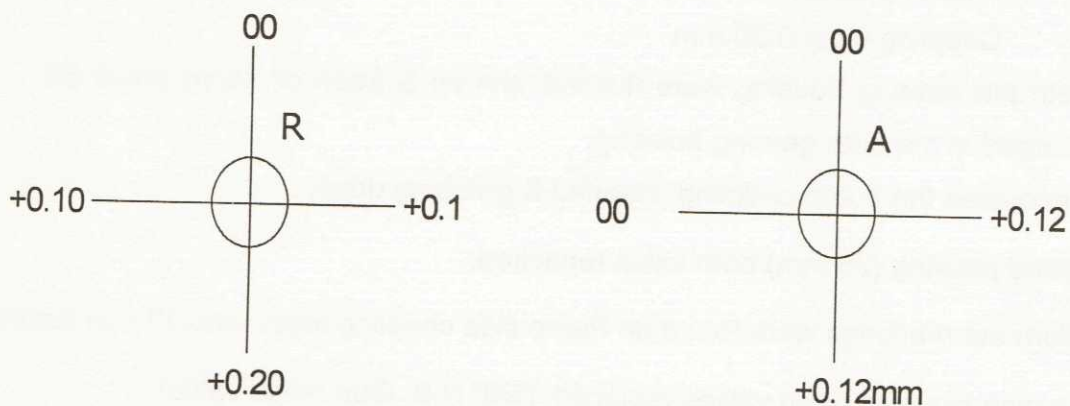
### COOLING WATER PUMP (P-4401 / D):

The lining of coupling end side journal bearing was pilled off at one location. Hence journal bearing was replaced. Final clearance : 0.20 mm

Pump casing lifted & heavy cavitations & pin holes was found on rotor. The new rotor assembly was replaced. (333300035 Repaired Item). This rotor was originally installed in P-4402 & was removed 2003 and repaired in Mech workshop by welding (Electrode 680).

Thrust bearing was found worn out hence replaced new bearing as SKF 6318 (455001124).

Gland packing (25 mm) both sides replaced.

Bearing housing drain valves replaced. (3/8" N.B. Gun metal valve).

Cleaned & greasing done after coupling.

Pump & Motor alignment was checked. The following are the readings:

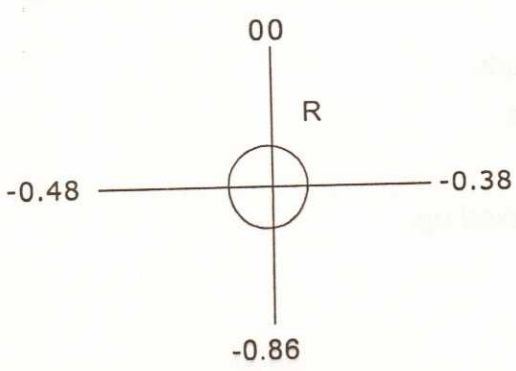
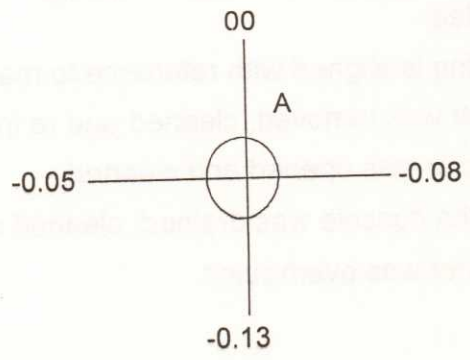
Alignment Readings: Pump To Turbine (Before Preventive maintenance)

Sr. No.	Description	Design Value	Actual Value (BM)	Actual Value
1	Axial Thrust	0.28 - 0.33	0.18 mm	0.18 mm
2	Radial bearing Clearance coupling end	0.13 - 0.18	0.15 mm	0.15 mm
3	Radial bearing Clearance free end	0.13 - 0.18	0.12 mm	0.12 mm
4	Oil Laby. clearance CE		0.20-0.25	0.12-0.15
5	Oil Laby clearance TE		0.20-0.25	0.17-0.18
6	Coupling Float			9.30 mm

- Removal of coupling spacer - Match marks was checked.
- Checking of alignment & axial play of pump shaft.
- Removal of DE & NDE bearings top halves.
- Cleaning of Radial & Thrust bearings.
- Checking radial clearances of bearings using lead wire.
- Alignment readings and bearings clearances were checked.
- Same bearings were assembled after polishing and cleaning.
- Install coupling spacer with reference to match marks.
- Cleaning / replacing oil filters and oil in the oil console.
- Checking oil line, water line for leaks.
- Suction filter of the pump was cleaned

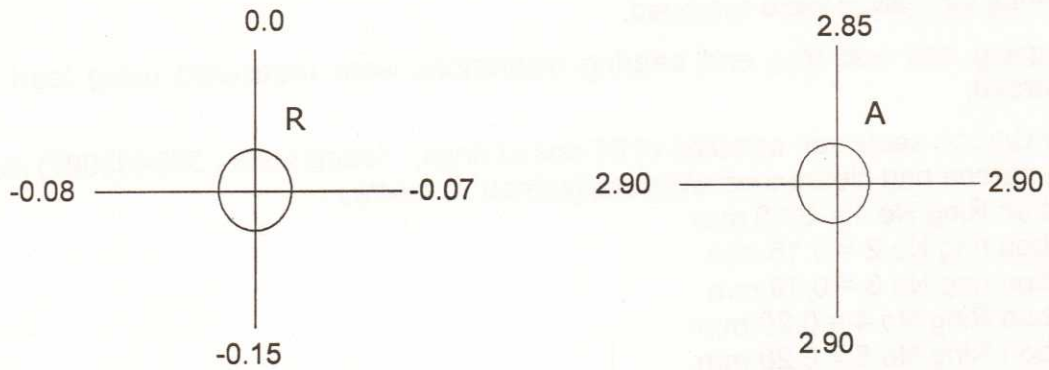
**Gear Box to Motor: Before Preventive Maintenance:**

Sr. No.	Description	Actual value (Before)	Actual value APM
1	Bull gear axial float	0.15	0.17
2	Pinion DE bearing clearance	0.15 - 0.16	0.15
3	Pinion NDE Bearing Clearance	0.15 - 0.17	0.15 - 0.17 mm
4	Bull gear D/E bearing clearance	0.13 - 0.15	0.13 - 0.15
5	Bull gear NDE bearing clearance	0.12 - 0.13	0.12 - 0.13 mm
6	Coupling float motor to GB	7.70	7.90
7	Coupling Float (Gear Box to Pump)	8.30	8.65
